4.20 TICONDEROGA RANGE (OLD) MRS (NYHQ-021-R-01) AND TICONDEROGA RANGE (OLD) SDZ (NYHQ-021-R-02)

4.20.1 Site Description

Figure 4.20-1
Ticonderoga Range (old) (Aerial)
AEDB-R # NYHQ-021-R-01
Essex County, New York

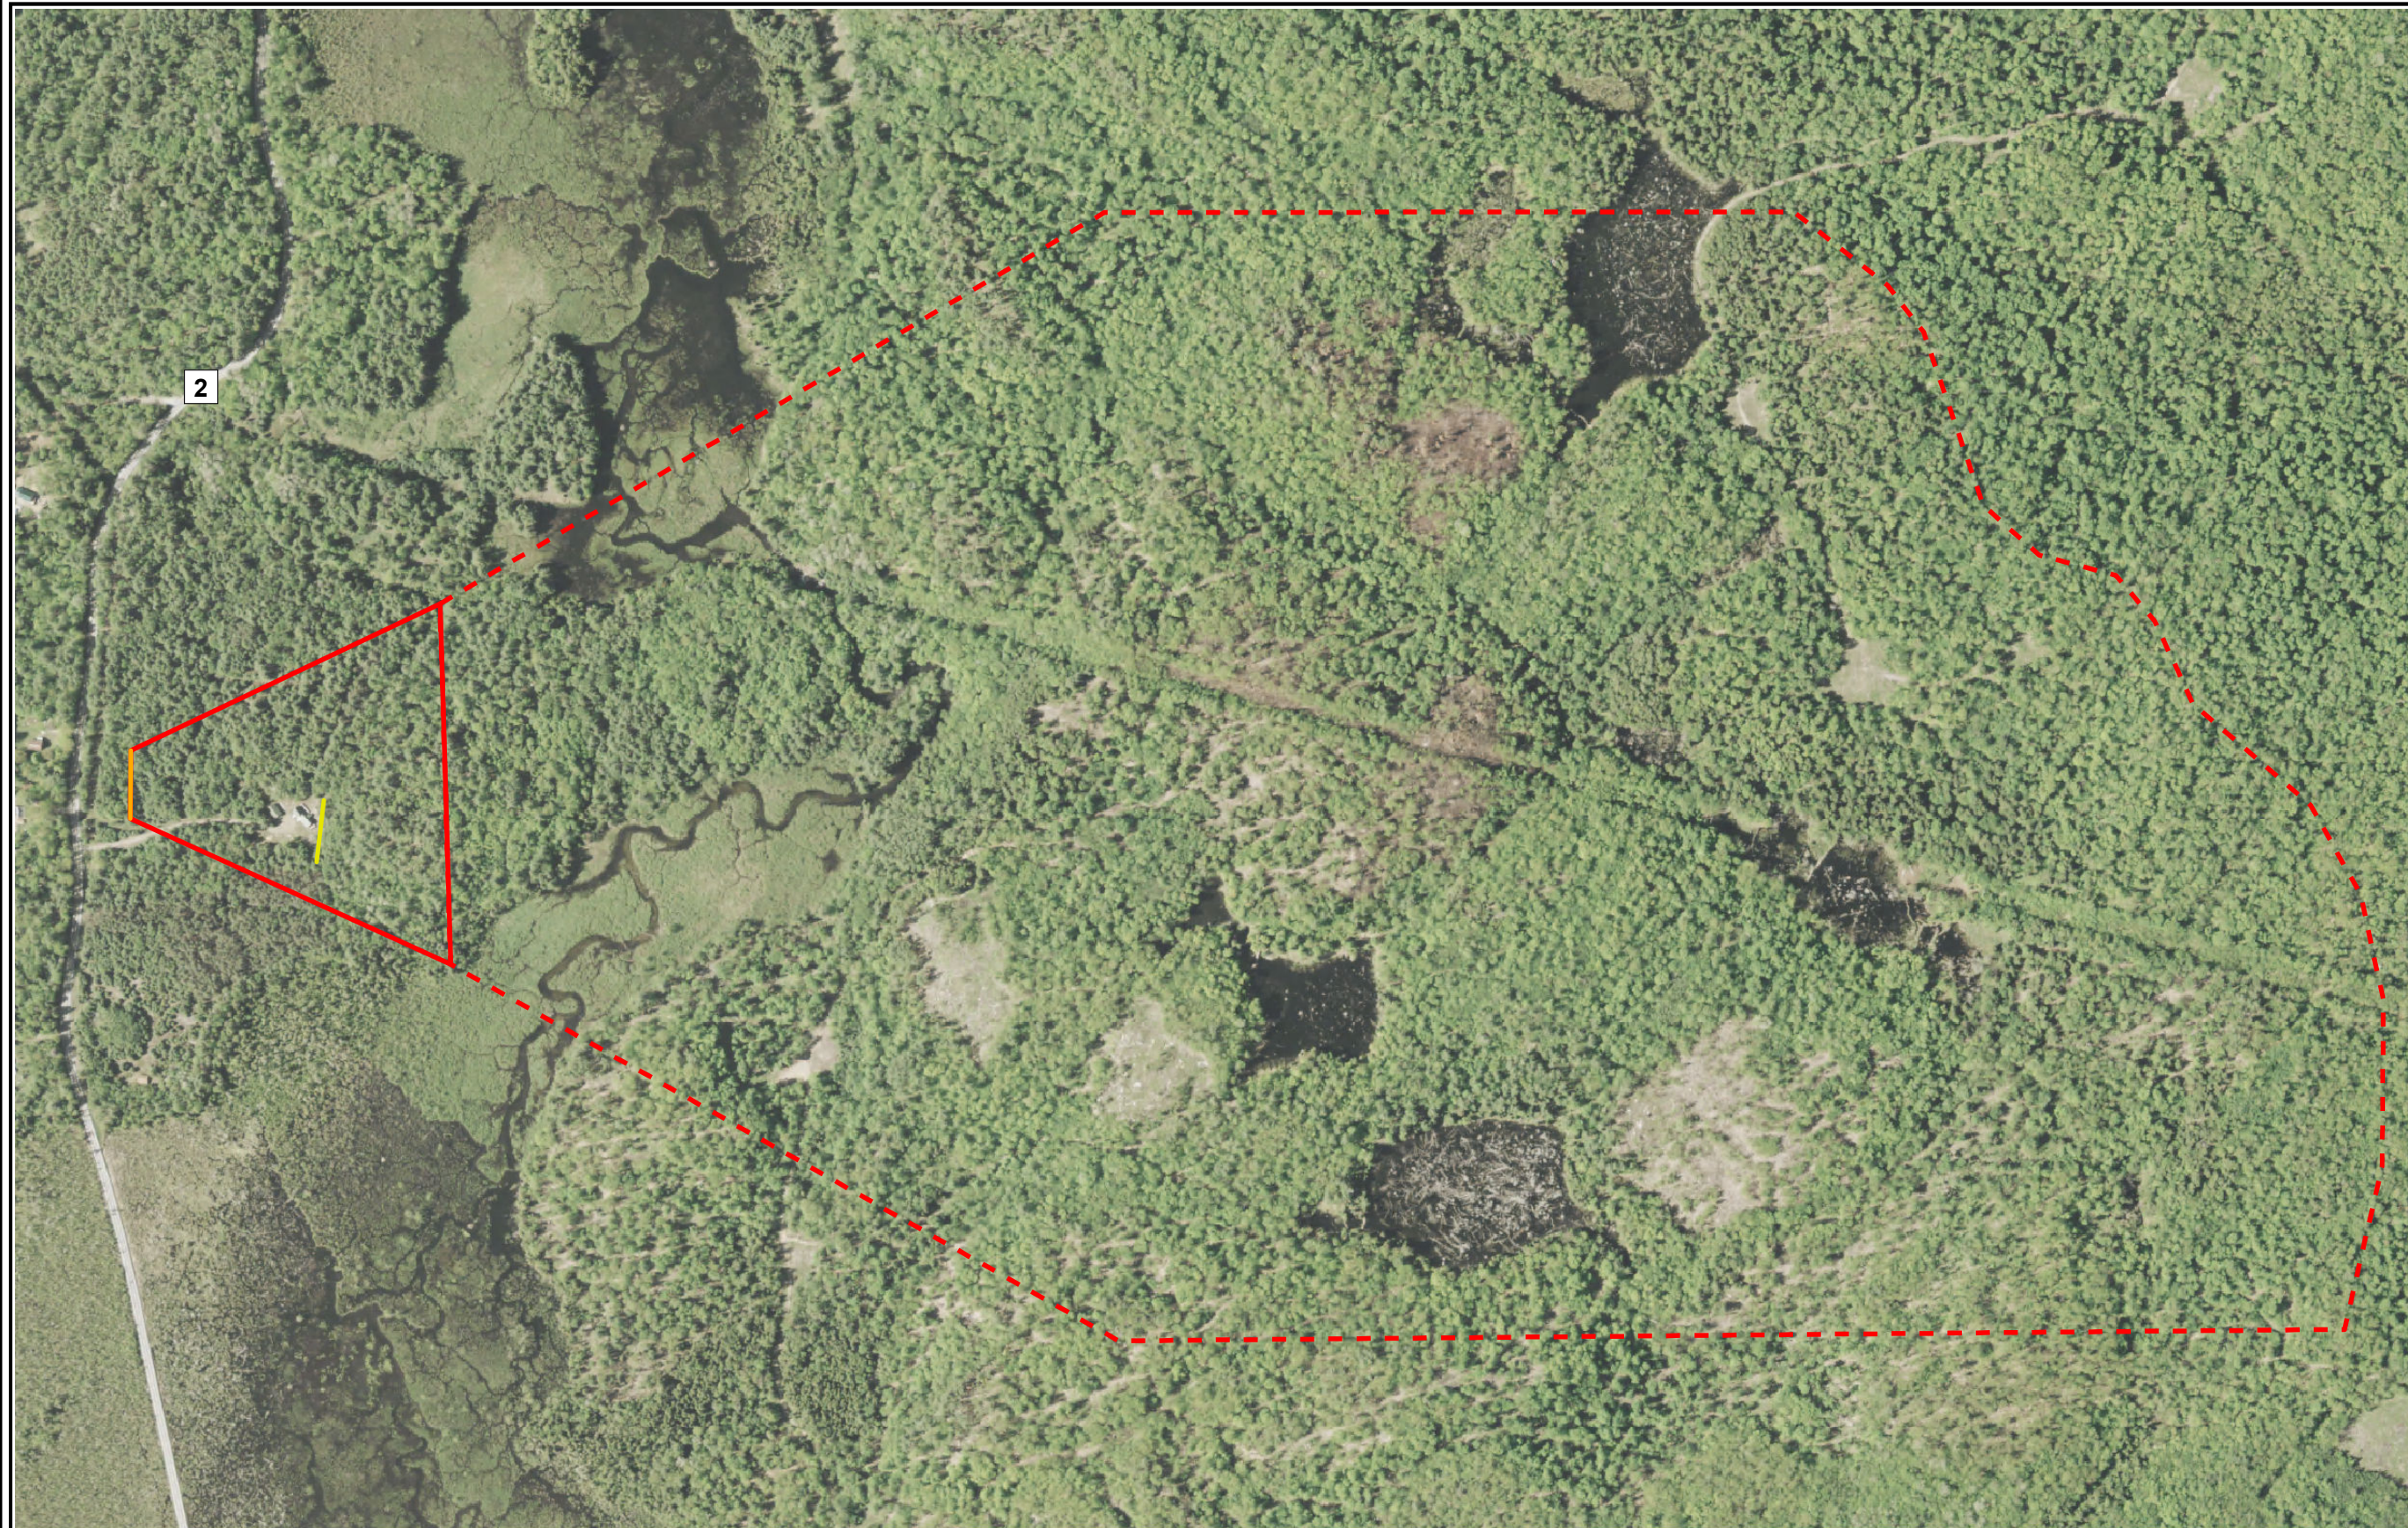
As documented in the approved HRR/WP the MRS was divided approximately 100 yards behind (east) of the target berm. Ticonderoga Range (old) MRS includes the suspected firing point location, the target berm, part of the natural backstop and 100 yards behind the berm. The Ticonderoga Range (old) MRS is approximately 15.5 acres. Ticonderoga Range (old) SDZ MRS includes the remainder of the land east of the target berm and is approximately 394 acres. Currently, the MRSs include undeveloped forested land. One residential property is located on Ticonderoga Range (old). The MRS location is shown in Figure 4.20-1.

At the small arms range, the direction of fire was to the east with seven targets and a natural backstop was located east of the targets. The range was approximately 250 feet wide by 900 feet long. Potential munitions used were small arms (.22, .30 .38, .45 and .50 caliber, and 5.56mm and 7.62mm).

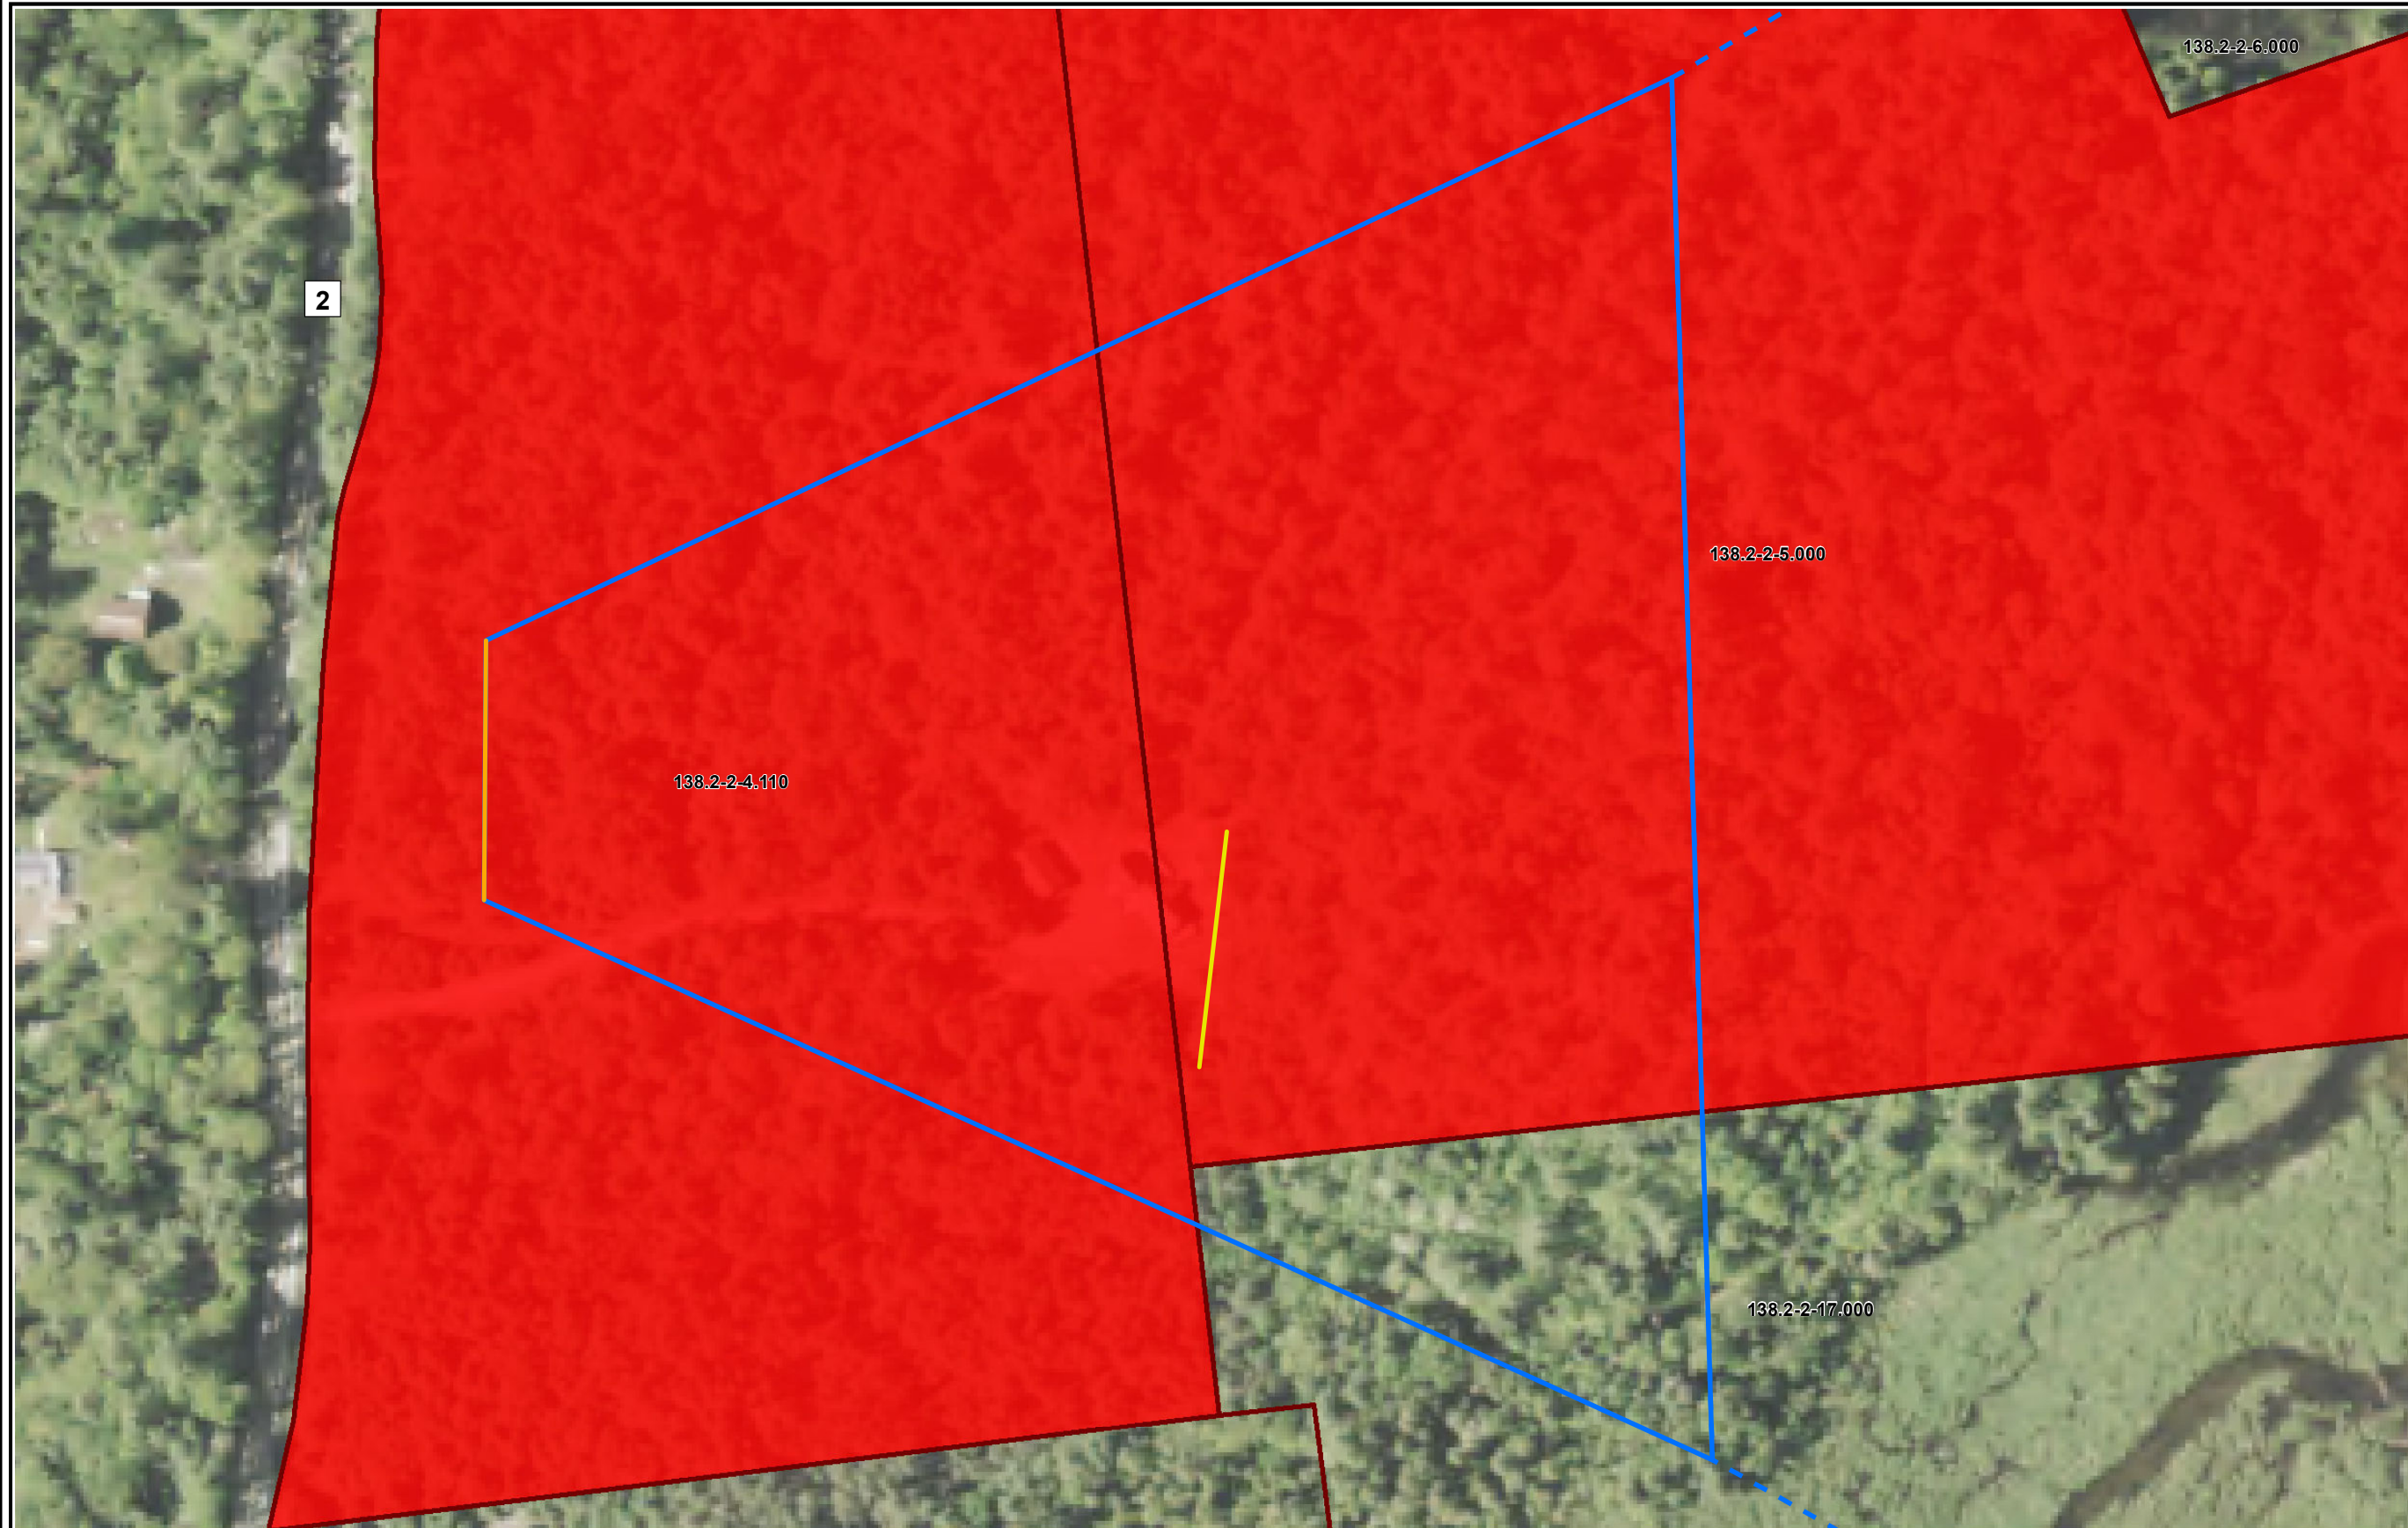
Figure 4.20-2
Ticonderoga Range (old) – ROE Refusal
AEDB-R # NYHQ-021-R-01
Essex County, New York

Table 4.20-1 lists the three properties, or “parcels” for which site access was requested by USACE in order to complete the SI for both the Ticonderoga Range (old) MRS and the Ticonderoga Range (old) SDZ MRS. The parcels are shown on Figure 4.20-2. Access to the parcels was required in order for fieldwork to be completed. ROEs were not obtained for any of the three parcels; therefore, fieldwork could not be completed as planned at the MRS.

The ROE for parcels 138.2-1-21.000, 138.2-2-4.110 and 138.2-2-5.000 were refused prior to the Final HRR/WP approval and negotiations with the landowner were unsuccessful; therefore, no fieldwork was proposed for this site.

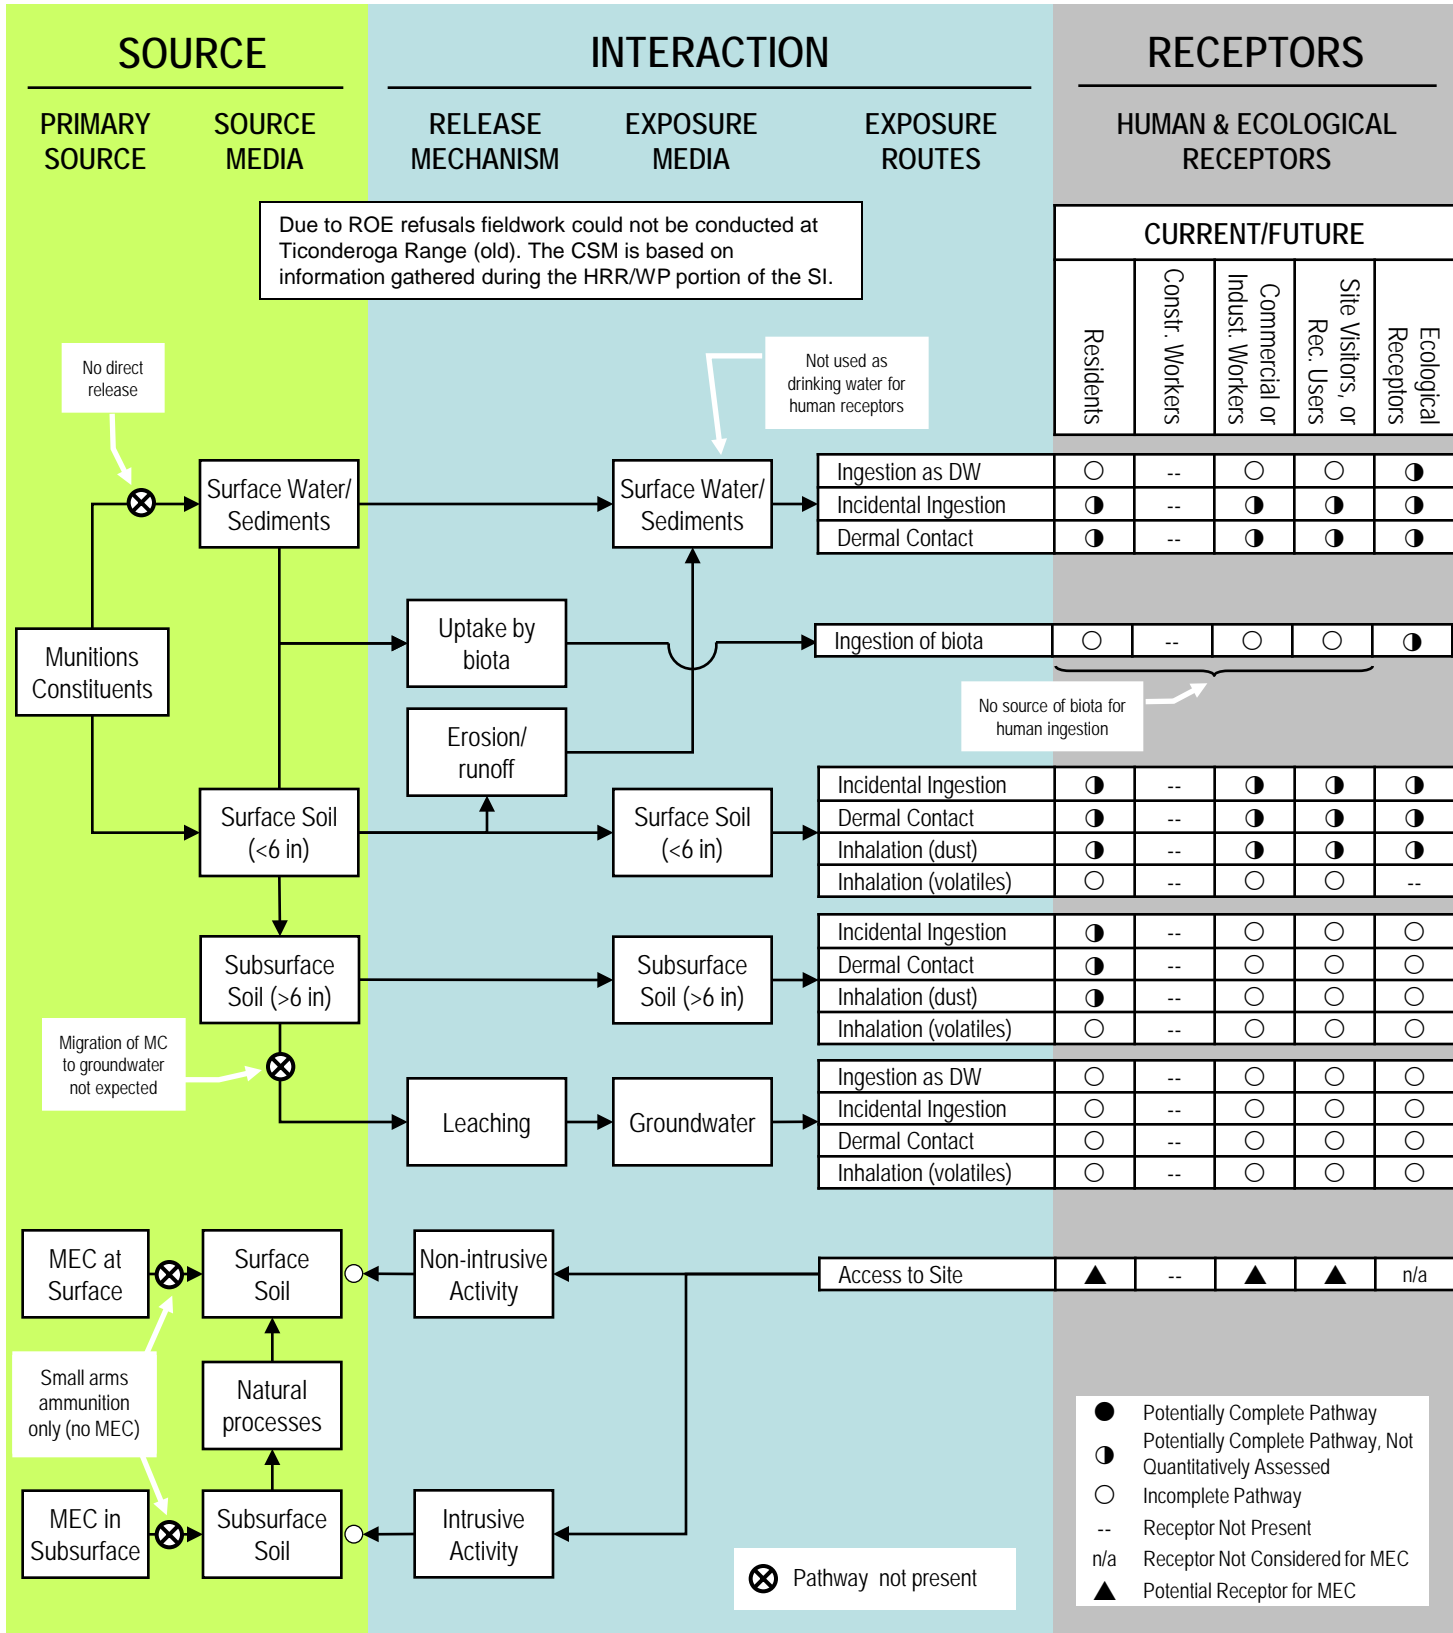
FIGURE 4.20-3A CONCEPTUAL SITE MODEL DIAGRAM

The CSM for these MRSs (Table 4.20-2) describes the physical profile, including geology, topography, soil classification and climate, potential release mechanisms, and land use and ecological exposure profiles together with the current understanding of the site. Figure 4.20-3a and b present the CSMs for the Ticonderoga Range (old) MRS and the Ticonderoga Range (old) SDZ MRS, respectively, current and potential future receptors in graphical form pursuant to EM 1110-1-1200 (USACE, 2003).

Profile Type	MRS Characterization
	<p>chemical degradation over time, which results in these compounds being less persistent in the environment than MC metals. Based on these properties, while MC compounds potentially are present in surface and subsurface soil, the migration of MC metals to groundwater is not expected at this MRS. No surface water/sediment present within the MRS. Based on the limited amount of contaminated surface soil anticipated, contaminated dust is not expected to migrate off-site.</p> <p>Ticonderoga Range (old) SDZ: None, no source present.</p>
	<p><u>Pathway Analysis:</u> While the presence of MC contamination at this MRS has not been confirmed, the historic use of the site may have resulted in the release of MC to site media. All pathways noted that are potentially complete were not quantitatively assessed given the ROE refusals at this MRS. Based on the possible presence of MC in surface soil, the primary potentially complete exposure pathways for residents, commercial or industrial workers, and site visitors are through direct contact (i.e., incidental ingestion, dermal contact, and inhalation of suspended particulates).</p> <p>There is also the potential for exposure to these compounds in subsurface soil for residents during intrusive gardening activities; however, these pathways are considered to be potentially complete but not quantitatively assessed. The subsurface exposure pathways are incomplete for the commercial/industrial workers and site visitors because it is unlikely for these receptors to expose themselves to subsurface soil for anticipated non-intrusive activities.</p> <p>There is no surface water in the vicinity of the area where munitions were formerly used, however, there is potential that MC in soil might have migrated to surface water within the MRS via erosion/runoff. Therefore, surface water and sediment exposure pathways (i.e., incidental ingestion and dermal contact) are potentially complete but not quantitatively assessed for all receptors within the MRS. The ingestion as drinking water exposure pathway is incomplete because the surface water is not used as a source of drinking water by human receptors. The groundwater exposure pathways are incomplete for all receptors because migration of MC to groundwater is not expected. The ingestion of biota exposure pathway is incomplete for all receptors at this MRS because there are no sources of biota for human ingestion.</p> <p>MEC is not anticipated at the MRS since only small arms ammunition was used.</p> <p>Ticonderoga Range (old) SDZ: None of the exposure pathways are potentially complete for all receptors within the MRS since no source is present.</p>

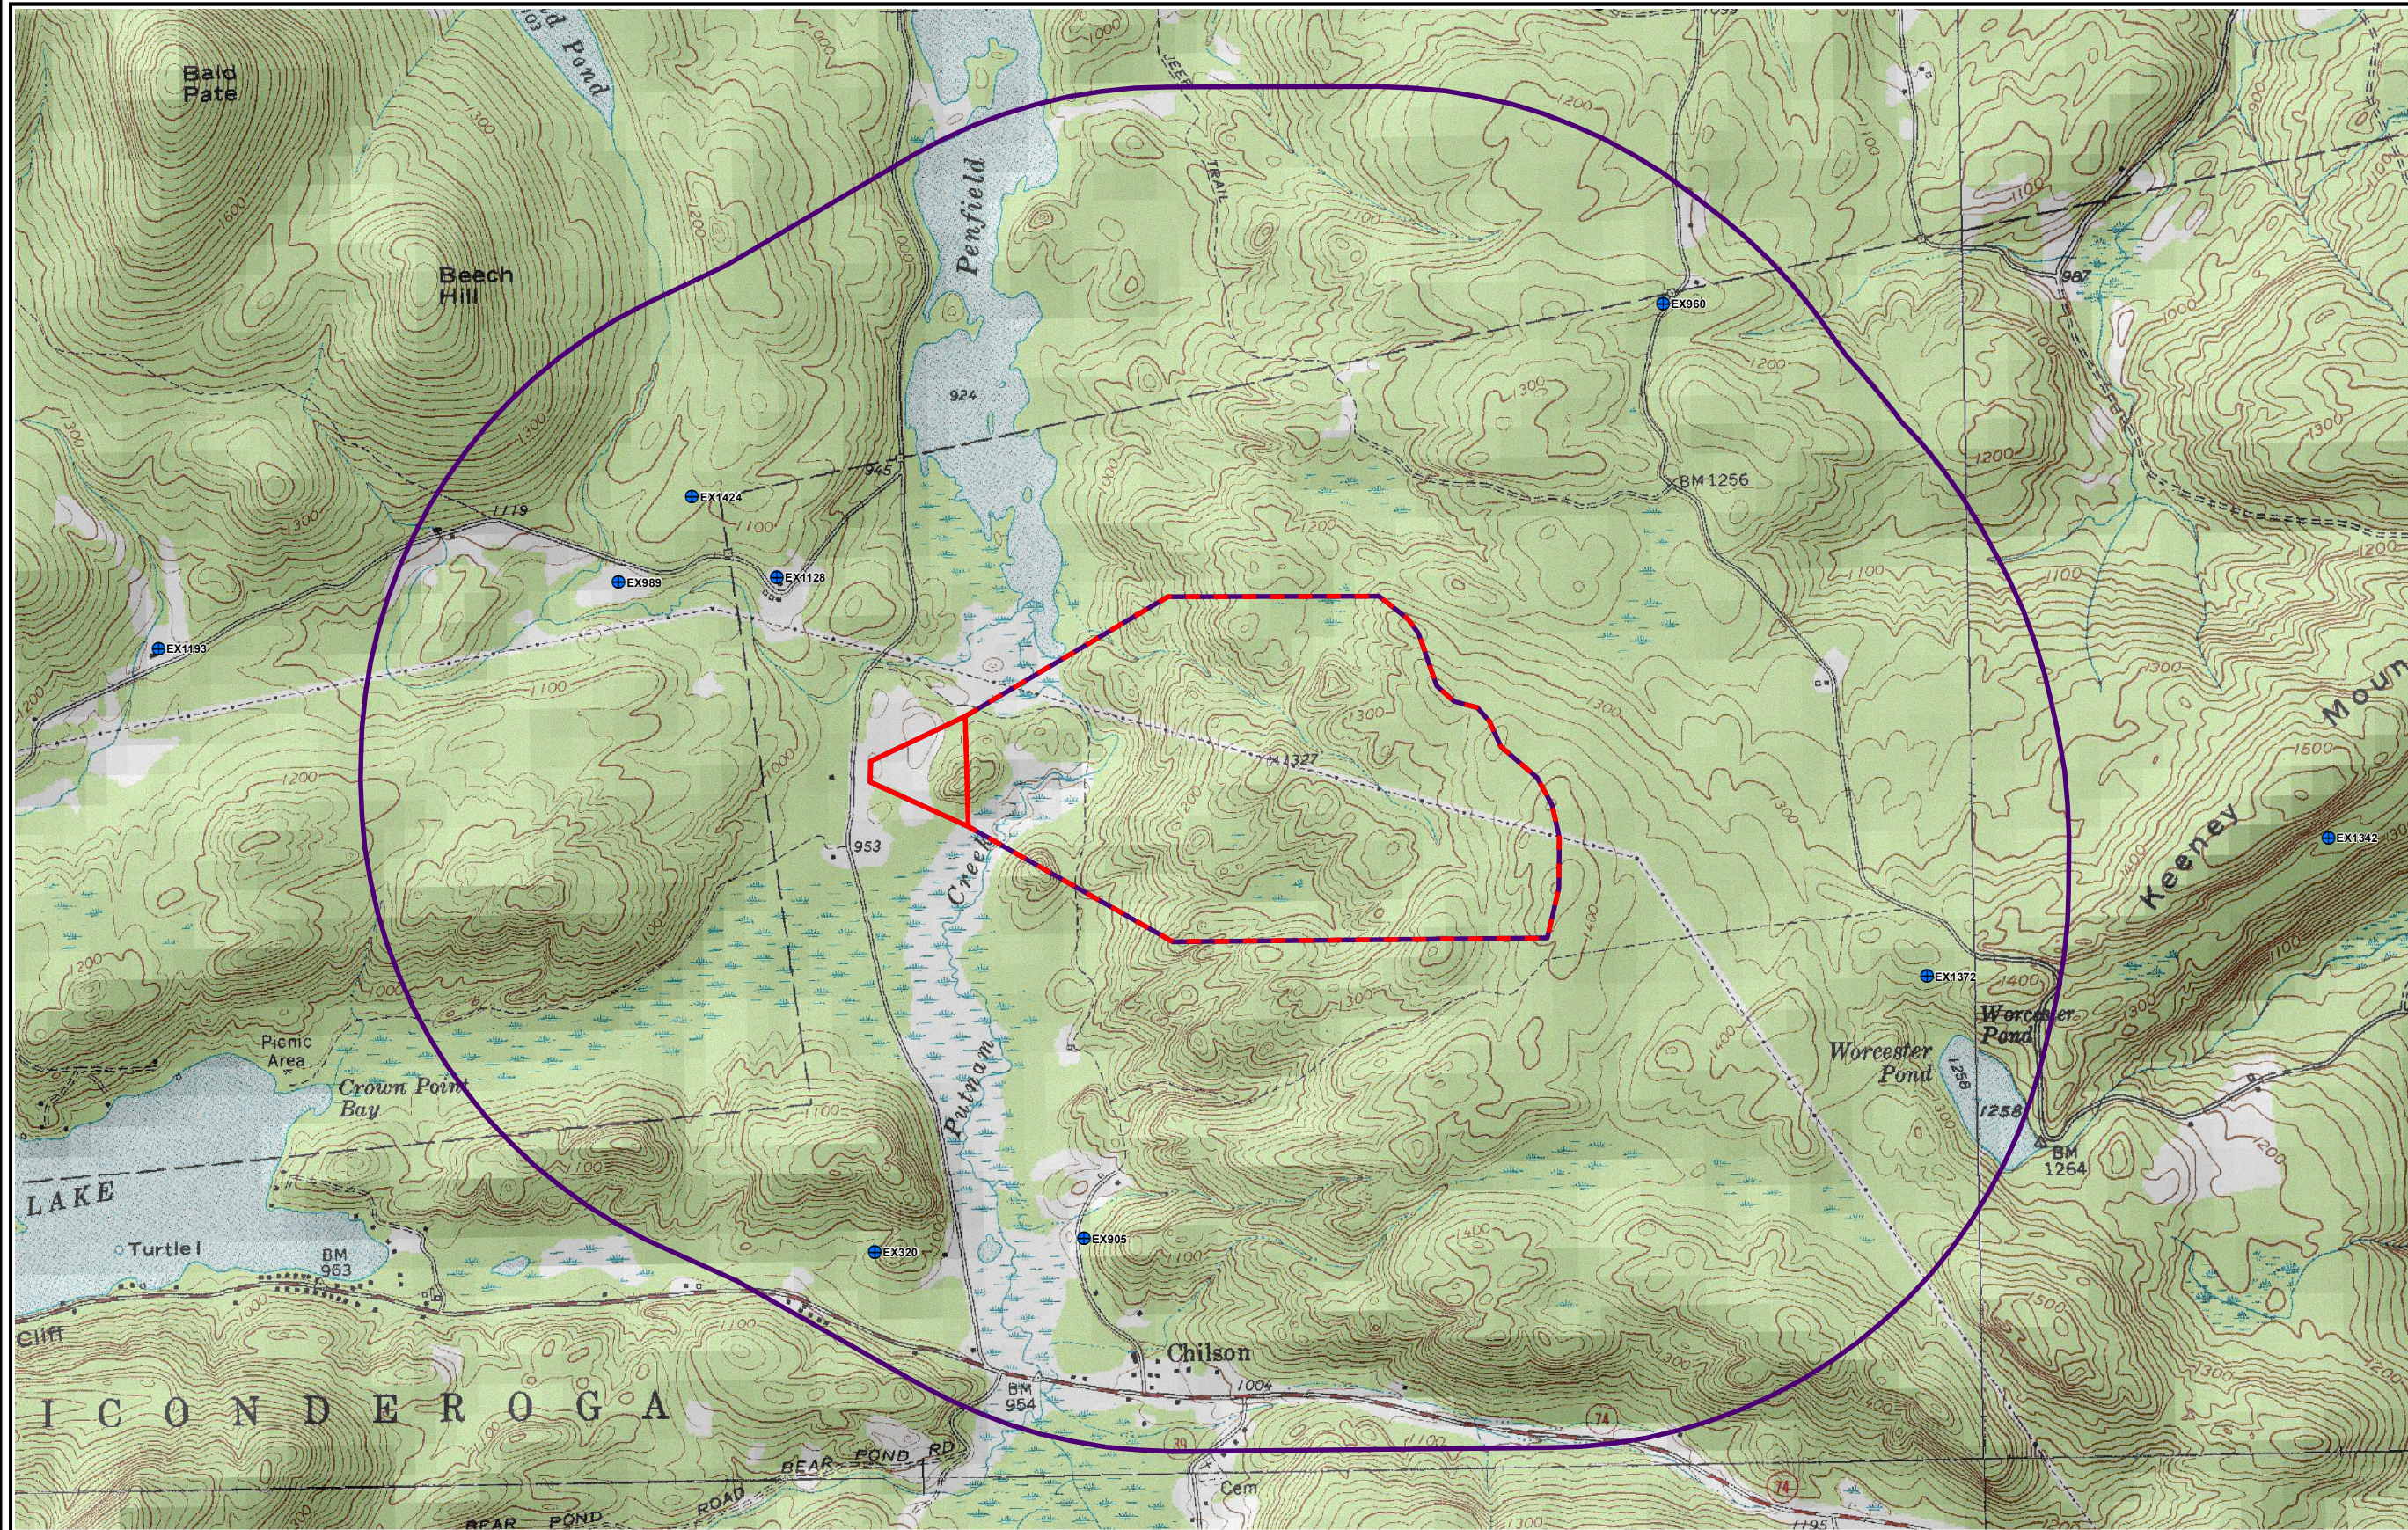
Figure 4.20-5
Ticonderoga Range (old) - Water Wells Within 1-Mile Buffer
AEDB-R # NYHQ-021-R-01
Essex County, New York

<p><u>Soil:</u> The soil within the Ticonderoga Range (old) MRS is predominantly Champlain loamy sand in a stream terrace landform. The material is derived from sandy glacial lake deposits. A typical soil profile is loamy sand from 0 to 10 inches; sand from 10 to 16 inches; fine sand from 16 to 50 inches; and sand from 50 to 72 inches. The soil on the hill at the eastern border of the MRS is Lyman-Knob Lock complex on a steep, very rocky surface. The material is derived from glacial till. The soil profiles for the components of this soil complex include decomposed plant material at the surface, a relatively thin layer of gravelly sandy loam or fine sandy loam on shallow unweathered bedrock. (NRCS, 2011).</p>
	<p><u>Hydrogeology:</u> USGS well data in the vicinity of the Ticonderoga Range (old) MRS indicate aquifers are found primarily in rocks of the basement complex (USGS, 2011). The basement complex consists of crystalline igneous and metamorphic rocks, primarily granitic gneiss and metamorphosed sedimentary rocks (Thompson et al., 1990). The intergranular porosity of crystalline rocks is insignificant and pore spaces are not interconnected. Therefore, movement of water through crystalline rock aquifers is dependent on fractures and jointing within the rock. The fracture permeability in crystalline rocks is a result of cooling of igneous rocks, deformation of metamorphic rocks, faulting and weathering. Such openings may follow the original fabric of the rock but are generally very heterogeneous in size, orientation, and degree of interconnectivity. Fracture permeability tends to decrease with increasing depth. Water in these aquifers is generally unconfined. Well yields commonly range from 2 to 10 gpm (Olcott, 1995).</p> <p>There are no groundwater wells within the Ticonderoga Range (old) MRS as shown in Figure 4.20-5. Domestic well number EX1128 is approximately 0.4-mile northwest of the MRS. The well depth is reported as 725 feet below land surface and the water depth is reported at 716 feet.</p>
