Re: Submittal of Technical Data and Information  
Former Camarota Cleaners  
327 Park Avenue, Mechanicville, New York

This letter transmits the technical data, photographs, and information collected on behalf of Royal R. Dyer Construction Co. Inc. (Dyer Construction) for the former Camarota Cleaners property (site) in Mechanicville. We understand that through mutual agreement, NYSDEC will perform future work that is required at this site.

The work included installing and sampling four permanent ground water monitoring wells, installing hybrid poplar trees surrounding three sides of the property to promote phytoremediation, excavating and removing a previously unknown, abandoned underground storage tank (UST), and installing a sub-slab depressurization system within the former Camarota Cleaners building.

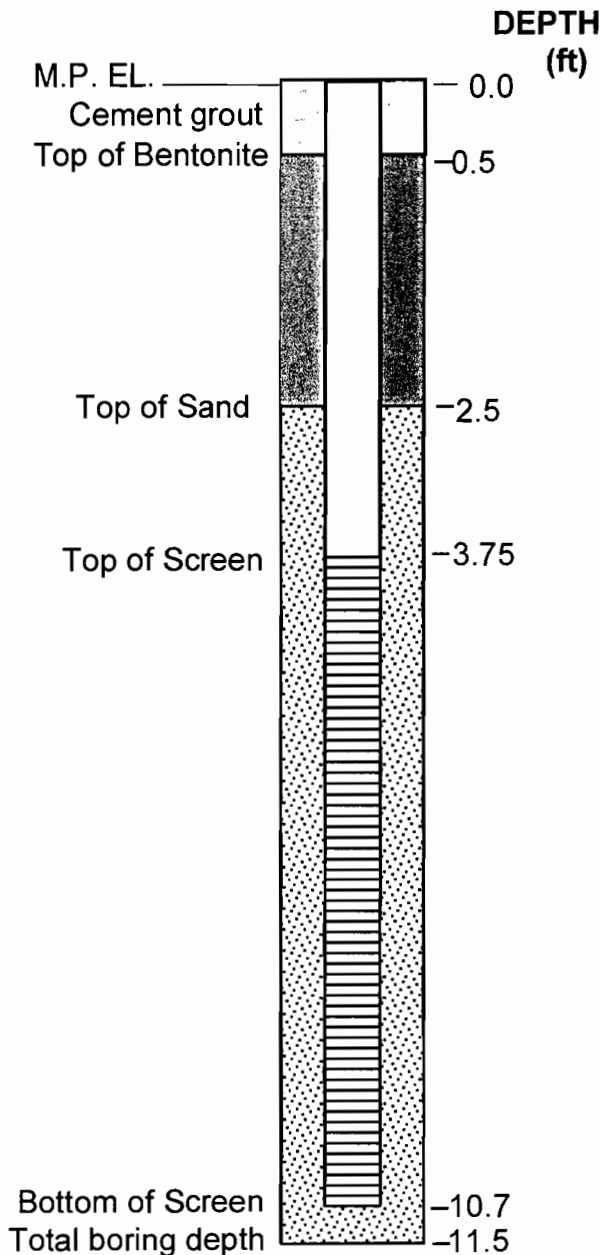
Well MW-2  
Project Camarota Cleaners  
Project No. 07108  
Client Royal R. Dyer Construction  
Date Drilled 4/17/07  
Date Developed 4/17/07

Geologist J. M. Neubeck  
Drilling Contractor ADT, Inc.  
Type of Well Monitoring  
Static Water Level 5.33\* Date 4/17/07  
Measuring Point Top of PVC  
Total Well Depth 10.7 feet below ground surface  
\*Measured before well development

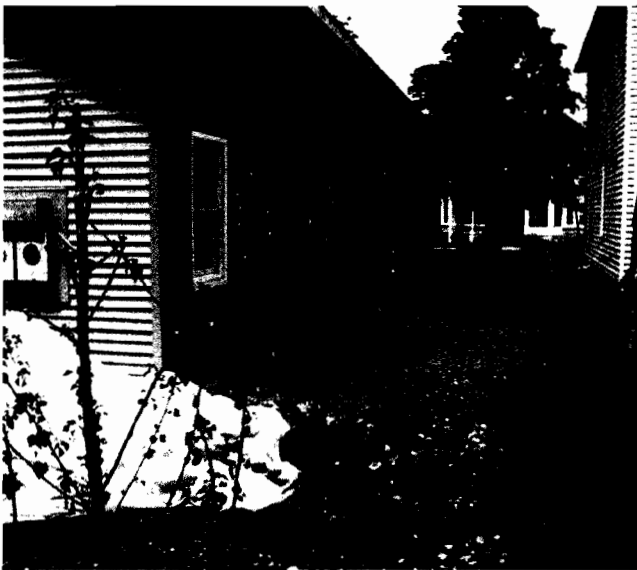
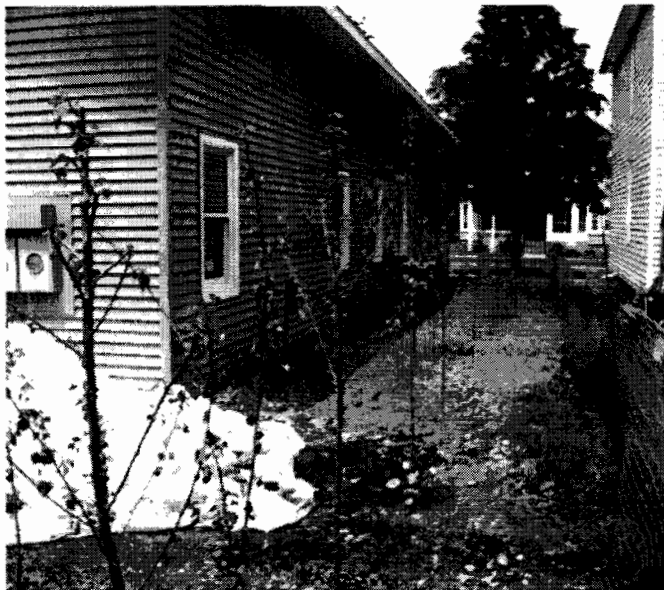
East yard, looking north

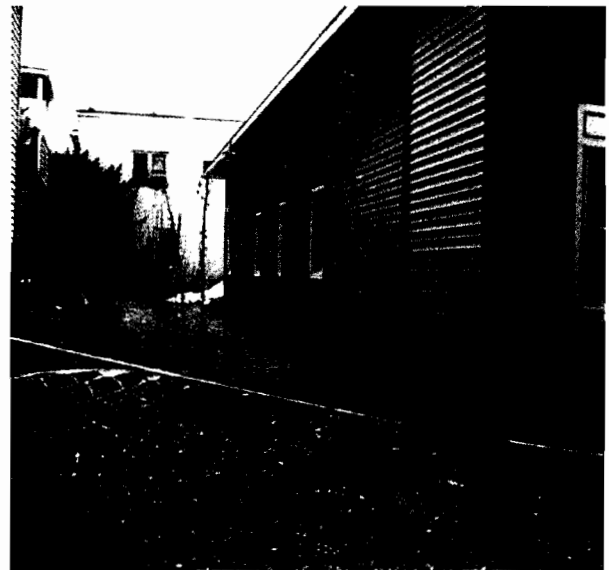
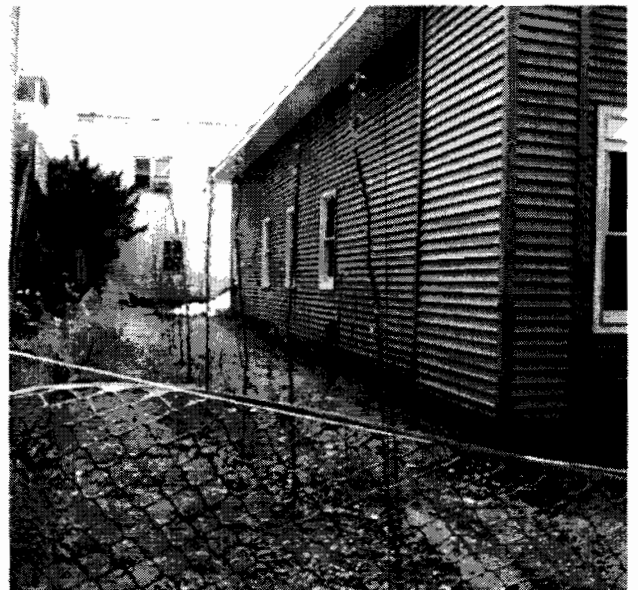
East yard, looking south

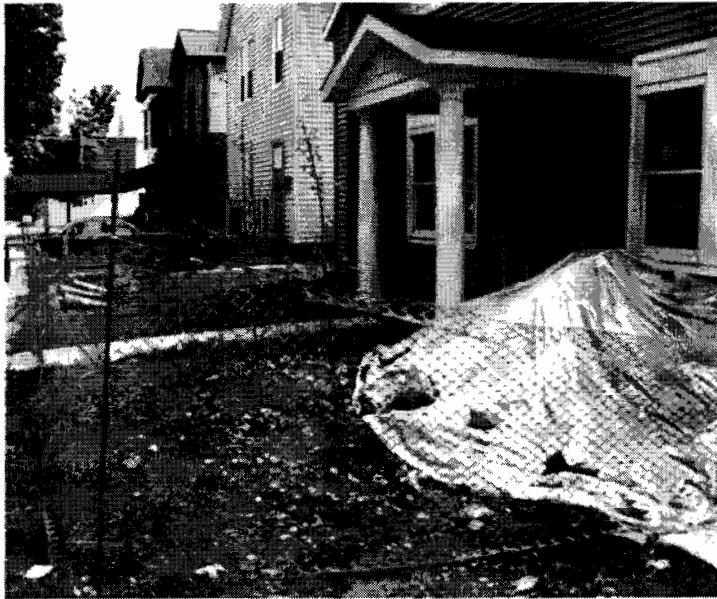
Front (north) yard, looking east
