**ENGINEERING INVESTIGATIONS
AT INACTIVE HAZARDOUS
WASTE SITES
PHASE II INVESTIGATION**

Ilion Landfill
Site No. 622004
Village of Ilion, Herkimer County
Final - April 1988

EA REPORT DEC52E1

ILION LANDFILL
VILLAGE OF ILION, HERKIMER COUNTY
NEW YORK I.D. NO. 622004

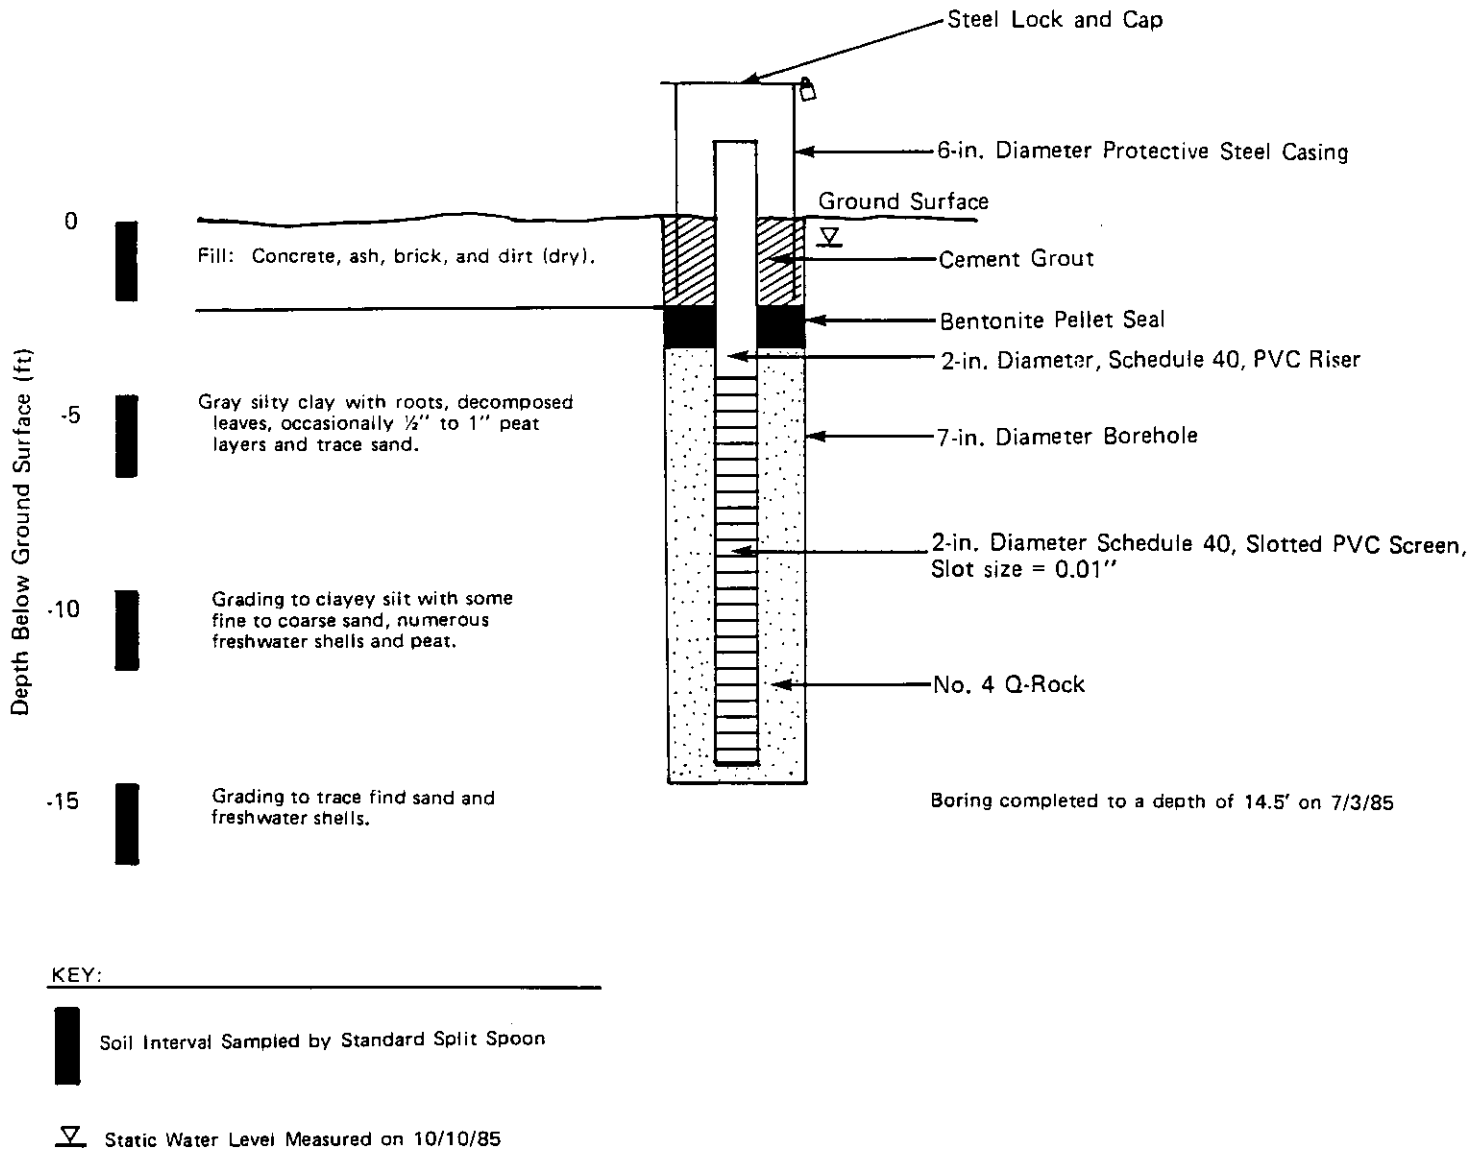
Figure 3-4. Boring log and well schematic, Ilion Landfill Site.

**WELL IL-3
(Upgradient)**
