**Final Soil Vapor Intrusion Survey  
Data Summary Report  
for Apron 2, Building 817/WSA,  
Building 775, and AOC 9**

**Former Griffiss Air Force Base  
Rome, New York**

**October 2007**

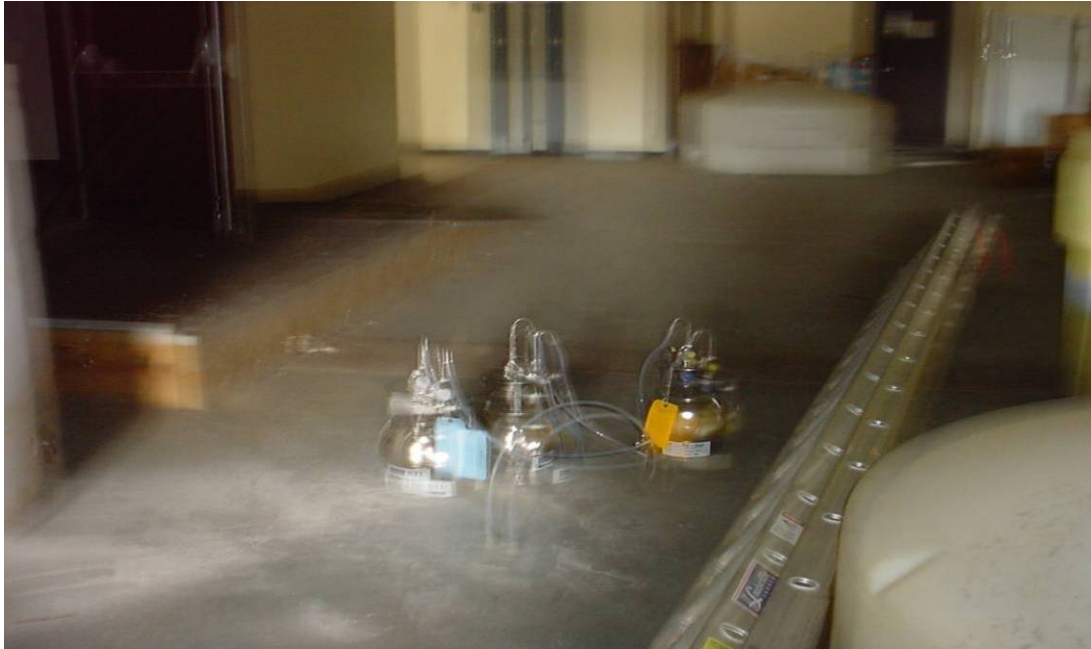
<b>Photo/Frame No.:</b>	SubSlab Vapor - 1	<b>Description:</b> Canisters set at WSA-SSV1, WSA-SSV1/D and WSA-SSV/S
<b>Date/Time:</b>	10/24/06	
<b>Photographer:</b>	AH

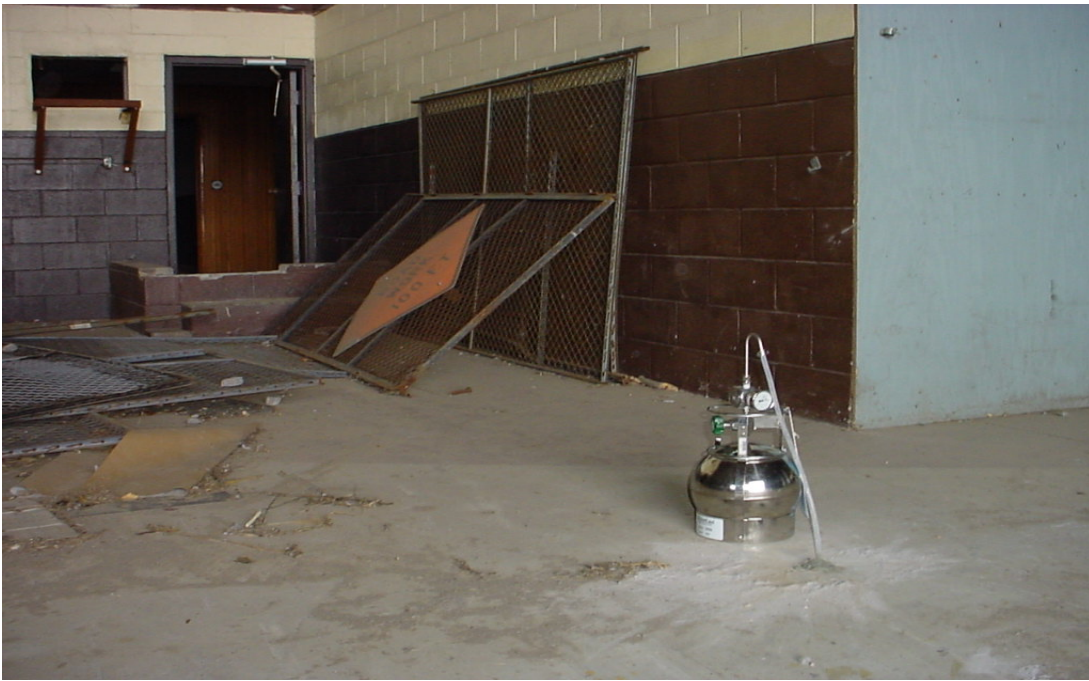
<b>Photo/Frame No.:</b>	SubSlab Vapor - 3	<b>Description:</b> Canisters set at B785-SSV1
<b>Date/Time:</b>	10/24/06	
<b>Photographer:</b>	AH

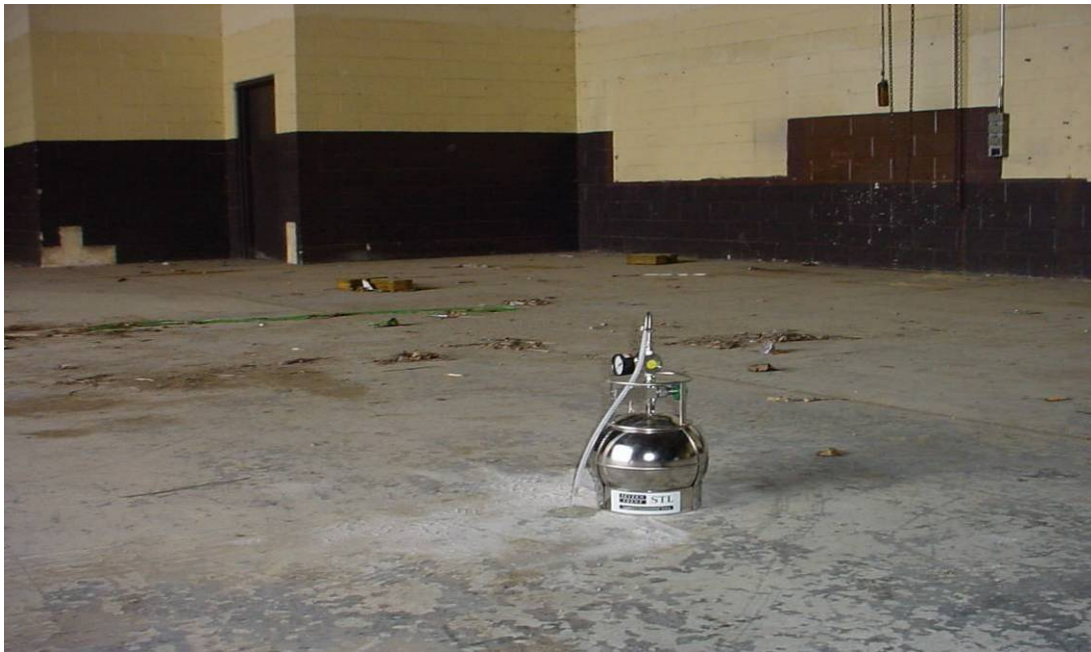
<b>Photo/Frame No.:</b>	SubSlab Vapor - 4	<b>Description:</b> Canisters set at B785-SSV2
<b>Date/Time:</b>	10/24/06	
<b>Photographer:</b>	AH

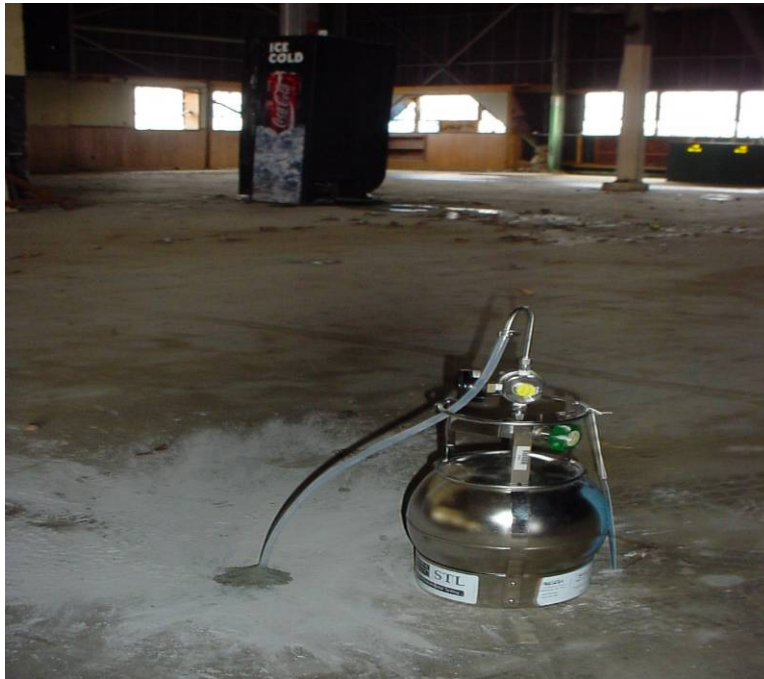
<b>Photo/Frame No.:</b>	SubSlab Vapor - 5	<b>Description:</b> Canisters set at B784-SSV1
<b>Date/Time:</b>	10/24/06	
<b>Photographer:</b>	AH

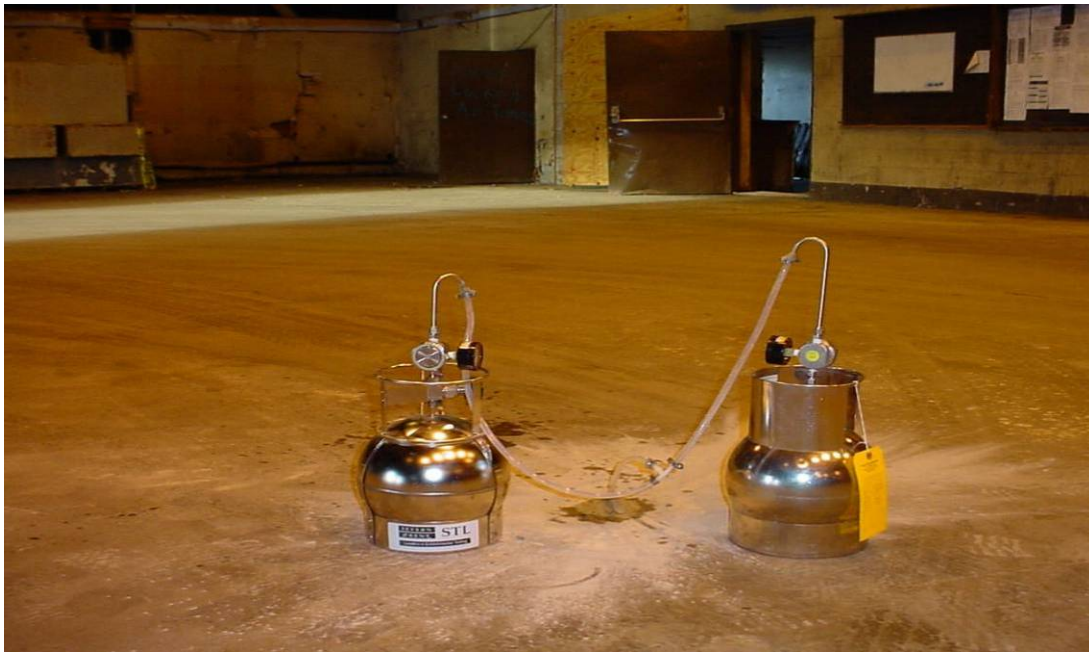
<b>Photo/Frame No.:</b>	SubSlab Vapor - 6	<b>Description:</b> Canisters set at B784-SSV2
<b>Date/Time:</b>	10/24/06	
<b>Photographer:</b>	AH

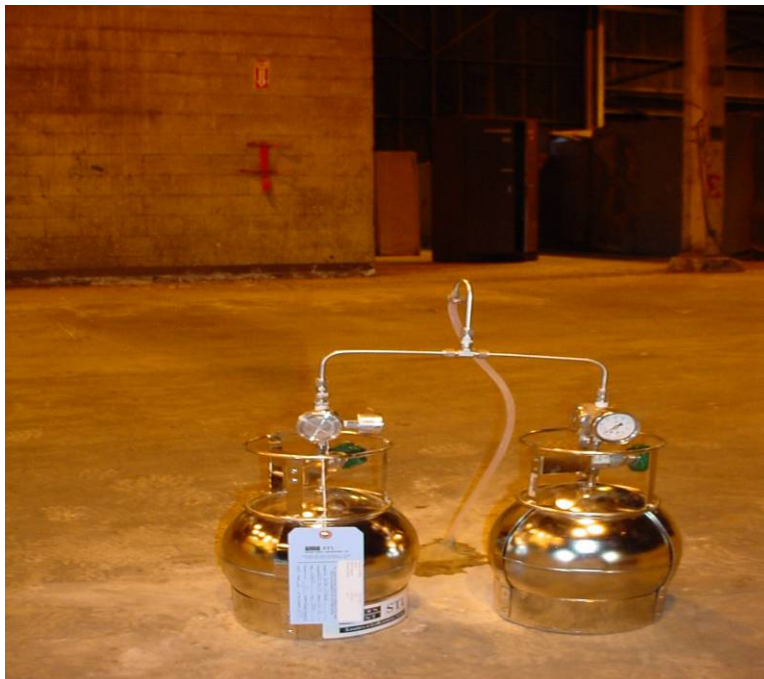
<b>Photo/Frame No.:</b>	SubSlab Vapor - 7	<b>Description:</b> Canisters set at B786-SSV1
<b>Date/Time:</b>	10/25/06	
<b>Photographer:</b>	AH

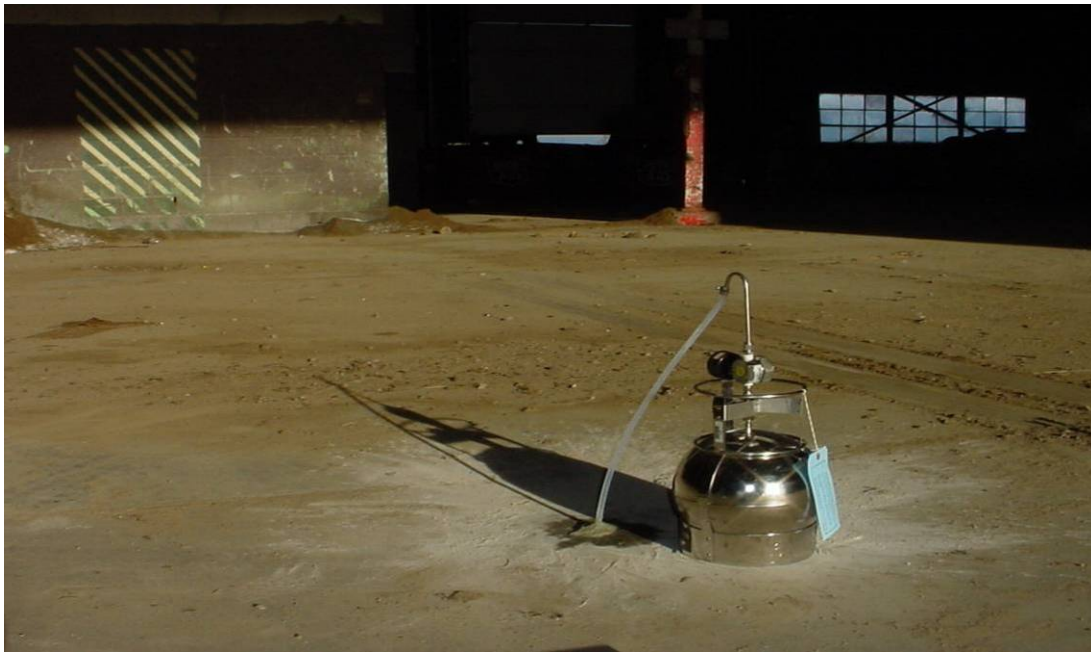
<b>Photo/Frame No.:</b>	SubSlab Vapor - 8	<b>Description:</b> Canisters set at B786-SSV2
<b>Date/Time:</b>	10/25/06	
<b>Photographer:</b>	AH

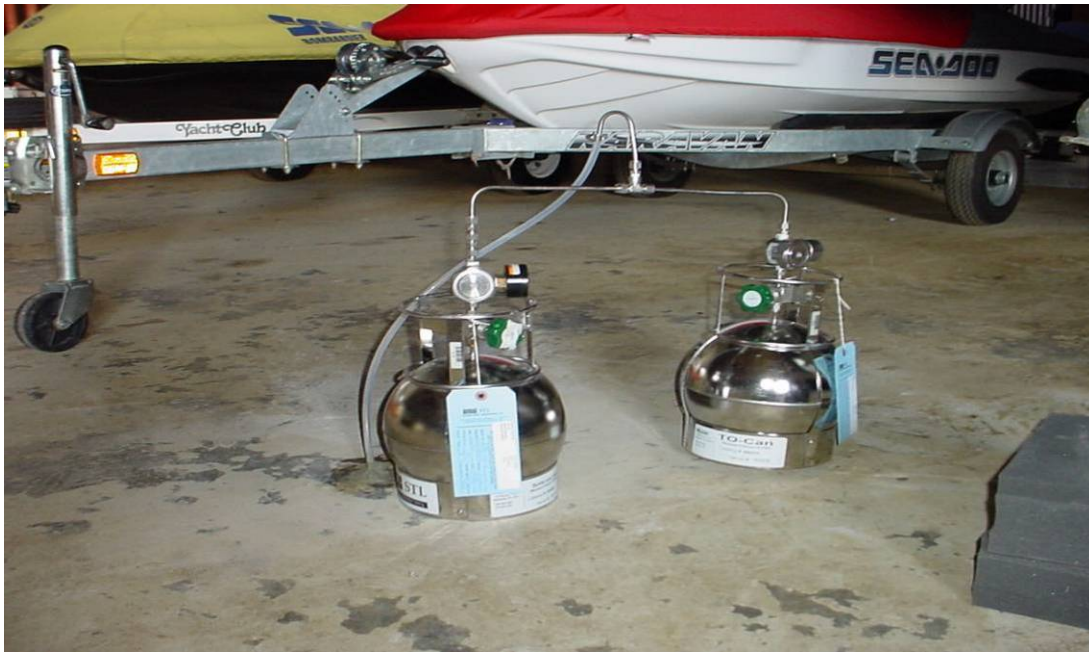
<b>Photo/Frame No.:</b>	SubSlab Vapor - 10	<b>Description:</b> Canisters set at B783-SSV2
<b>Date/Time:</b>	10/25/06	
<b>Photographer:</b>	AH

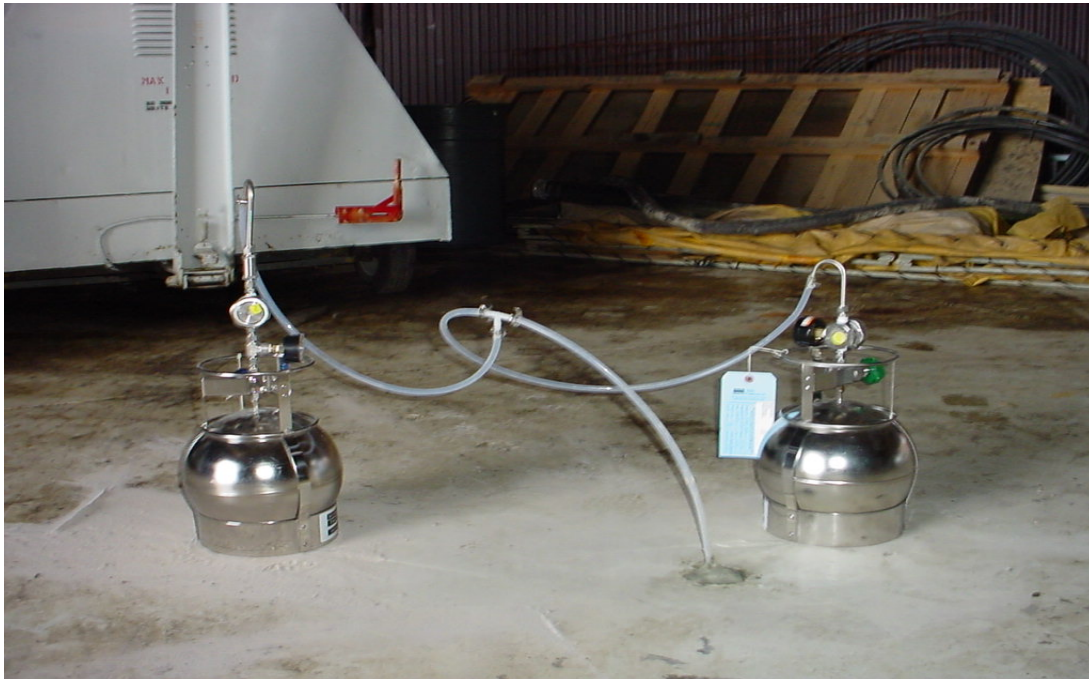
<b>Photo/Frame No.:</b>	SubSlab Vapor - 11	<b>Description:</b> Canisters set at B782-SSV1
<b>Date/Time:</b>	10/25/06	
<b>Photographer:</b>	AH

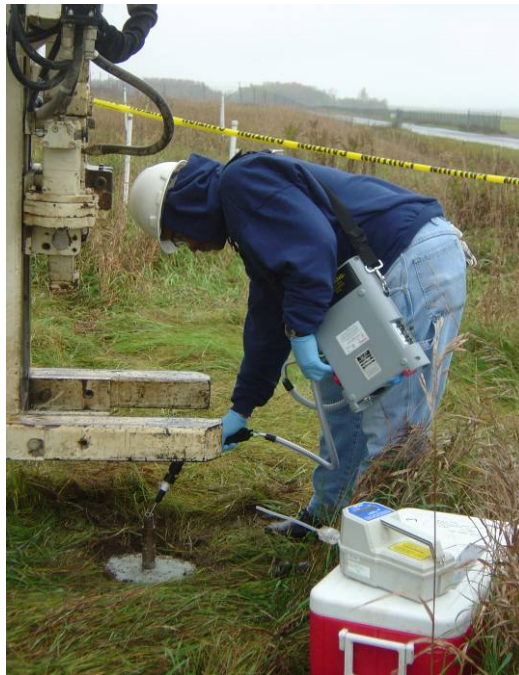
<b>Photo/Frame No.:</b>	Soil Vapor - 1	<b>Description:</b> AOC9 – Attaching tubing to probe
<b>Date/Time:</b>	10/18/06	
<b>Photographer:</b>	BC

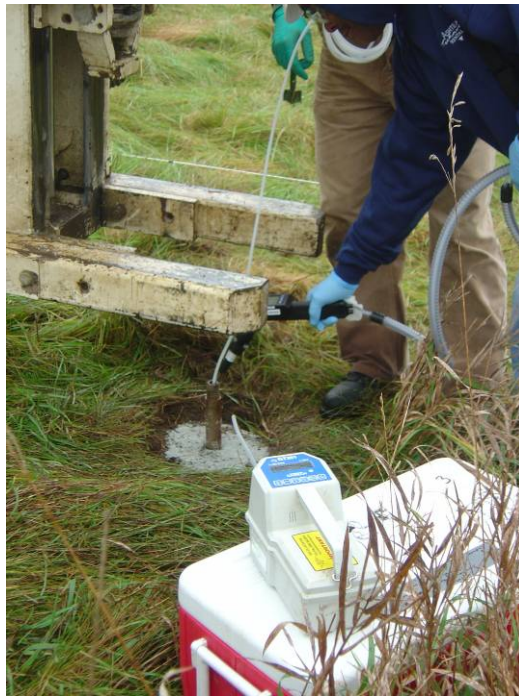
<b>Photo/Frame No.:</b>	Soil Vapor - 2	<b>Description:</b> AOC9 PID Scan
<b>Date/Time:</b>	10/18/06	
<b>Photographer:</b>	BC

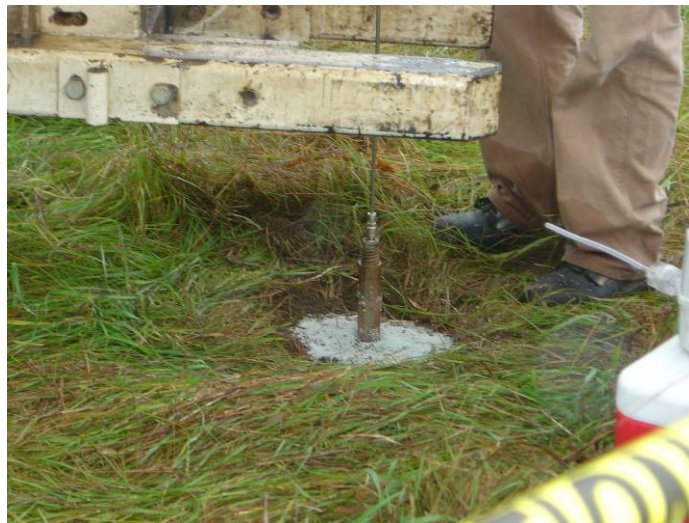
<b>Photo/Frame No.:</b>	Soil Vapor - 3	<b>Description:</b> AOC9 – PID Reading
<b>Date/Time:</b>	10/18/06	
<b>Photographer:</b>	BC

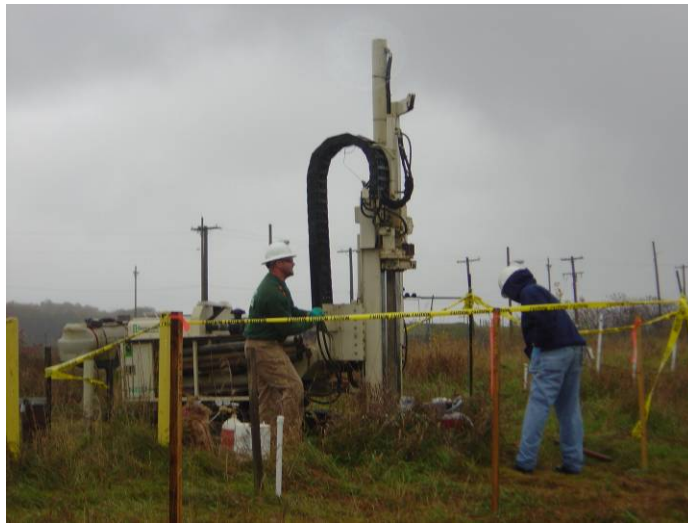
<b>Photo/Frame No.:</b>	Soil Vapor - 4	<b>Description:</b> AOC9 –Releasing probe
<b>Date/Time:</b>	10/18/06	
<b>Photographer:</b>	BC

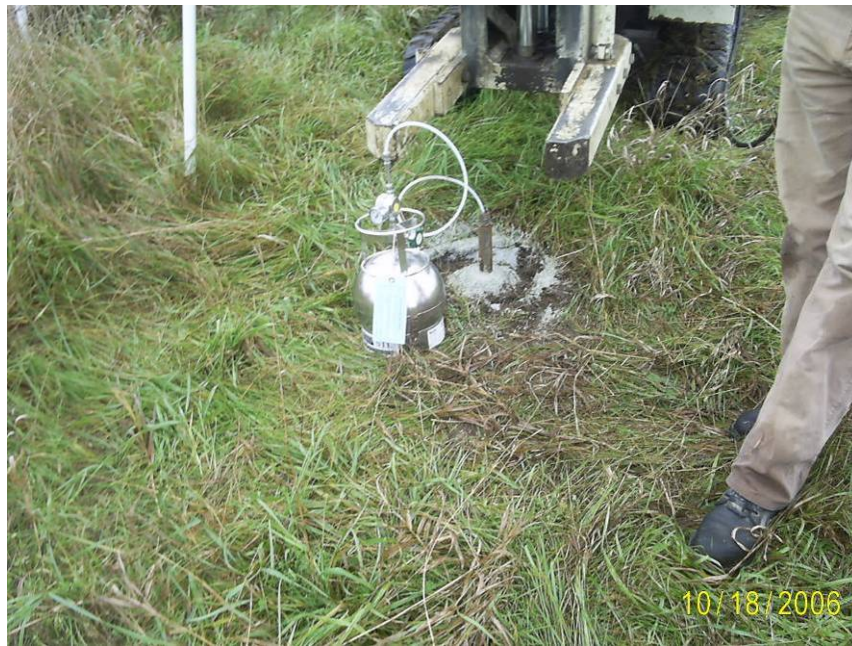
<b>Photo/Frame No.:</b>	Soil Vapor - 9	<b>Description:</b> AOC9 Collection of soil vapor sample
<b>Date/Time:</b>	10/18/06	
<b>Photographer:</b>	BC

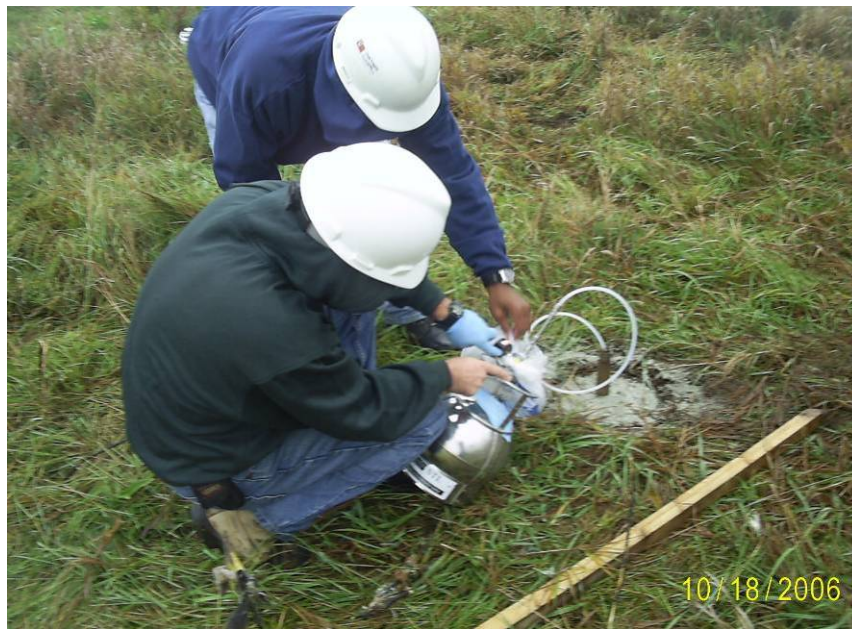
<b>Photo/Frame No.:</b>	Soil Vapor - 10	<b>Description:</b> AOC9 Collection of soil vapor sample
<b>Date/Time:</b>	10/18/06	
<b>Photographer:</b>	BC

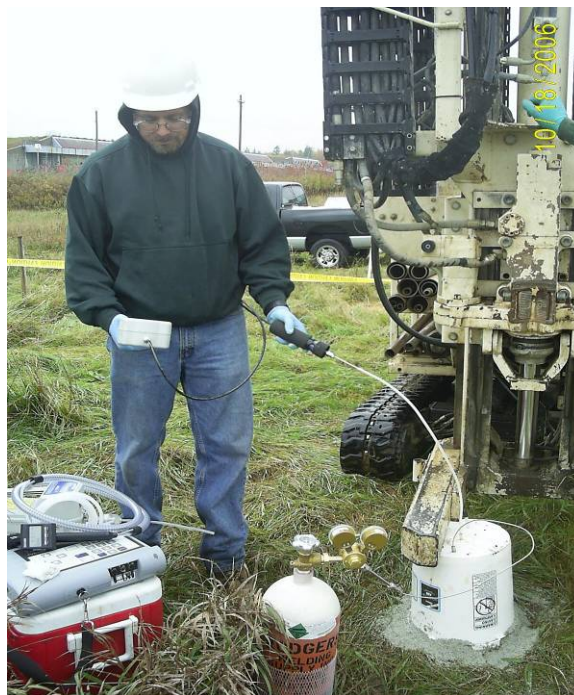
<b>Photo/Frame No.:</b>	Soil Vapor - 11	<b>Description:</b> Checking Pressure in Canister
<b>Date/Time:</b>	10/18/06	
<b>Photographer:</b>	BC

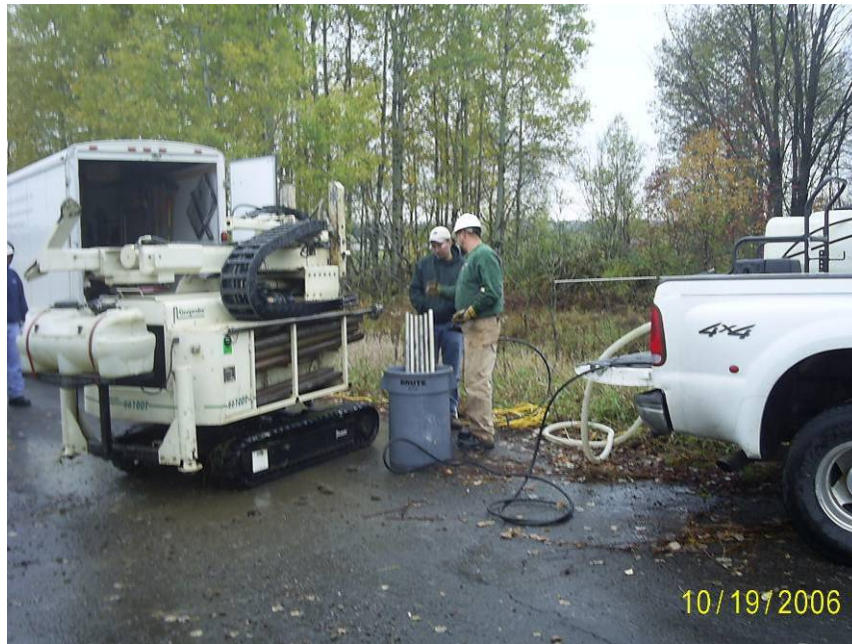
<b>Photo/Frame No.:</b>	Soil V	<b>Description:</b> AOC9 – Checking Helium in the Bucket
<b>Date/Time:</b>	10/18/06	
<b>Photographer:</b>	BC

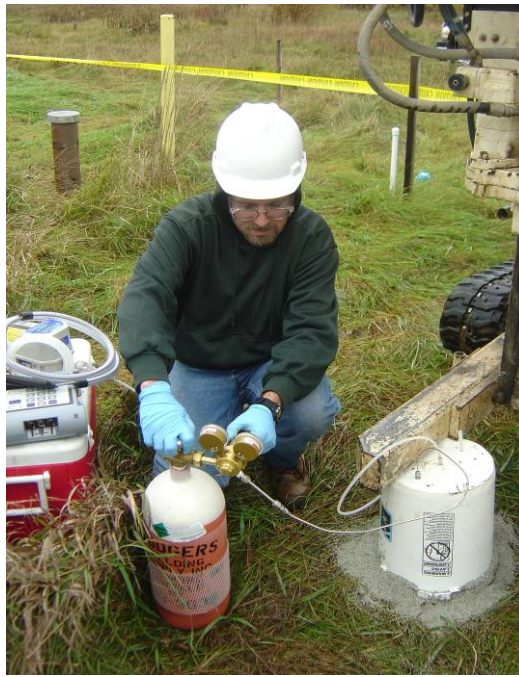
<b>Photo/Frame No.:</b>	Soil Vapor - 19	<b>Description:</b> Adding Helium for Leak test
<b>Date/Time:</b>	10/18/06	
<b>Photographer:</b>	BC

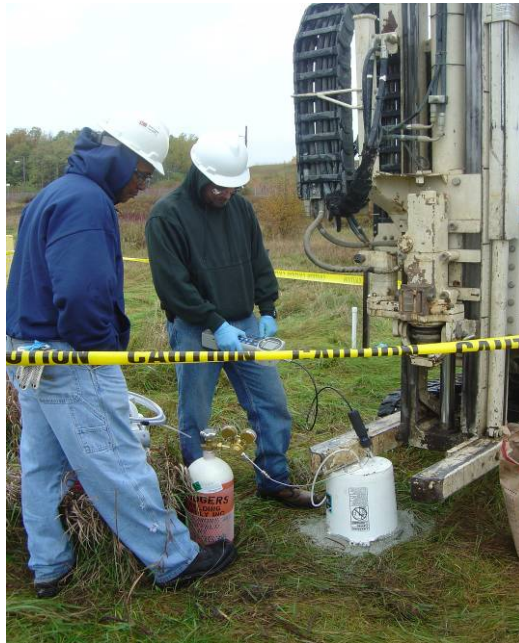
<b>Photo/Frame No.:</b>	Soil Vapor - 20	<b>Description:</b> Checking Helium in Bucket
<b>Date/Time:</b>	10/18/06	
<b>Photographer:</b>	BC

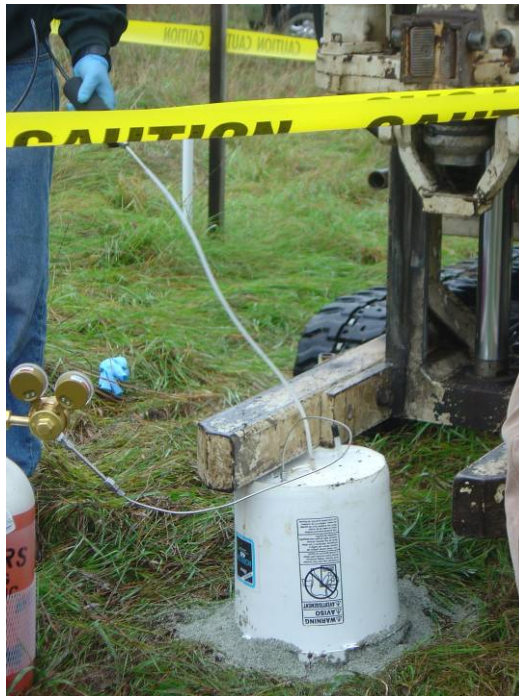
<b>Photo/Frame No.:</b>	Soil Vapor - 21	<b>Description:</b> Soil Vapor Ground Seal to prevent leaks
<b>Date/Time:</b>	10/18/06	
<b>Photographer:</b>	BC

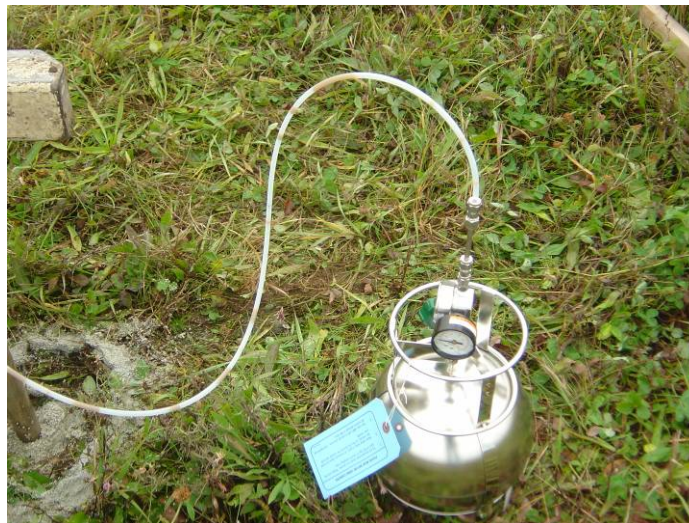
<b>Photo/Frame No.:</b>	Soil Vapor - 22	<b>Description:</b> WSA – Water in tubing
<b>Date/Time:</b>	10/18/06	
<b>Photographer:</b>	BC

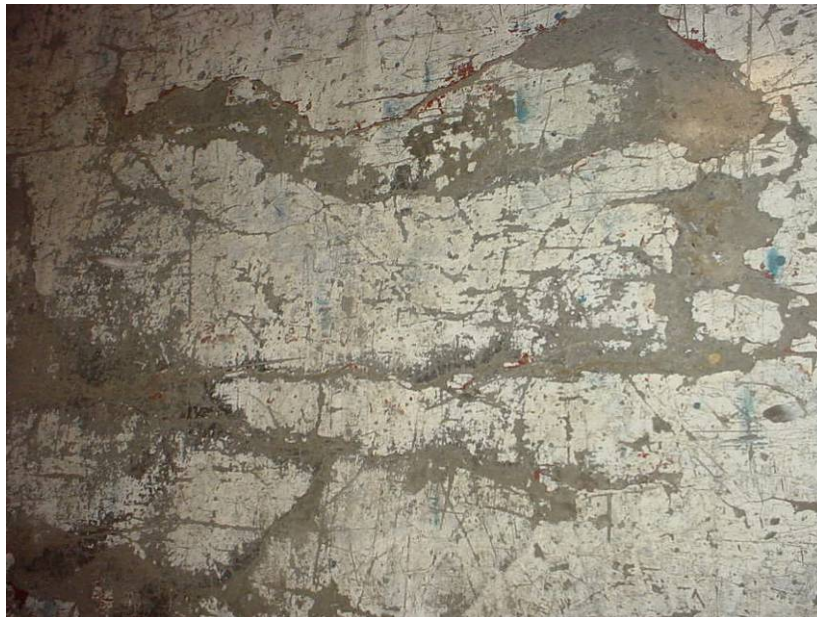
<b>Photo/Frame No.:</b>	Soil Vapor - 32	<b>Description:</b> Cracks in Building 786 floor.
<b>Date/Time:</b>	12/20/06	
<b>Photographer:</b>	RM

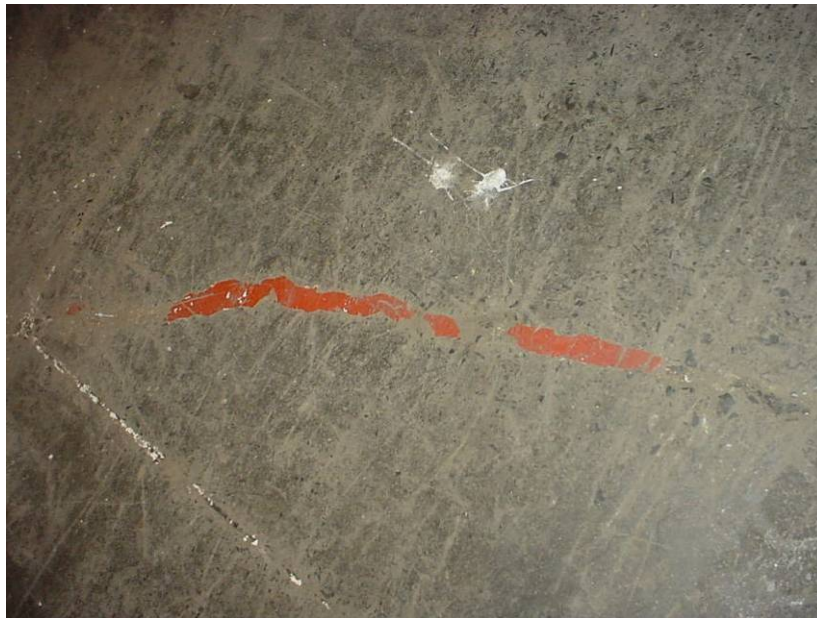
<b>Photo/Frame No.:</b>	Soil Vapor - 33	<b>Description:</b> Repaired cracks in Building 786 floor.
<b>Date/Time:</b>	12/20/06	
<b>Photographer:</b>	RM

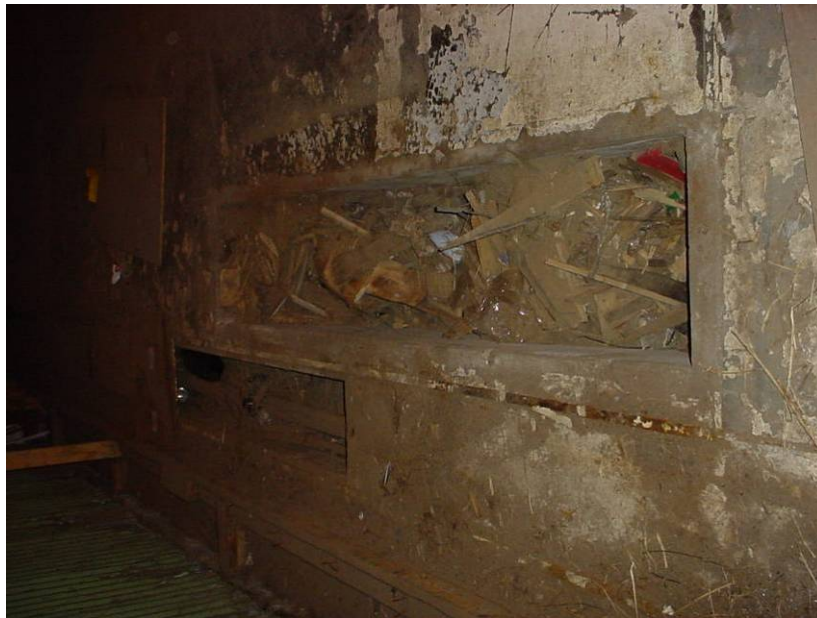
<b>Photo/Frame No.:</b>	Soil Vapor - 39	<b>Description:</b> Concrete vault adjacent to steam pipe trench approx 1.5' by 6'; appears to have solid concrete bottom approx 1' deep.
<b>Date/Time:</b>	12/20/06	
<b>Photographer:</b>	RM

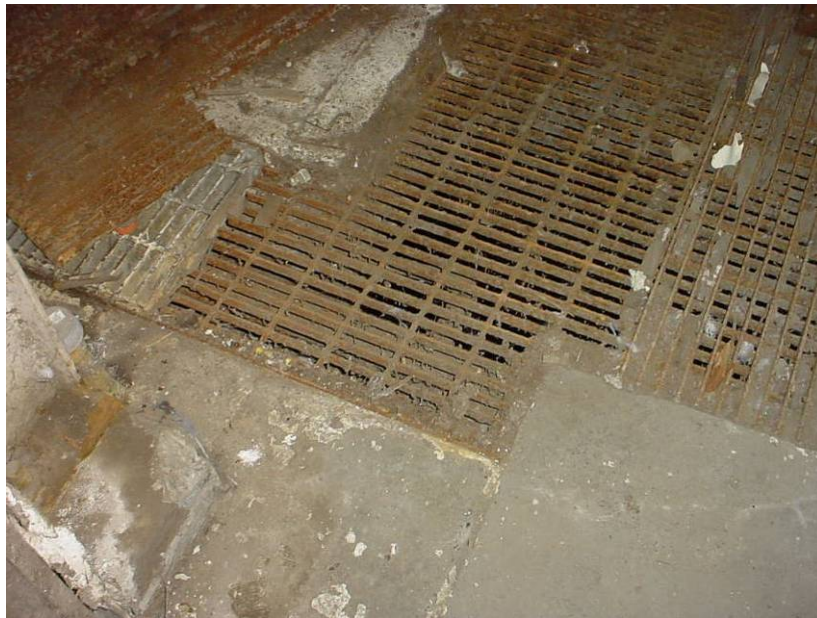
<b>Photo/Frame No.:</b>	Soil Vapor - 40	<b>Description:</b> Steam pipe trench "sump" contains rusty water; unable to open/remove the grate.
<b>Date/Time:</b>	12/20/06	
<b>Photographer:</b>	RM

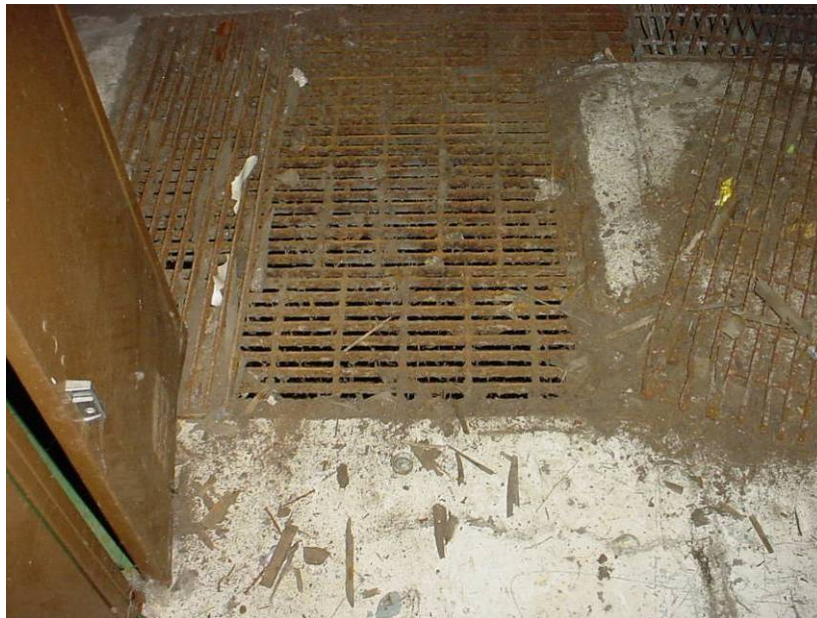
<b>Photo/Frame No.:</b>	Soil Vapor - 41	<b>Description:</b> Steam pipe trench "sump" contains rusty water; unable to open/remove the grate.
<b>Date/Time:</b>	12/20/06	
<b>Photographer:</b>	RM

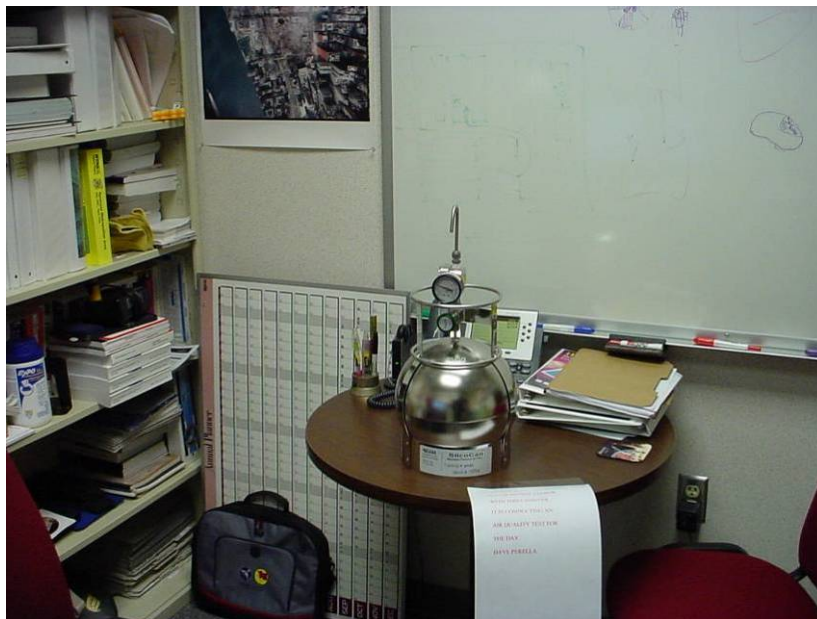
<b>Photo/Frame No.:</b>	Soil Vapor - 42	<b>Description:</b> SVI Sampling - Building 774 IA1 location.
<b>Date/Time:</b>	12/20/06	
<b>Photographer:</b>	RM

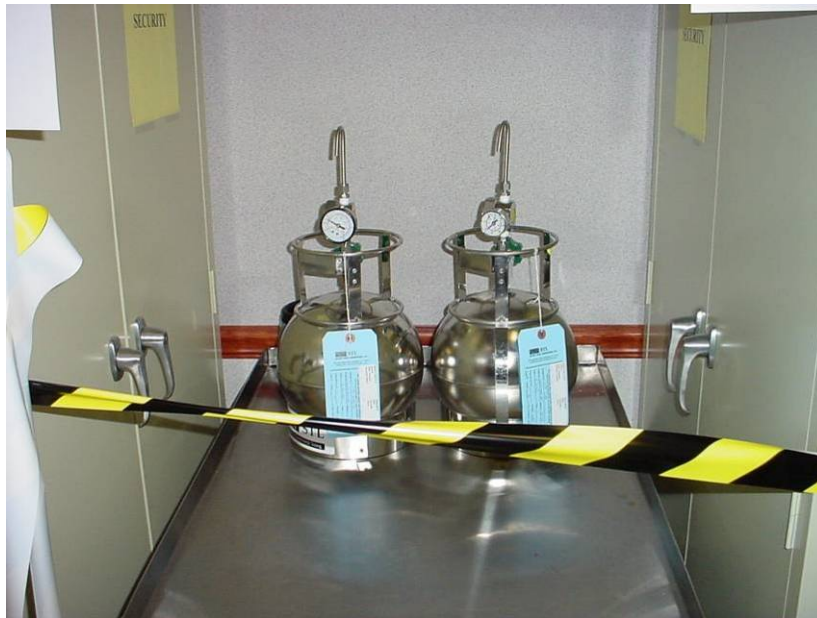
<b>Photo/Frame No.:</b>	Soil Vapor - 43	<b>Description:</b> SVI Sampling - Building 774 IA2 (+dupe) location.
<b>Date/Time:</b>	12/20/06	
<b>Photographer:</b>	RM

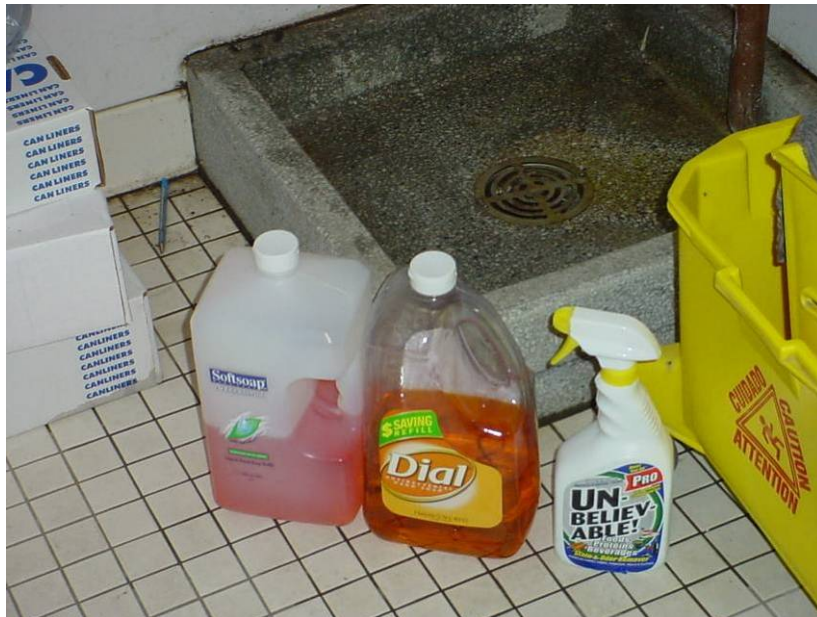
<b>Photo/Frame No.:</b>	Soil Vapor - 44	<b>Description:</b> Building 774 janitors closet with floor drain and soap.
<b>Date/Time:</b>	12/20/06	
<b>Photographer:</b>	RM

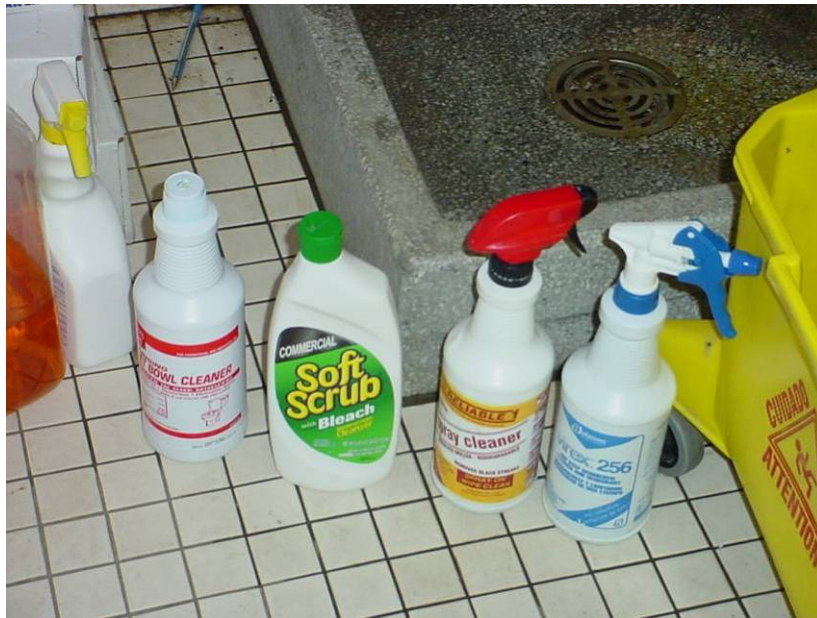
<b>Photo/Frame No.:</b>	Soil Vapor - 45	<b>Description:</b> Building 774 janitors closet with miscellaneous cleaners.
<b>Date/Time:</b>	12/20/06	
<b>Photographer:</b>	RM

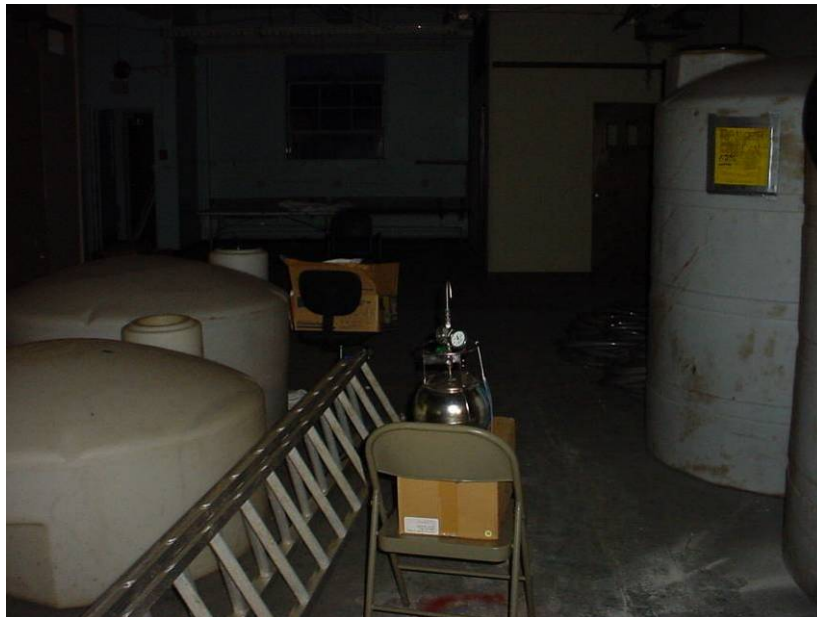
<b>Photo/Frame No.:</b>	Soil Vapor - 46	<b>Description:</b> SVI Sampling - WSA-IA1 location.
<b>Date/Time:</b>	12/20/06	
<b>Photographer:</b>	RM

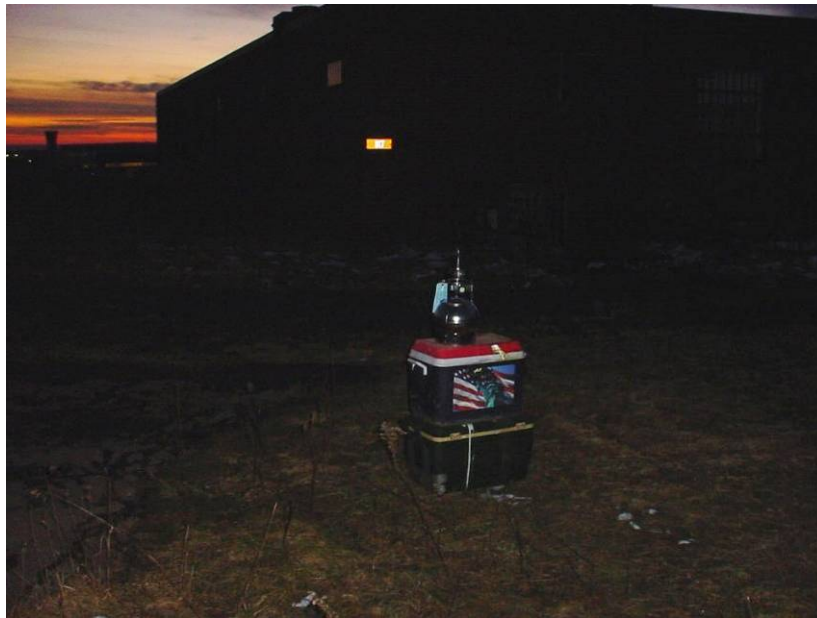
<b>Photo/Frame No.:</b>	Soil Vapor - 47	<b>Description:</b> SVI Sampling - WSA-OA1 location.
<b>Date/Time:</b>	12/20/06	
<b>Photographer:</b>	RM

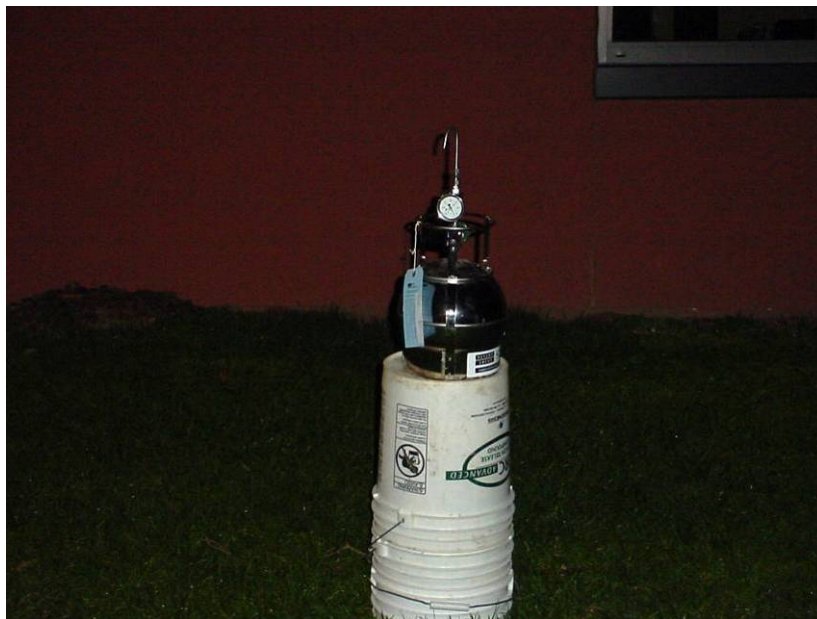
<b>Photo/Frame No.:</b>	Soil Vapor - 48	<b>Description:</b> SVI Sampling - 774-OA1 location (outside facing Building 776).
<b>Date/Time:</b>	12/20/06	
<b>Photographer:</b>	RM

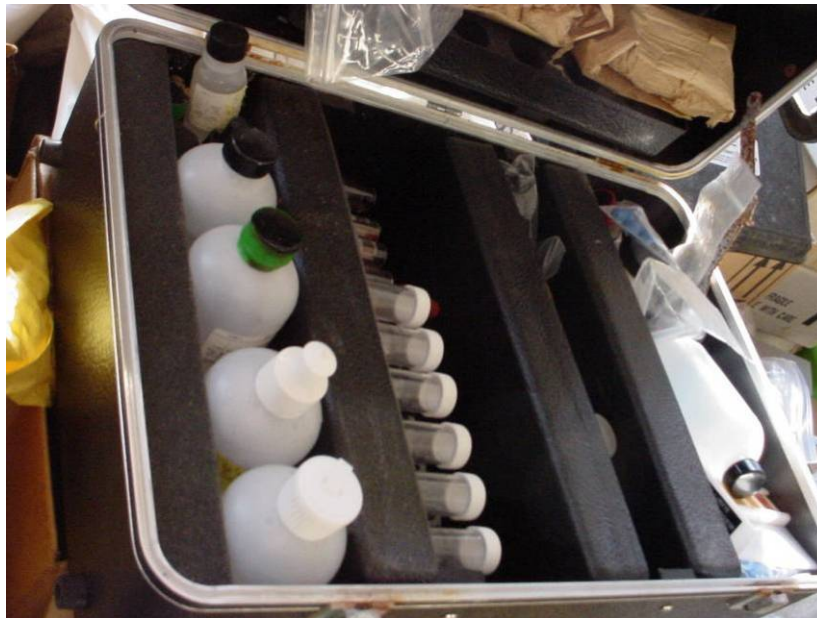
<b>Photo/Frame No.:</b>	Soil Vapor - 51	<b>Description:</b> Building 817 Lamotte combination soil test kit.
<b>Date/Time:</b>	12/21/06	
<b>Photographer:</b>	RM

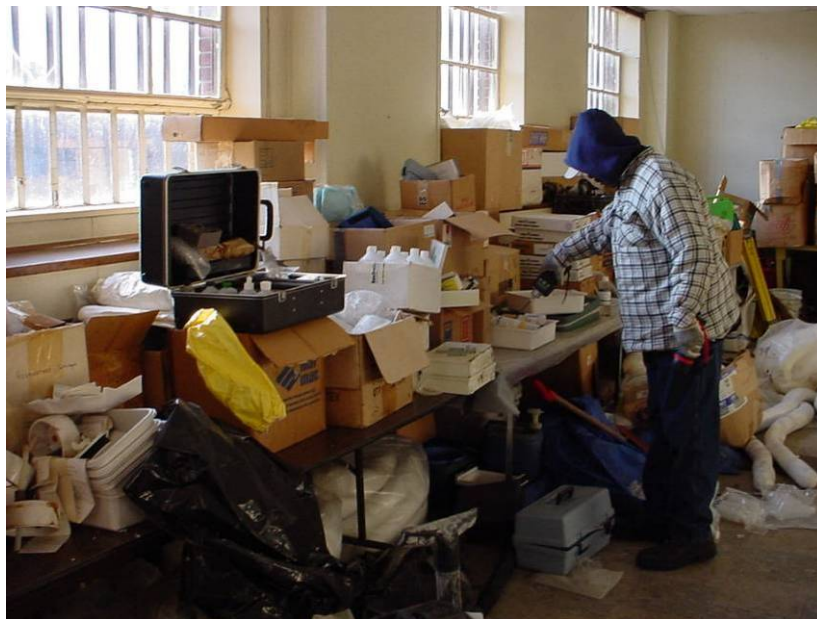
<b>Photo/Frame No.:</b>	Soil Vapor - 52	<b>Description:</b> Jim Mays taking ppb readings of soil test kit and groundwater (pH/temp/conductivity) solutions.
<b>Date/Time:</b>	12/21/06	
<b>Photographer:</b>	RM

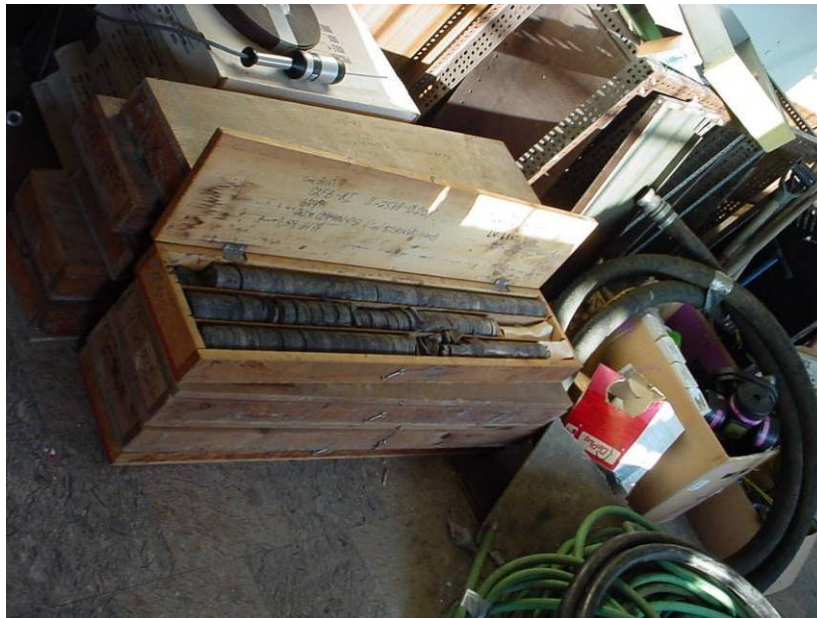
<b>Photo/Frame No.:</b>	Soil Vapor - 53	<b>Description:</b> Building 817 bedrock core samples.
<b>Date/Time:</b>	12/21/06	
<b>Photographer:</b>	RM

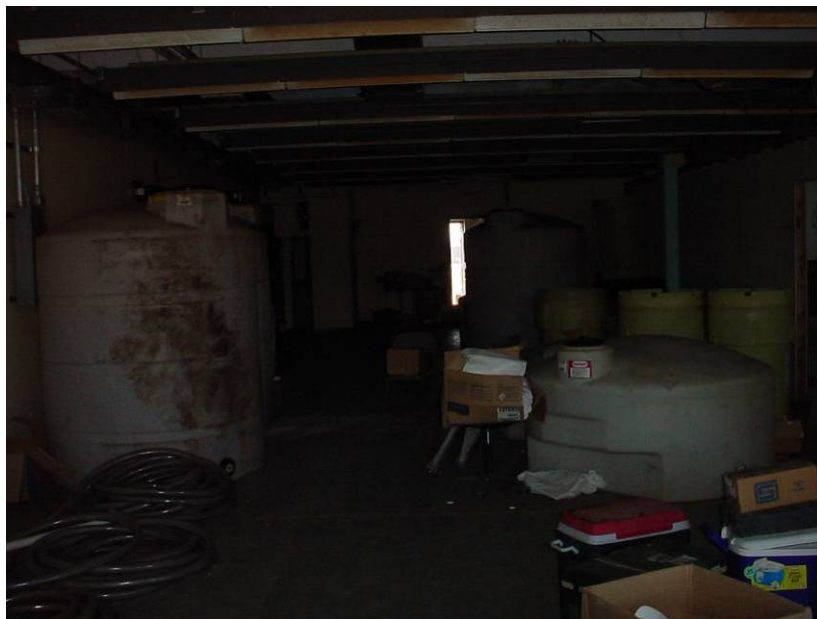
<b>Photo/Frame No.:</b>	Soil Vapor - 54	<b>Description:</b> Building 817 poly tank storage room at center of building.
<b>Date/Time:</b>	12/21/06	
<b>Photographer:</b>	RM

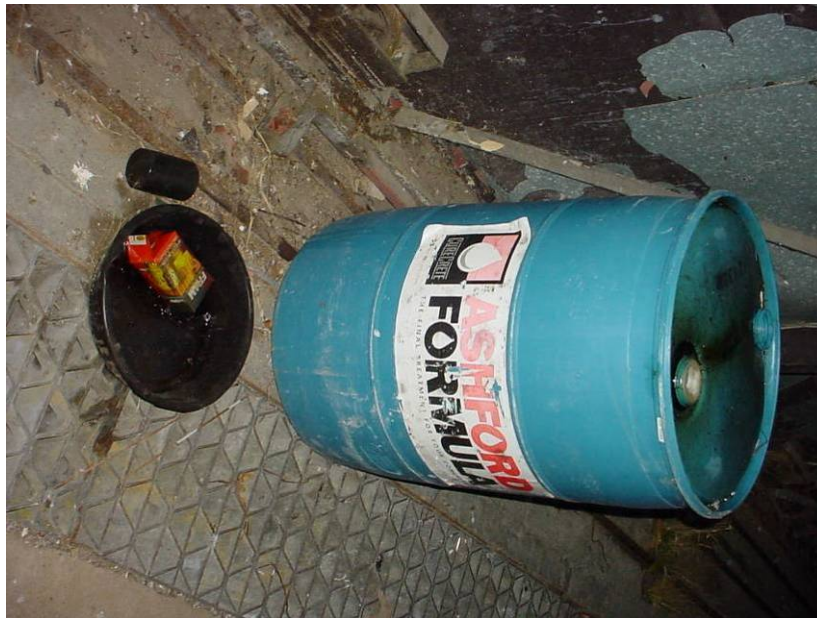
<b>Photo/Frame No.:</b>	Soil Vapor - 57	<b>Description:</b> Building 785 concrete sealer drum and used motor oil filter.
<b>Date/Time:</b>	12/21/06	
<b>Photographer:</b>	RM

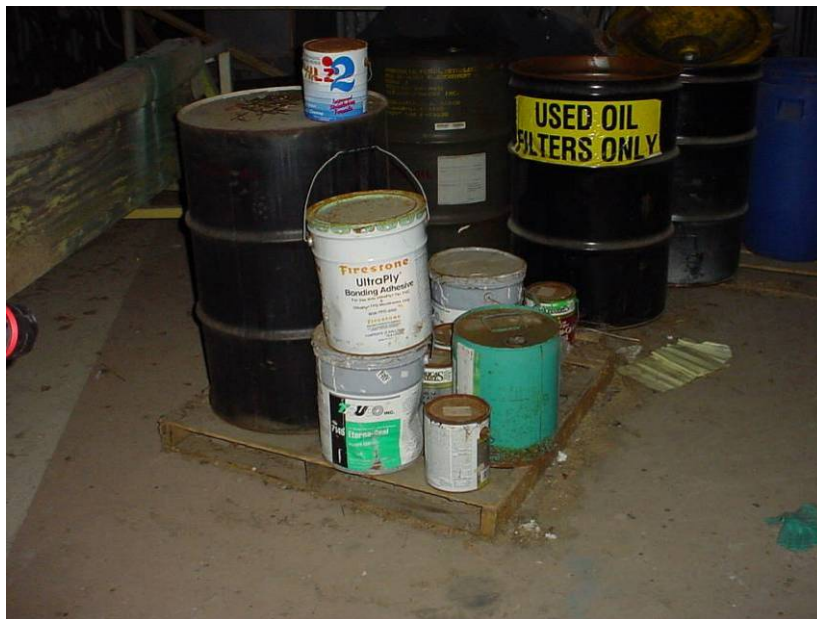
<b>Photo/Frame No.:</b>	Soil Vapor - 58	<b>Description:</b> Building 785 drums (used oil), paint cans, 5 gal bucket of adhesive, sealer, etc.
<b>Date/Time:</b>	12/21/06	
<b>Photographer:</b>	RM

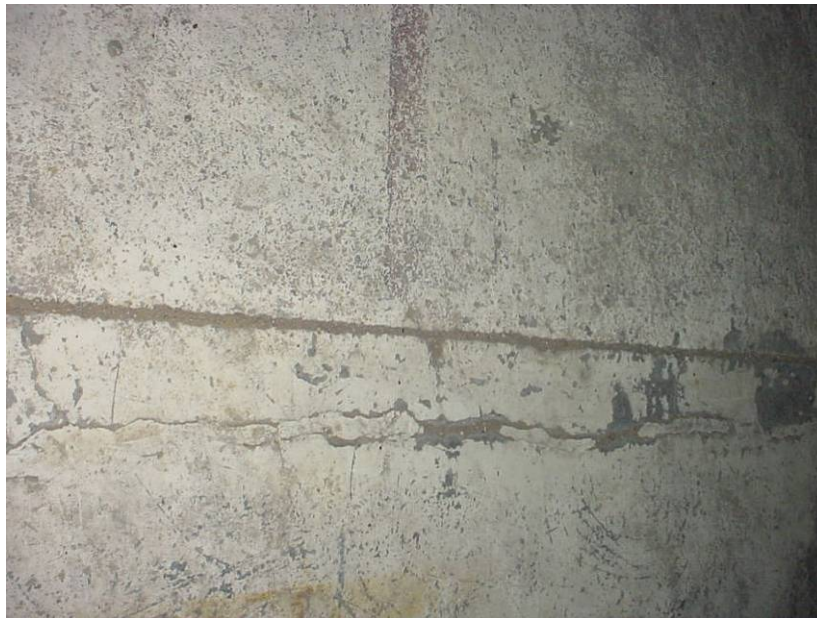
<b>Photo/Frame No.:</b>	Soil Vapor - 59	<b>Description:</b> Building 785 main room floor, repaired cracks.
<b>Date/Time:</b>	12/21/06	
<b>Photographer:</b>	RM

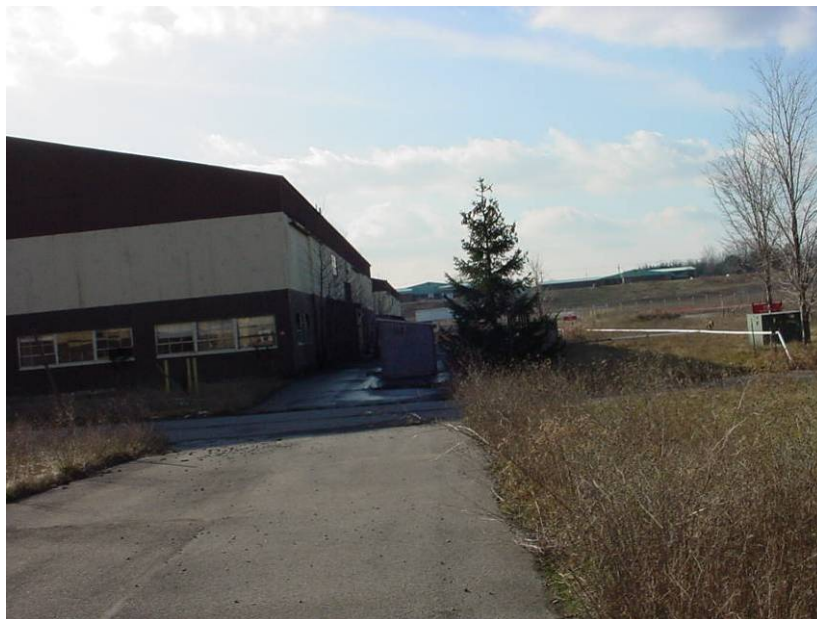
<b>Photo/Frame No.:</b>	Soil Vapor - 60	<b>Description:</b> Back of Building 785 with shed containing compressor for air injection system currently in operation (FPM operating).
<b>Date/Time:</b>	12/21/06	
<b>Photographer:</b>	RM
