**TECHNICAL MEMORANDUM
LONG TERM MONITORING OF
LANDFILL AREAS OF CONCERN
FORMER GRIFFISS AIR FORCE BASE
ROME, NEW YORK**

PREPARED BY : Bhate Environmental Associates, Inc.

DATE: May 9, 2017

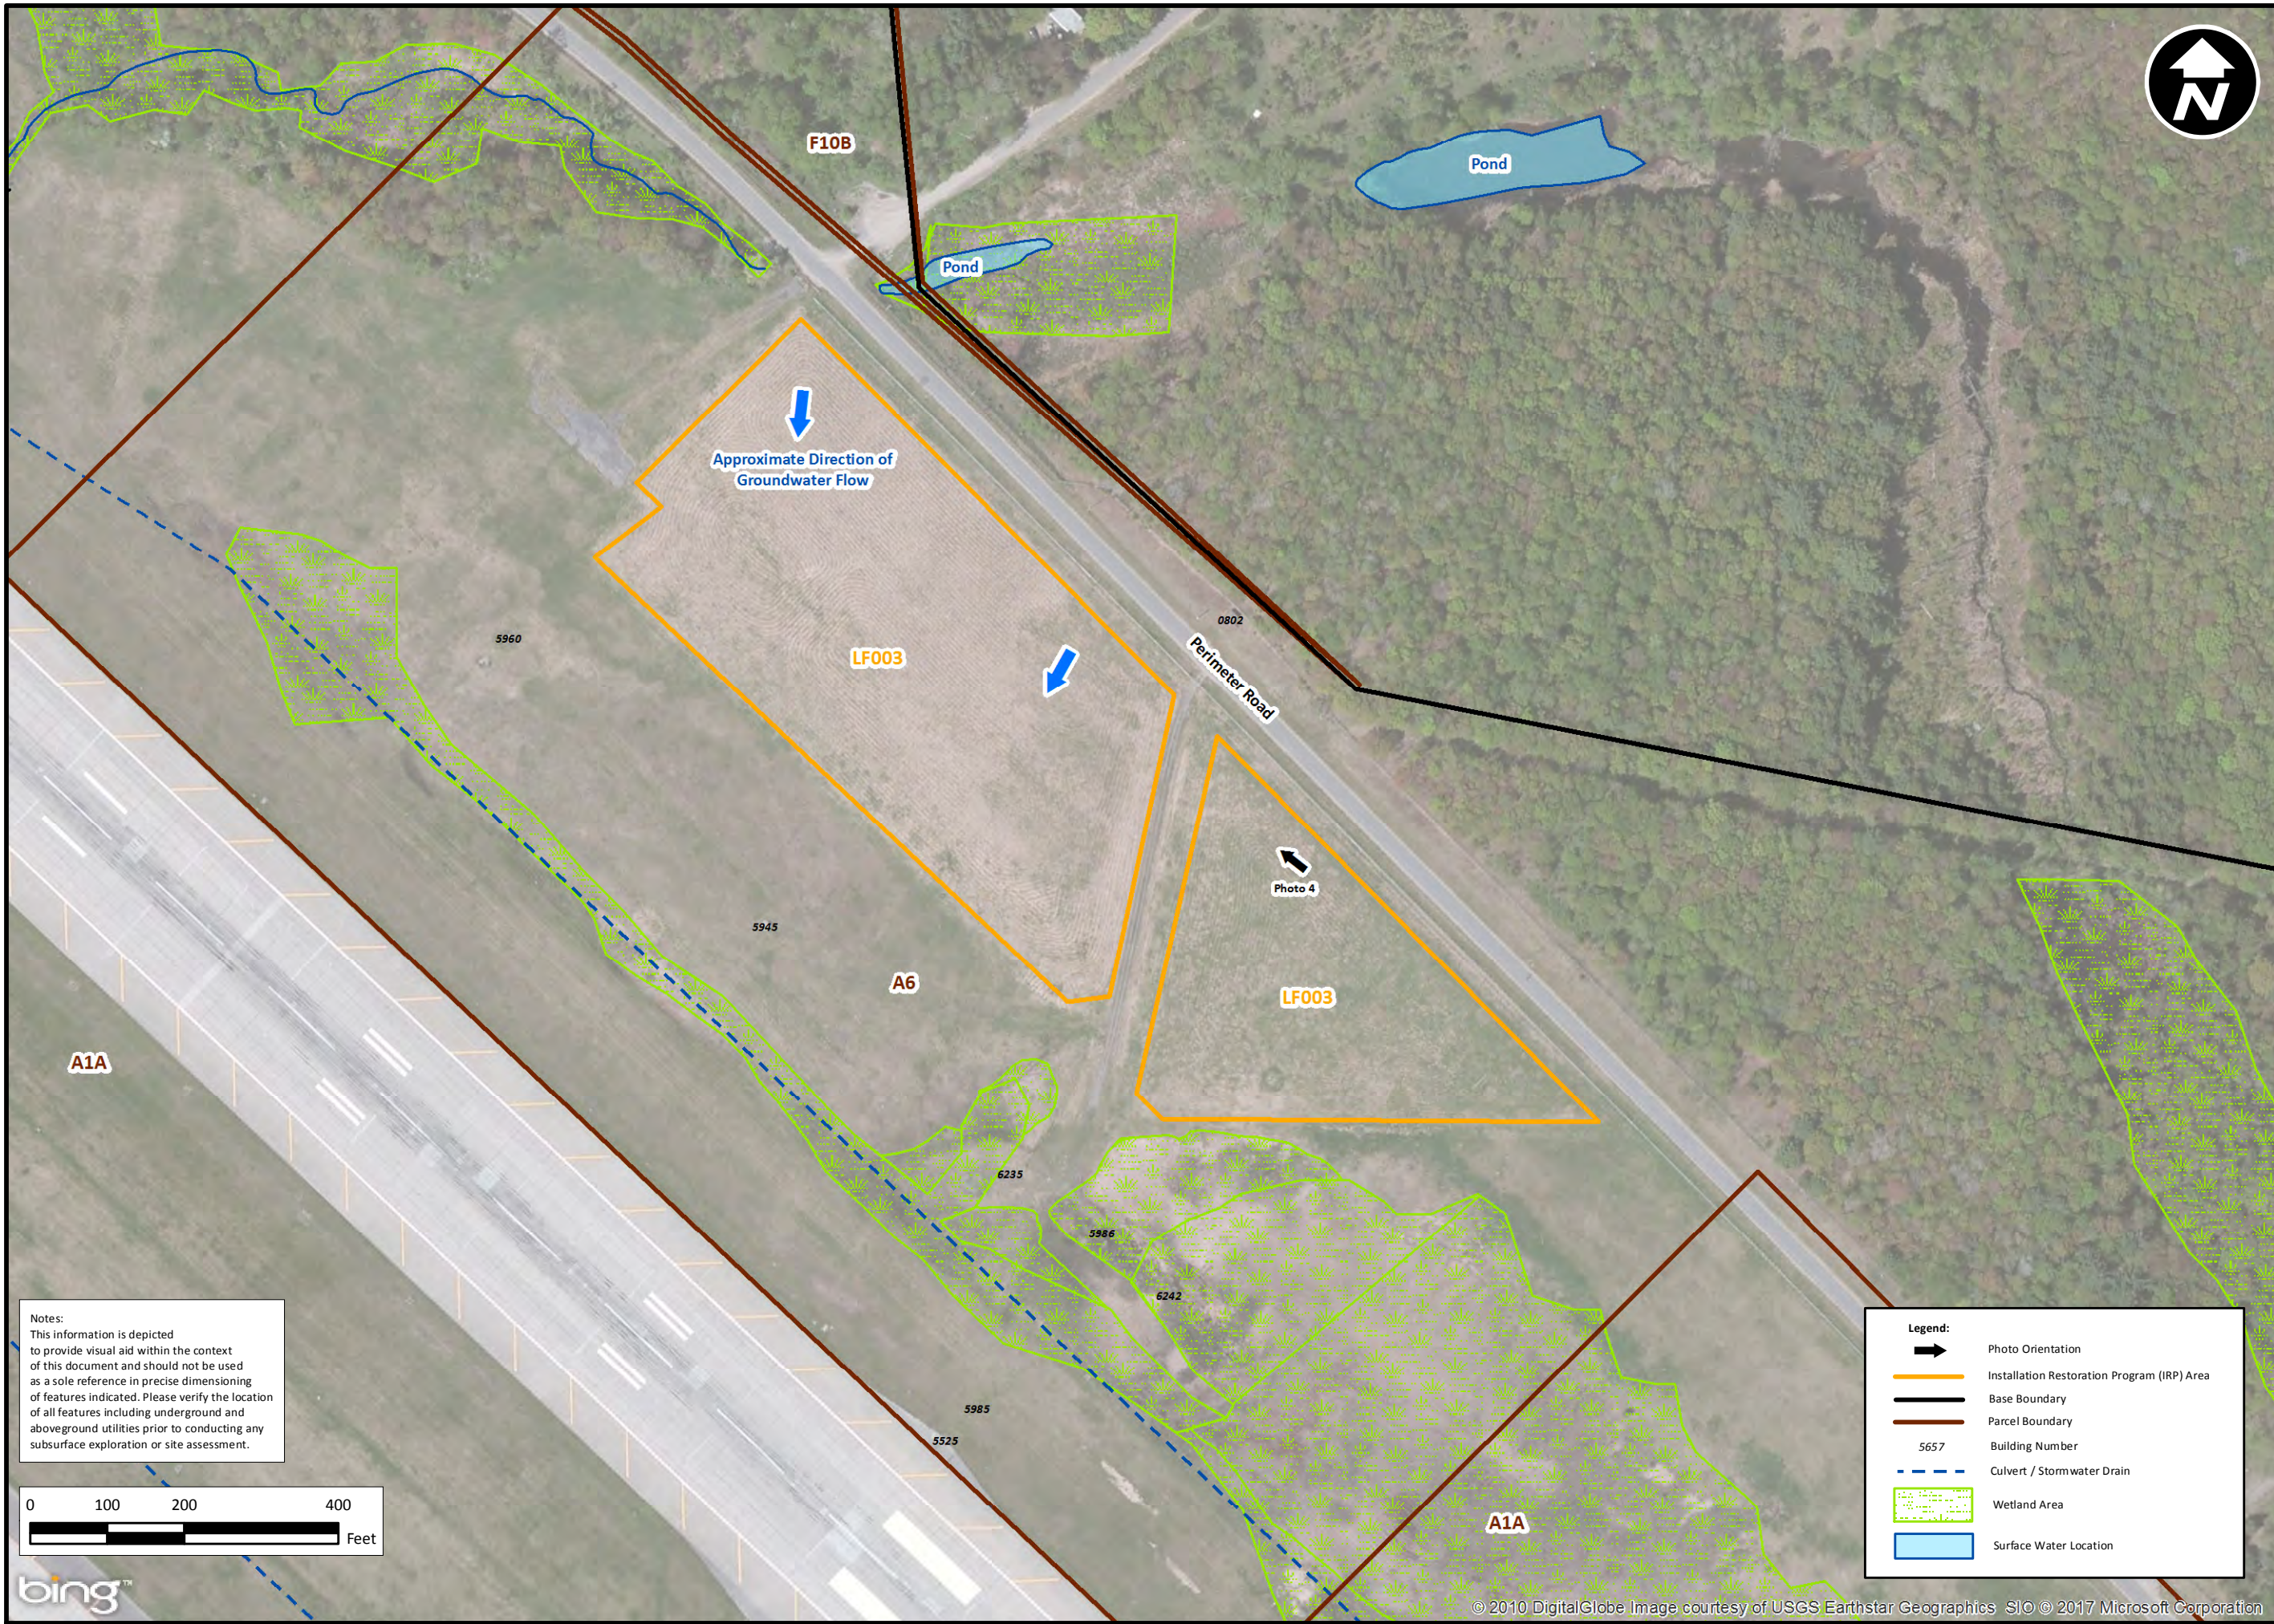
Figure 6

LF003 (Landfill 7 AOC) Fall 2016 Inspection

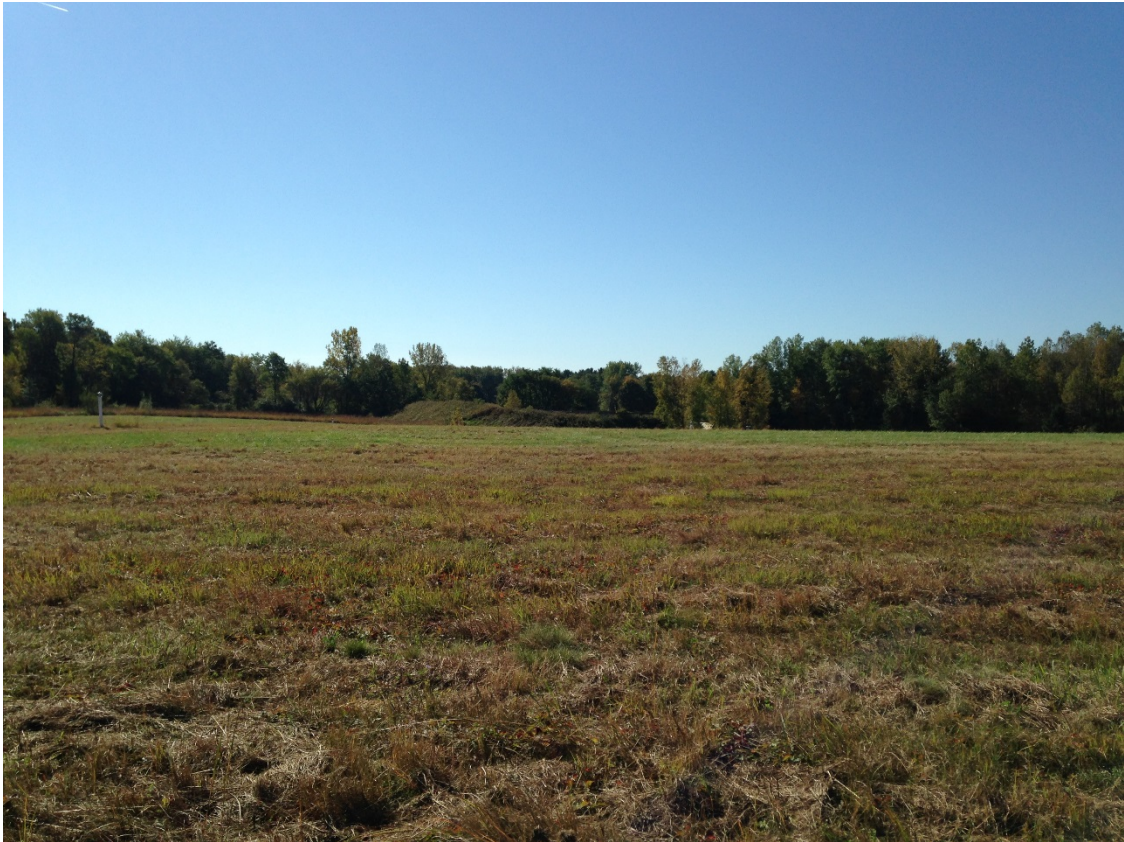
Photo 1: LF001 (Landfill 1 AOC) – Facing South

Soil Cover Integrity APPEARS IN GOOD CONDITION. (SOME SNOW COVER)

Slopes APPEAR IN GOOD CONDITION.

Cover Vegetation APPEARS IN GOOD CONDITION, NO CONC OF STRESSED AREAS NOTED.

Gas Probes LF GMP-~~4~~ 4 HAS BROKEN NOZZLE → ALL OTHERS IN GOOD CONDITION.

Gas Vents VENT 6 CROSS-THREADED LID (STUCK), ALL OTHERS IN GOOD CONDITION

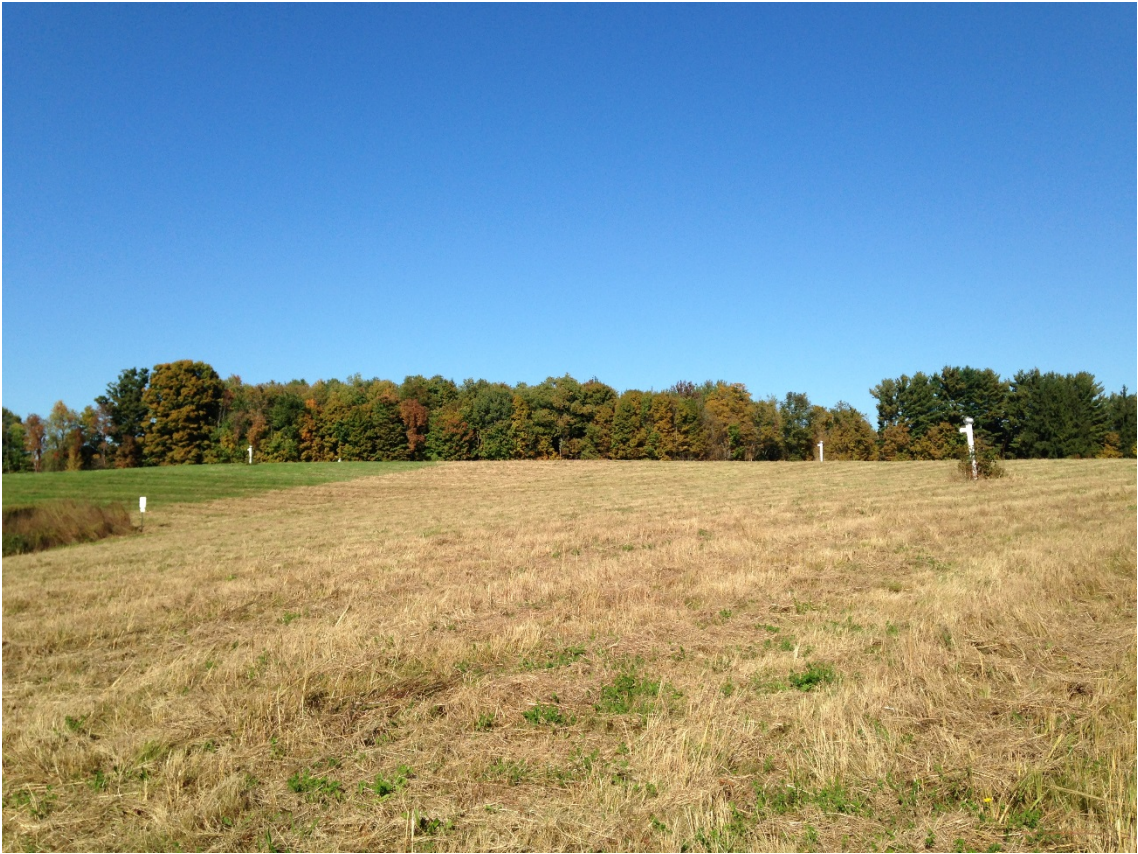
Photo 3: LF002 (Landfill 2/3 AOC) – Facing North

Soil Cover Integrity APPEARS IN GOOD CONDITION. (SOME SNOW COVER)

Slopes APPEAR IN GOOD CONDITION

Cover Vegetation APPEARS IN GOOD CONDITION, NO STRESSES OR BARE AREAS OBSERVED.

Gas Probes ALL APPEAR IN GOOD CONDITION (LOCK SEIZED ON GMP-03, NO ACCESS)

Security Fencing/Gates PERIMETER ROAD GATE IN GOOD CONDITION → LOCK DOESN'T EASILY LOCK. ALL OTHER CHAIN-LINK AND BARBED WIRE APPEAR IN GOOD CONDITION

The inspections did not identify any major deficiencies that would jeopardize the integrity of the cover and there is optimal vegetation cover present on the cap. However, the animal burrow observed at LF2VENT-03 is recommended for filling in the Spring. No significant weather events have occurred in 2016 that warranted additional inspections. Based on the *Final Optimization Plan for Landfill Areas of Concern Long-Term Management Program* (Bhate, November 2016), it is recommended that the frequency continue semiannually with a limited landfill inspection in the Spring and the more comprehensive inspection in the Fall to correlate with annual mowing and landfill gas monitoring. Results from the gas sampling events at LF002 (Landfill 2/3 AOC)

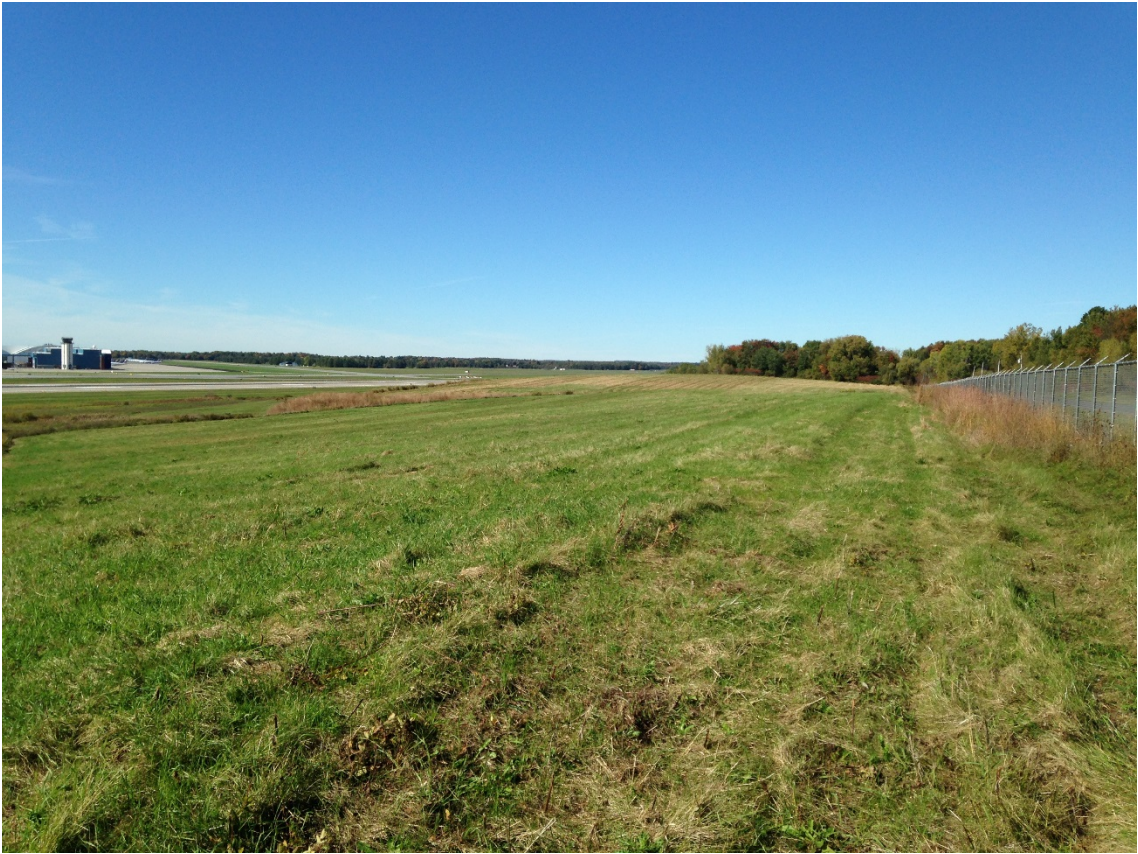
Photo 4: LF003 (Landfill 7 AOC) – Facing Northwest

The inspections did not identify any major deficiencies that would jeopardize the integrity of the cover and there is optimal vegetation cover present on the cap. No significant weather events

have occurred in 2016 that warranted additional inspections. Based on the *Final Optimization Plan for Landfill Areas of Concern Long-Term Management Program* (Bhate, November 2016), it is recommended that the frequency continue semiannually with a limited landfill inspection in the Spring and the more comprehensive inspection in the Fall to correlate with annual mowing.

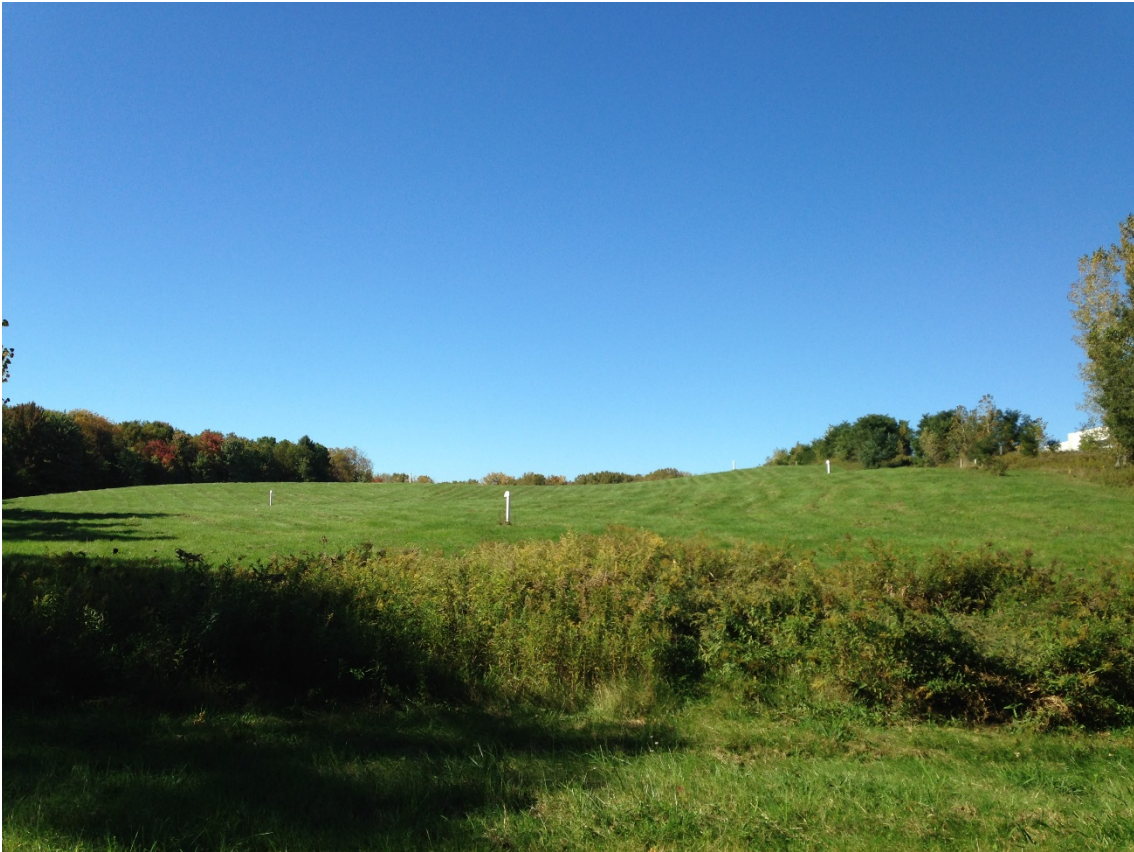
Photo 6: LF009 (Landfill 6 AOC) – Facing Northwest from Southeastern Corner

Soil Cover Integrity No bare spots or stressed vegetation noted

Slopes All slopes and coverage appeared to be in good condition

Cover Vegetation Grass cover of LF appeared in good condition

Vectors/Holes Animal burrow noted next to Vent 10
" " " " " Vent 13
" " " between Vents 15 and 16

The inspections did not identify any major deficiencies that would jeopardize the integrity of the cover, and there is optimal vegetation cover on the cap. However, the observed animal burrows are recommended for filling in the Spring. Potential cap damage due to the standing water, observed between GMP-13 and GMP-11 on the west side of the access road, should be assessed during the Spring 2017 cap inspection. No significant weather events have occurred in 2016 that warranted additional inspections. Based on the *Final Optimization Plan for Landfill Areas of Concern Long-Term Management Program* (Bhate, November 2016), it is recommended that the frequency continue semiannually with a limited landfill inspection in the Spring and the more comprehensive inspection in the Fall to correlate with annual mowing and landfill gas monitoring. Landfill gas monitoring from 2011 to 2014 shows that methane levels are stable or absent at all of the gas monitoring probes. Based upon historical data (FPM, December 2015) coupled with the Fall 2016 readings, Bhate recommends that landfill gas monitoring for the Fall of 2017 only include the following four vents: LF6VENT-02, LF6VENT-03, LF6VENT-04, and LF6VENT-06. **Attachment A-Figure 9** shows the LF009 (Landfill 6 AOC) proposed Fall 2017 landfill gas sampling locations. This reduction is based upon methane not being detected above 0.1% in the other monitoring points for the past five years.
