Remedial Action Report

5140 Site

Yorkville, New York

January 13, 2017

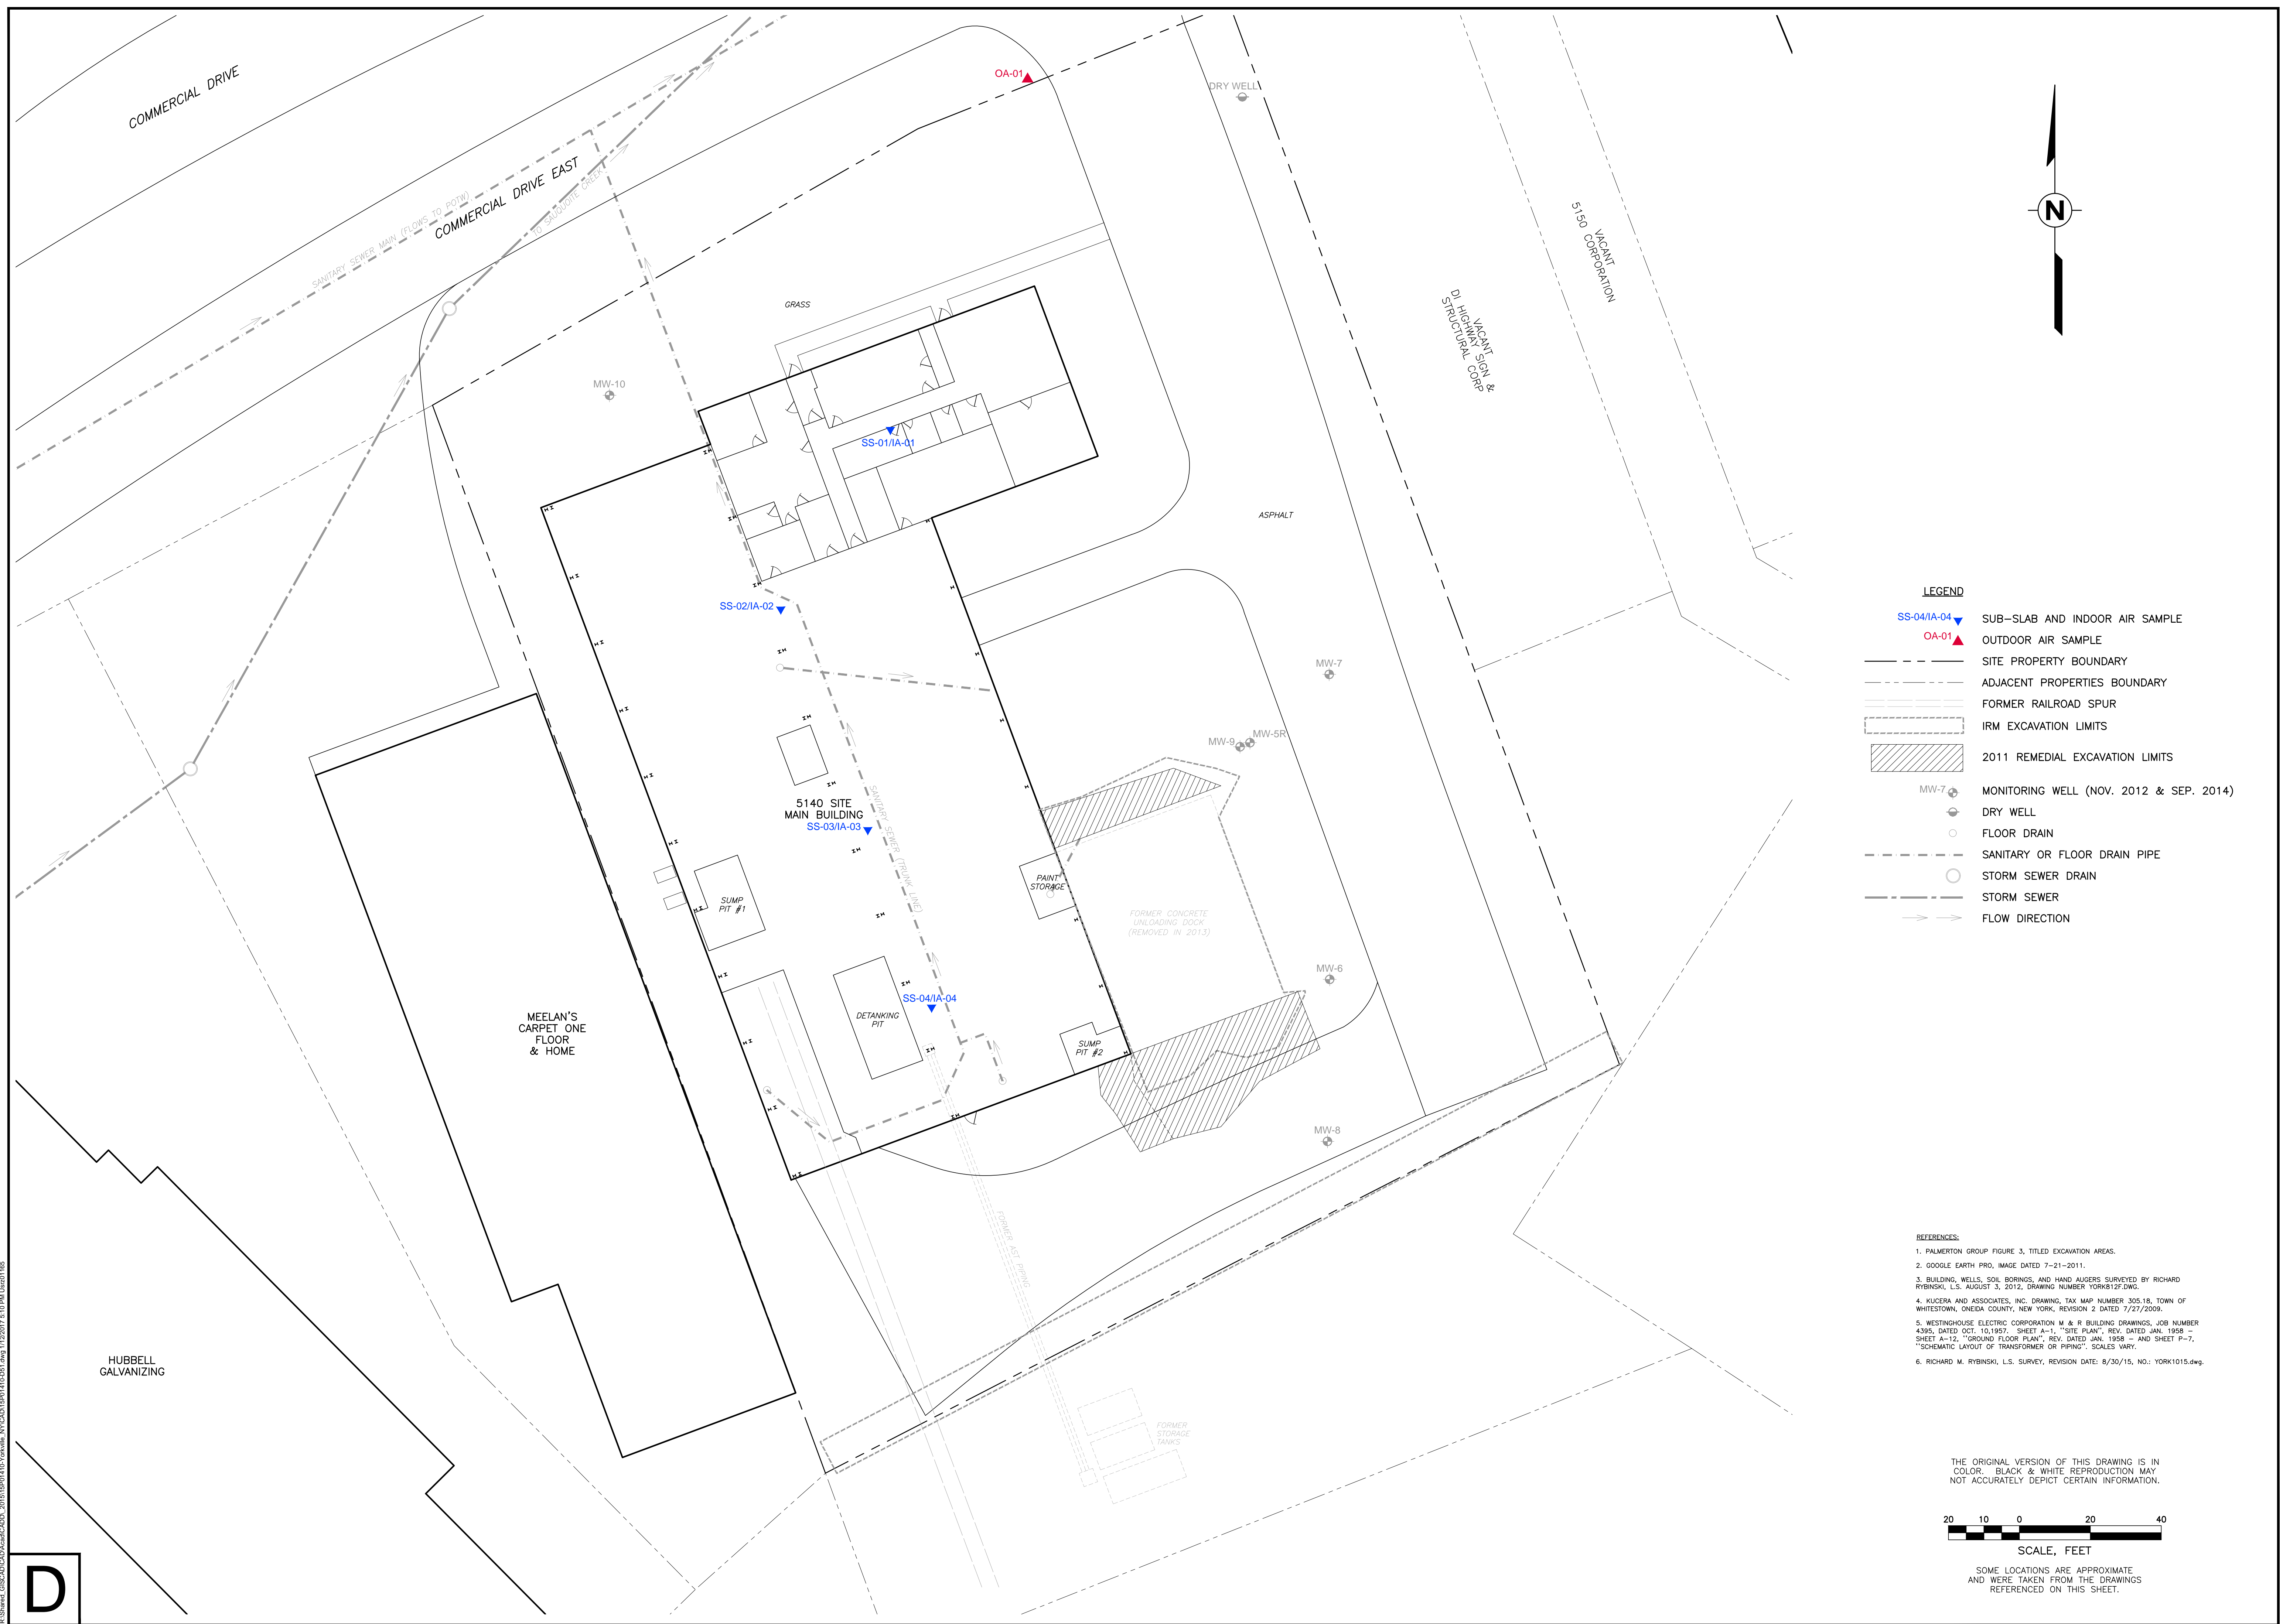
SUB-SLAB, INDOOR AIR, AND OUTDOOR AIR SAMPLING LOCATIONS

- LEGEND**
- SS-04/IA-04 ▽ SUB-SLAB AND INDOOR AIR SAMPLE
 - OA-01 ▲ OUTDOOR AIR SAMPLE
 - SITE PROPERTY BOUNDARY
 - - - ADJACENT PROPERTIES BOUNDARY
 - - - FORMER RAILROAD SPUR
 - - - IRM EXCAVATION LIMITS
 - ▨ 2011 REMEDIAL EXCAVATION LIMITS
 - MW-7 ○ MONITORING WELL (NOV. 2012 & SEP. 2014)
 - DRY WELL
 - FLOOR DRAIN
 - - - SANITARY OR FLOOR DRAIN PIPE
 - STORM SEWER DRAIN
 - - - STORM SEWER
 - FLOW DIRECTION

The vapor sampling results revealed trace concentrations from a number of compounds, including the four chemical compounds with criteria established by the NYSDOH (tetrachloroethene, trichloroethene (TCE), 1,1,1 trichloroethane, and carbon tetrachloride). Only one of the four, TCE, was detected at concentrations that, when compared to NYSDOH's decision matrix, yield a recommended action of "Monitor;" however, WSP concluded (and the Departments ultimately agreed¹⁵) that, based on the lack of correlated soil detections and the conservative nature of the evaluation criteria (established for private residences) that the detections were not a concern.

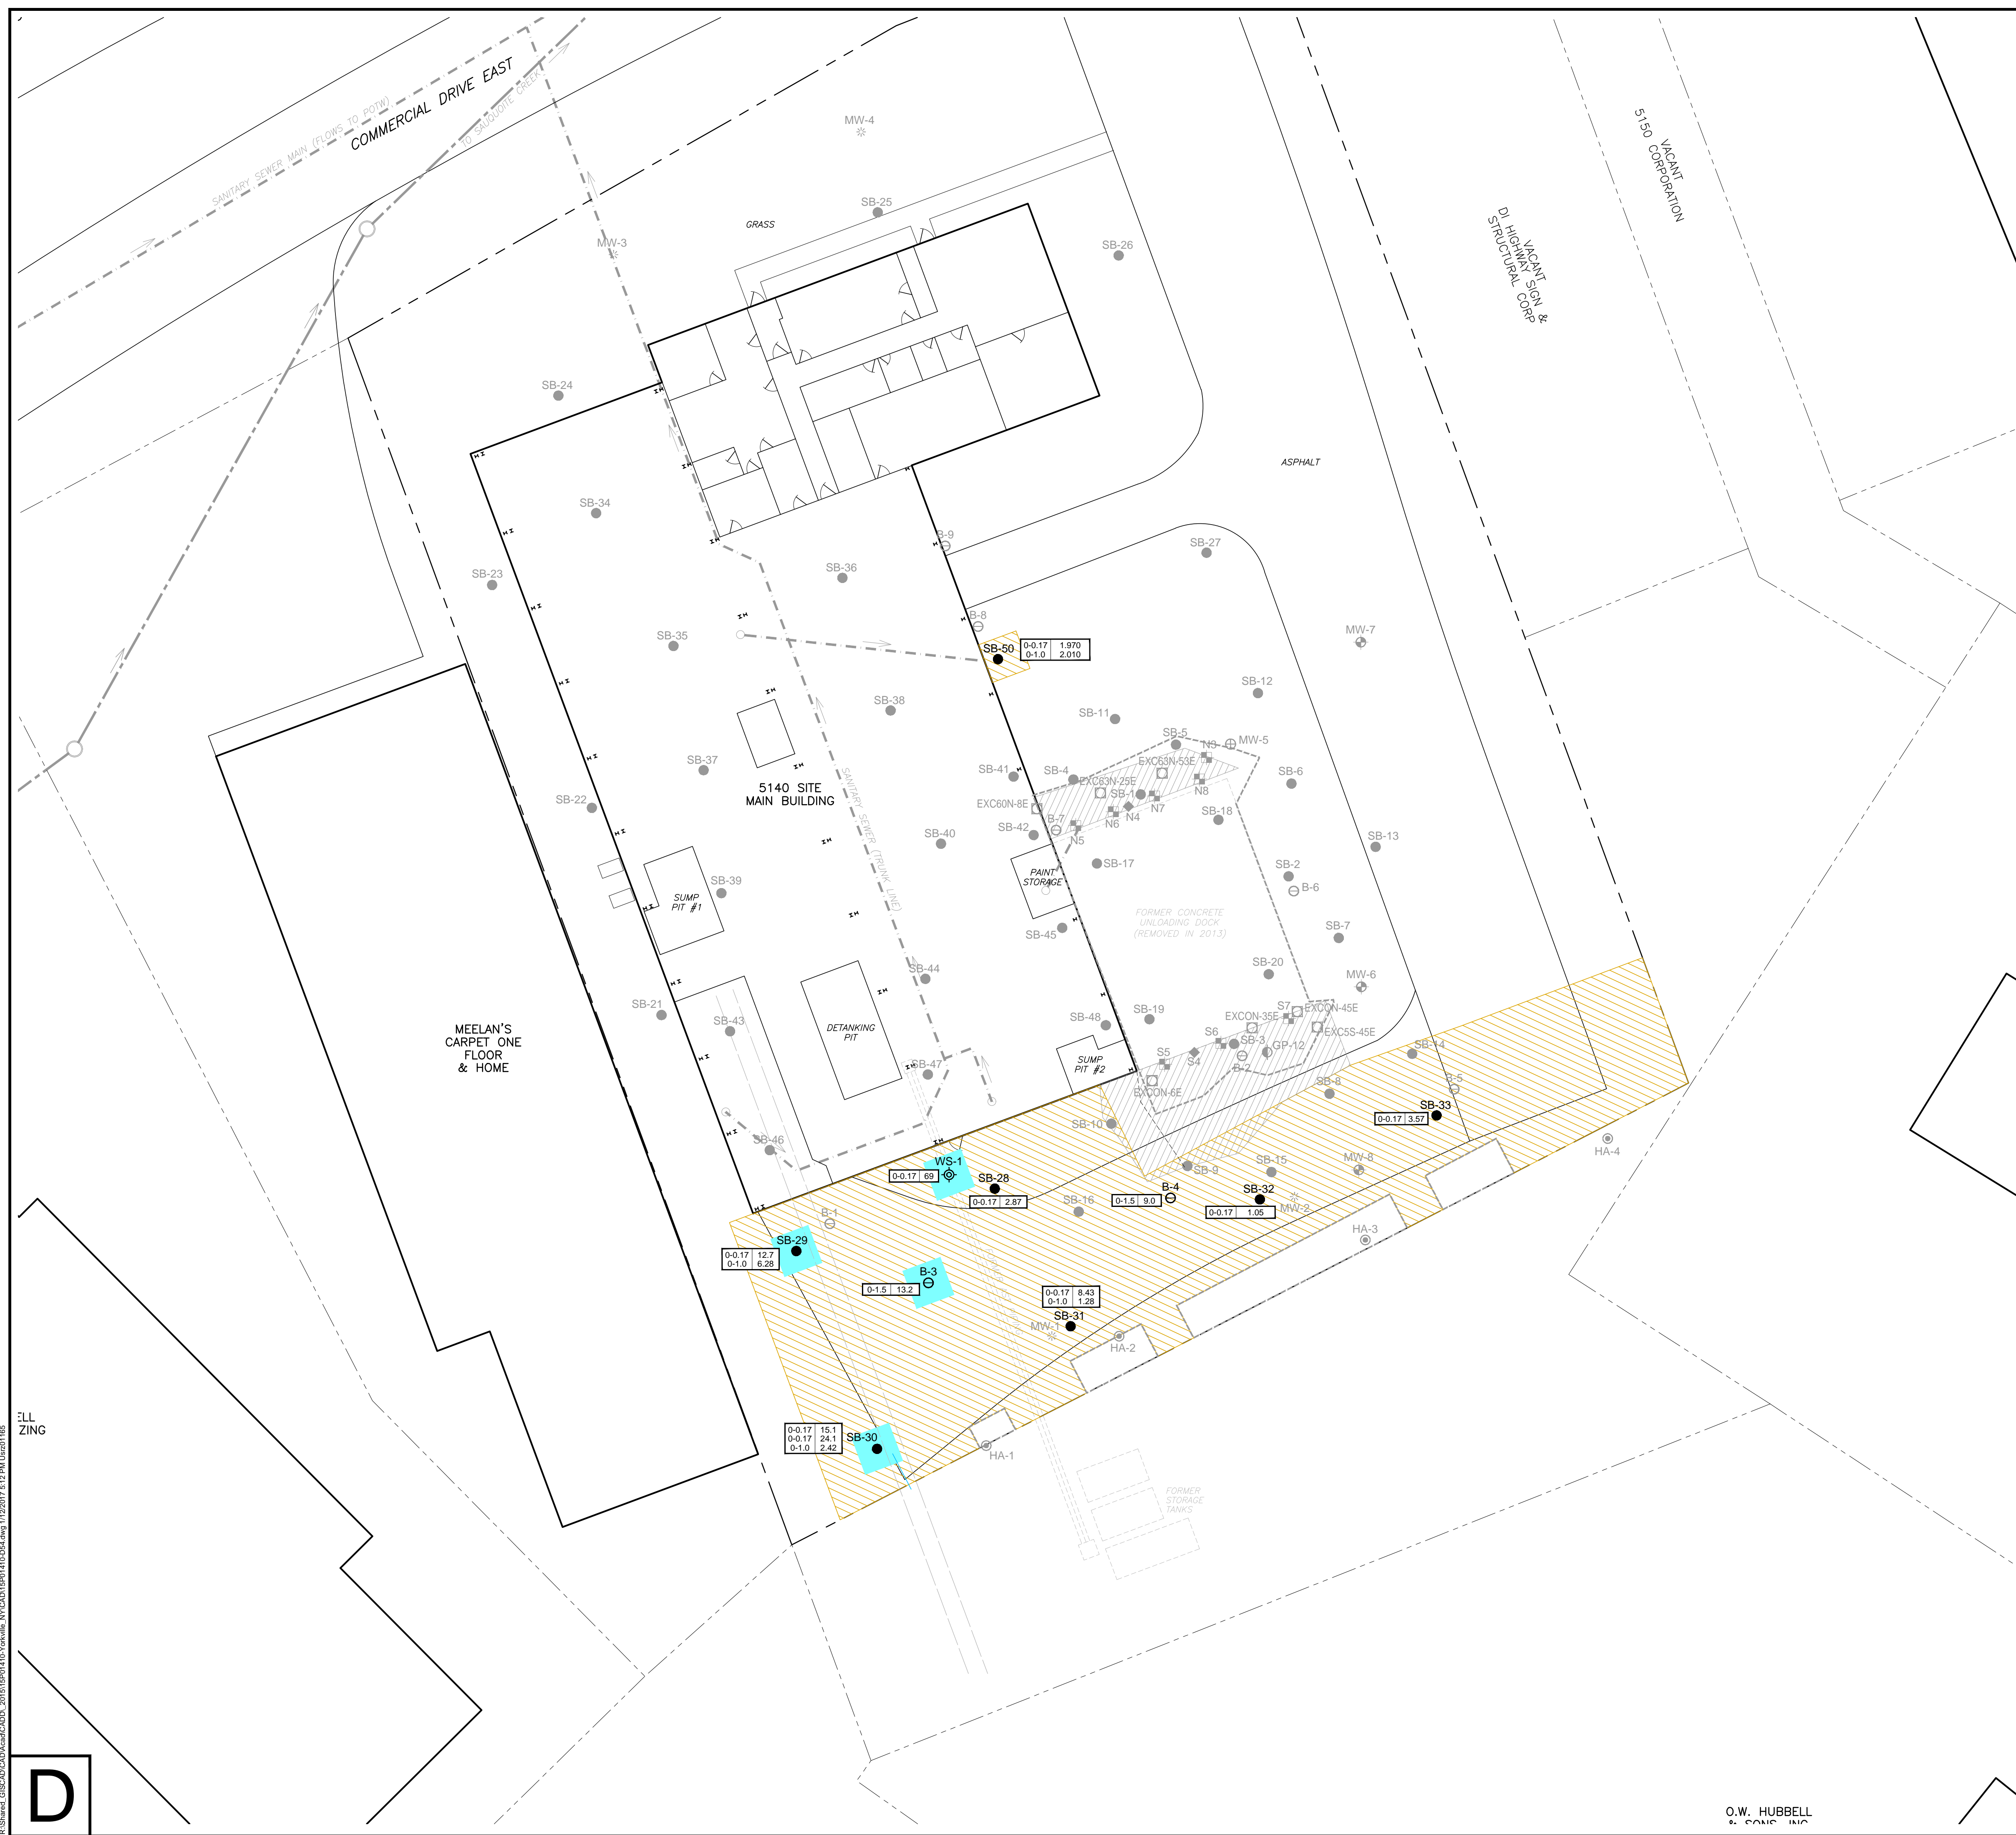
HOT SPOT AND SOIL COVER EXCAVATIONS

- LEGEND**
- HOT SPOT EXCAVATION
 - CONFIRMATION SOIL SAMPLE (2014)
 - SOIL BORING (2012)
 - HAND AUGER LOCATION (2012)
 - MONITORING WELL (NOV. 2012)
 - MONITORING WELL (ABANDONED NOV. 2012)
 - MONITORING WELL DAMAGED AND REMOVED DURING INTERIM REMEDIAL MEASURES (FEB. 2014)
 - SOIL BORING (2011)
 - CONFIRMATION SOIL SAMPLE (2011)
 - TEST PIT (2011)
 - SOIL BORING (DEC. 2010)
 - DRY WELL
 - WASTE CHARACTERIZATION SOIL BORING (2016)
 - SITE PROPERTY BOUNDARY
 - ADJACENT PROPERTIES BOUNDARY
 - FORMER RAILROAD SPUR
 - IRM EXCAVATION LIMITS
 - 2011 REMEDIAL EXCAVATION LIMITS
 - SOIL COVER LIMITS
 - SAMPLE DEPTH (FEET BELOW GRADE SURFACE)
 - 9-11 | 1.023 TOTAL PCB CONCENTRATION IN MILLIGRAMS PER KILOGRAM (mg/kg)
 - FLOOR DRAIN
 - SANITARY OR FLOOR DRAIN PIPE
 - STORM SEWER DRAIN
 - STORM SEWER
 - FLOW DIRECTION

The extents of the hot spot (400 square feet) and soil cover excavations (11,810 square feet for the southern cover and 100 square feet for the eastern excavation) were not altered during the implementation of the remedy. The limits depicted on Figure 15, which were surveyed in advance of the work, are consistent with the revised bounds discussed in the alterations section above and accurately reflect the ground conditions at the site. Figure 15 includes the State Plane (NAD 83) coordinates for each corner of the soil cover system for reference.

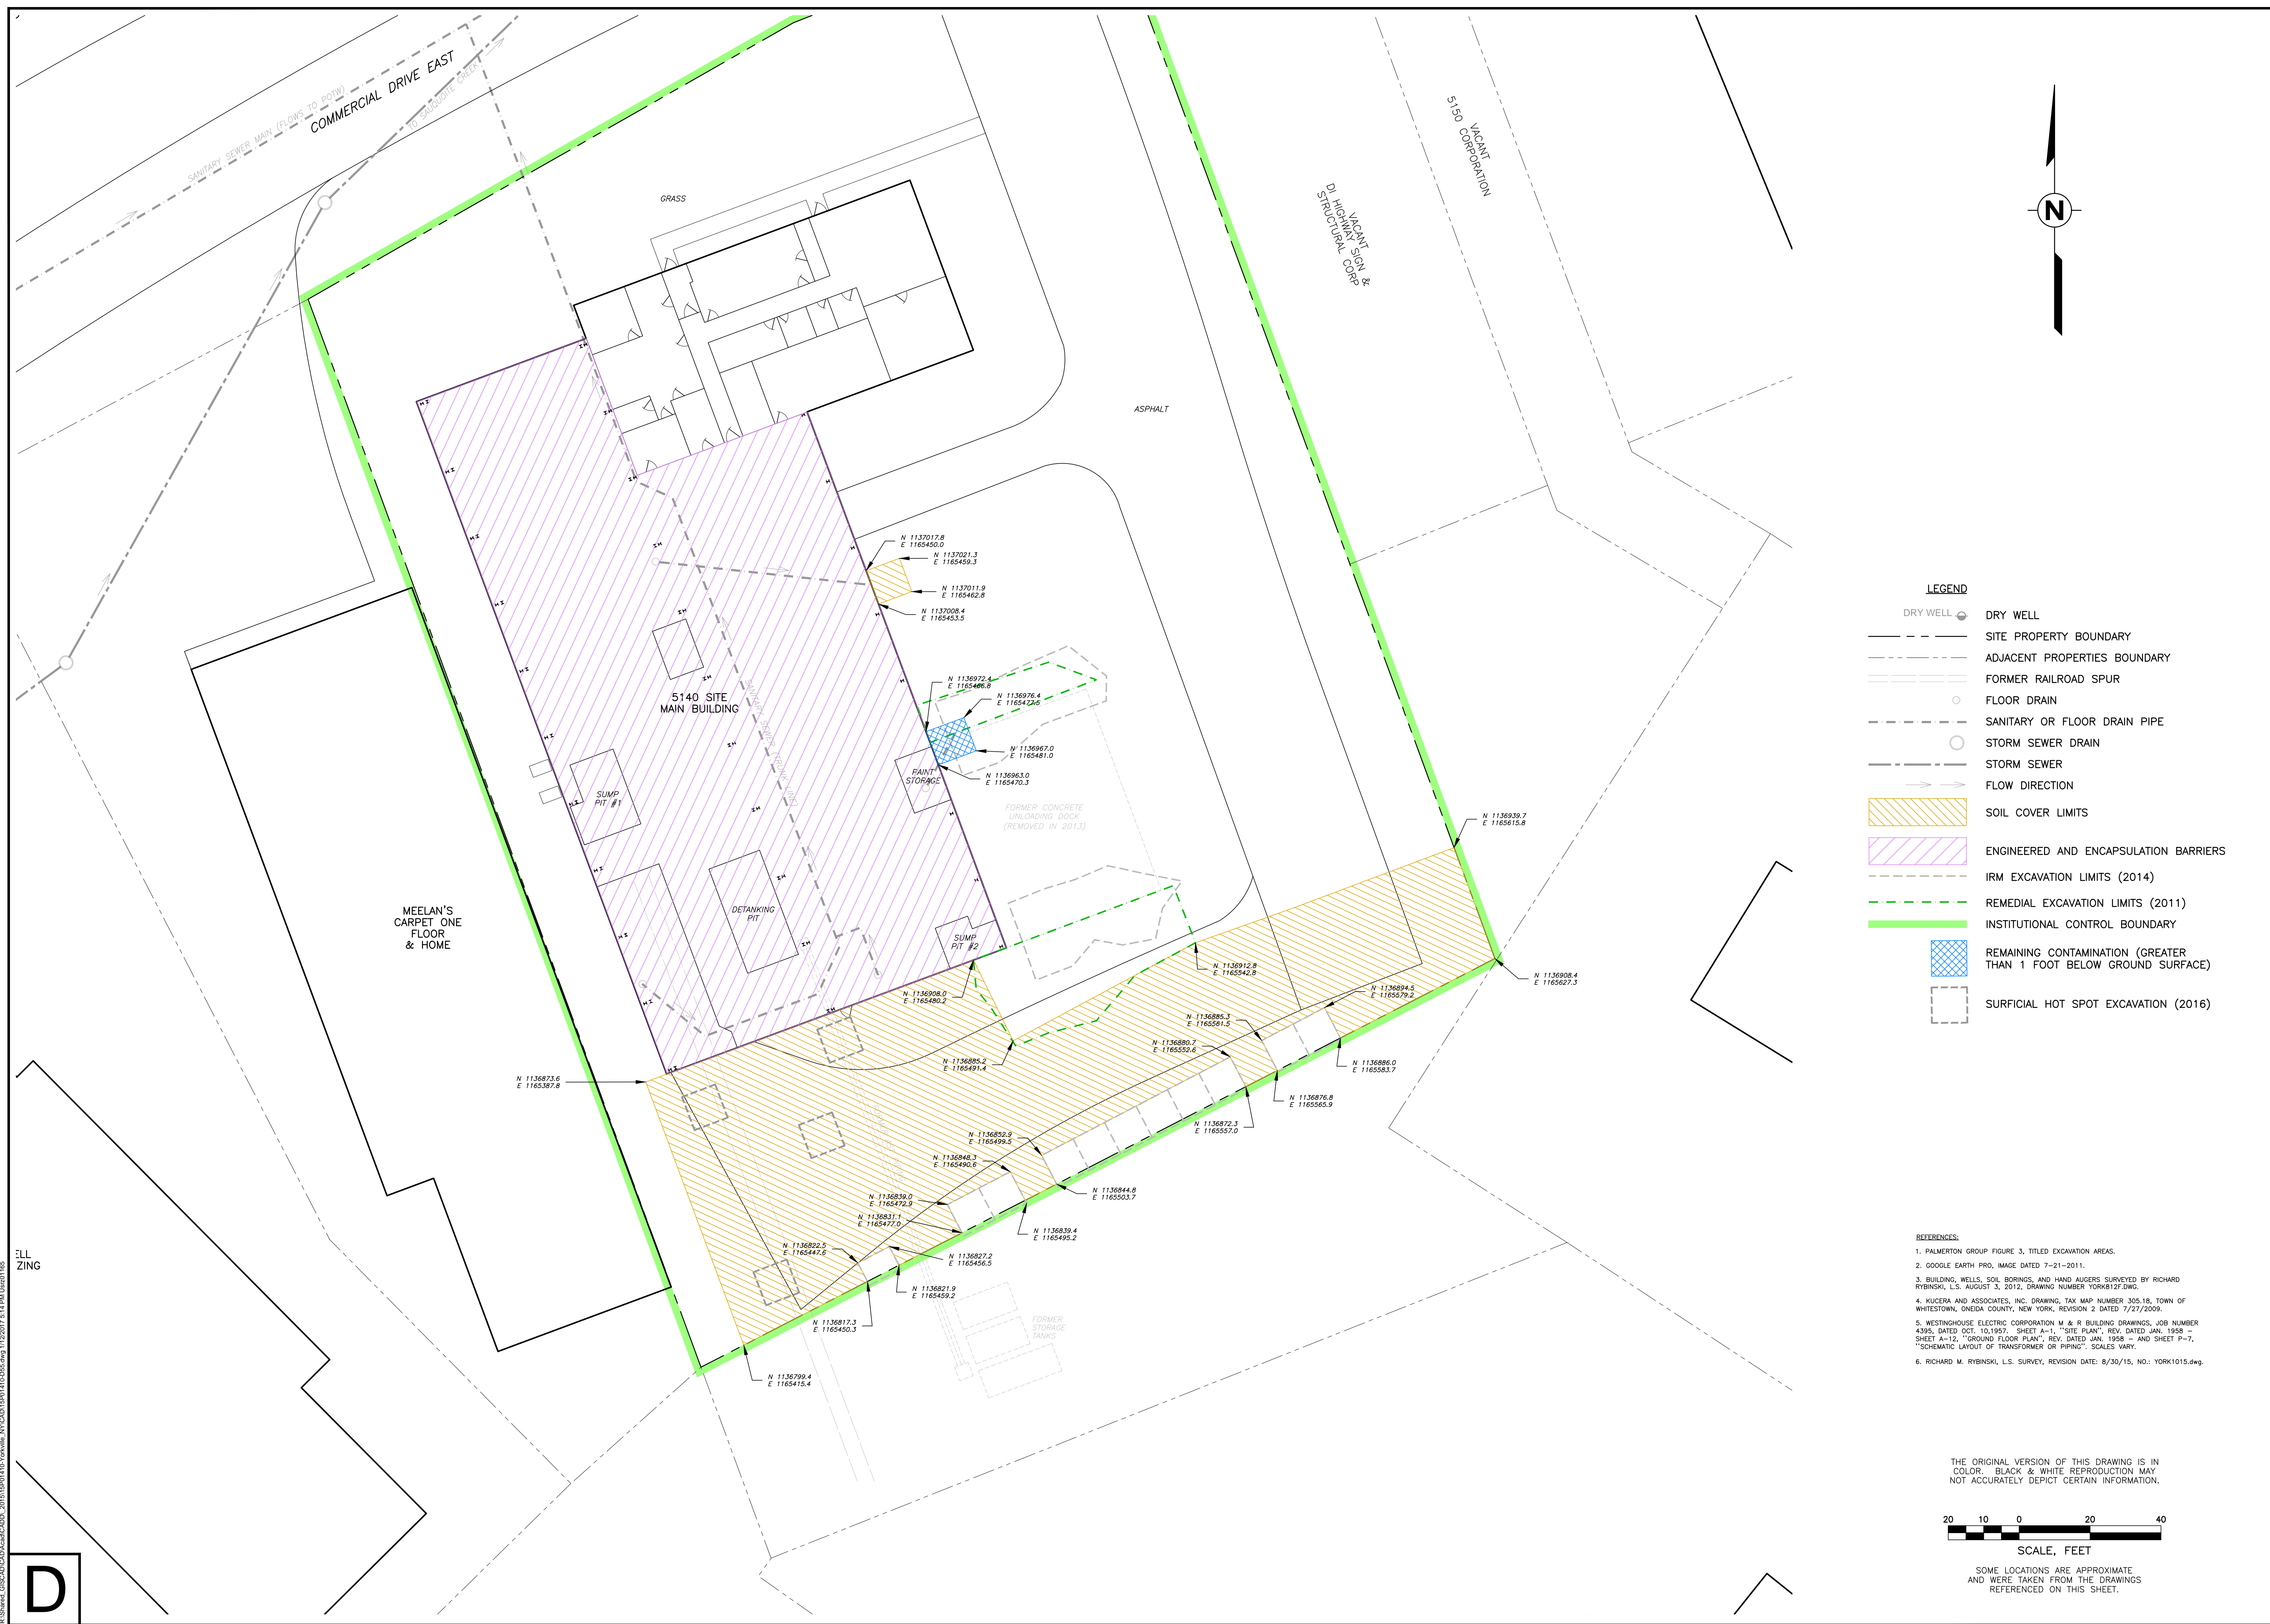
- LEGEND**
- DRY WELL
 - SITE PROPERTY BOUNDARY
 - - - ADJACENT PROPERTIES BOUNDARY
 - - - FORMER RAILROAD SPUR
 - FLOOR DRAIN
 - - - SANITARY OR FLOOR DRAIN PIPE
 - STORM SEWER DRAIN
 - - - STORM SEWER
 - FLOW DIRECTION
 - ▨ SOIL COVER LIMITS
 - ▨ ENGINEERED AND ENCAPSULATION BARRIERS
 - - - IRM EXCAVATION LIMITS (2014)
 - - - REMEDIAL EXCAVATION LIMITS (2011)
 - ▨ INSTITUTIONAL CONTROL BOUNDARY
 - ▨ REMAINING CONTAMINATION (GREATER THAN 1 FOOT BELOW GROUND SURFACE)
 - ▨ SURFICIAL HOT SPOT EXCAVATION (2016)
