# FINAL REPORT REMEDIAL INVESTIGATION ACCURATE DIE CASTING FACILITY FAYETTEVILLE, NEW YORK

## ITT COMMERCIAL FINANCE CORPORATION

STEARNS & WHELER Environmental Engineers and Scientists One Remington Park Drive Cazenovia, NY 13035

December 1993

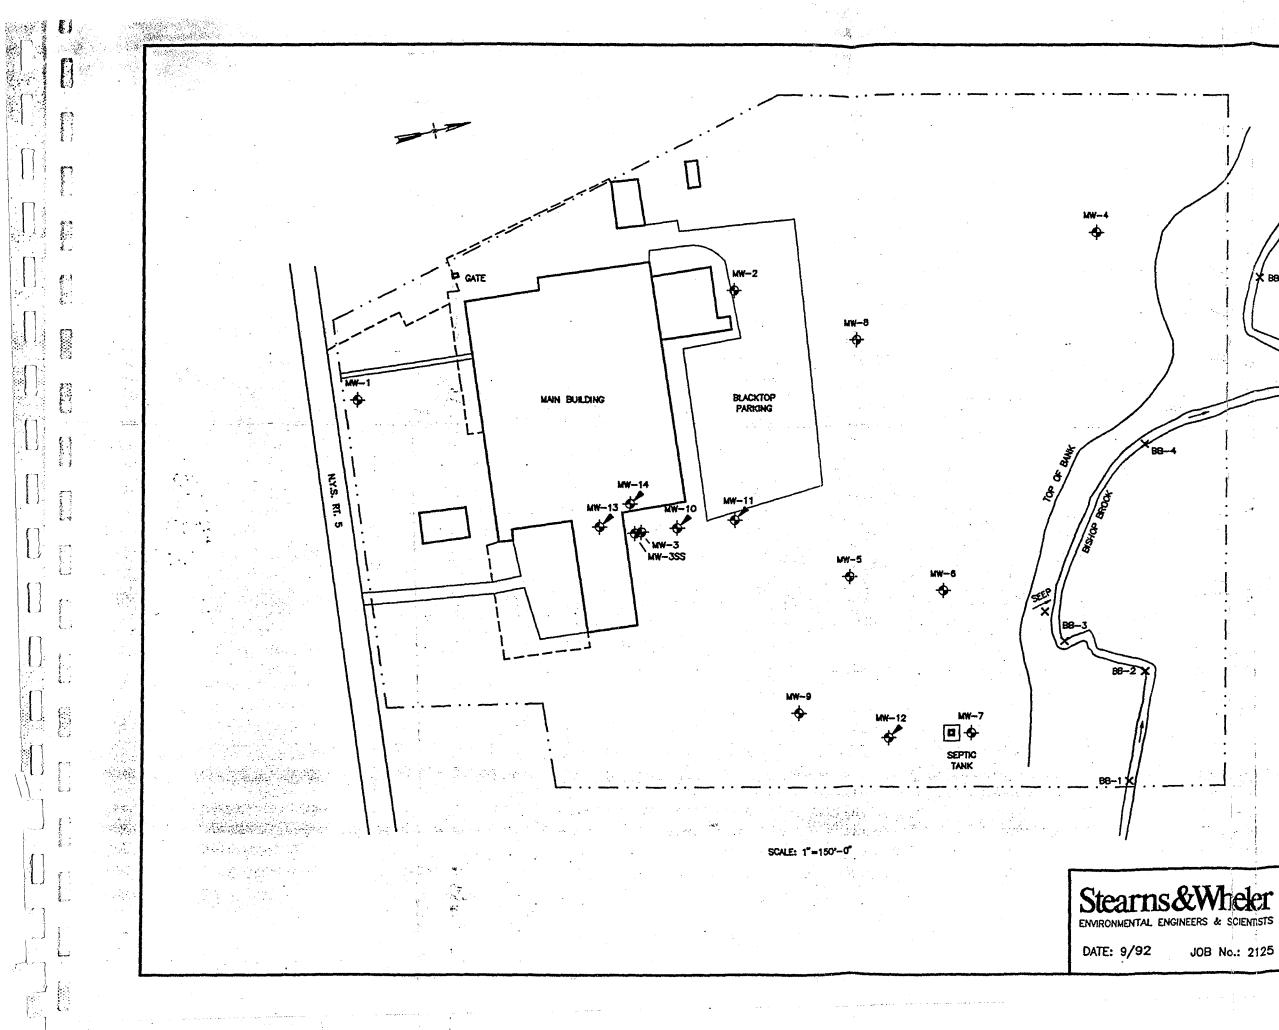
FIGURE 2-3 SAMPLING LOCATIONS

-				
i/	1.					
88-1	5					
	88-5					
•				•		
5			LEGEND			
	、	₩₩-4 •	- MONITORIN	ig well		
•			- PROPERTY	LINE		
			- Soil Same	۶E		
ļ		× 88-4	- STREAM S	AMPLING		
			- SEPTIC TAI SAMPLE	NK		,
					۰. ۱	
Wheler		ACCL FAYET SUBSU	JRATE DIE ( TEVILLE, NE RFACE INVE	CASTING W YORK		
RS & SCIENTISTS						1

D. Septic Tank Sampling. To investigate the possibility that the septic tank (Figure 2-3) is a source of groundwater contamination, the septic tank was sampled on May 28, 1992. Upon excavation and opening of the tank, it was observed that the tank had been decommissioned by being filled with gravel through three manways. The gravel did not fill the tank completely and between the manways, near the top of the tank, a white material with a soil-like consistency was found. This material was sampled. The sample was kept under chain-of-custody and transported via overnight mail to the laboratory. The sample was analyzed for TCL metals and TCL volatiles.

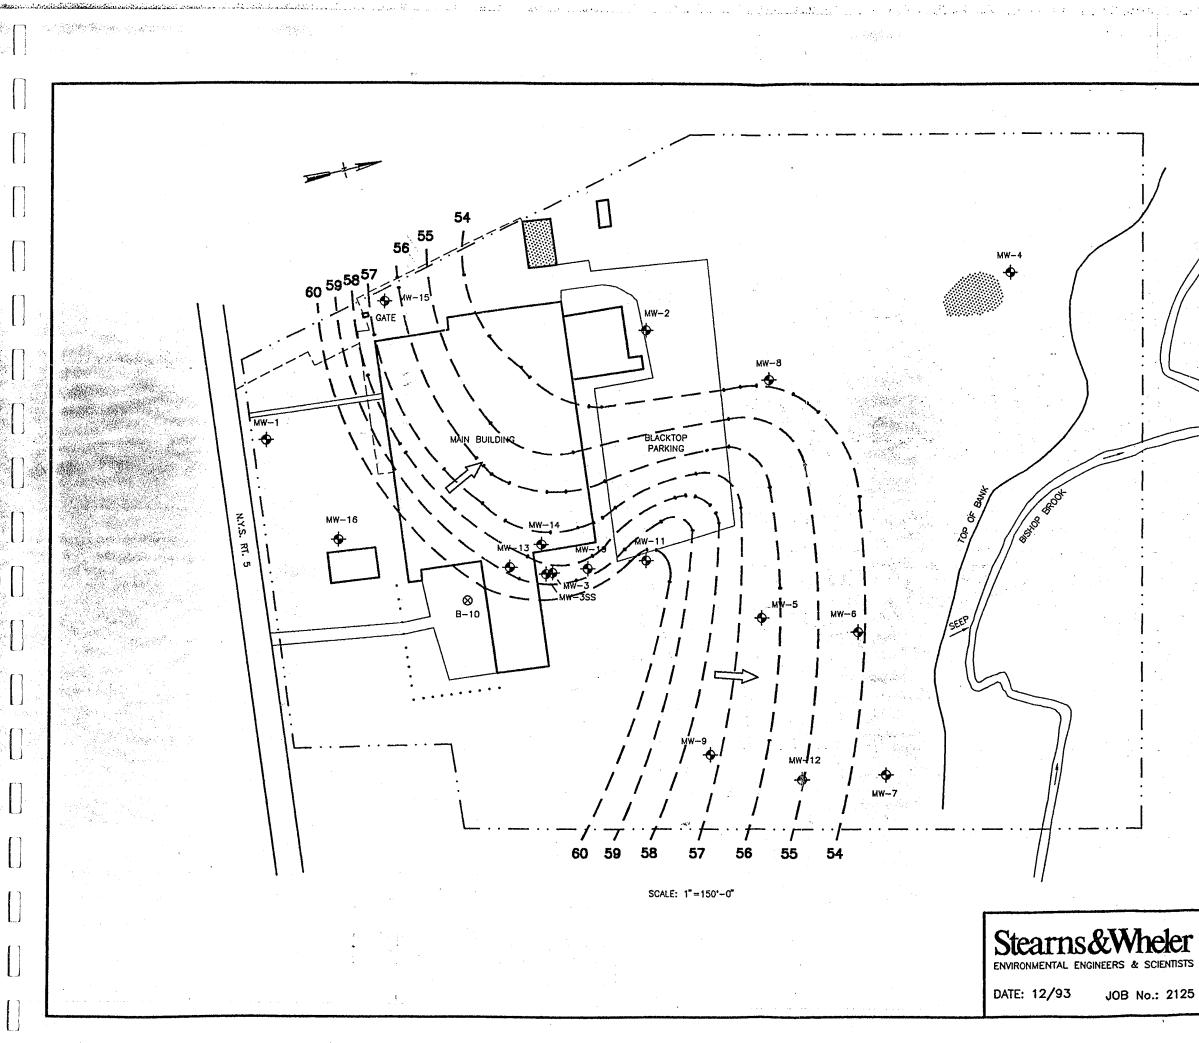
LEGEND MW-4 - MONITORING WELL ÷ PROPERTY LINE - FENCE . . . . . . B--6 - BORING SAMPLING LOCATION 8 - SOIL SAMPLE AREA WATER TABLE CONTOUR - GROUNDWATER FLOW DIRECTION ACCURATE DIE CASTING FAYETTEVILLE, NEW YORK SUBSURFACE INVESTIGATION FIGURE 7-3 BEDROCK AQUIFER GROUNDWATER CONTOURS
