Re: Excavation of Petroleum Impacted Soil at Test Pit 3-4
Emerson Power Transmission – Ithaca, New York
Order on Consent #A7-0125-87-09

On behalf of Emerson, WSP USA Corp. (WSP) is submitting this letter report summarizing the activities undertaken involving the excavation of petroleum containing soil identified at Test Pit 3-4 located to the south and west of the fire water reservoir at the Emerson Power Transmission (EPT) site in Ithaca, New York. As described in WSP's October 3, 2013 correspondence to the New York State Department of Environmental Conservation (NYSDEC), no light non aqueous phase liquid was measured in the 5 requested monitoring points installed around the south tank of the fire water reservoir, thus, Emerson proceeded with excavating petroleum affected soil identified around Test Pit 3-4. Figure 1 shows the location of Test Pit 3-4 and the limits of the soil excavation work. Enclosure A contains a log of photographs showing the work progress.

PHOTOGRAPHIC LOG

Test Pit 3-4 Soil Removal
Emerson Power Transmission, Ithaca, NY

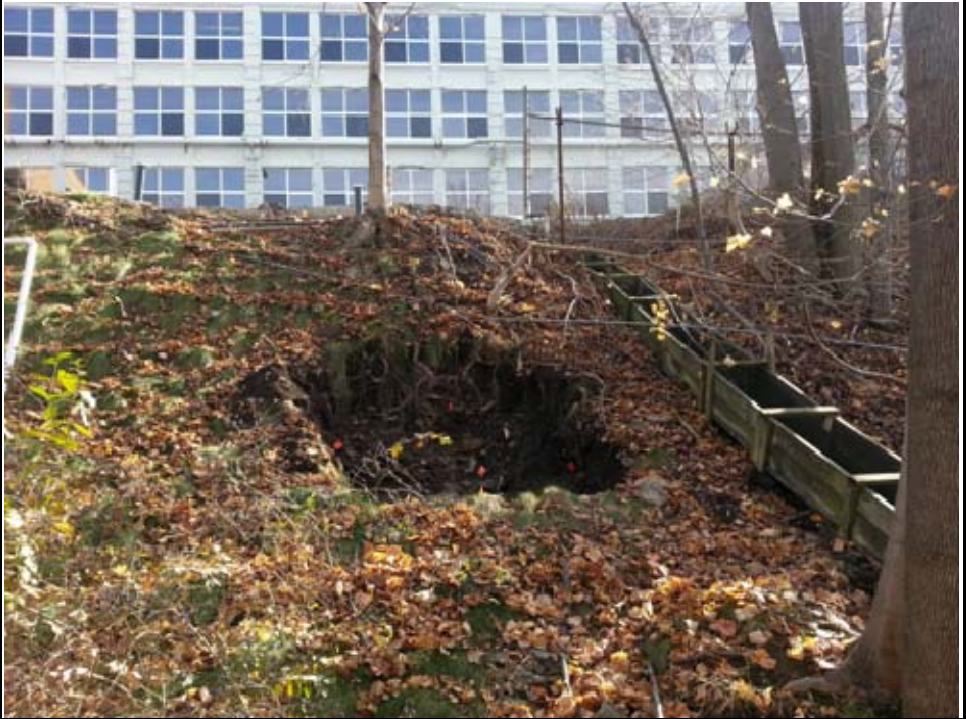
Photo No.	1

Description 11/14/13 Completed Test Pit 3-4 Excavation. Excavation dimensions are approximately 10 ft by 10 ft by 2 to 5 feet in depth. Confirmation sample locations are marked with orange flagging. Samples collected of the 4 walls and excavation base.

The excavation work was undertaken on November 14, 2013. A backhoe was used to excavate the soils (Figure 1). A total of approximately 13 cubic yards of soil was excavated from the Test Pit 3-4 area. The limits of the excavation are depicted in Figure 1 and photo 1. The excavated soil was directly loaded into a truck and disposed of at the High Acres Landfill in Fairport, New York. A waste profile was completed and approved based on the previous Test Pit 3-4 data. Enclosure B contains the disposal documentation for the single load of soil.

A photoionization detector (PID) was used to screen the sidewalls and base of the cavity to assess whether any organic compounds may be present. PID measurements ranged from 0.1 to 0.2 parts per million which was consistent with background readings. No visible indications of oil or odors were noted in soils within the excavated area. Next, confirmation samples were collected from the four walls and the base of the excavation. The samples were submitted to Accutest of New England for analysis of polycyclic aromatic hydrocarbons (PAHs) by EPA SW846 method 8270C and target compound list (TCL) volatile organic compounds (VOCs) by EPA SW846 method 8260B.

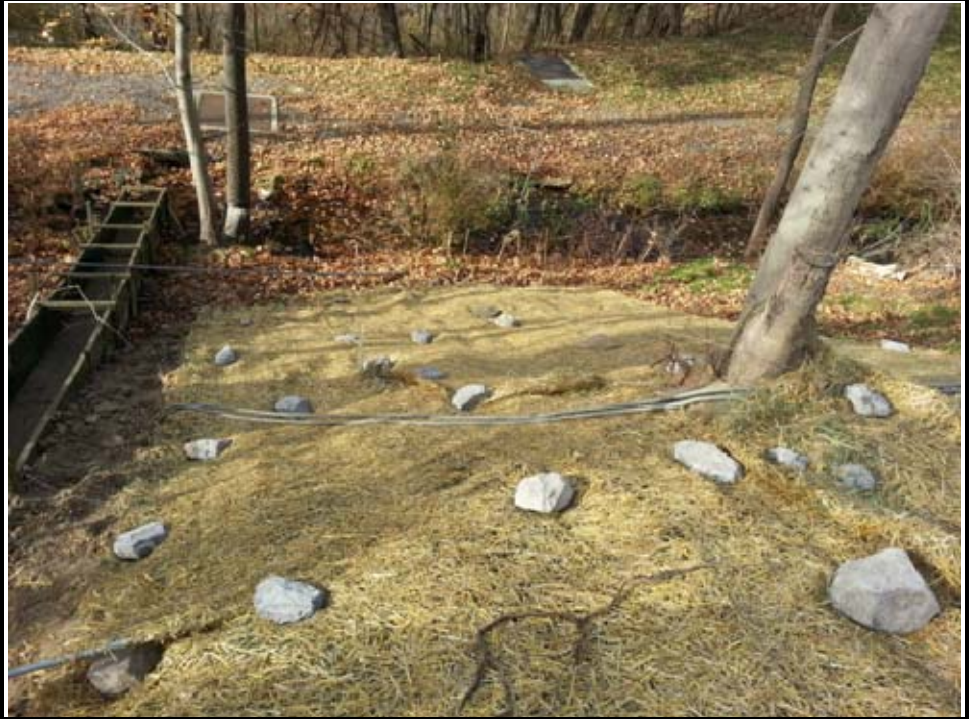
Photo No.

Restoration of the Test Pit 3-4 Area using straw matt. Area will be seeded during the spring of 2014.

Immediately following sample collection, the excavation was lined with a fabric and backfilled with imported clean topsoil (photo 2). To protect the slope against erosion from runoff, a straw mat fabric was placed over the disturbed area and anchored with soil staples and rocks (photo 3). The area will be
