**PRELIMINARY REVIEW
and
VISUAL SITE INSPECTION**

FOSTER WHEELER ENERGY CORPORATION

9431 FOSTER WHEELER ROAD
DANSVILLE, NEW YORK

FEBRUARY 2006

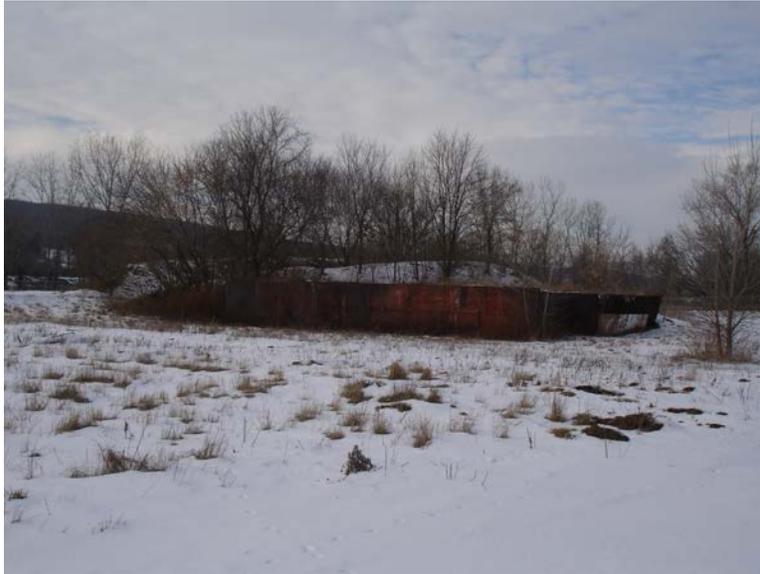
Photograph #1

This area was used from 1980 until 1995 for collecting general trash. It was located northwest of the High Bay area, on the northern side of the railroad tracks. At the time of the inspection, there was no evidence of a release from this unit.

This area was used from 1992 until 1995 for collecting scrap wood. It was located on the northern side of the railroad tracks, between SWMUs 311A and 322. At the time of the inspection, there was no evidence of a release from this unit.

This area was used for waste piles of dirt and concrete during 1980. The area was located northwest of the High Bay area, near SWMU 331A, 312A and 332. At the time of the inspection, there was no evidence of a release from this unit.

This area was used for a waste pile of scrap wood from the 1970s until 1992. It was located south of SWMU #321A and adjacent to SWMU #312A. At the time of the inspection, there was no evidence of a release from this unit.

SWMUs #311A, 312A, 321A and 322

Photograph was taken December 22, 2005. The area was used for collecting scrap wood, general trash and dirt and concrete. SWMU #321A was a waste pile for dirt and concrete. Dumpsters were in front of ramp that was used for loading.

Conclusion and Recommendation: No further action is necessary for this SWMU.

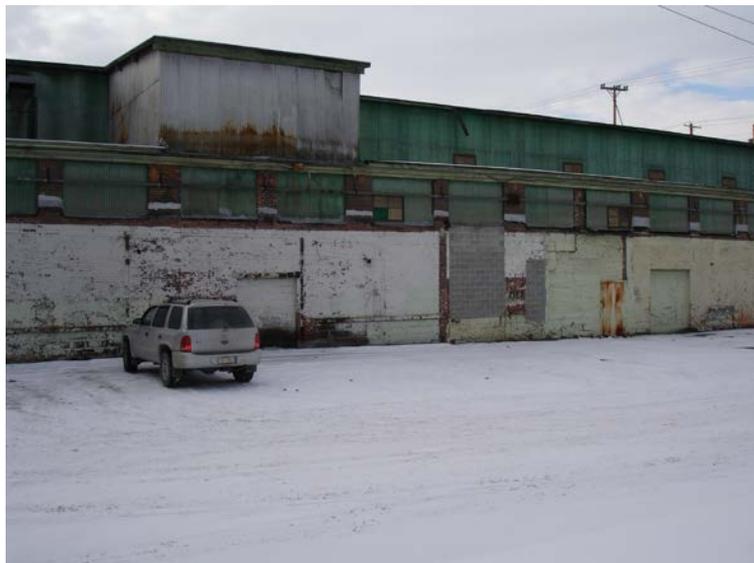
Photograph #2

This area was used from 1995 until 2003 for collecting general trash. It was located outside, on the eastern side of Tube I. At the time of the inspection, there was no evidence of a release from this unit.

311B. At the time of the inspection, there was no evidence of a release from this unit.

This area was used from 1995 until 2003 for collecting scrap metal. The area was located outside, on the eastern side of the Light Fabrication building and adjacent to SWMU 312B. At the time of the inspection, there was no evidence of a release from this unit.

SWMUs #311B, 312B and 313C

Photograph was taken December 22, 2005. This area was used for collecting scrap metal, scrap wood and general trash.

Conclusion and Recommendation: No further action is necessary for this SWMU.

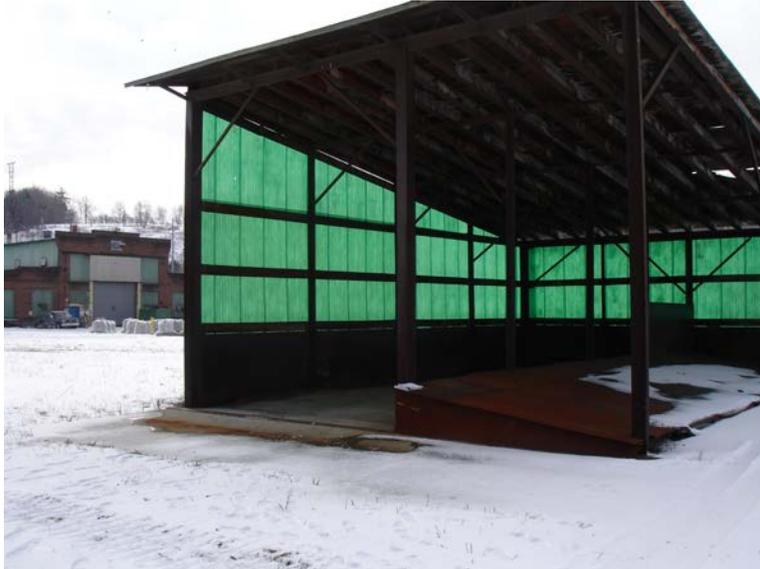
Photograph #3

This area was used from the 1970s until 1995 for collecting scrap metal. It was located outside, west of the High Bay area. At the time of the inspection, there was no evidence of a release from this unit.

This area was used from 1987 until 1990 for collecting carbon steel cuttings. It was located outside, west of the High Bay area and adjacent to SWMU 313A. The area was partially covered by a lean-to. At the time of the inspection, there was no evidence of a release from this unit.

SWMUs #313A and 313B

Photograph was taken December 22, 2005. The area was used for collecting scrap metal and steel cuttings.

Conclusion and Recommendation: No further action is necessary for this SWMU.

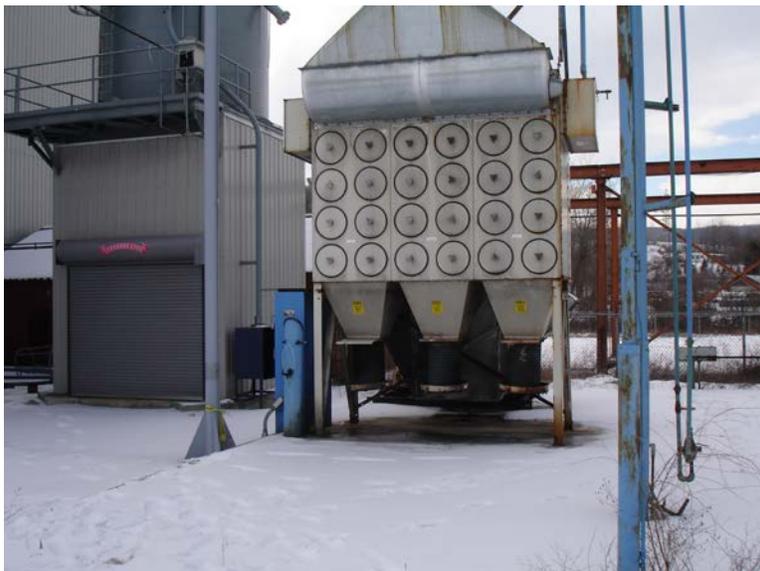
Photograph #4

This area operated as a drum storage area from 1985 until 2002 to store drums of coal dust. The area is located outside, on the northern side of the Test Facility. The drums were located under the dust collection structure. At the time of the inspection, there was no evidence of a release from this unit.

SWMU #314A

Photograph was taken December 22, 2005. The area was used for collecting drums of coal dust.

Conclusion and Recommendation: No further action is necessary for this SWMU.

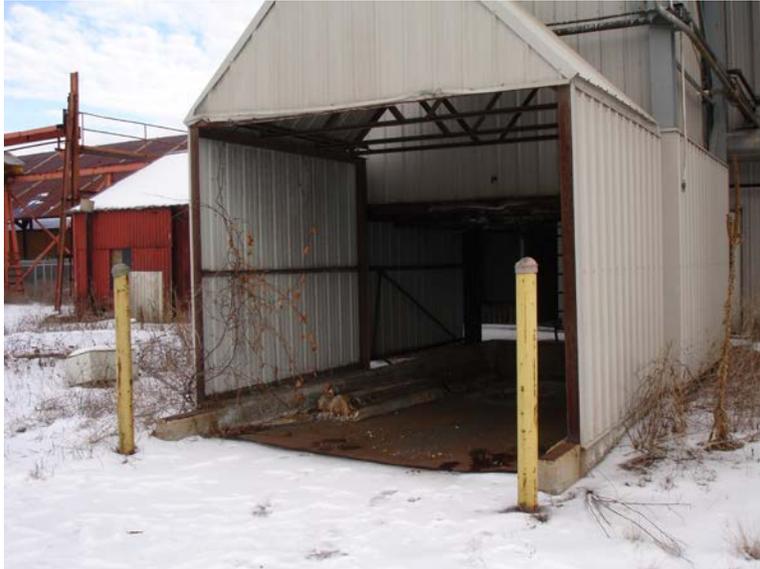
Photograph #5

This area was used from 1985 until 2002 for collecting fly ash in hoppers. The area was located outside, on the western side of the Test Facility. The hopper was located under collection equipment and partially protected. At the time of the inspection, there was no evidence of a release from this unit.

SWMU #314B

Photograph was taken December 22, 2005. The area was used for collecting fly ash in hoppers.

Conclusion and Recommendation: No further action is necessary for this SWMU.

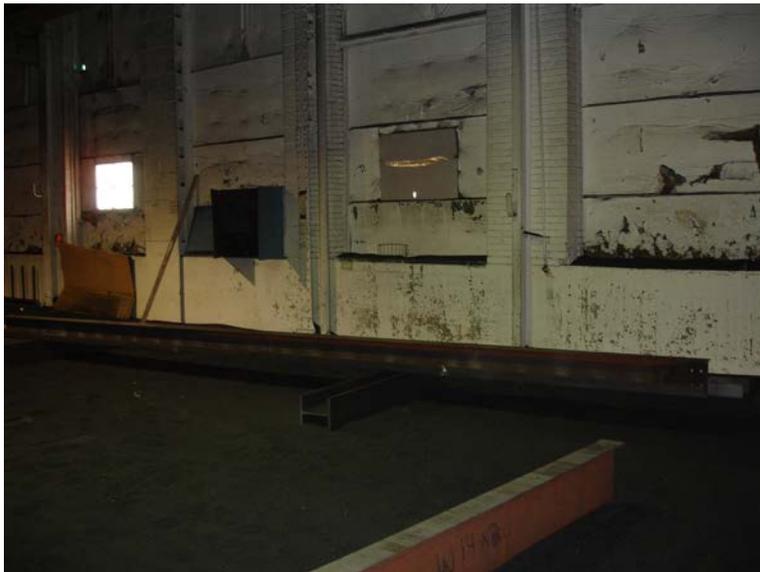
Photograph #6

This area was used as a less than 90 day container storage area from 1989 until 1995 to store drums of hazardous waste. The area was located inside Tube I, near the northwest corner. In July of 2005, LaBella conducted soil sampling at boring TB-15. The boring was located in the container storage area. The results showed a peak PID reading of 7.6 ppm at 12' - 14' BGS. Detected concentration of naphthalene in sample TB-15 (41.6 ug/kg) exceeds NYSDEC TAGM 4046 Recommended Soil Cleanup Objective for naphthalene of 13 ppm. The detected soil analytical results and exceedances for RCRA 8 metals showed metals did not exceed NYSDEC TAGM 4046 Recommended Soil Cleanup Objectives for boring TB-15. PCBs were non-detect at soil boring TB-15. At the time of the inspection, there was no evidence of a release from this unit.

SWMU #315A

Photograph was taken December 22, 2005. The area was used for collecting drums of hazardous waste. The area is currently used for sand blasting. The sand is shown in photograph.

Conclusion and Recommendation: No further action is necessary for this SWMU.

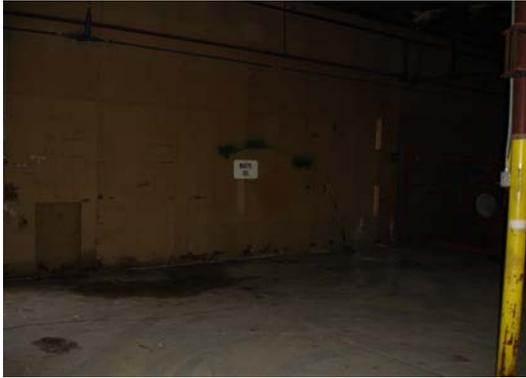
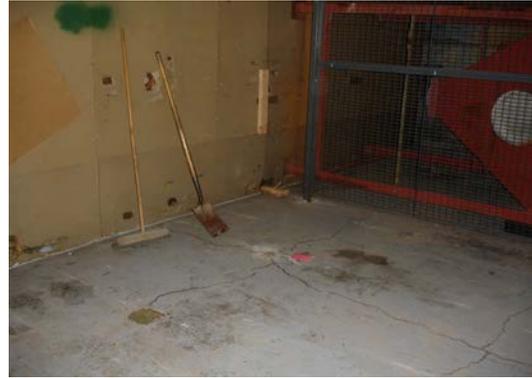
Photographs #7

This area was used as a less than 90 day container storage area from 1996 until 2003 to store drums of hazardous waste. The area was located inside Building 2. LaBella conducted soil sampling at boring TB-25, inside the container storage area. The results showed a peak PID reading of 0.0 ppm. Another boring, TB-22, was located just outside the building. TB-22 had a peak PID reading of 17.9 ppm at 4' - 6' BGS. The TB-22 soil boring detected acetone at a level of 60.5 ug/kg at 7' - 8' BGS, which exceeds the NYSDEC TAGM 4046 Recommended Soil Cleanup Objective for acetone of 0.2 ppm. However, the presence of acetone was not detected in groundwater samples from the site wide monitoring system installed by LaBella. The TB-22 soil boring also detected arsenic at a level of 13.9 mg/kg, which exceeds the NYSDEC TAGM 4046 Recommended Soil Cleanup Objective for arsenic of 7.5 mg/kg. No RCRA metals were detected in site wide groundwater samples at levels exceeding their associated NYSDEC Part 703 Groundwater Standards. PCBs were non-detect at soil boring TB-22. At the time of the inspection, there was no evidence of a release from this unit.

SWMU #315B

Photographs were taken December 22, 2005. The area was used for collecting drums of hazardous waste.

Conclusion and Recommendation: No further action is necessary for this SWMU.

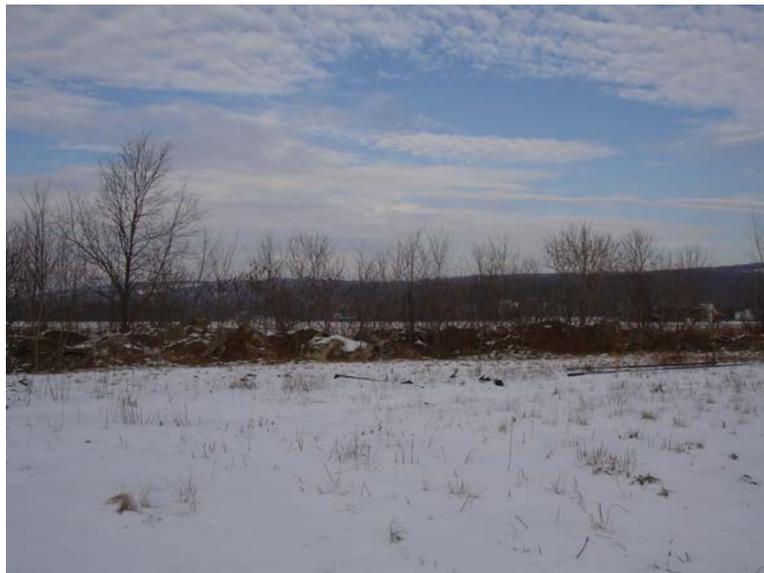
Photograph #8

This area was used for waste piles of dirt and concrete during 1993. The area was located north of the High Bay area, on the northern side of the railroad tracks. At the time of the inspection, there was no evidence of a release from this unit.

SWMU #321B

Photograph was taken December 22, 2005. The area was used as a waste pile for dirt and concrete.

Conclusion and Recommendation: No further action is necessary for this SWMU.

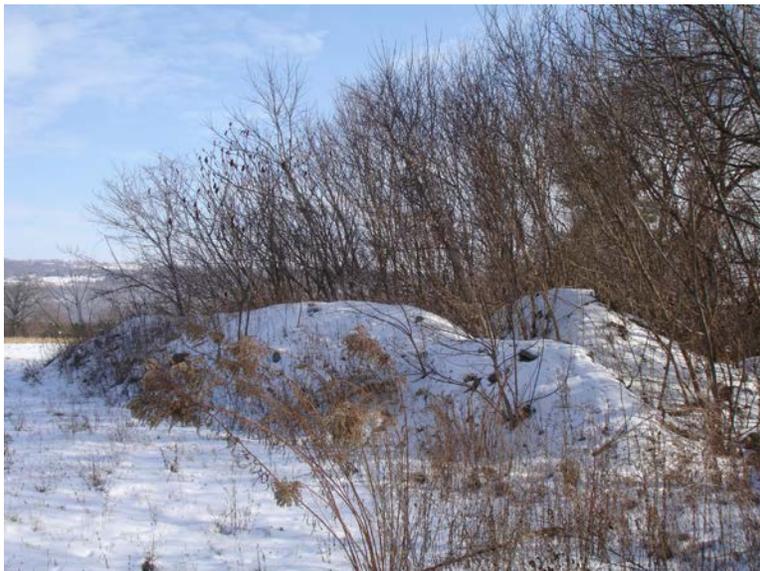
Photograph #9

This area was used for waste piles of dirt and concrete during 1995. The area was located east of Tube Prep building. At the time of the inspection, there was no evidence of a release from this unit.

SWMU #321C

Photograph was taken December 22, 2005. The area was used as a waste pile for dirt and concrete.

Conclusion and Recommendation: No further action is necessary for this SWMU.

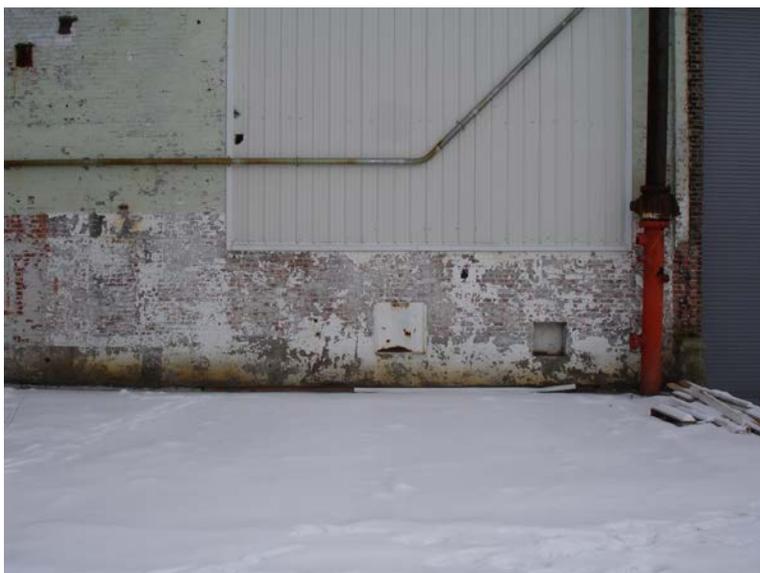
Photograph #10

The unit was a 500 gallon above ground tank located outside on the western side of the Machine Shop. The tank operated from 1990 until 1995 storing a non-hazardous waste mixture of Trimsol and water. At the time of the inspection, there was no evidence of a release from this unit.

SWMU #331A

Photograph was taken December 22, 2005. A 500 gallon tank was located on cement slab. The tank was used to store a mixture of Trimsol and water.

Conclusion and Recommendation: No further action is necessary for this SWMU.

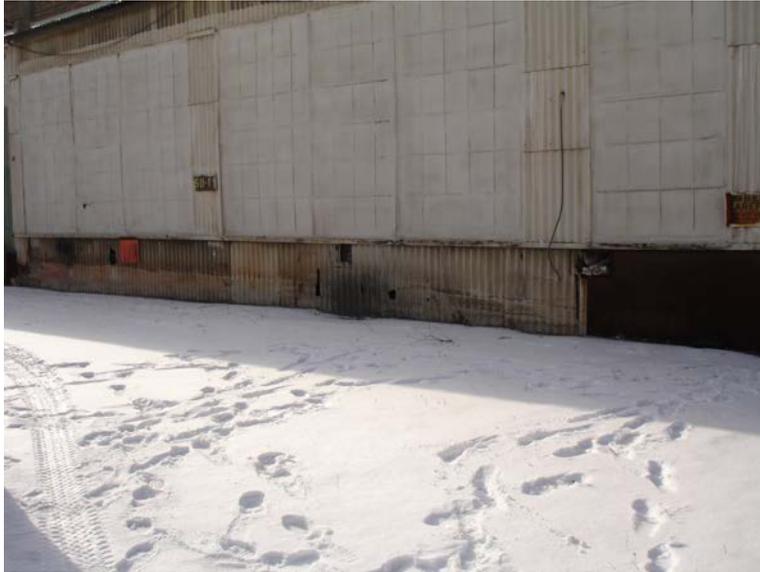
Photograph #11

The unit was a 500 gallon above ground tank located outside on the eastern side of the Low Bay area. The tank operated from 1995 until 1998 storing a non-hazardous waste mixture of Trimsol and water. At the time of the inspection, there was no evidence of a release from this unit.

SWMU #331B

Photograph was taken December 22, 2005. A 500 gallon tank was located on cement slab. The tank was used to store a mixture of Trimsol and water.

Conclusion and Recommendation: No further action is necessary for this SWMU.

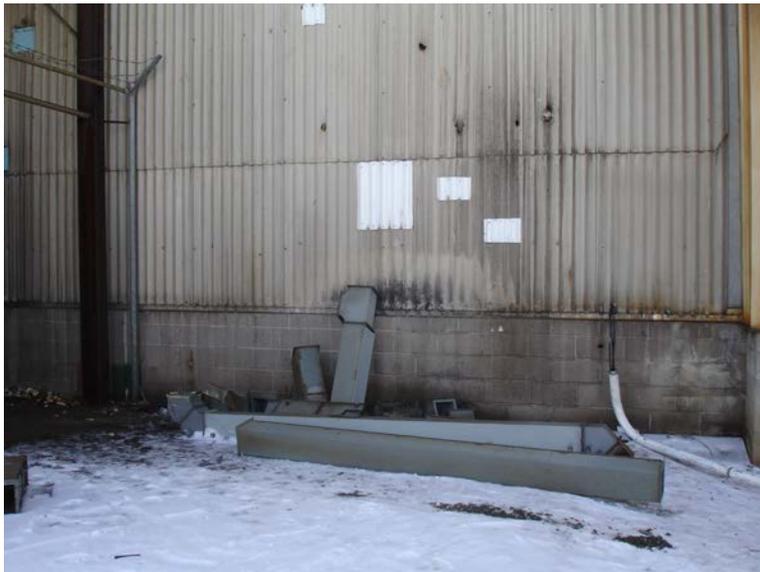
Photograph #12

The unit was a 1000 gallon above ground tank located outside on the eastern side of the Tube Prep building. The tank was covered and operated from the 1960s until 1990 storing used Oakite. At the time of the inspection, there was no evidence of a release from this unit.

SWMU #341A

Photograph was taken December 22, 2005. A 1000 gallon tank was used to store a mixture of Trimsol and water.

Conclusion and Recommendation: No further action is necessary for this SWMU.

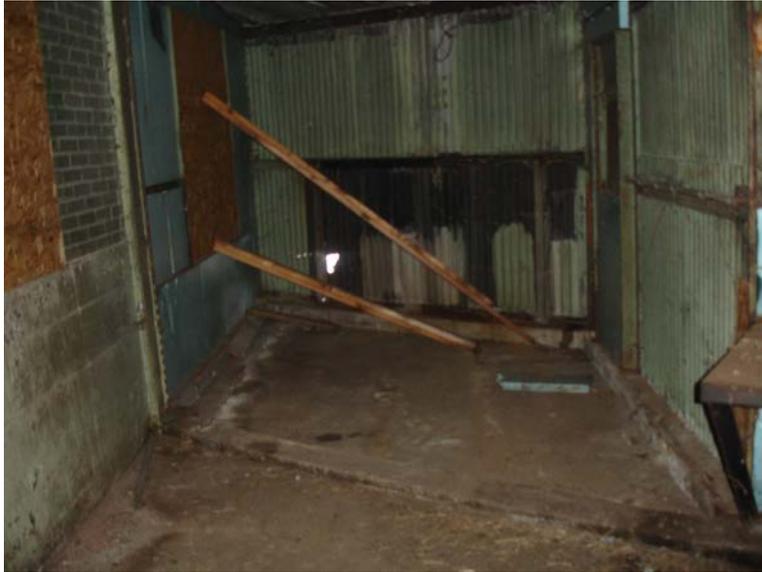
Photograph #13

The unit was a 1000 gallon above ground tank located inside Tube I in the southwest corner. The tank operated from the 1960s until 1980 storing used Oakite. At the time of the inspection, there was no evidence of a release from this unit.

SWMU #341B

Photograph was taken December 22, 2005. A 1000 gallon tank was located inside the building. The tank was used to store used Oakite.

Conclusion and Recommendation: No further action is necessary for this SWMU.

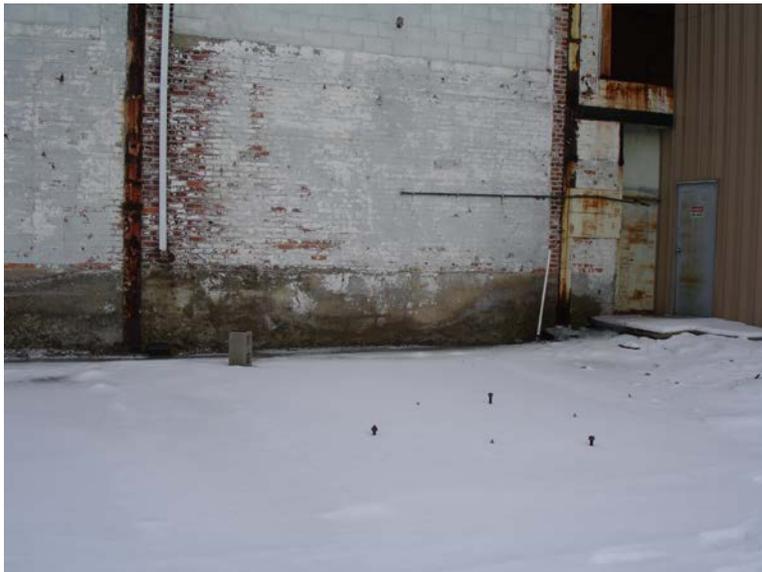
Photograph #14

The unit was a 1000 gallon above ground tank located outside, between Tube I and the Machine Shop Building. The tank was covered and operated from 1985 until 1995 storing used hydraulic fluid. At the time of the inspection, there was no evidence of a release from this unit.

SWMU #342

Photograph was taken December 22, 2005. A 1000 gallon tank was used to store a hydraulic fluid.

Conclusion and Recommendation: No further action is necessary for this SWMU.

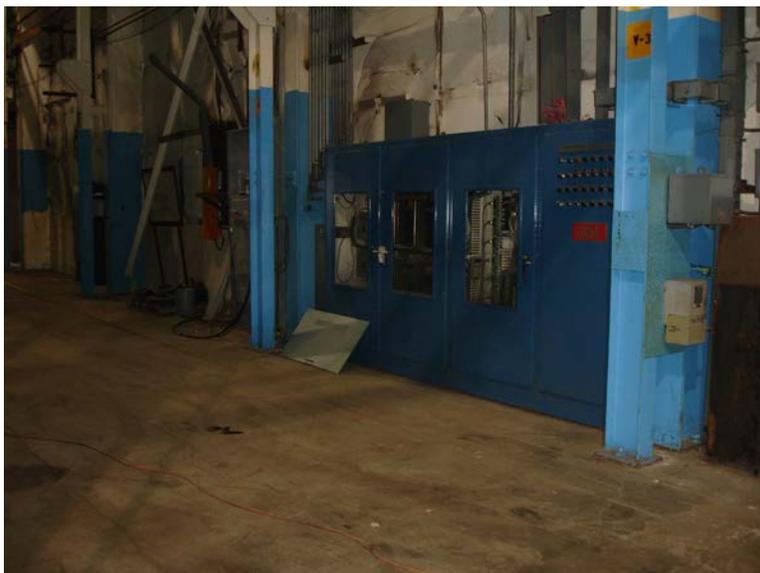
Photograph #15

The area was used to store 55 gallon drums of hydraulic fluid and a Trimsol and water mixture from 1997 until 2002. The area was located in the southeast corner of the Tube Prep building. Soil boring TB-29 was located near the sump platform at the intersection of Tube II and the Tube Prep building. Soil boring TB-29, had a peak PID reading of 0.0 ppm. Soil boring TB-11 was located in the eastern portion of Tube II, near the sump pump area, AOC 1. Soil boring TB-11 had a peak PID reading of 36.4 ppm at 12' - 14' BGS. At the time of the inspection, the floor appeared in good condition.

SWMU #343

Photograph was taken December 22, 2005. The area was used to store drums of hydraulic fluid and a mixture of Trimsol and water. The floor appeared in good shape.

Conclusion and Recommendation: No further action is necessary for this SWMU.

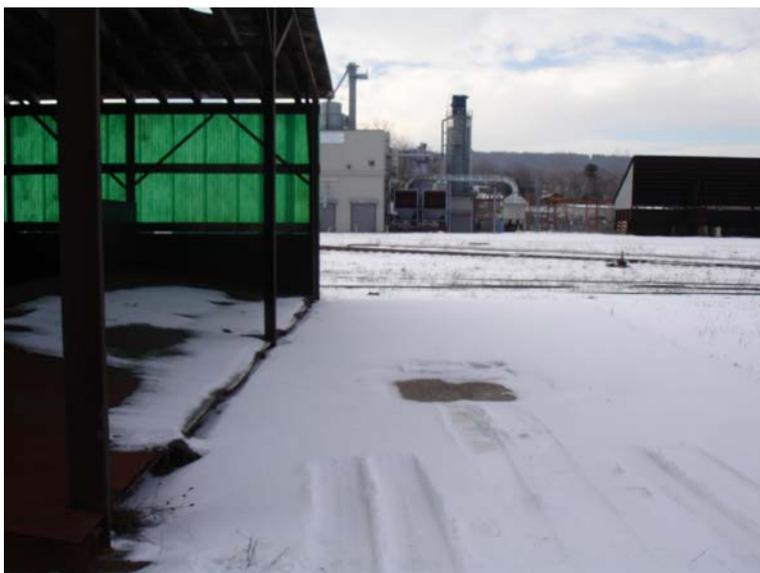
Photograph #16

This area was used for burning general trash and wood from the 1970s until 1980. It is

located north of SWMUs 313A and 313B. At the time of the inspection, there was no evidence of a release from this unit.

SWMU #371

Photograph was taken December 22, 2005. The area was used for burning general trash and wood.

Conclusion and Recommendation: No further action is necessary for this SWMU.

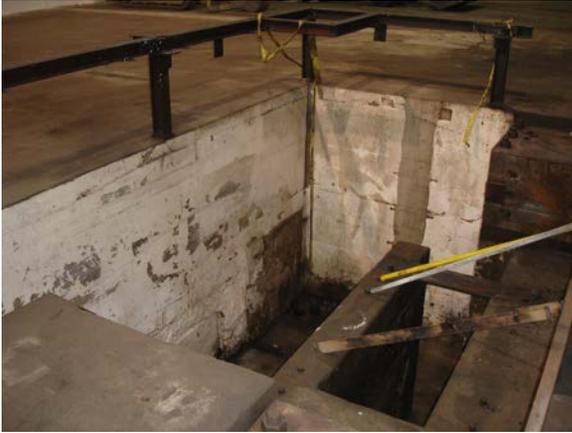
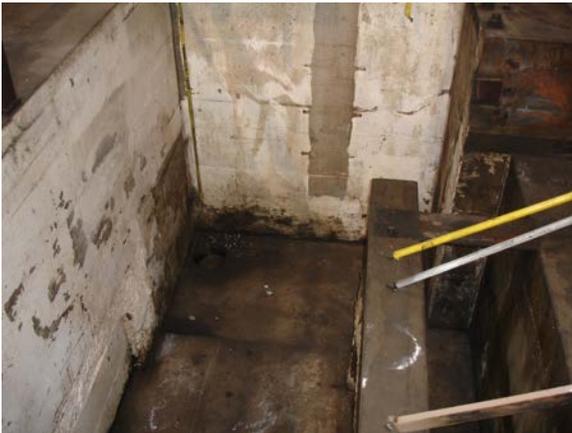
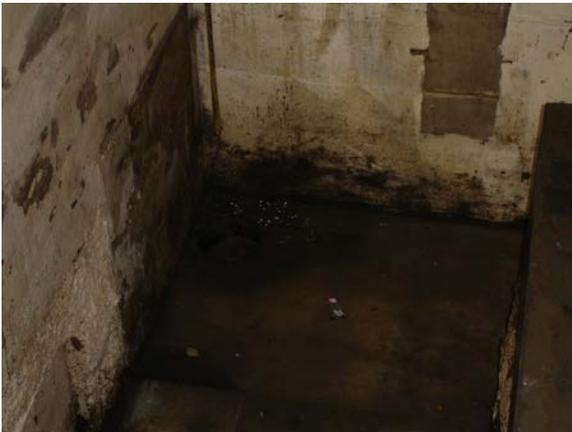
Photographs #17

This area contained a sump pump associated with a milling machine that used hydraulic oil. It was located in the eastern end of Tube II. During a site visit by LaBella on October 11, 2004, an oil sheen in the sump pump was observed under grating associated with the machine and the area was identified as possible soil and/or groundwater contamination. LaBella sampled the area near the sump platform at the intersection of Tube II and the Tube Prep building, TB-29, and received a PID reading of 0.0ppm. At the time of the DEC inspection, the area appeared to have been cleaned, leaving only a small amount of hydraulic oil remaining in the sump.

AOC #1 – Sump Pump Area

The photographs were taken December 22, 2005. The sump pump area is located in the eastern end of Tube II. The sump may have contained PCB from hydraulic oils used by the milling machine.

Conclusion and Recommendation: DEC is requesting concrete core samples from the sump to verify that the oil used did not contain PCBs. DEC is also requesting the analytical results of sampling done for disposal characterization of the drums containing waste produced from the cleaning processes conducted by LMC at the facility.
