REPORT

**Debris Pile Characterization
80 Steel Street
Rochester, New York**

**Ben Weitsman of Rochester, LLC and
Weitsman Rochester Realty, LLC**

August 2013

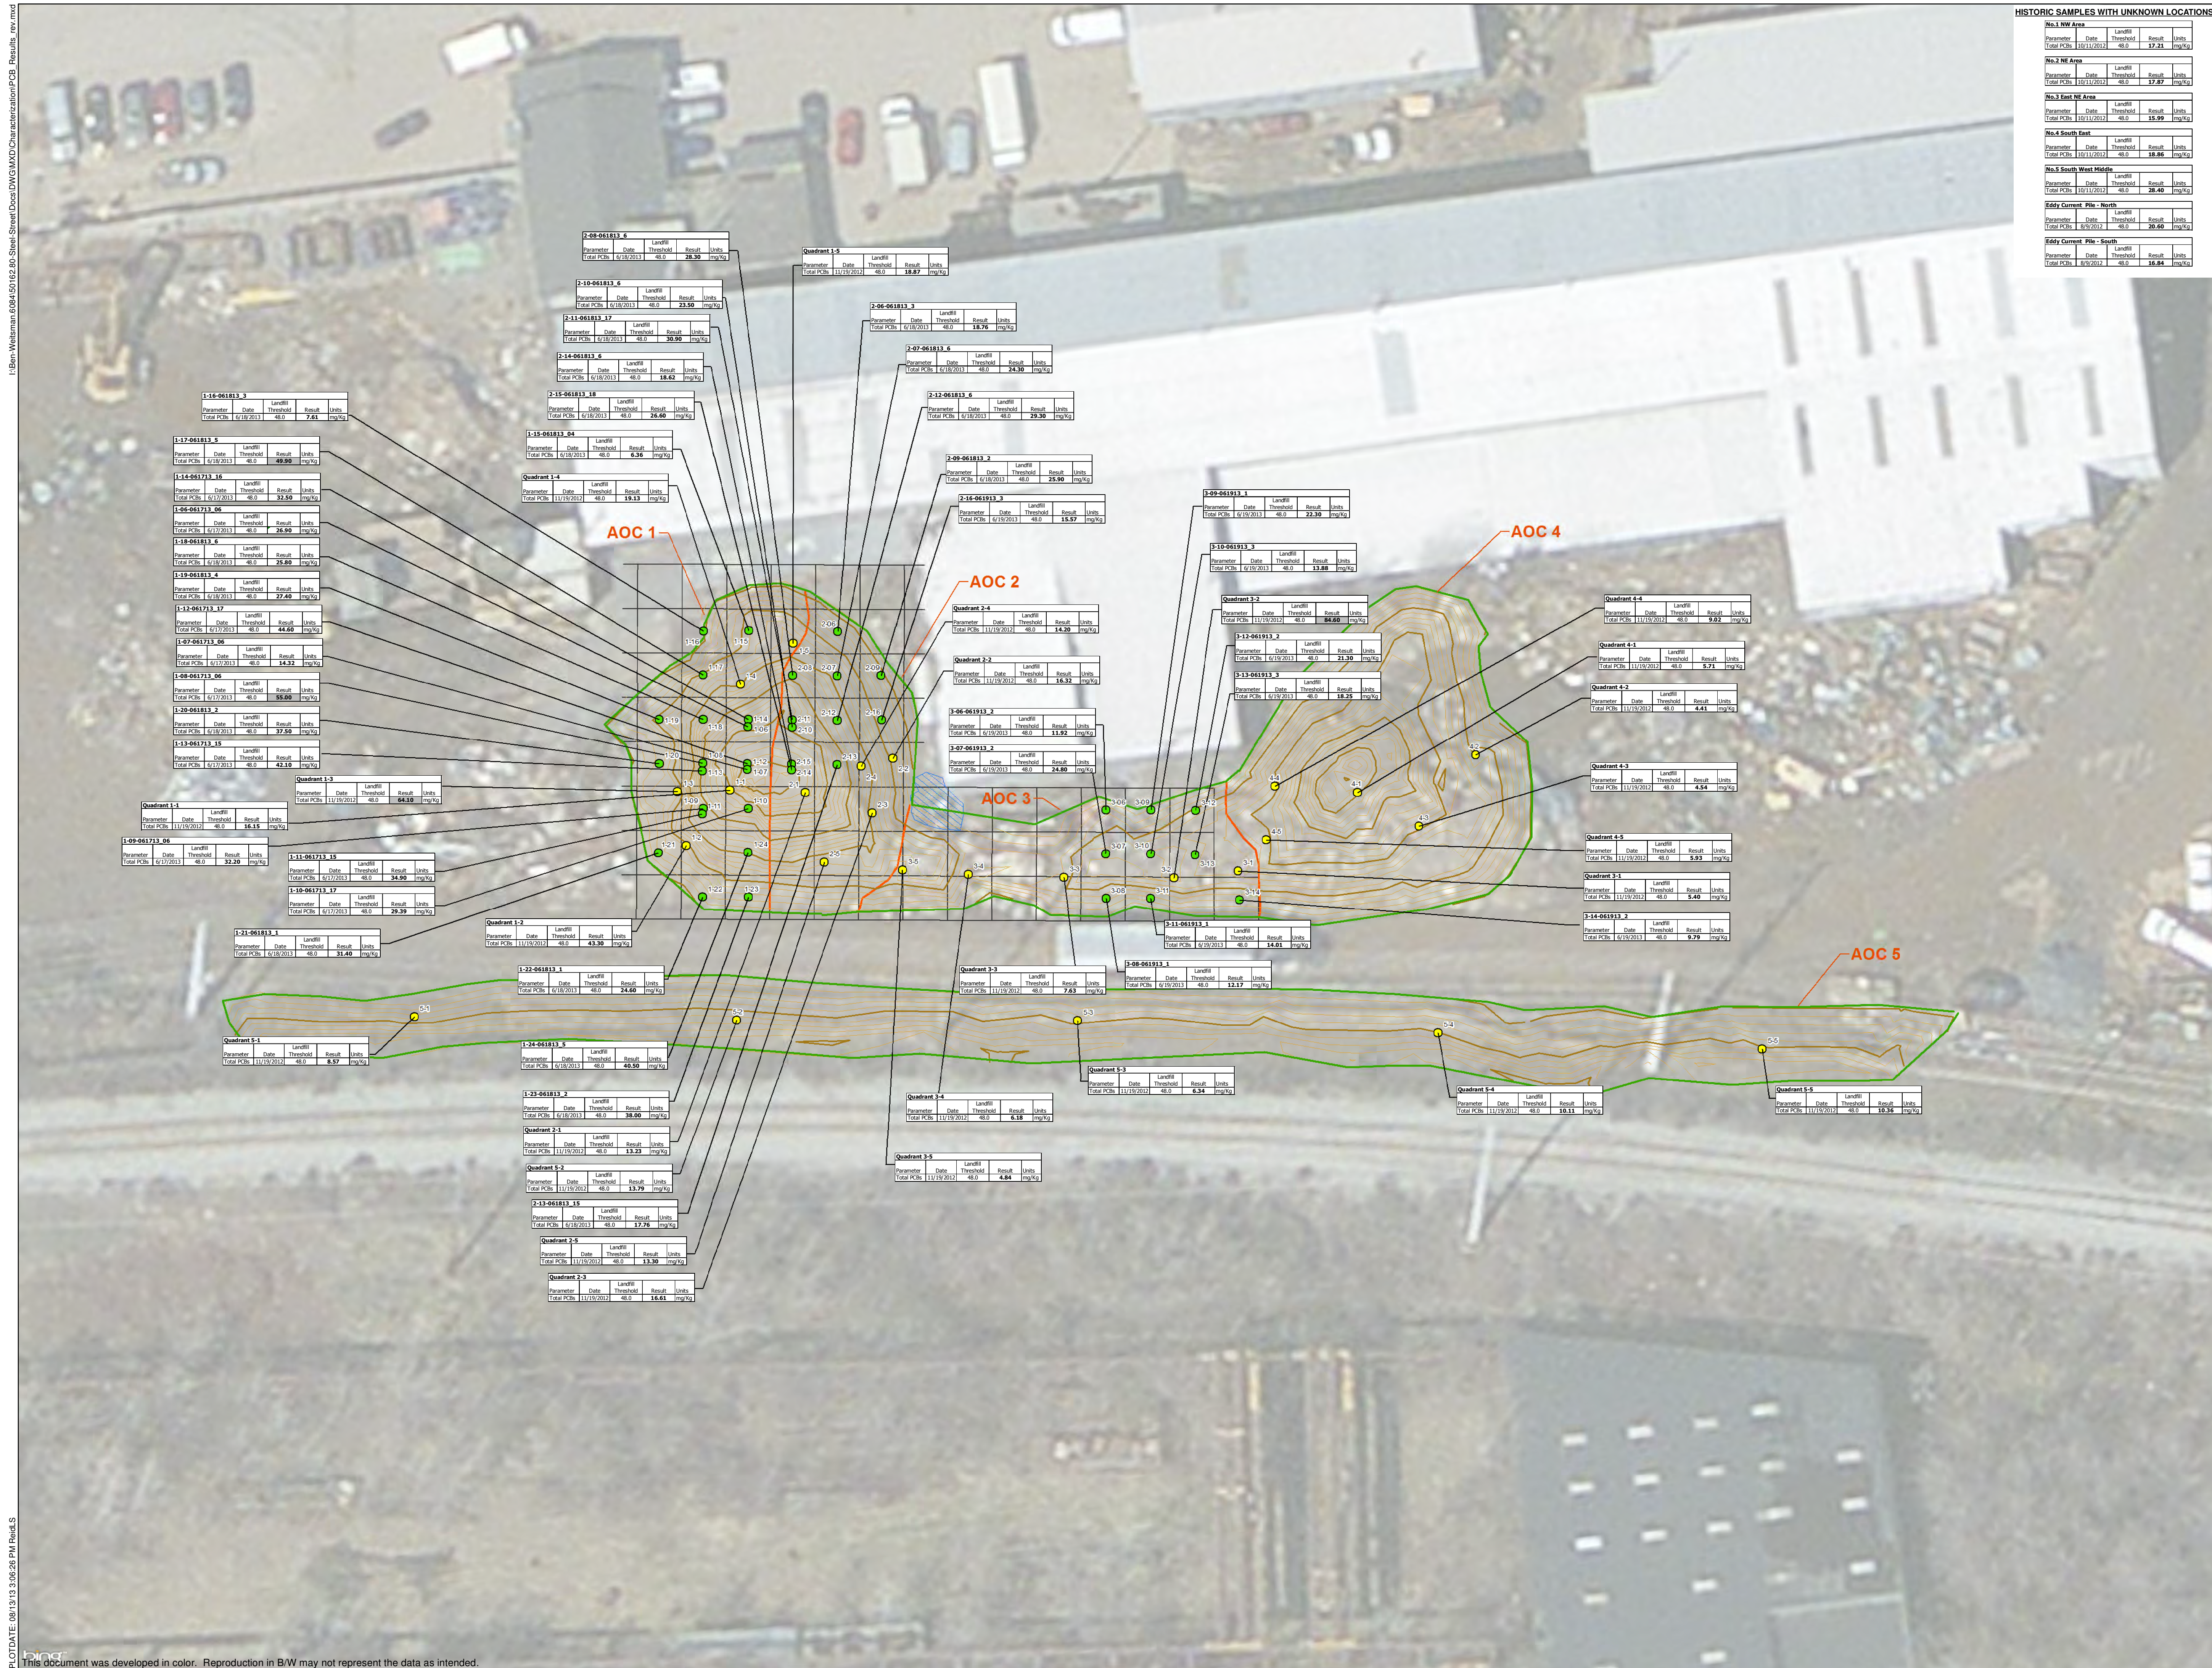
FIGURE 2

Approximately 150 compressed gas cylinders of unknown condition and content were found by O'Brien & Gere's operator on AOC Quadrants 2 and 3, as shown on [Figure 2](#). The gas cylinders were not disturbed due to Health and Safety concerns. Sample 2-16 could not be accessed, as the original plan was to clear a path through a portion of AOC Quadrant 3 to access the back side of AOC Quadrant 2 through this area. Accordingly, O'Brien & Gere utilized a hand auger to collect the sample at sample location 2-16.

- Approximately 150 compressed gas cylinders of unknown condition need to be addressed.

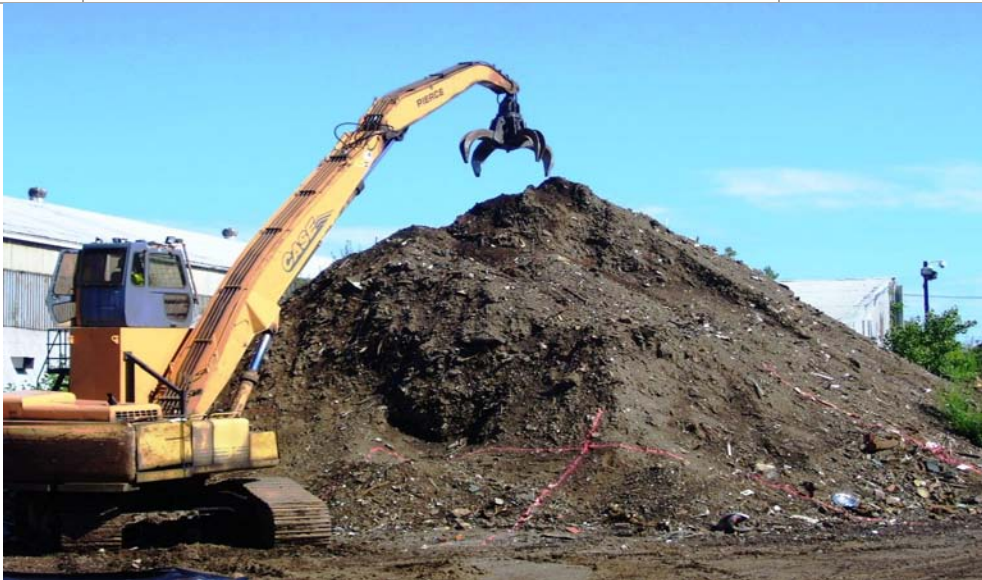
CLIENT NAME: Ben Weitsman of Rochester, LLC Weitsman Rochester Realty, LLC		SITE LOCATION: 80 Steel Street Rochester, New York 14606	PROJECT NO. 6084 50162
PHOTO NO. 001	DATE: 06/19/13

DESCRIPTION View of grapple utilized to collect characterization soil samples of individual locations within each of the AOCs.

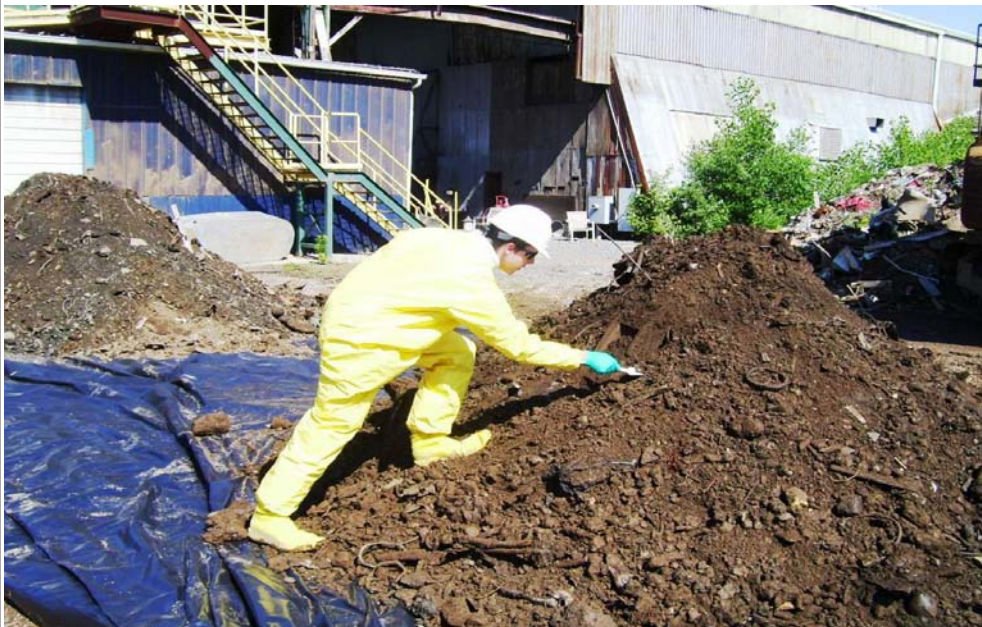
Client Name: Ben Weitsman of Rochester, LLC Weitsman Rochester Realty, LLC		Site Location: 80 Steel Street Rochester, New York 14606	Project No. 6084 50162
Photo No. 002	Date: 06/19/13

Description View of soil sample collection for laboratory analysis of PCBs from an AOC's individual sample location pile staged on poly sheeting.

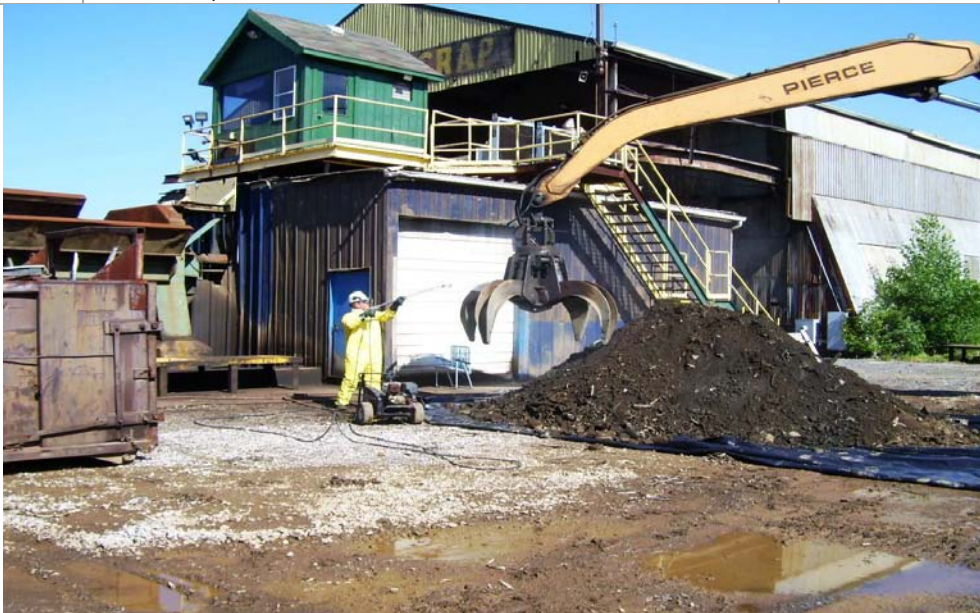
Client Name: Ben Weitsman of Rochester, LLC Weitsman Rochester Realty, LLC		Site Location: 80 Steel Street Rochester, New York 14606	Project No. 6084 50162
Photo No. 003	Date: 06/19/13

Description View of decontaminating grapple by steam cleaning between individual AOC sample locations.

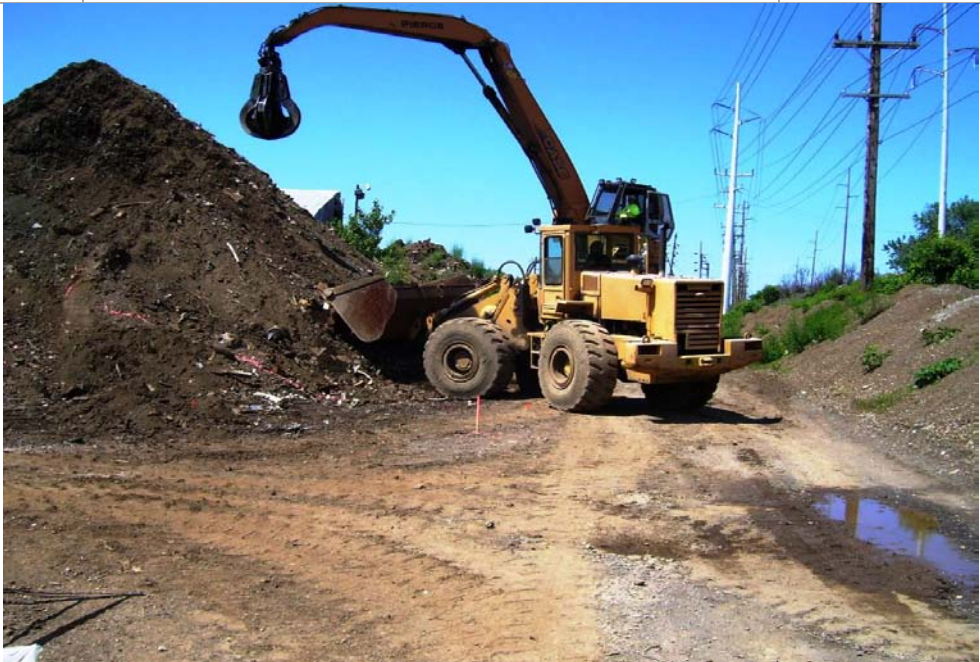
Client Name: Ben Weitsman of Rochester, LLC Weitsman Rochester Realty, LLC		Site Location: 80 Steel Street Rochester, New York 14606	Project No. 6084 50162
Photo No. 004	Date: 06/19/13

Description View of utilizing the front-end loader to transfer debris to the individual AOC location sample piles staged on poly sheeting.

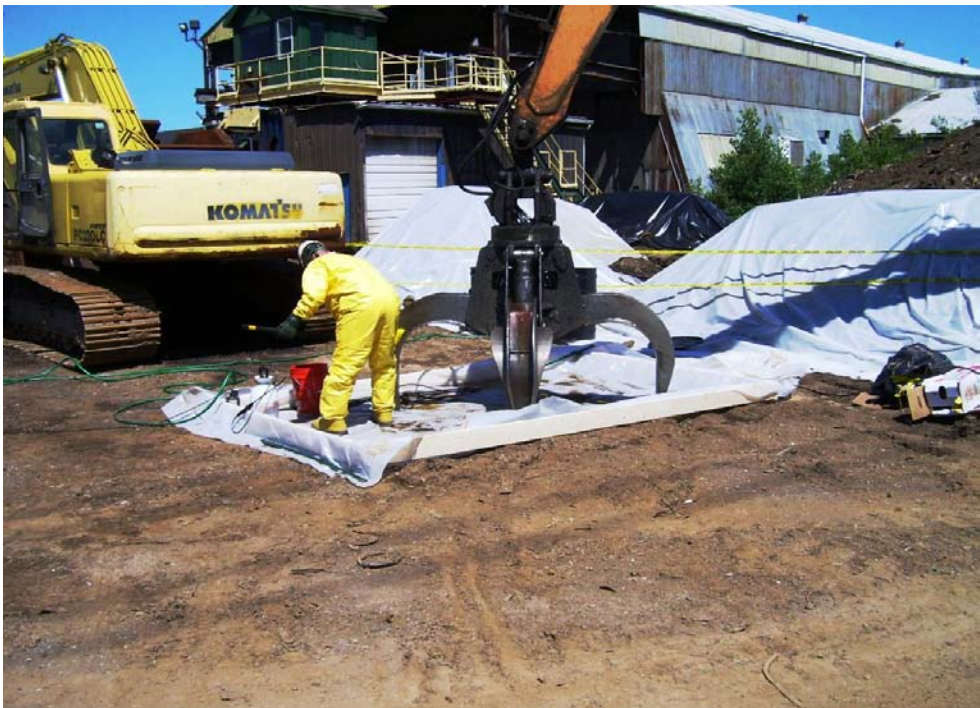
Client Name: Ben Weitsman of Rochester, LLC Weitsman Rochester Realty, LLC		Site Location: 80 Steel Street Rochester, New York 14606	Project No. 6084 50162
Photo No. 004	Date: 06/19/13

Description View of the double solvent wash and rinse decontamination of grapple at the end of the sampling program.
