**2015 Annual Corrective Measures
Summary Report
Eastman Kodak Company –
Eastman Business Park
Rochester, New York
Site No. 828177**

March 2016

**ECOLOGY AND ENVIRONMENT ENGINEERING, P.C.
368 Pleasant View Drive
Lancaster, New York 14086**

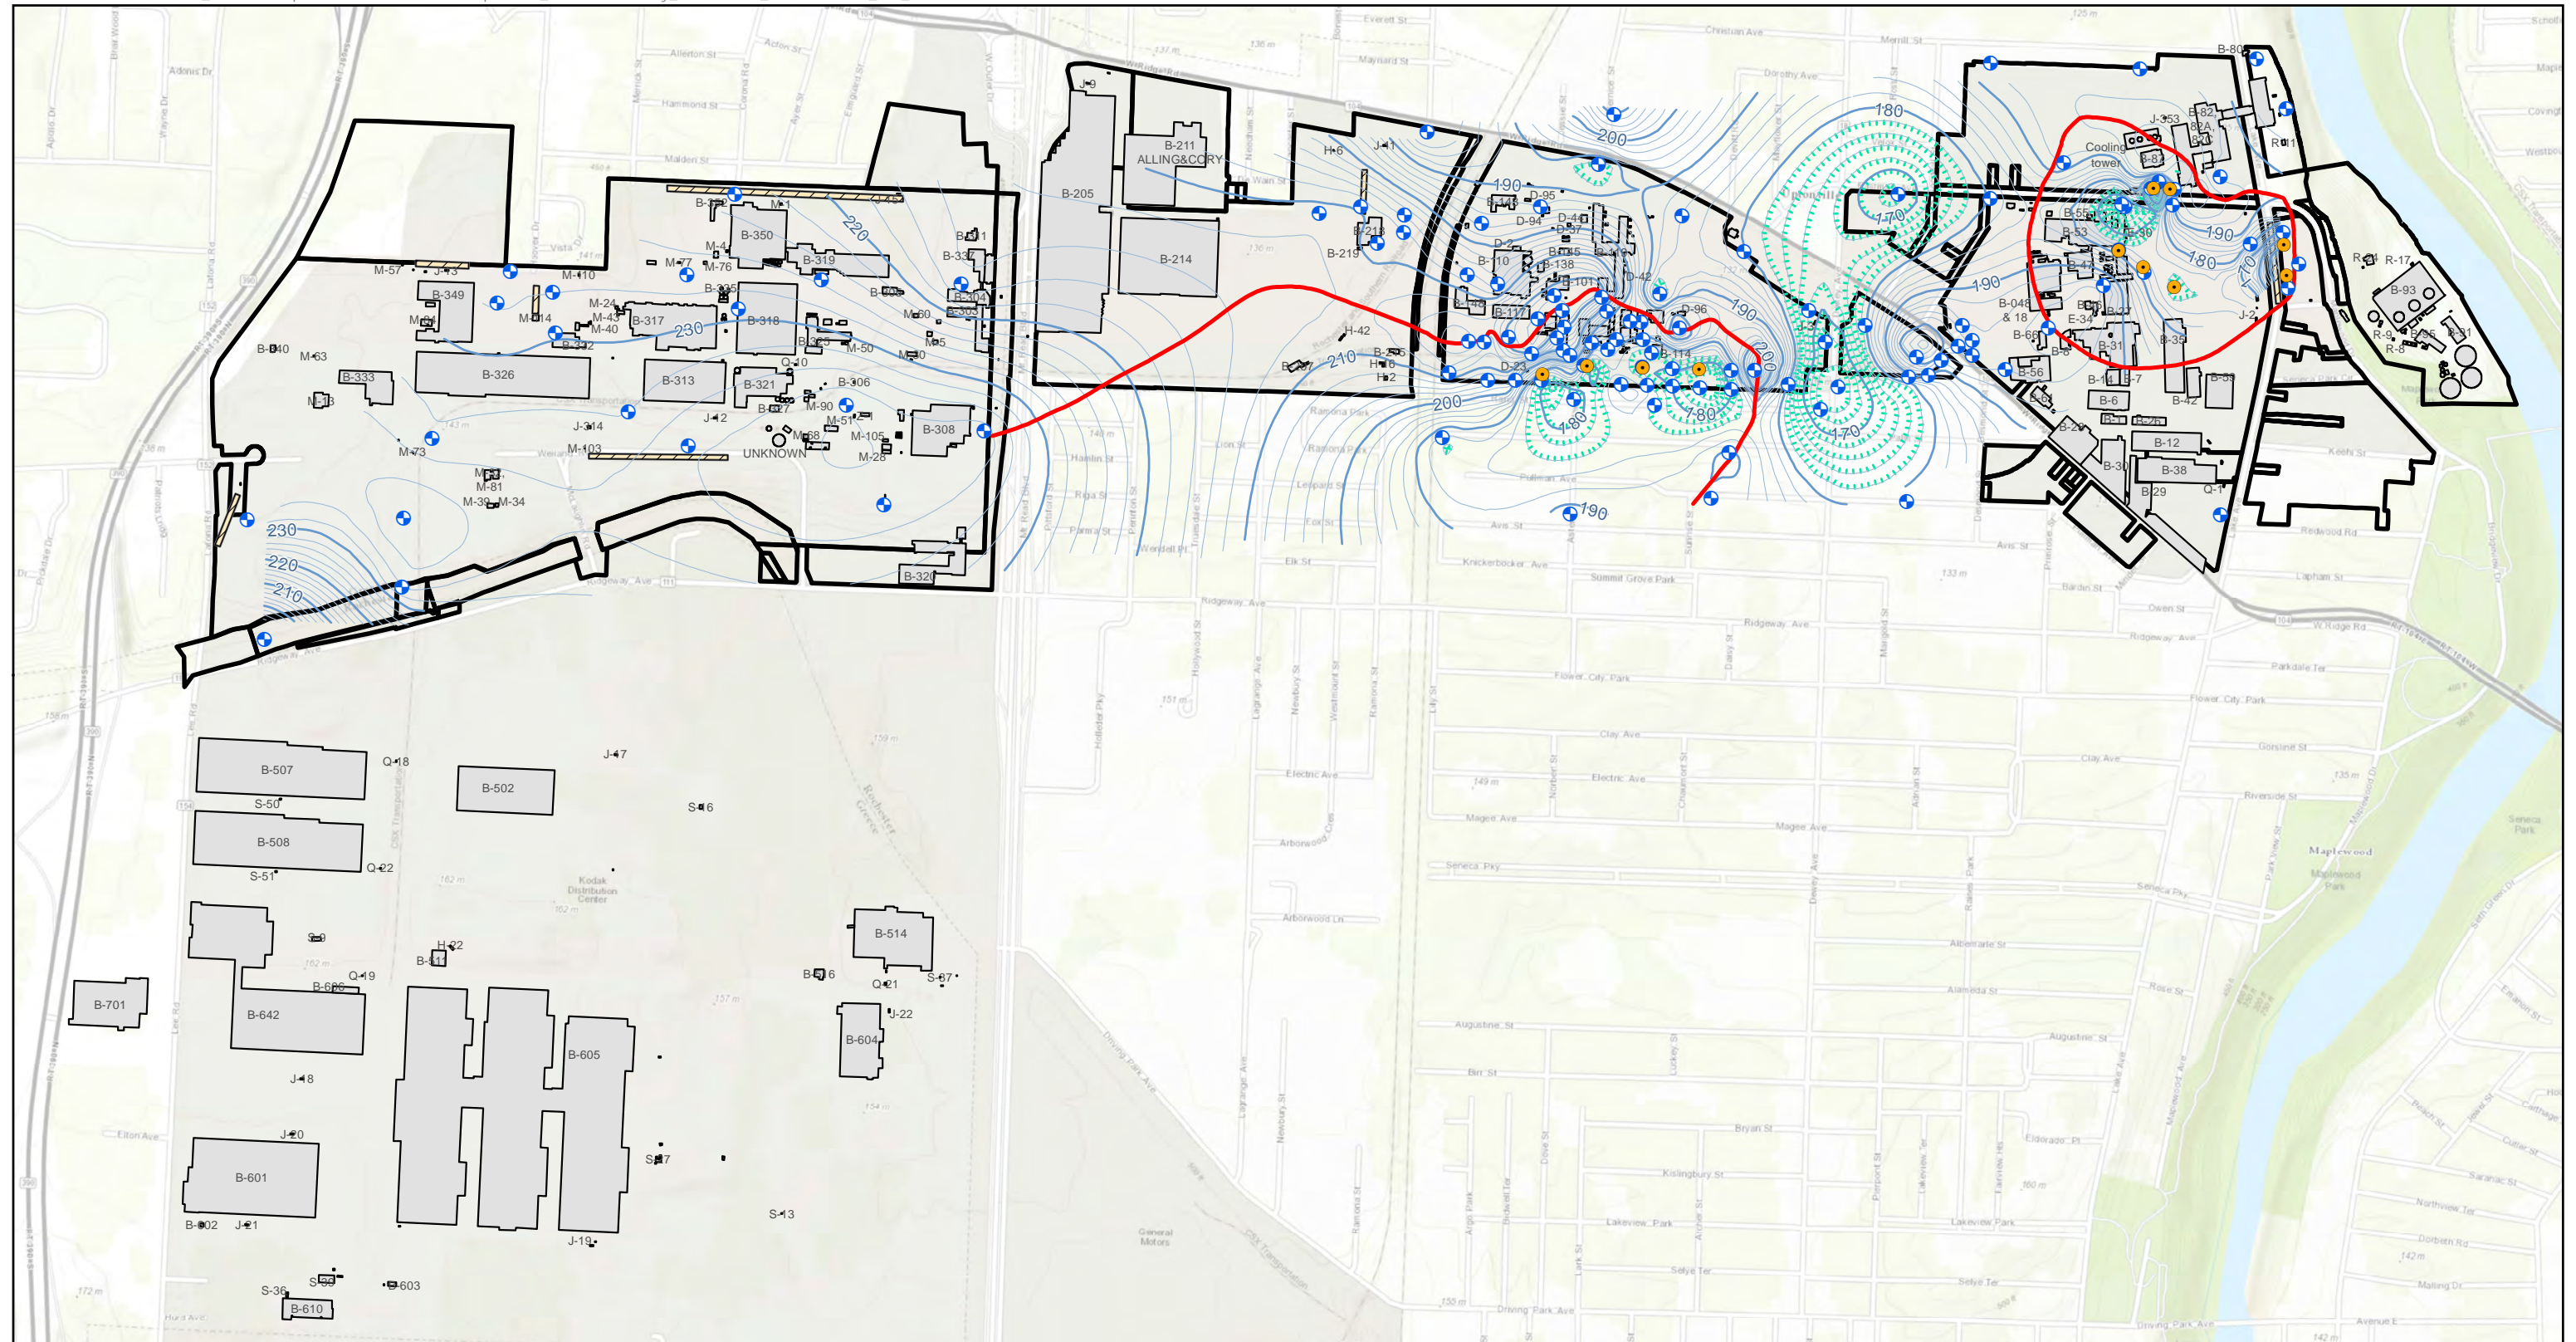
Figure 3
 2015 Top-of-Rock Groundwater Potentiometric Surface
 Eastman Business Park
 Rochester, New York

- KEY:**
- Pumping Well
 - Monitoring Well
 - Kodak Park Parcels
 - Corrective Measure Zone of Capture
 - Existing Building
 - Approximate Location of Corrective Measure Trench
 - Grimsby Queenston Groundwater Elevation (Feet, Kodak Park Datum)
 - 10 foot Contour Interval
 - 2 foot Contour Interval
 - Depression

Contours of the TOR flow zone potentiometric surfaces in EBPM area are presented in Figure 3. The hydraulic capture zone exerted by the Building 329/349 Area Remediation System is illustrated on these maps. Within the capture zone, groundwater flows to the two trenches/pumping wells within the system.

Contours of the TOR flow zone potentiometric surface in EBPE, EBPM, and EBPW are presented in Figure 3. These systems were not designed based on a hydraulic capture zone specification, so a hydraulic capture zone is not illustrated for the individual systems.

Contours of the TOR and GQ flow zone potentiometric surfaces in the northeast EBPE area are presented in Figures 3 and 4. The hydraulic capture zones exerted by the system are illustrated on these maps. Groundwater within the capture zones flows to the system pumping wells.

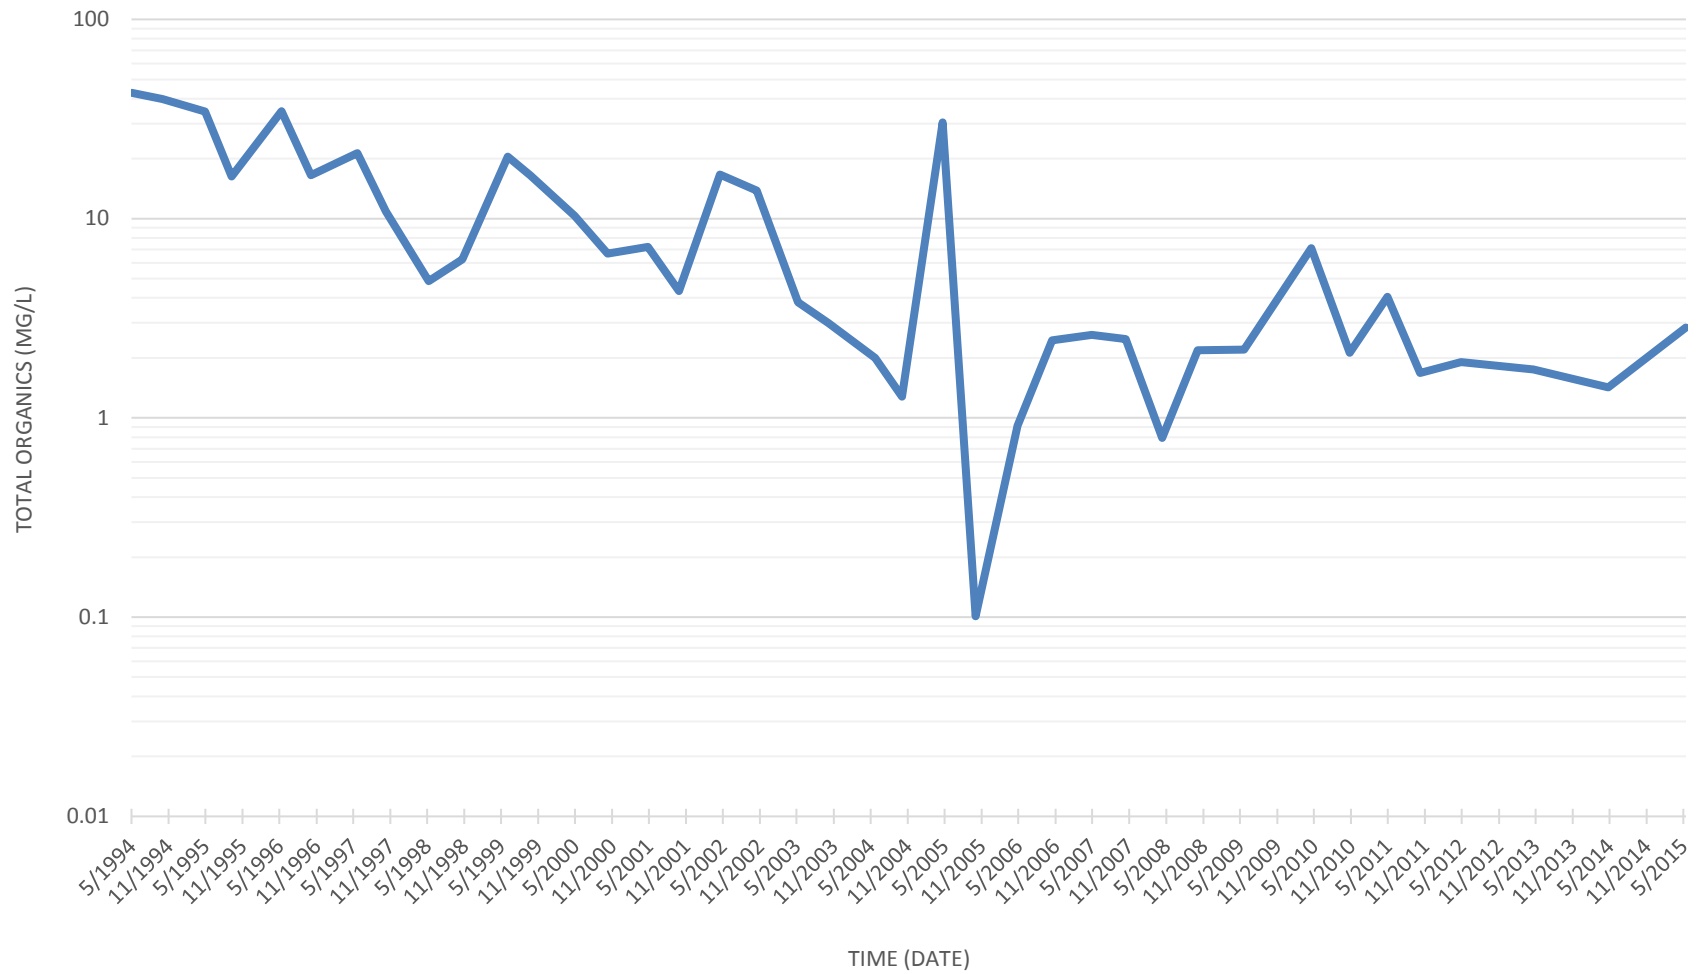
PB136S Concentration-Time Series

Note: The total organic concentrations presented on this concentration time series plot represent the totalized values for constituents tested for in this well in accordance with the KPGSAP protocol.

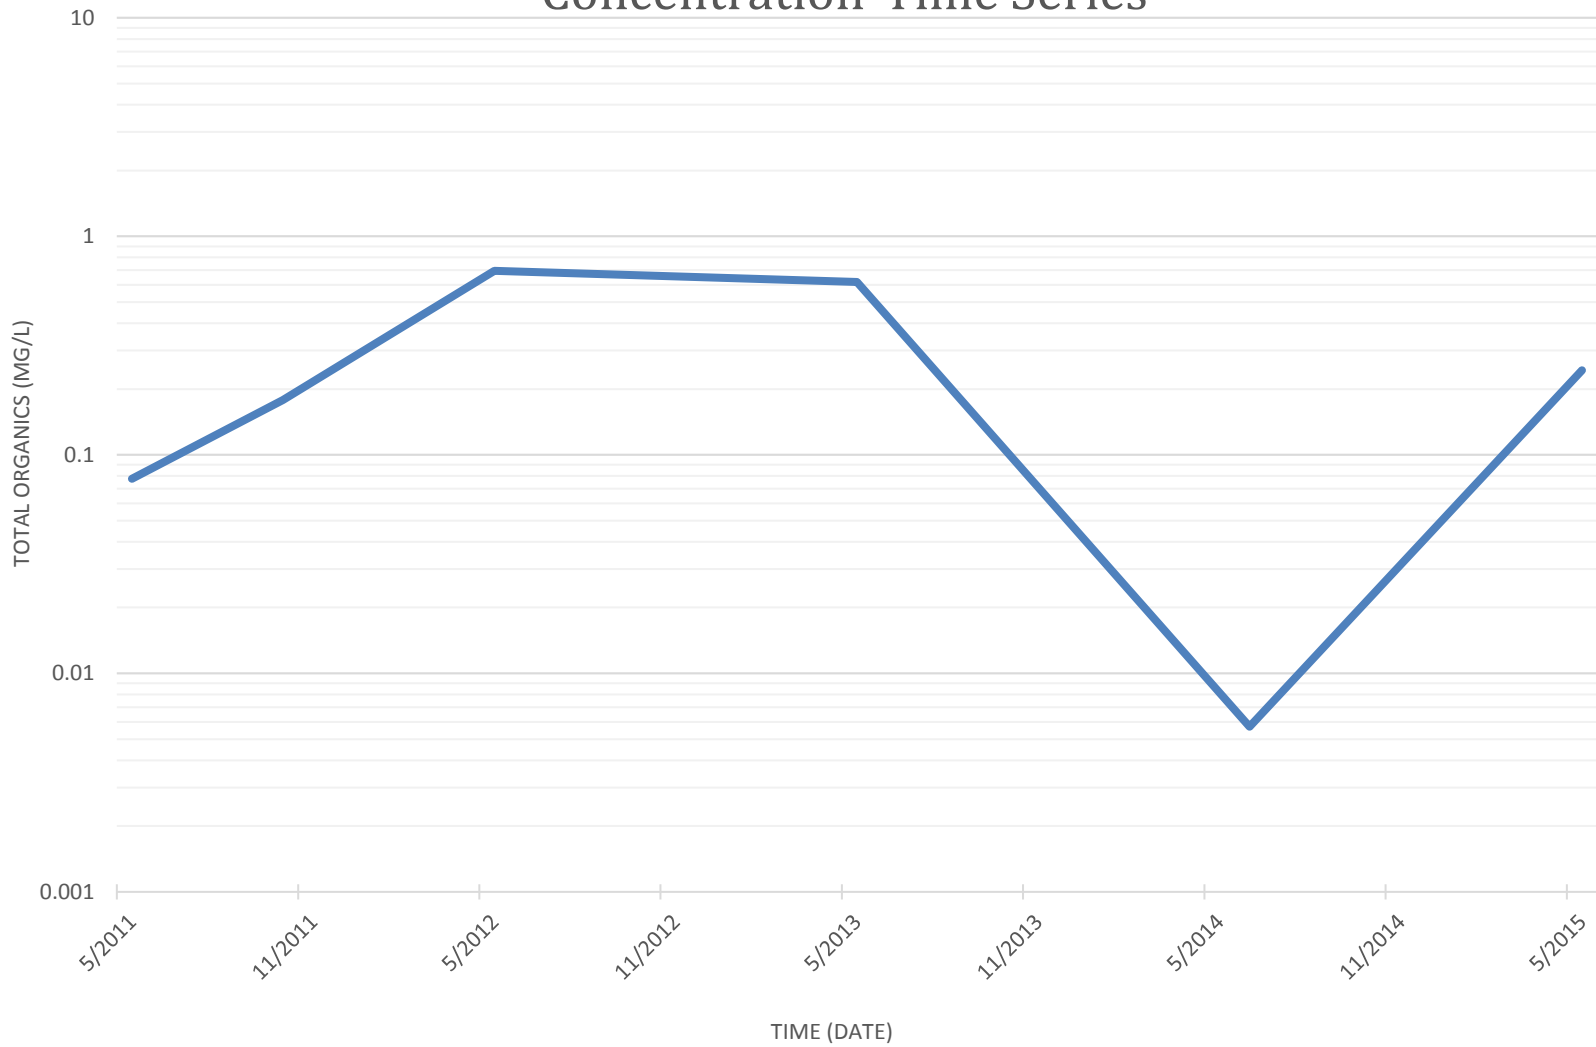
PB307E2 Concentration-Time Series

Note: The total organic concentrations presented on this concentration time series plot represent the totalized values for constituents tested for in this well in accordance with the KPGSAP protocol.
