**2018 Annual Corrective Measures
Implementation Summary Report
Eastman Business Park
Rochester, New York
Site No. 828177**

April 2019

**ECOLOGY AND ENVIRONMENT ENGINEERING AND GEOLOGY, P.C.
368 Pleasant View Drive
Lancaster, New York 14086**

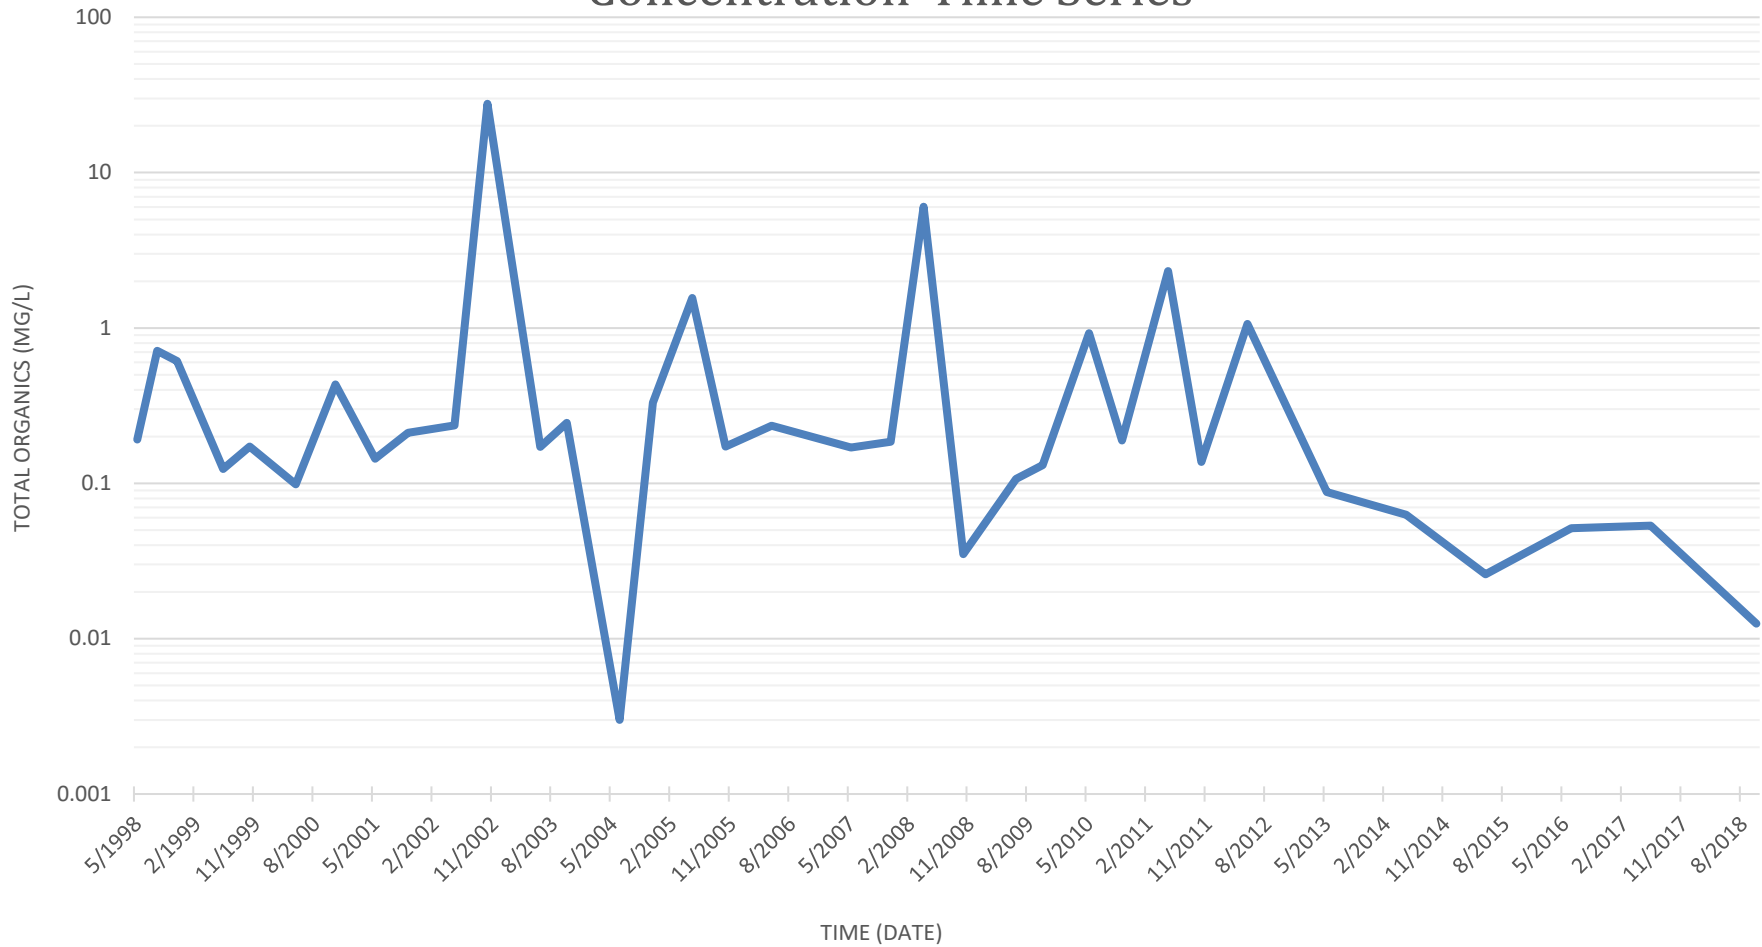
PL54NE Concentration-Time Series

Total VOC concentrations decreased in two of the four tested wells in 2018 (PL54W and PL54NE). Historic total organic concentrations in PL54NE have been variable, with the highest level of organics (28 milligrams per liter [mg/L]) observed in 2002, while the lowest concentration (0.003 mg/L) was observed in 2004. In 2018, the total organic concentration (0.0125 mg/L) was the lowest concentration observed since 2004. Historic total organic concentrations in PB119ER have been highly variable, ranging from 12 mg/L in 2002 to 0.018 mg/L in 2013. Since 2013, the concentration has slightly increased, with 0.038 mg/L observed in 2017 and 0.066 mg/L observed in 2018, but the overall concentration trend is generally decreasing.

Note: The total organic concentrations presented on this concentration time series plot represent the totalized values for constituents tested for in this well in accordance with the KPGSAP protocol.

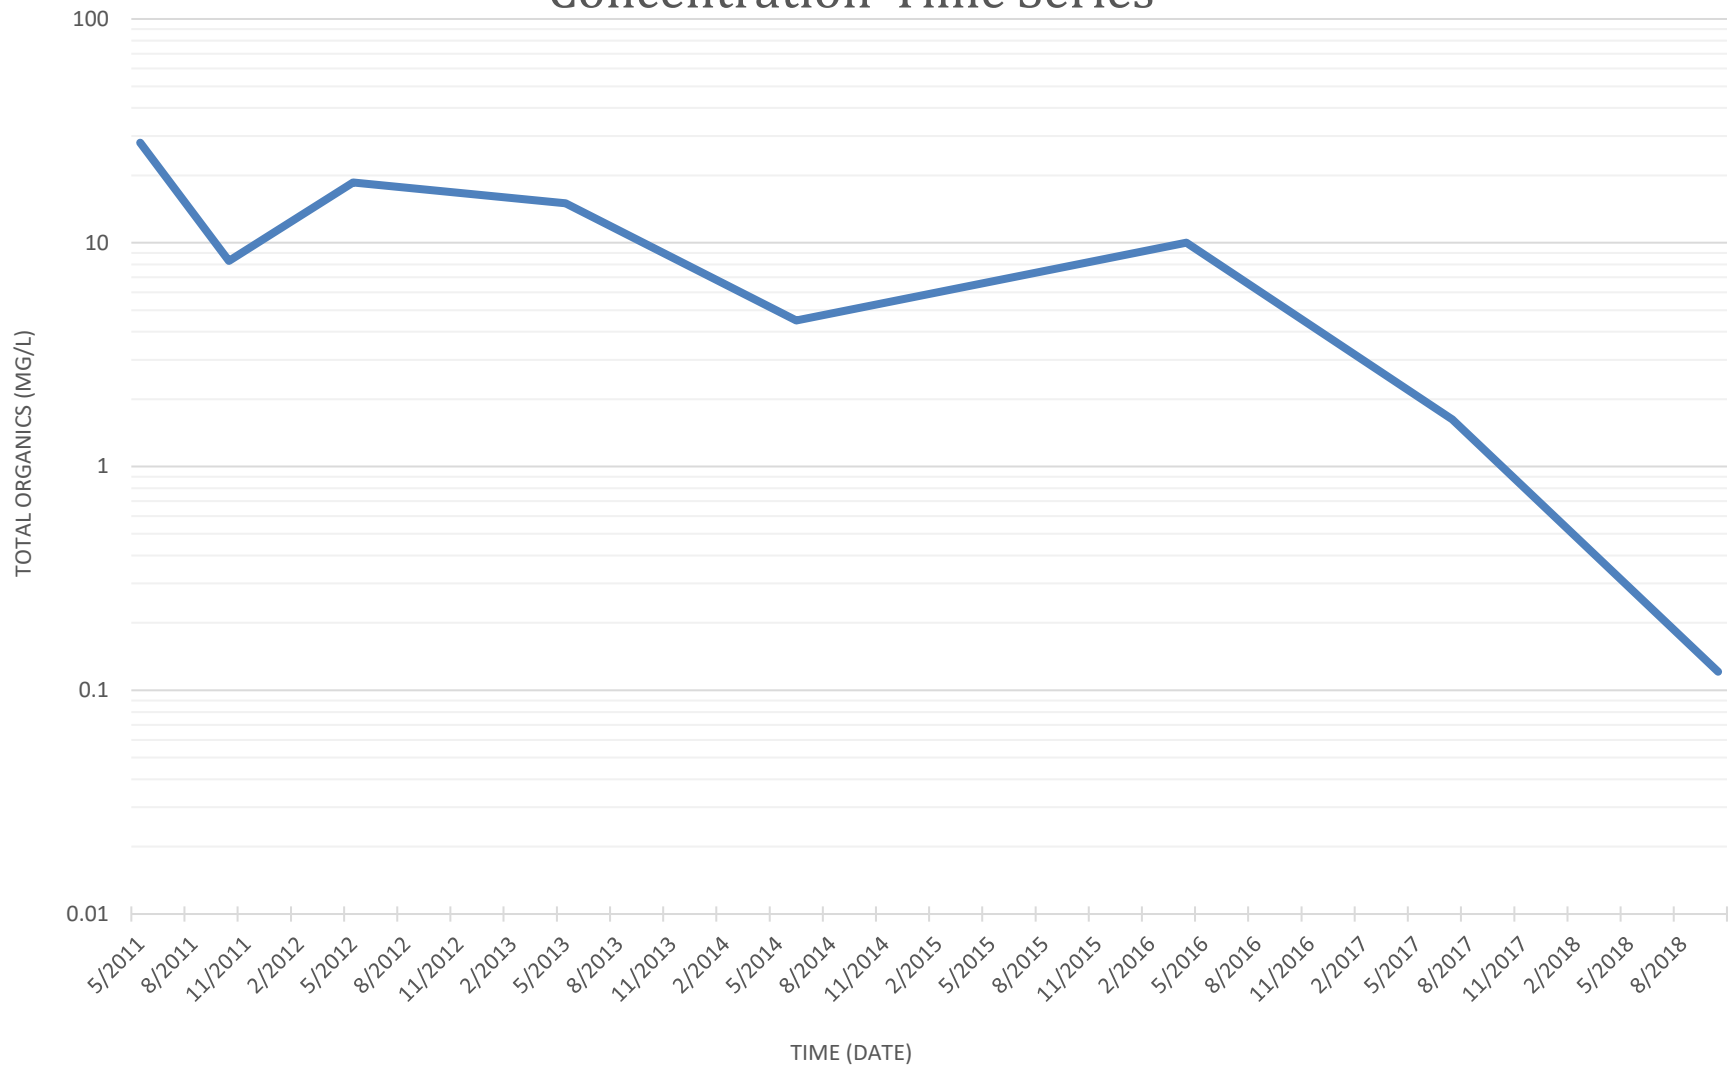
PB322NE4 Concentration-Time Series

Note: The total organic concentrations presented on this concentration time series plot represent the totalized values for constituents tested for in this well in accordance with the KPGSAP protocol.

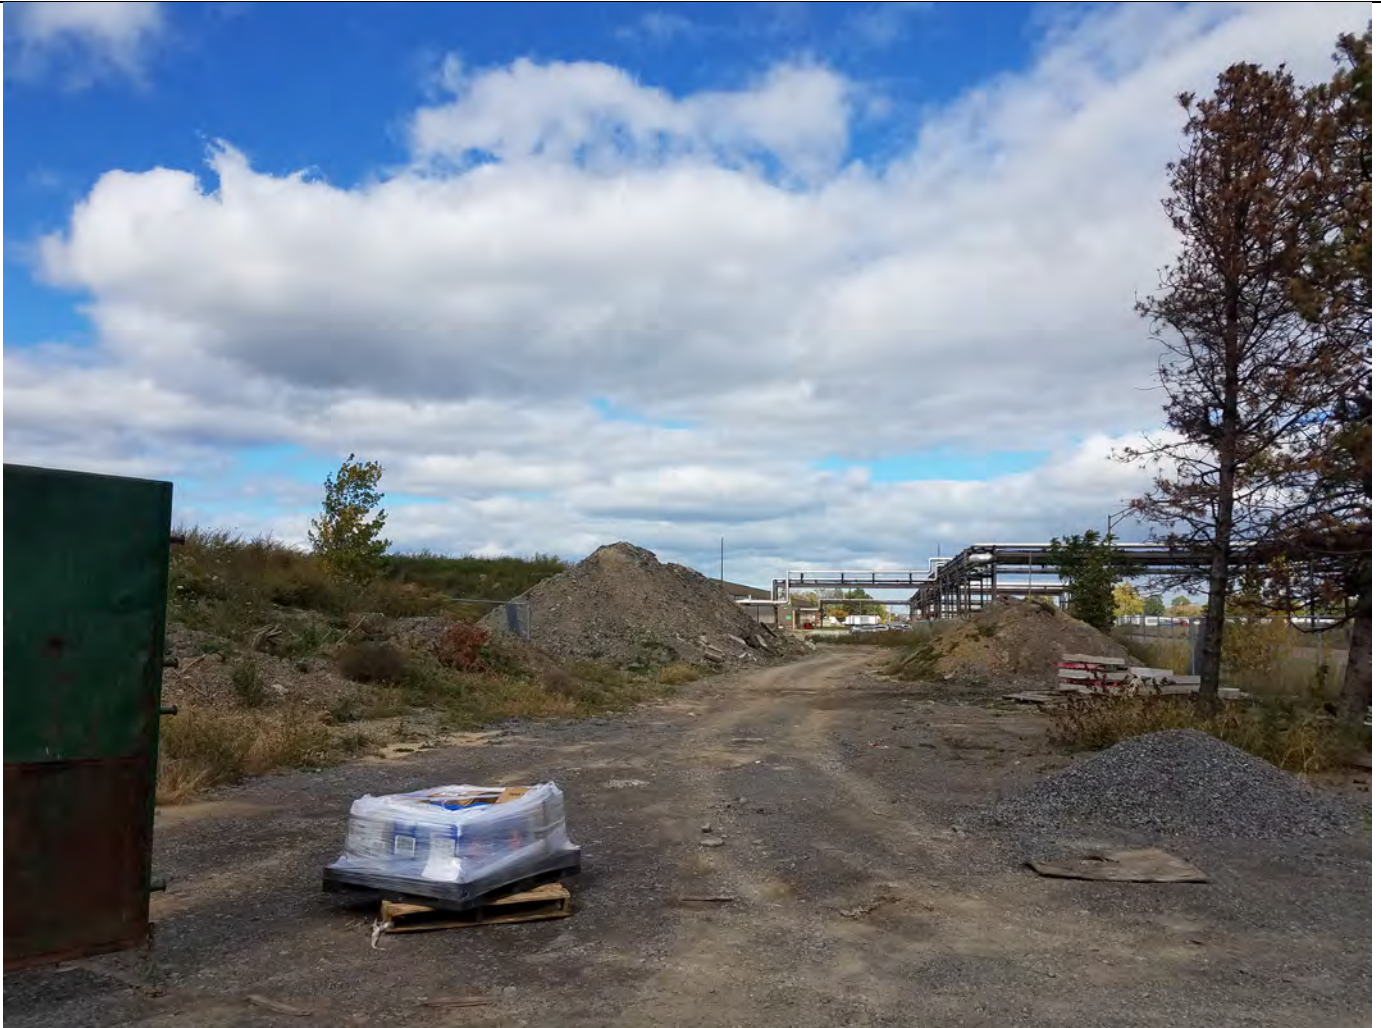
Photo 20181018_133230

Maintenance issues and corresponding site location maps for each soil protective cover area are documented in Appendix B. Minor visual deficiencies were noted during the October 2018 soil cover inspection in the MIA-WRL area, where the edge of landscape fabric beneath gravel was exposed. The landscape fabric is not part of the cover, but was used to separate gravel from soil, and no action was required.
