INTERIM REMEDIAL MEASURES WORK PLAN

46 Mount Hope Avenue
Rochester, New York

LaBella Project No. 2160225

Re: 46 Mt. Hope Ave., Rochester, NY
Sub-slab communication testing and building assessment
Soil Vapor Intrusion Mitigation System Proposal

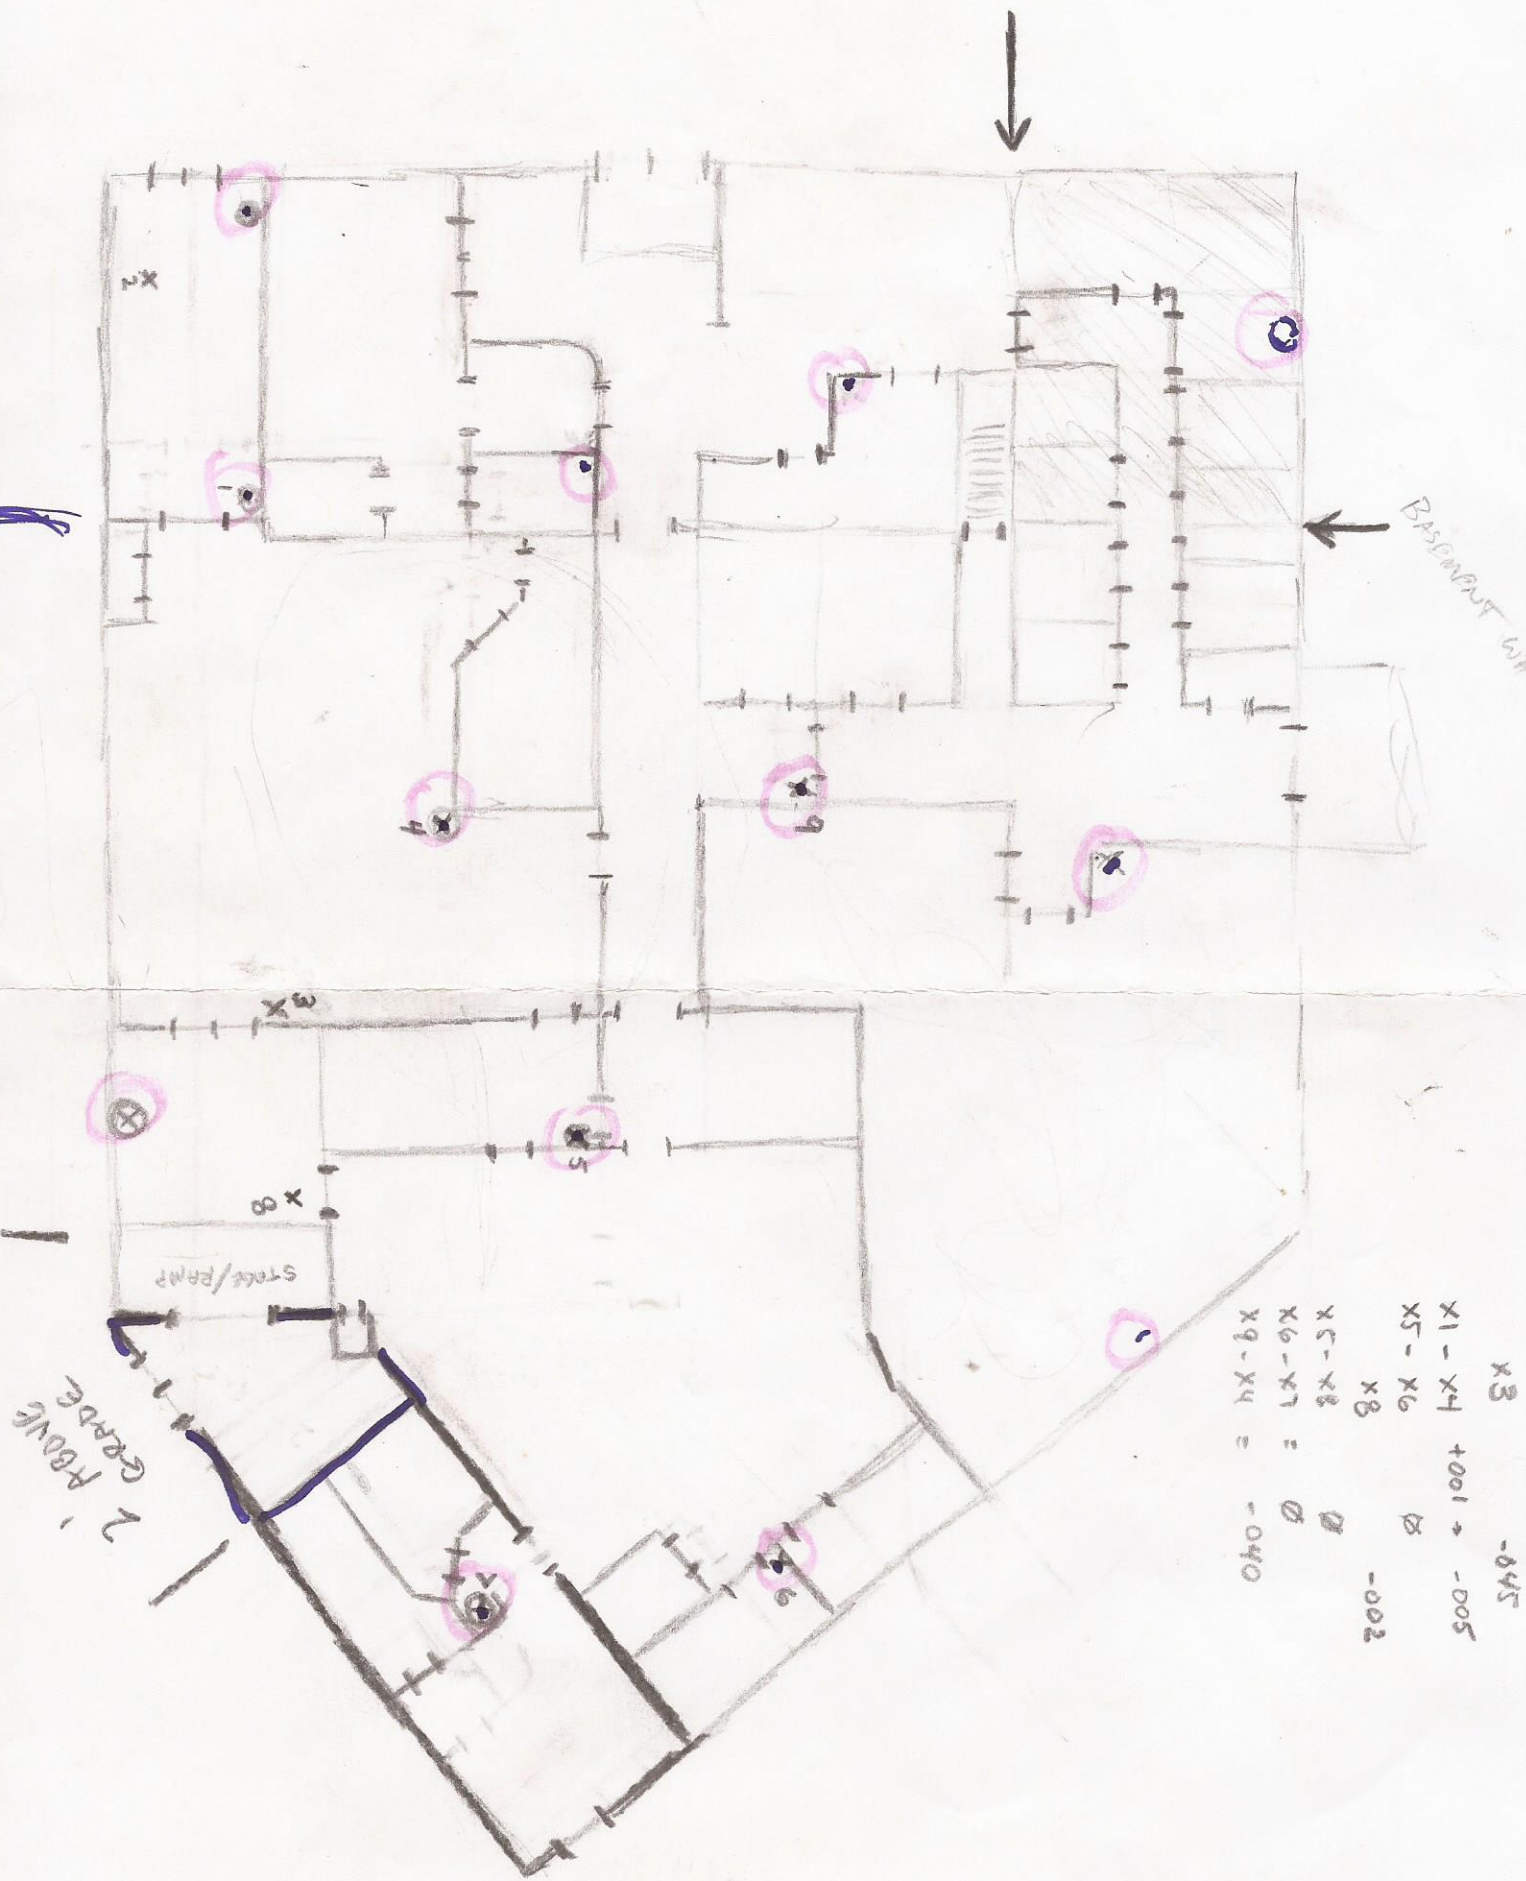
46 Mount Hope - FIELD NOTES - MARCH 16, 2017

$X1-X2 + 1003 \rightarrow -001$ WINDY $\frac{1}{2}$ S
 $X3$ -045
 $X1-X4 + 1001 \rightarrow -005$
 $X5-X6$ B
 $X8$ -002
 $X5-X8$ Ø
 $X6-X7 =$ Ø
 $X9-X4 = -040$

Mitigation tech technicians visited the site on March 1, 2017 and again on March 16, 2017 to perform sub-slab air communication testing and a general building assessment. Sub-slab air communication testing was utilized to design the most efficient system configuration. The test procedure included drilling test holes at several locations to create and measure vacuum influence. The site is occupied and highly compartmentalized. The enclosed design is a result of weighing key elements (fan type, suction point location, pipe diameter, etc.) against the cost of different construction techniques and materials. Fan maintenance, noise and operating cost are considered in system design. Field notes attached, labeled "46 Mt Hope – Field Notes – March 16, 2017."
