**Final Site Characterization Report
Canisteo Town Garage
Site Number 8-51-020
Steuben County, New York**

November 2006

NEW YORK STATE DEPARTMENT OF ENVIRONMENTAL CONSERVATION
625 Broadway
Albany, New York 12233

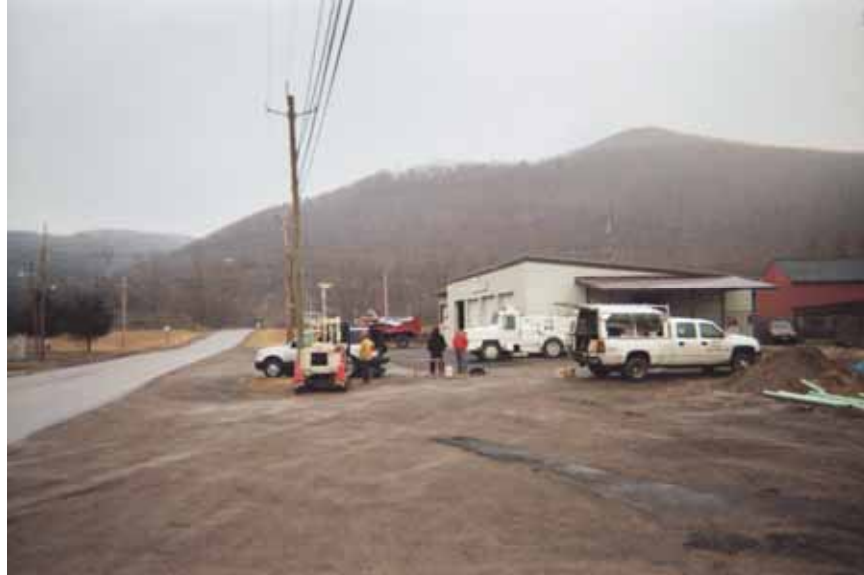
Date: 1/24/06	Subject: Direct-Push activities at the Canisteo Town Garage Site boring TG-BH-03
Photographer: Robert Meyers

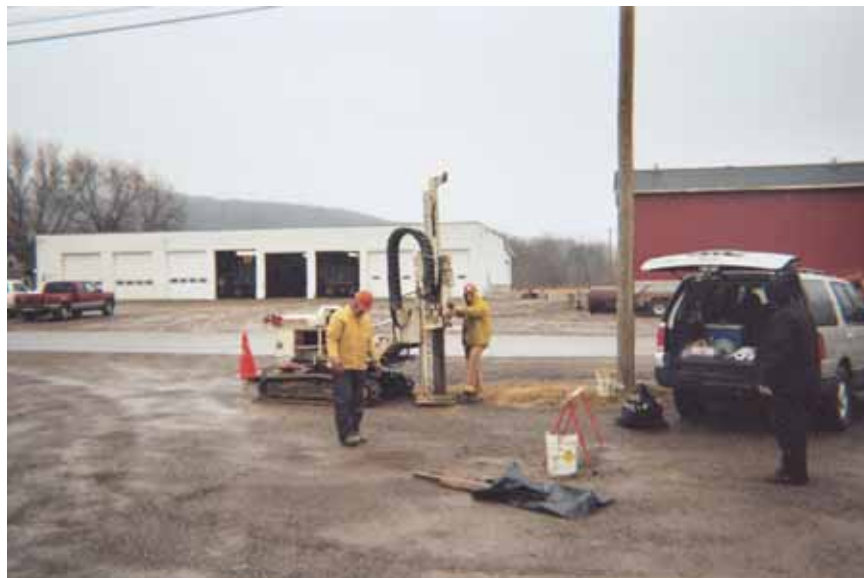
Date: 1/24/06	Subject: Direct-Push activities at the Canisteo Town Garage Site boring TG-BH-04
Photographer: Stephanie Reynolds Smith

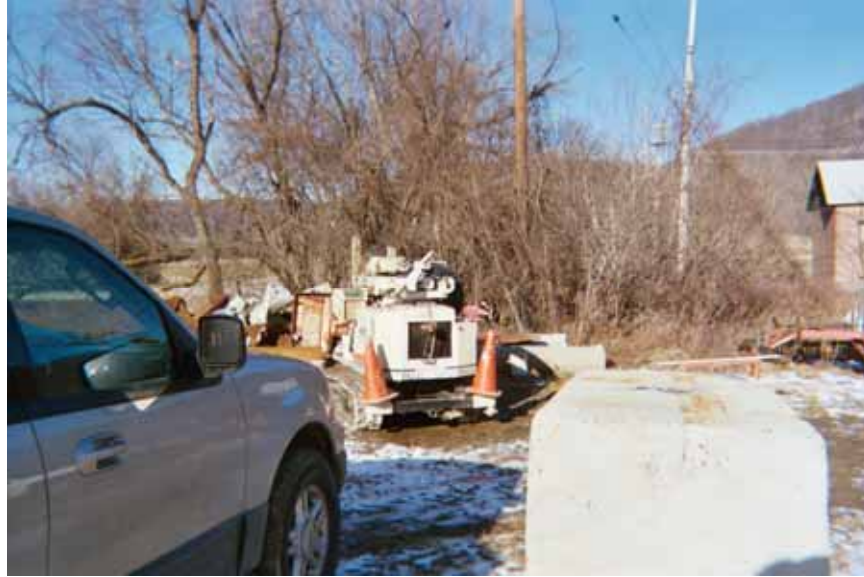
Date: 1/24/06	Subject: Direct-Push activities at the Canisteo Town Garage Site boring TG-BH-01
Photographer: Stephanie Reynolds Smith

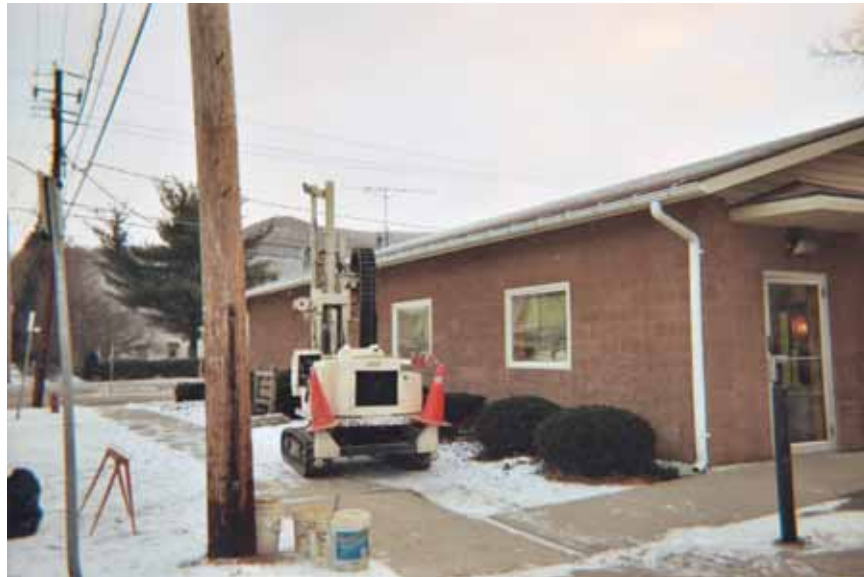
Time/Date: 1/26/06	Subject: Direct-Push activities at the Former Depot Street Dry Cleaner Site boring DS-BH-06
Photographer: Stephanie Reynolds Smith

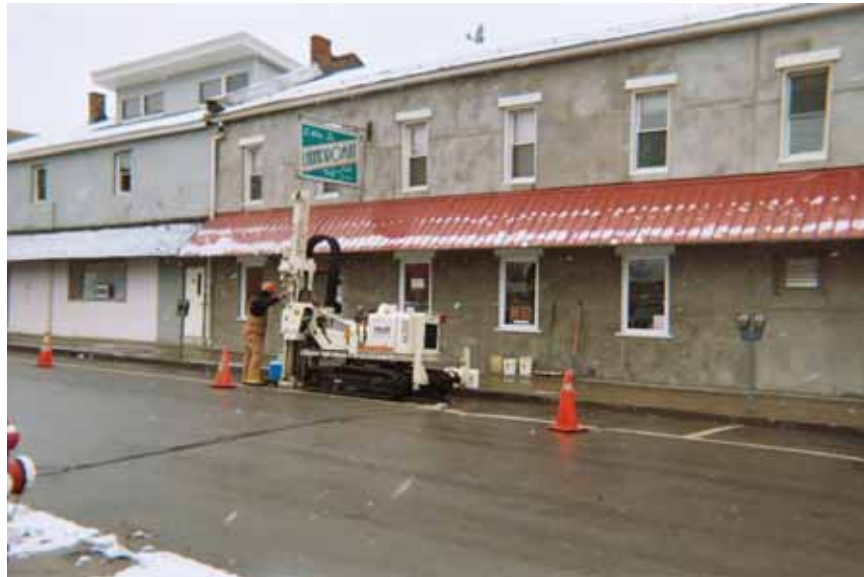
Date: 1/23/06	Subject: Direct-Push activities at the Former Liberty Street Dry Cleaners Site boring LS-BH-06
Photographer: Robert Meyers

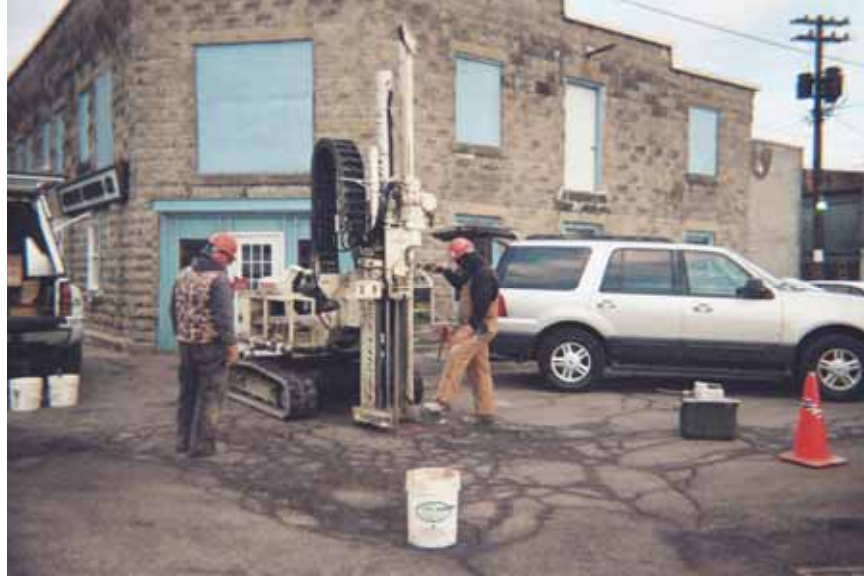
Date: 1/23/06	Subject: Direct-Push activities at the Former Liberty Street Dry Cleaners Site boring LS-BH-05
Photographer: Robert Meyers

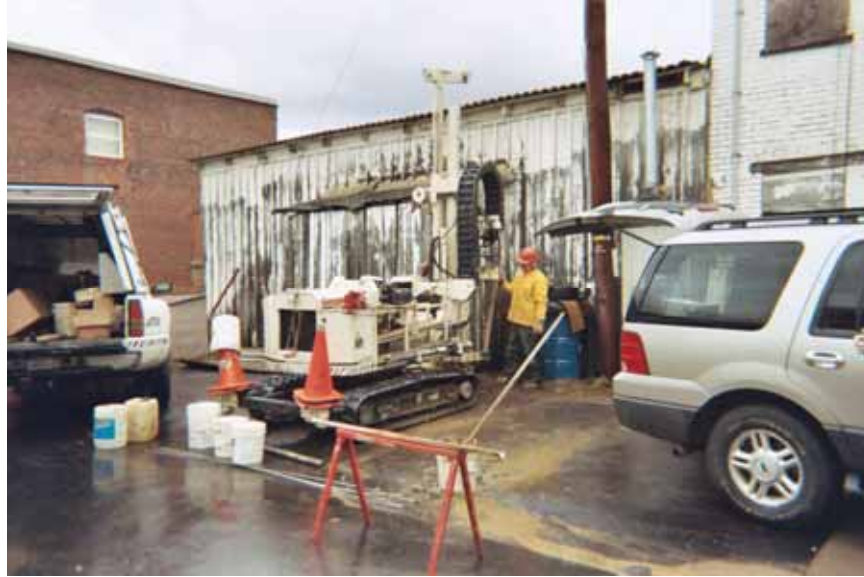
Date: 1/23/06	Subject: Direct-Push activities at the Former Liberty Street Dry Cleaners Site boring LS-BH-03
Photographer: Robert Meyers

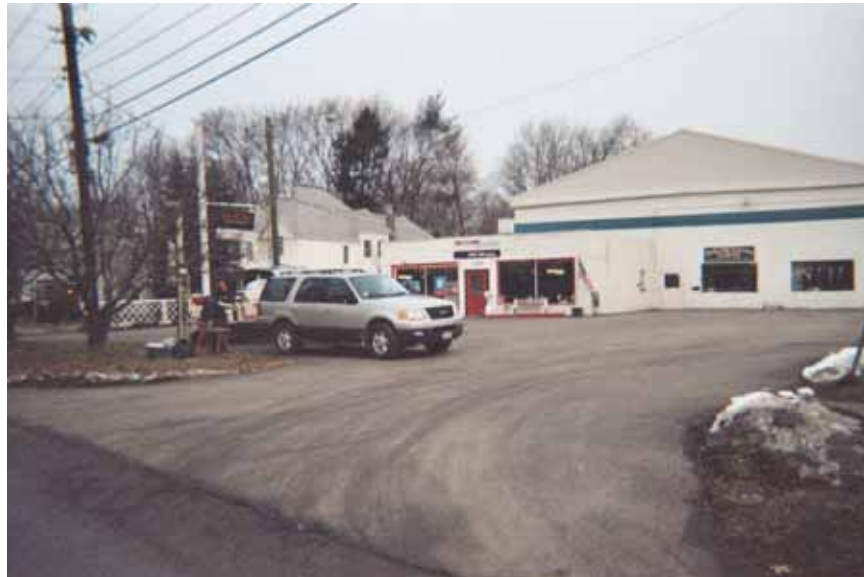
Date: 1/11/06	Subject: Direct-Push activities at the Former Loohns Cleaners Site boring FL-BH-03
Photographer: J. Mays

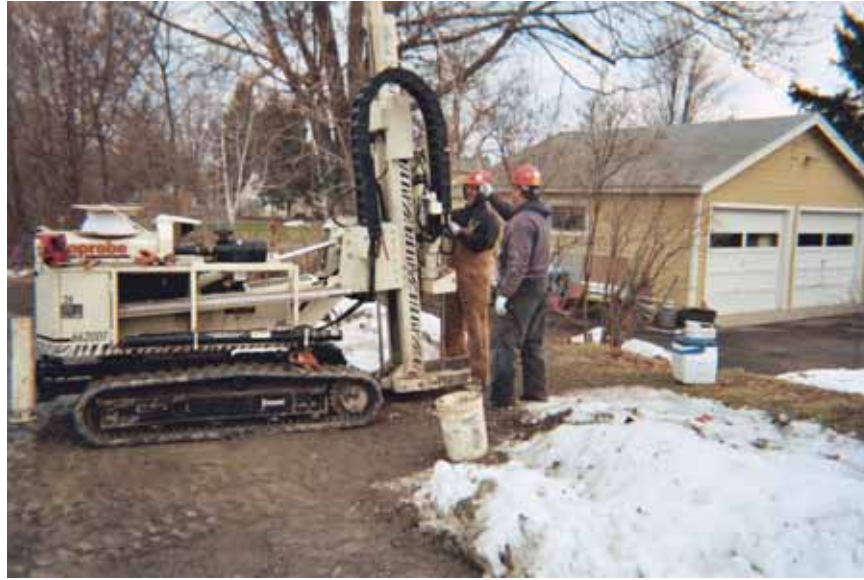
Date: 1/9/06	Subject: Direct-Push activities at the Former Loohns Cleaners Site boring FL-BH-01
Photographer: Jim Mays
