FINAL
Site Characterization of the
Former Depot Street Dry Cleaner
Canisteo, Steuben County
New York

Site Number 8-51-021

November 2008

NEW YORK STATE DEPARTMENT OF ENVIRONMENTAL CONSERVATION
625 Broadway
Albany, New York 12233

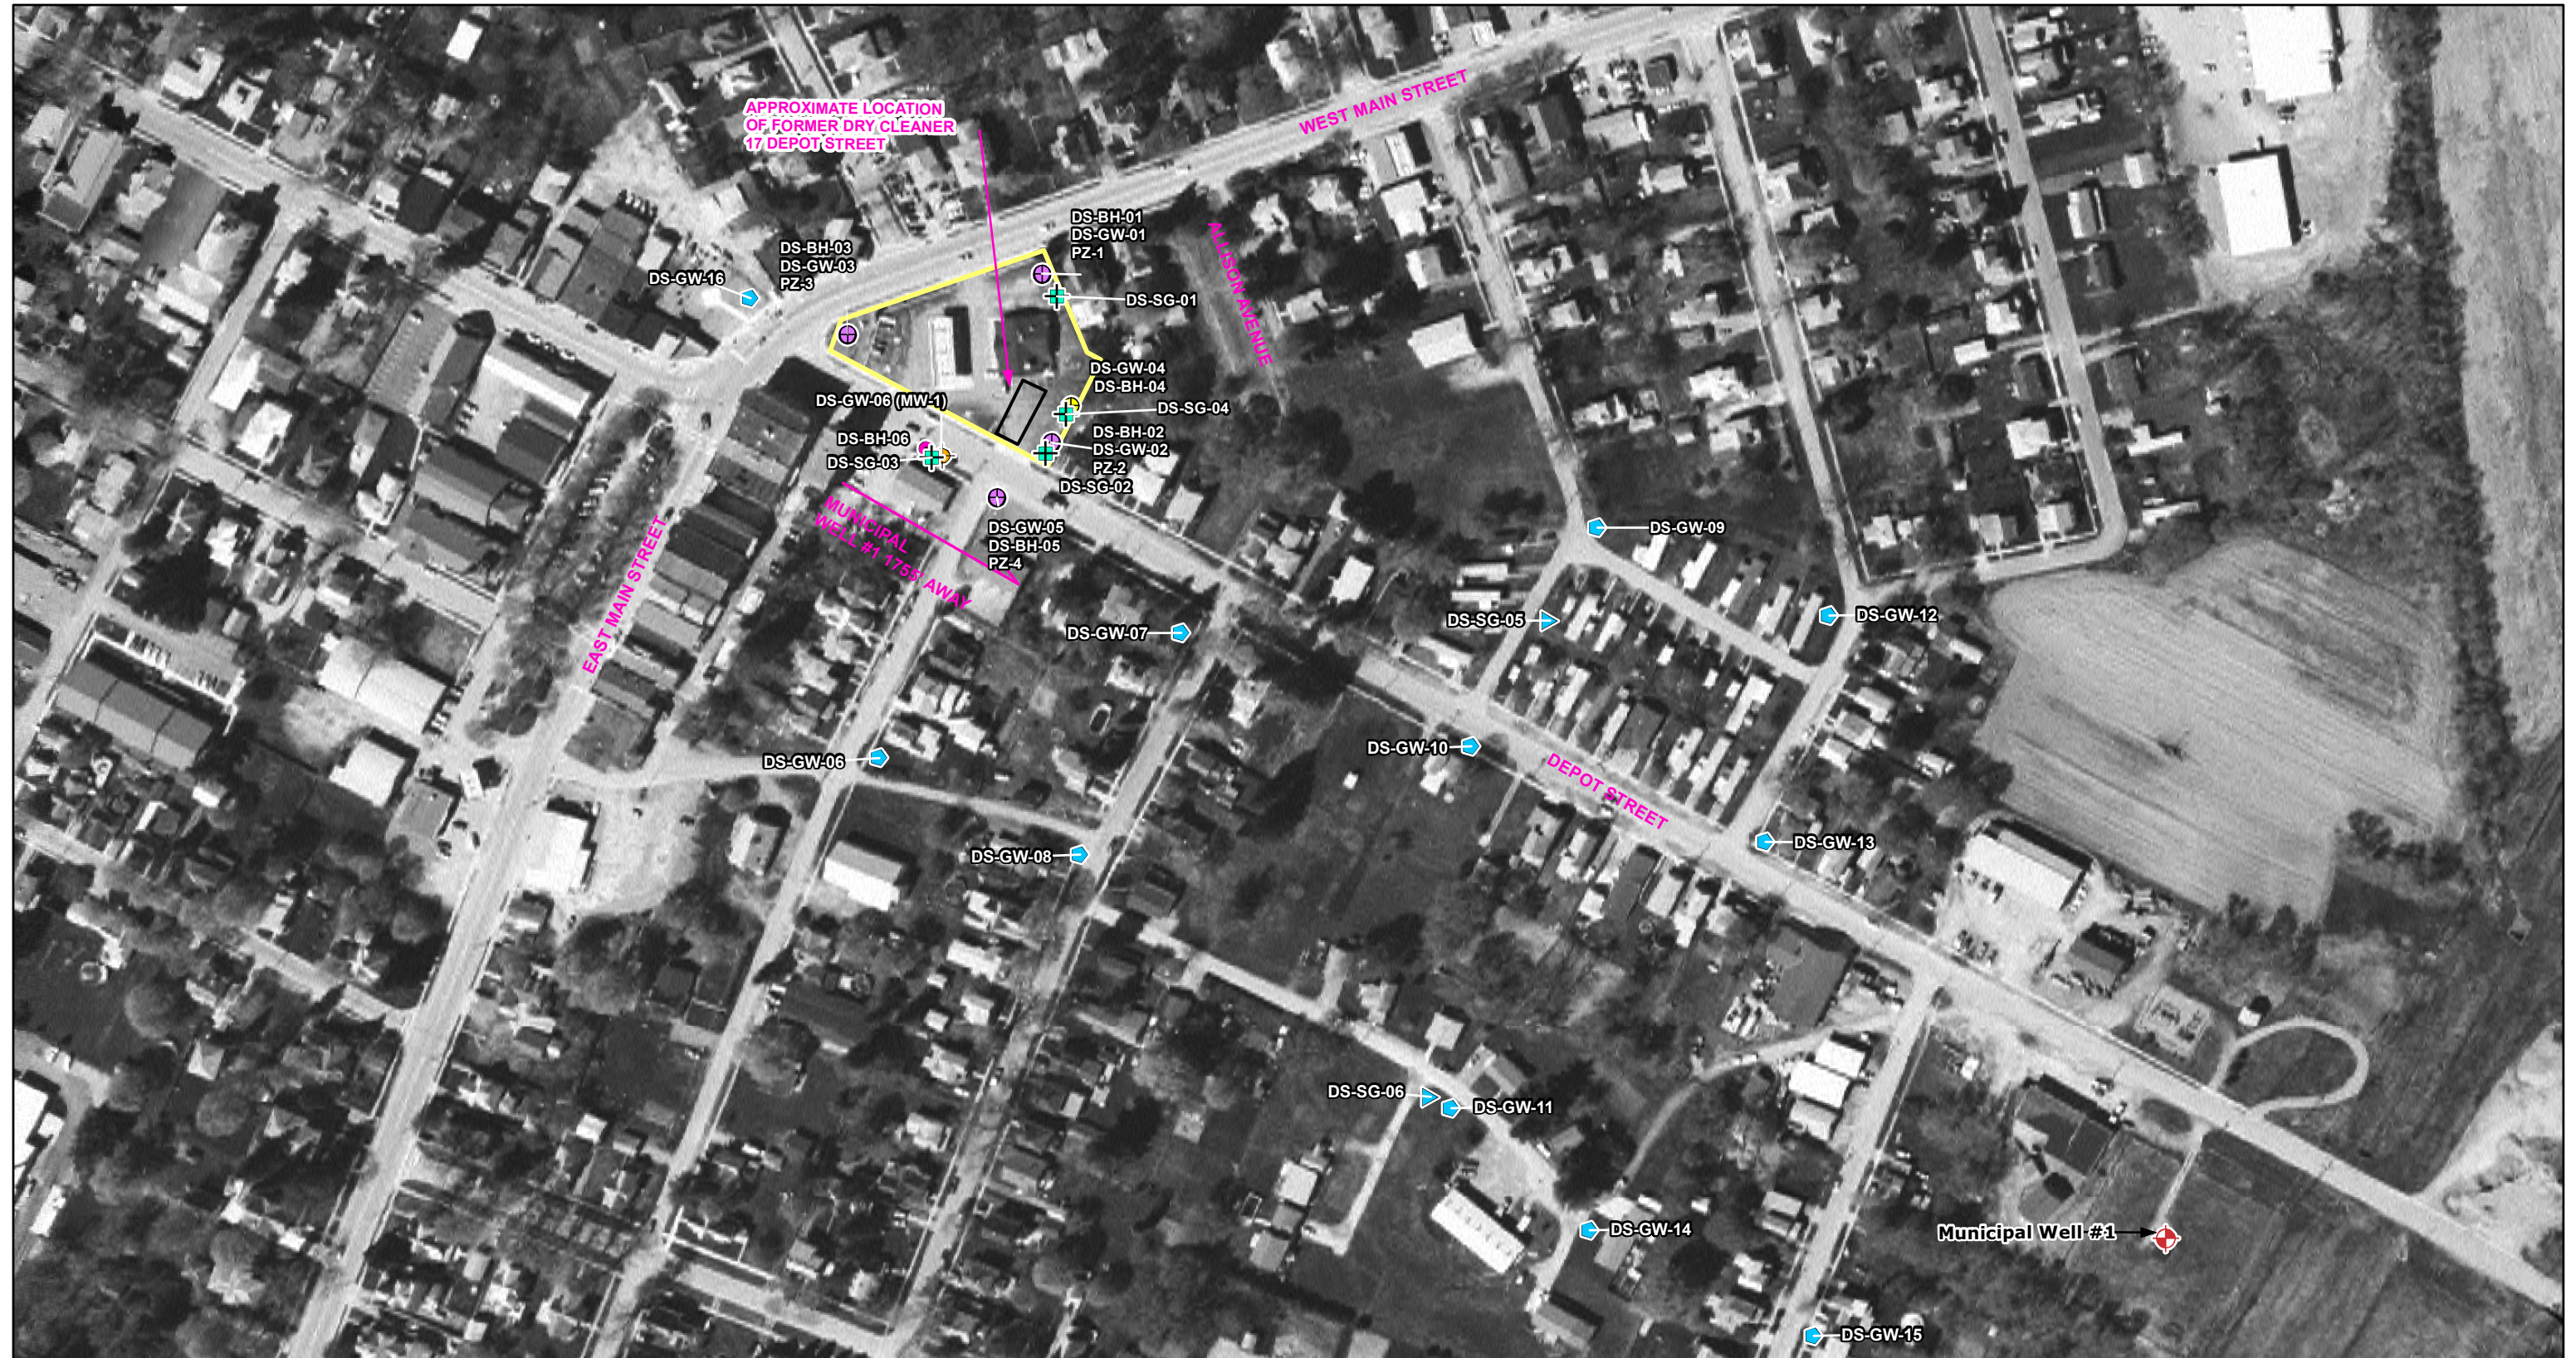
Figure 3-1
Former Depot Street Dry Cleaner
Sample Locations

Phase I Sample Locations (2006)

- Soil Vapor Sampling Location
- Soil Boring Only Sample
- Soil and Groundwater Sample Location
- Soil and Groundwater Sample Location W/ Piezometer
- Existing Monitoring Well (MW-1) Sampled

Phase II Sample Locations (2007)

- Groundwater Sampling Location
- Soil Vapor Sampling Location
- Approximate Property Boundary

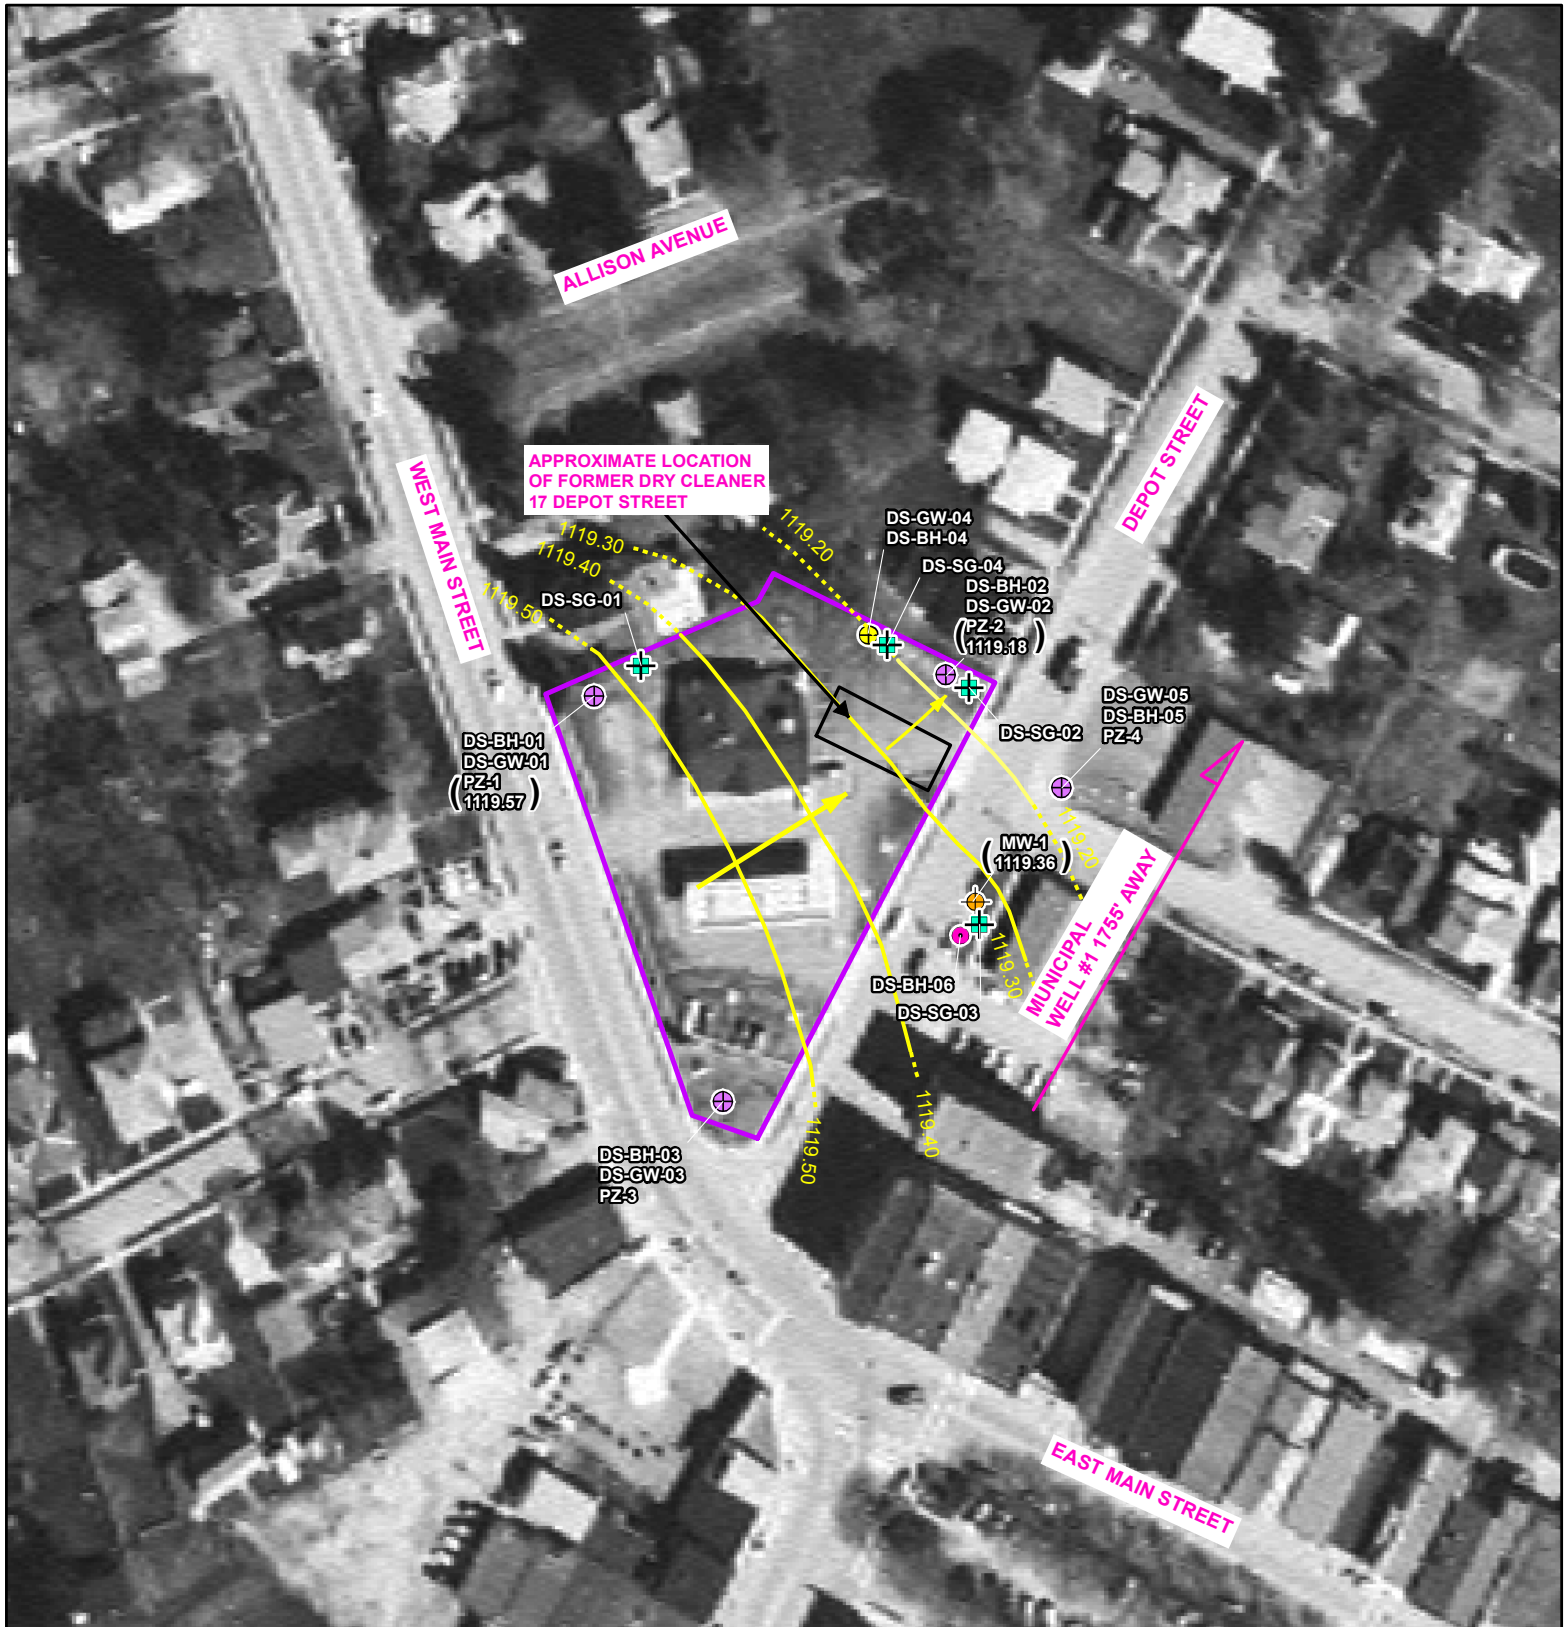
Figure 3-2
Former Depot St. Dry Cleaner
Sample Locations and
Groundwater Contours

Groundwater levels were measured in piezometers PZ-1, PZ-2, and existing monitoring well MW-1. Groundwater flow at the site is toward the northeast at a very low horizontal gradient of 0.002 feet per foot (see Figure 3-2). Flow is generally toward the municipal well, which is approximately 1,570 feet to the northeast.

One discrete groundwater sample was collected from existing monitoring well MW-1 using a PDB sampler (see Section 3.2.3.2). The groundwater sample contained total BTEX at a concentration of 240 ppb, with xylenes having the highest concentration; no benzene was detected. Isopropylbenzene was found at 10 ppb. Each compound exceeded the respective NYSDEC screening criteria (see Table 4-2a). Monitoring well MW-1 is east of the site, across Depot Street, and was installed by others as part of an active NYSDEC Spills Program remediation (see Figure 3-2).

Groundwater levels were measured in the three installed piezometers and existing well MW-1, as noted on Figure 3-2. Groundwater flow is toward the northeast at a horizontal gradient of 0.002 feet per foot. Flow is generally toward the municipal well, which is approximately 1,570 feet to the northeast.

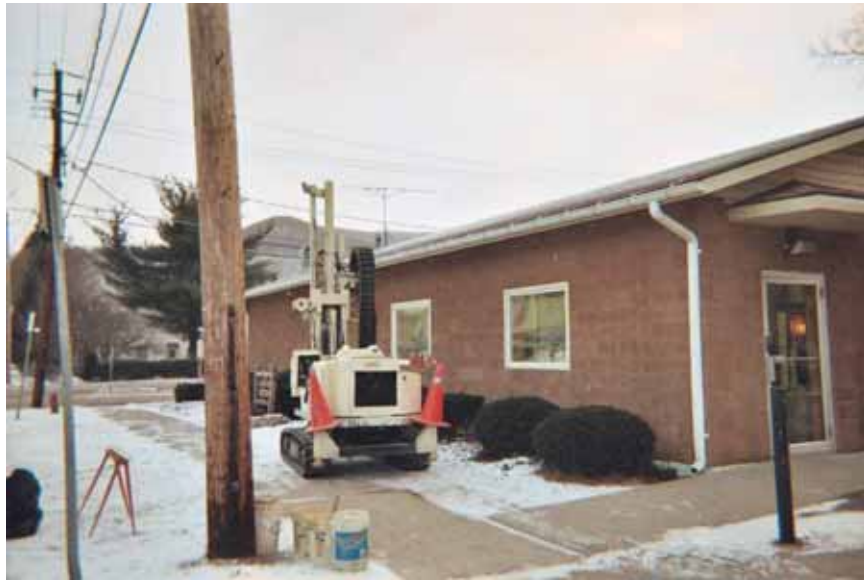
| Time/Date: 1/26/06 | Subject: Direct-Push activities at the Former Depot Street Dry Cleaner Site boring DS-BH-06 |

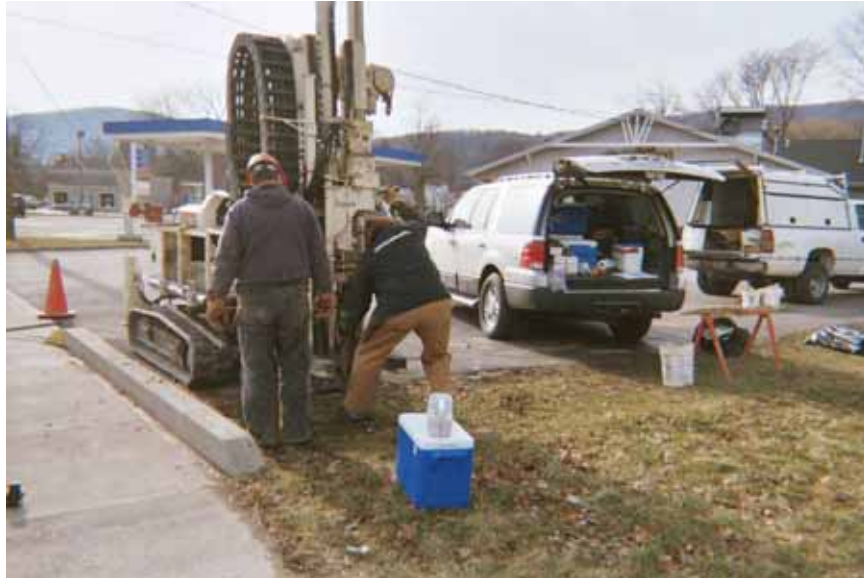
| Date: 1/26/06 | Subject: Direct-Push activities at the Former Depot Street Dry Cleaner Site boring DS-BH-02 |

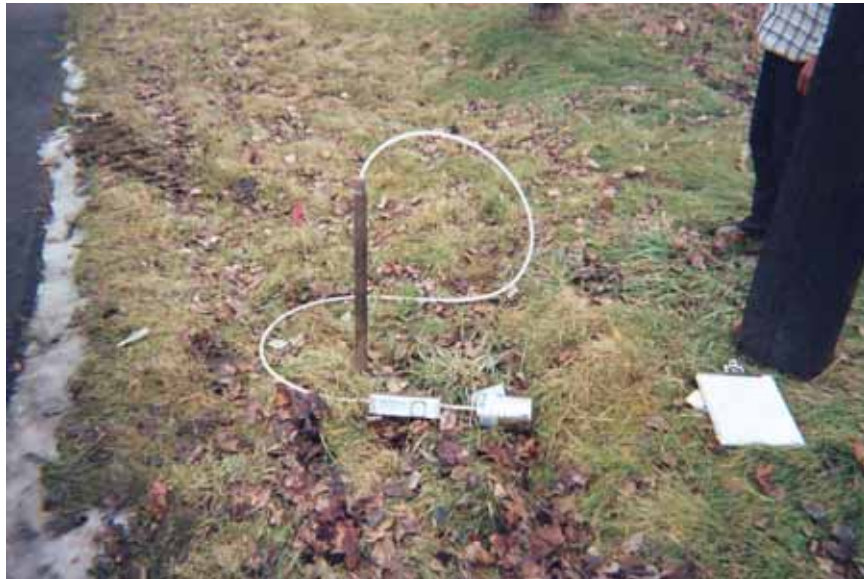
| Date: 1/4/06 | Subject: Typical soil gas sample collection set-up |
