FINAL COMPLETION REPORT

**REMEDIAL ACTIVITIES FOR
SEPARATOR AND POWERHOUSE**

**SINCLAIR REFINERY SITE
WELLSVILLE, NEW YORK**

Project Number GQ3201

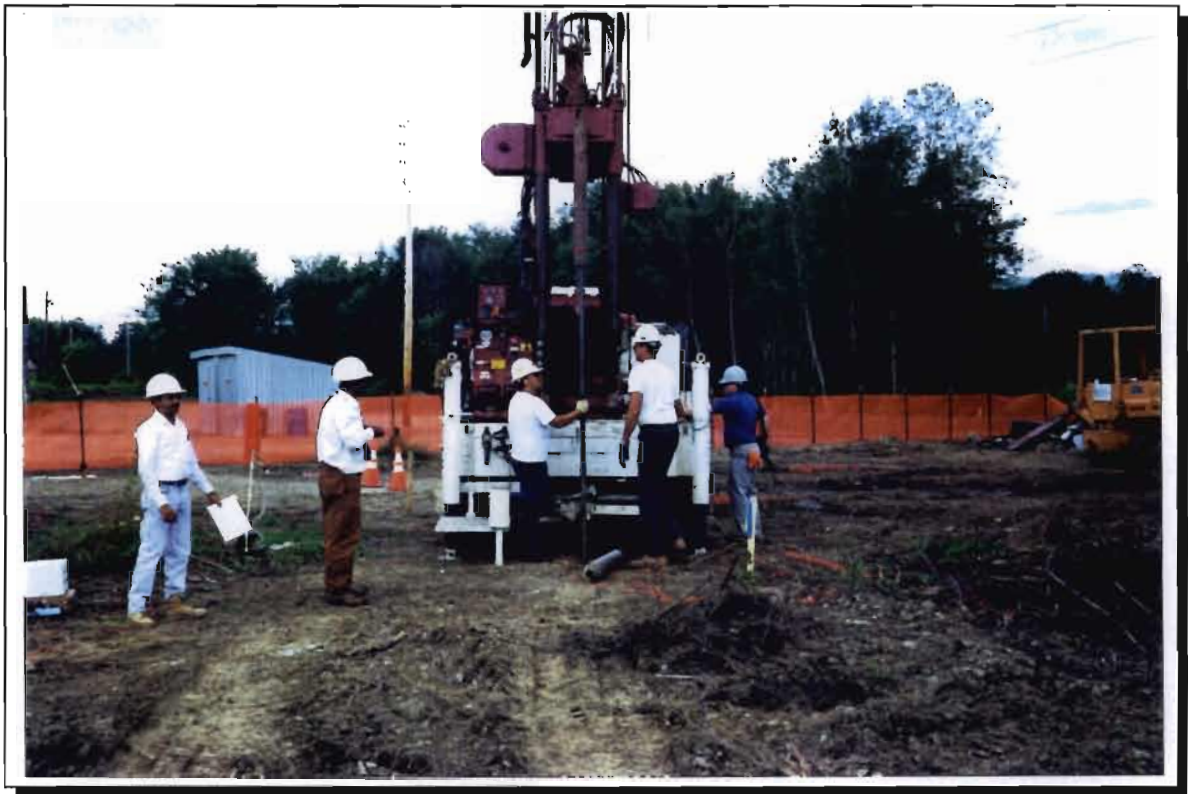
Photograph 1. Soil sampling along by-pass sewer alignment.

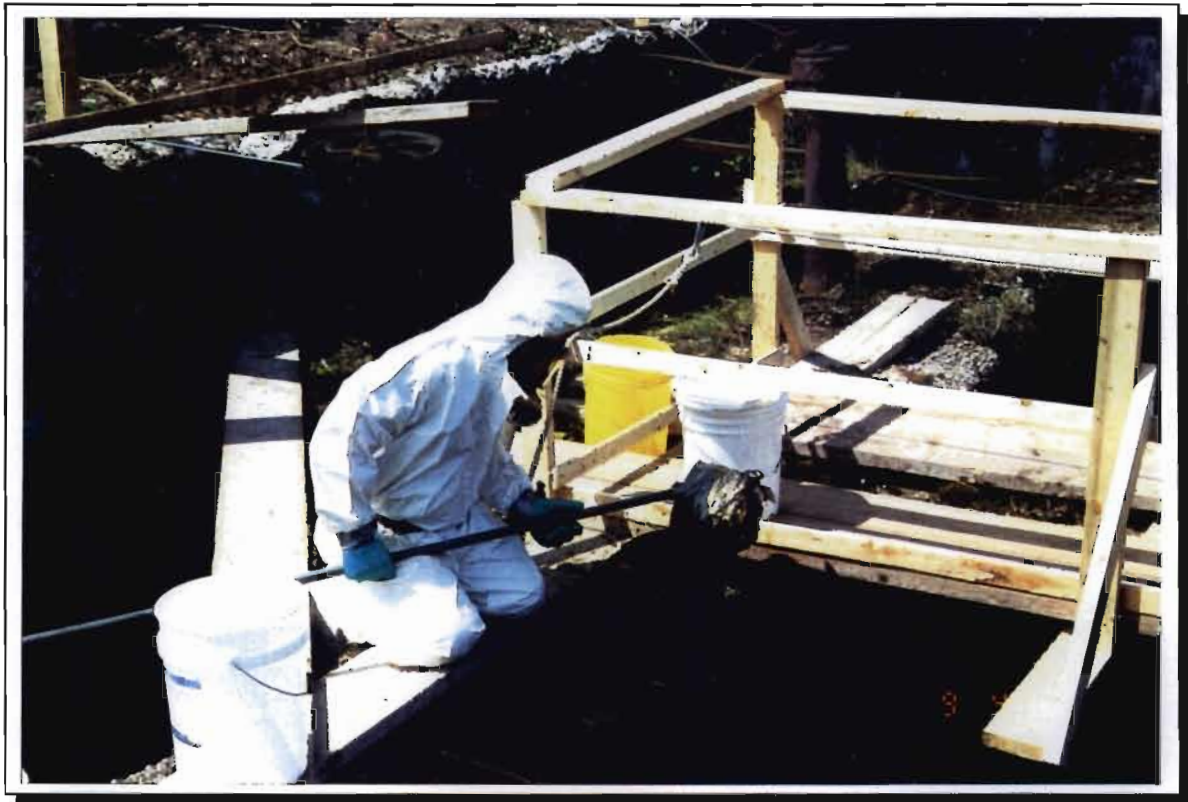
Photograph 2. Sampling contents of separator.

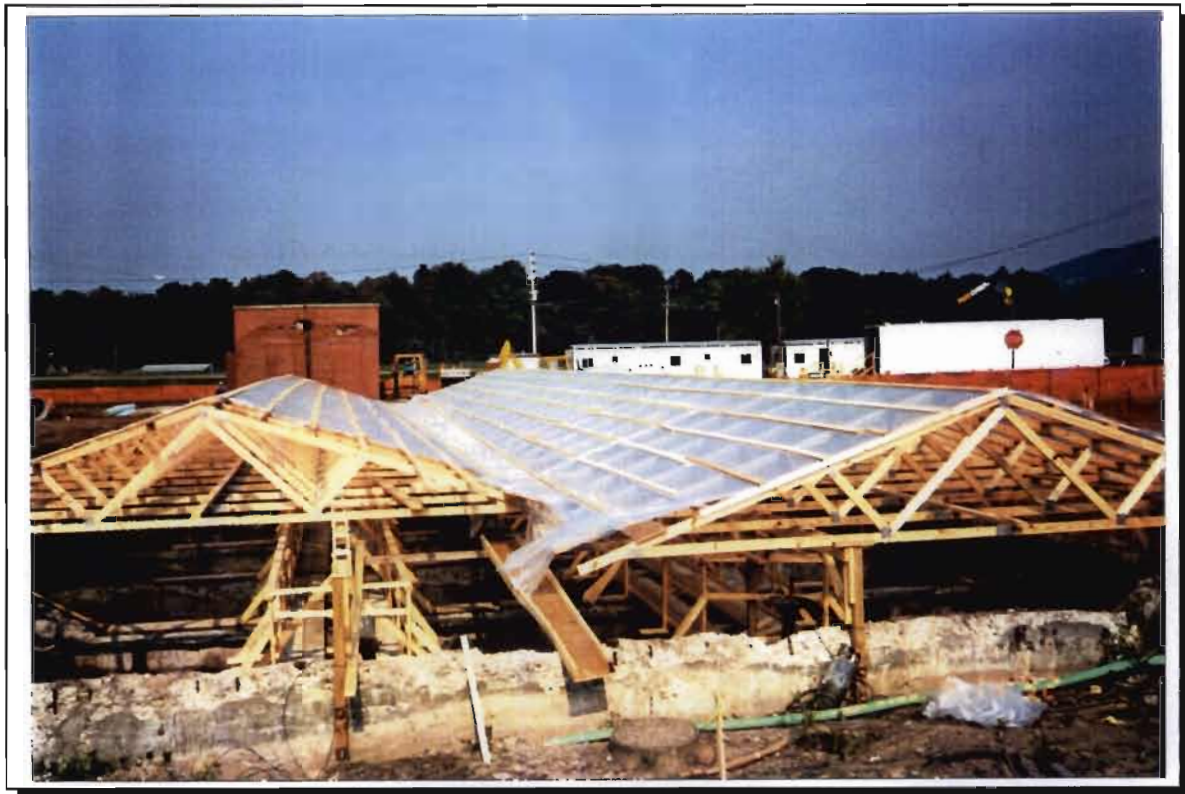
Photograph 3. Temporary access walkways and cover.

On 1 September 1992, Sevenson started to construct: (i) two access stairways to the top of the cell walls; (ii) walkways along the top of the cell walls in the longitudinal direction (i.e., two walkways between the three trains); and (iii) a cover, consisting of wooden trusses covered with polyethylene, over the separator. This work was completed on 15 September 1992. The cover was constructed to protect the separator from precipitation while activities relating to the removal of hazardous materials from the separator and the documentation of the separator were in progress. The temporary facilities were constructed and installed to comply with applicable OSHA regulations. Sevenson submitted Inspection Report Form A-7, Install Access and Cover (Appendix E), following completion of the installation.

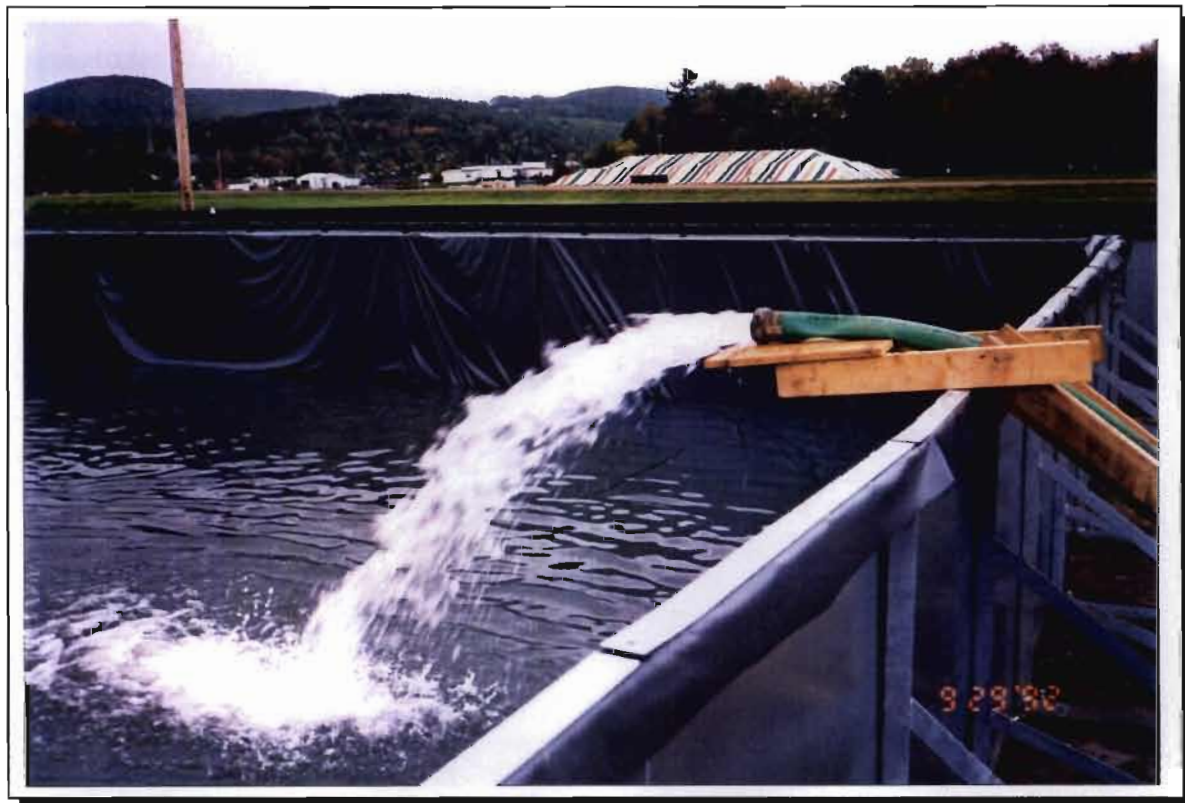
Photograph 4. Discharge of aqueous phase to 100,000 gal (375,000 l) Modutank.

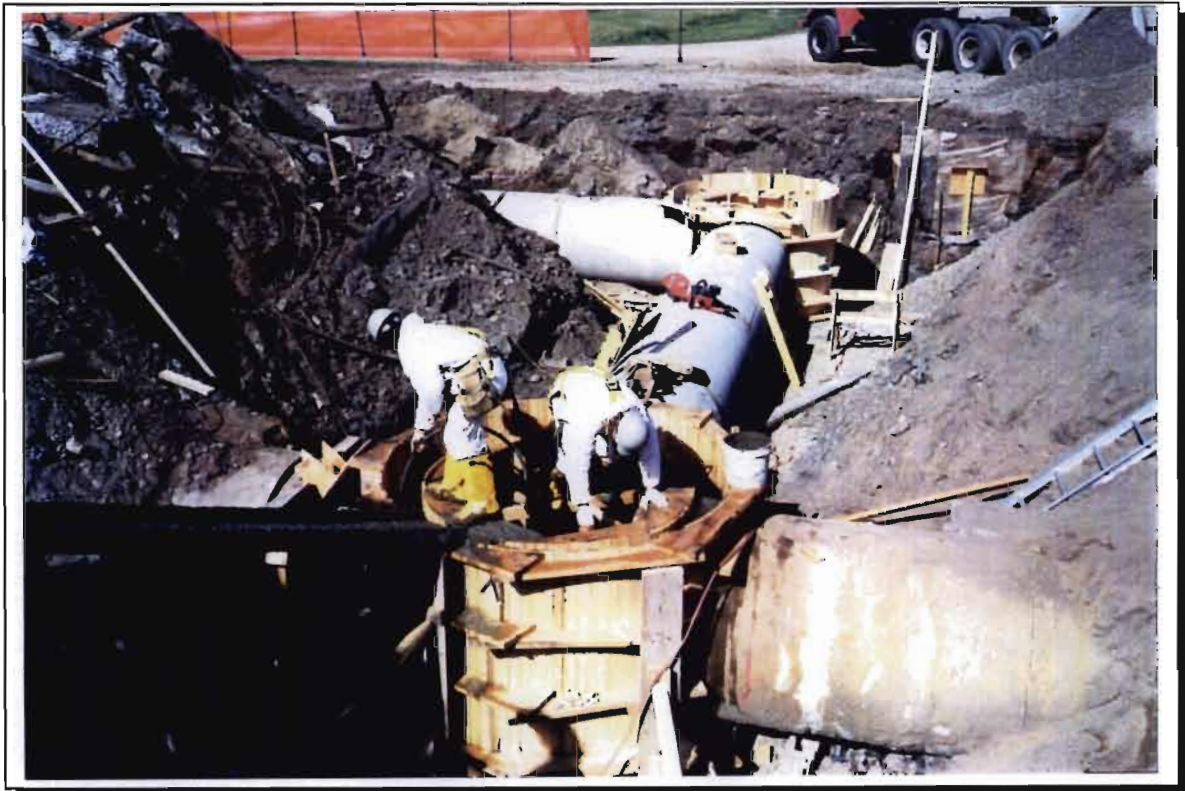
Photograph 5. Construction of by-pass sewer, showing construction of manhole MH-4 in foreground, on existing effluent line from separator, and manhole MH-3 in background.

The by-pass sewer was leak tested with water in two sections. The 42-in. (1.05-m) diameter section between manholes MH-2 and MH-4 was tested on 15 and 16 October 1992, and the 18-in. (0.45-m) diameter section between manholes MH-1 and MH-2 was tested between 26 and 28 October 1992. Both tests were conducted by filling the appropriate by-pass sewer section with water and applying a 2-ft (0.6-m) head of water to the manhole at the upgradient end of the section being tested. The test on the 42-in. (1.05-m) diameter section resulted in an average leakage rate, during a 24-hour period, of 166 gal/in. diameter/mile/day (1,415 l/m diameter/km/day). The test on the 18-in. (0.45-m) diameter section resulted in a leakage rate, over the last 17 hours of the test, of 88 gal/in. diameter/mile/day (750 l/m diameter/km/day). Both results were less than the maximum acceptable criterium established in the Work Plan of 250 gal/in. diameter/mile/day (2,130 l/m diameter/km/day).

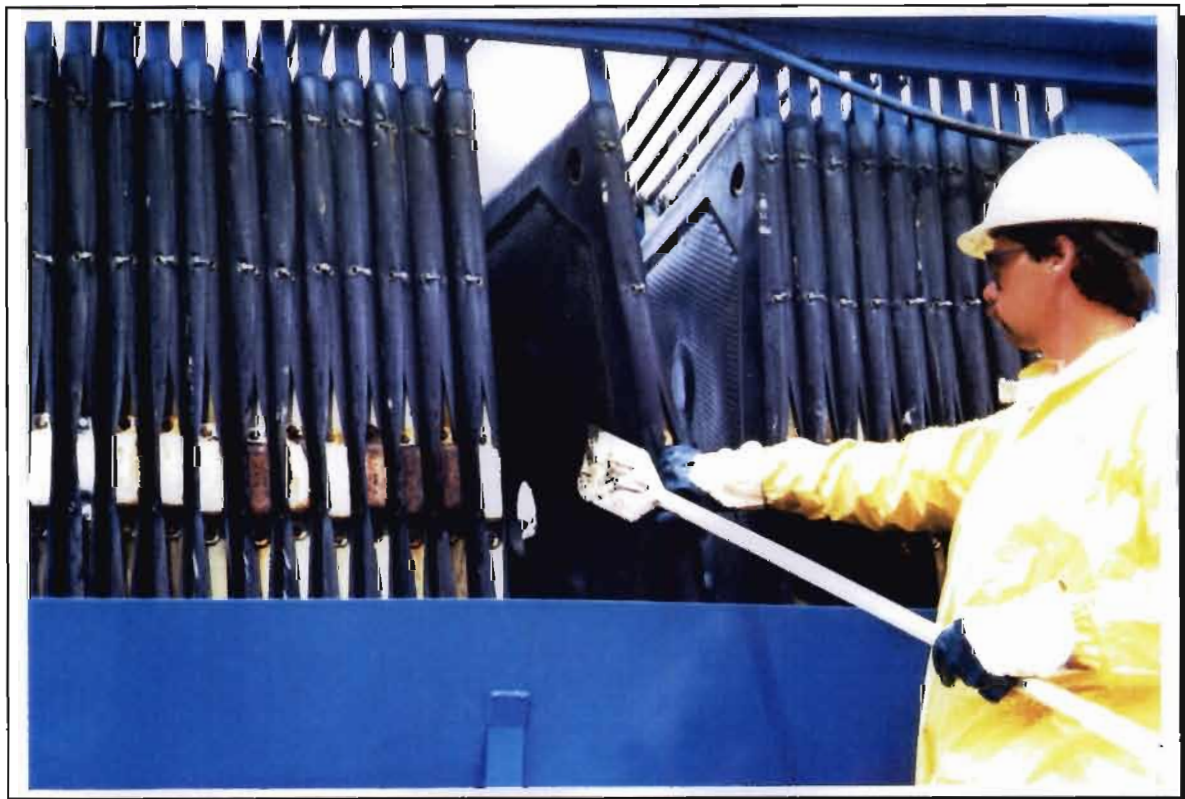
Photograph 6. Filter press.

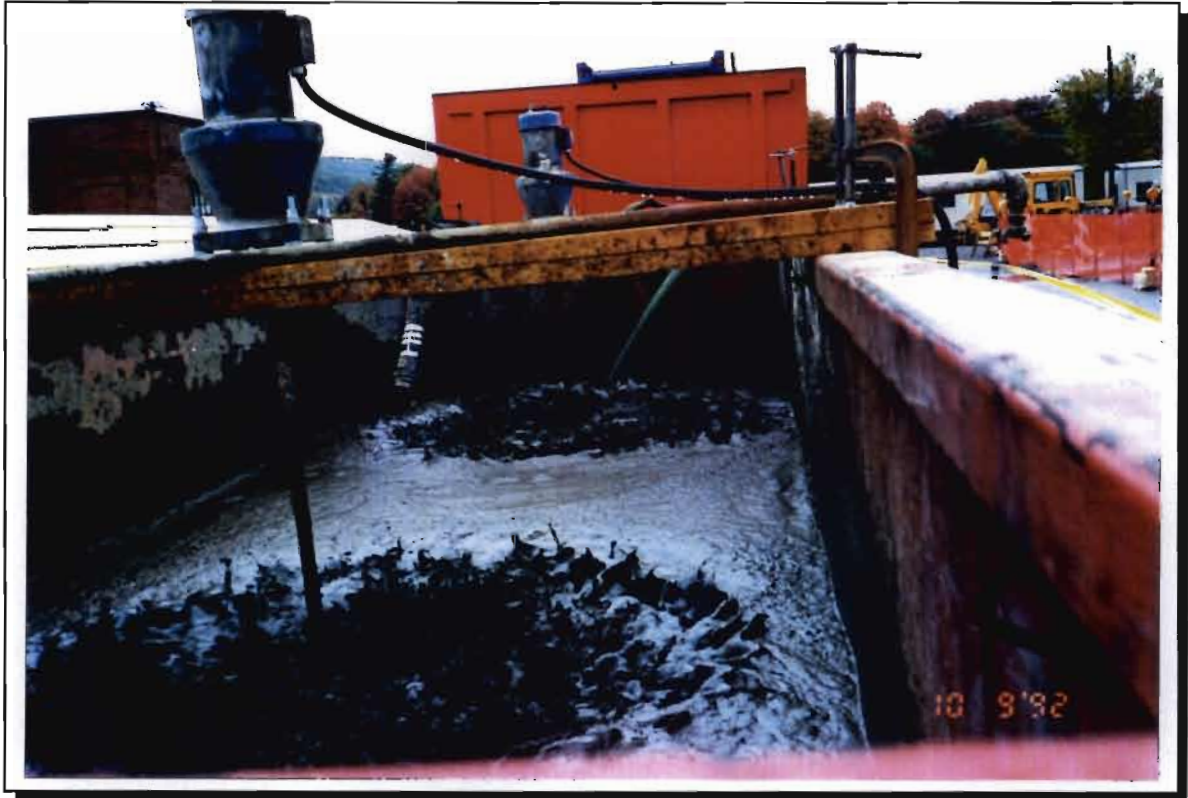
Photograph 7. Unprocessed sludge from separator.

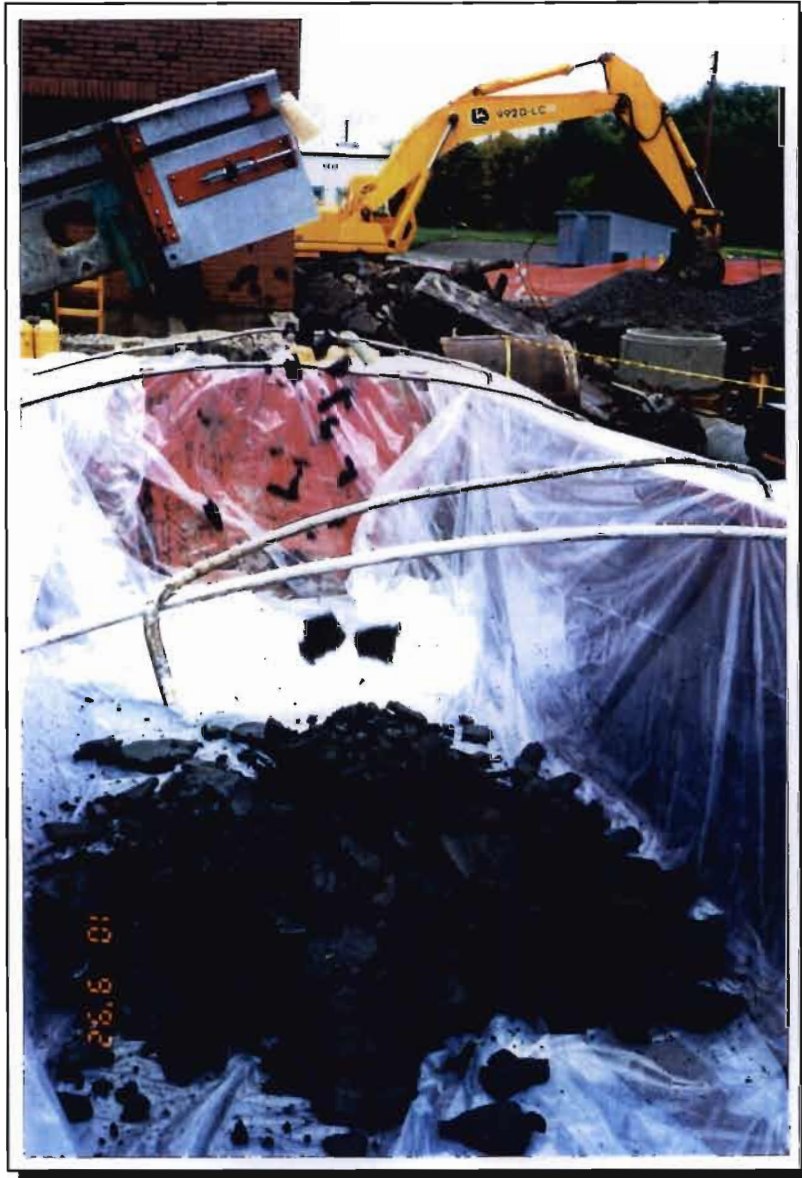
Photograph 8. Filter cake.

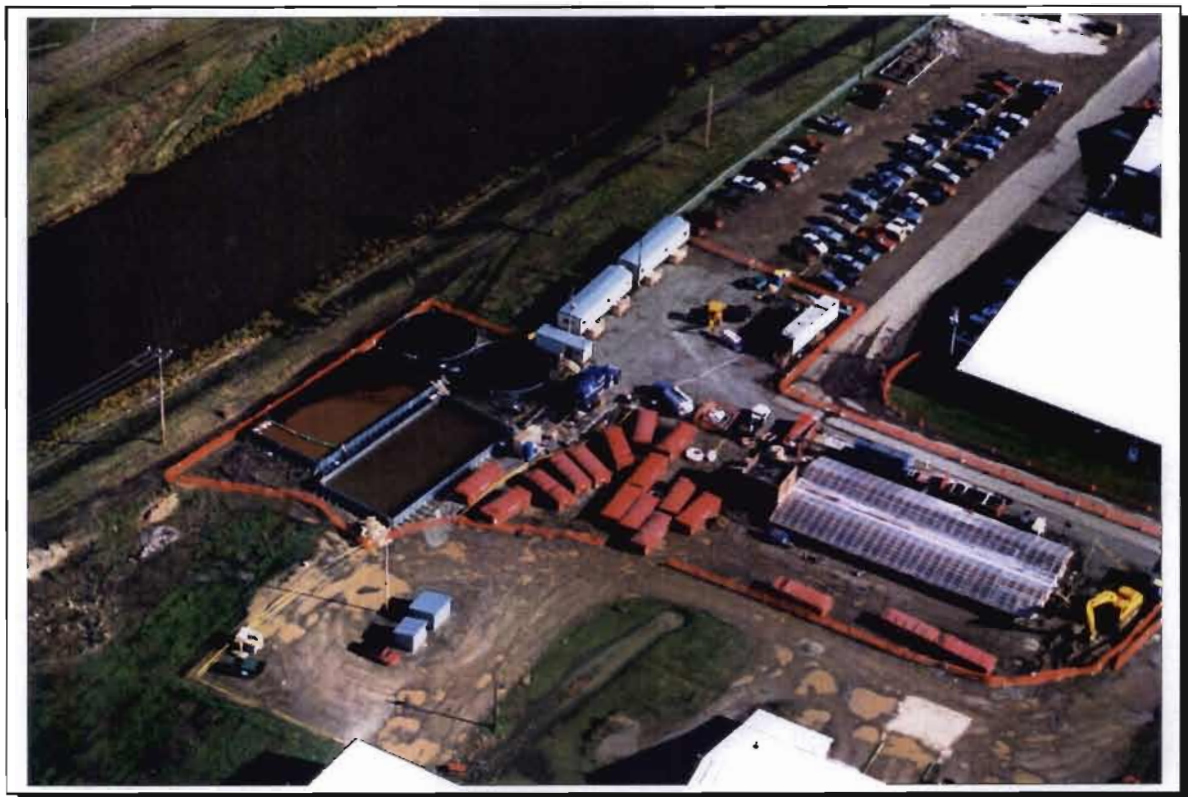
Photograph 9. General site layout showing: (i) Genesee River; (ii) temporarily covered separator; (iii) completed by-pass sewer; (iv) covered roll-off boxes containing filter cake; (v) large Modutanks with untreated filtrate; and (vi) small Modutanks with pretreated filtrate.

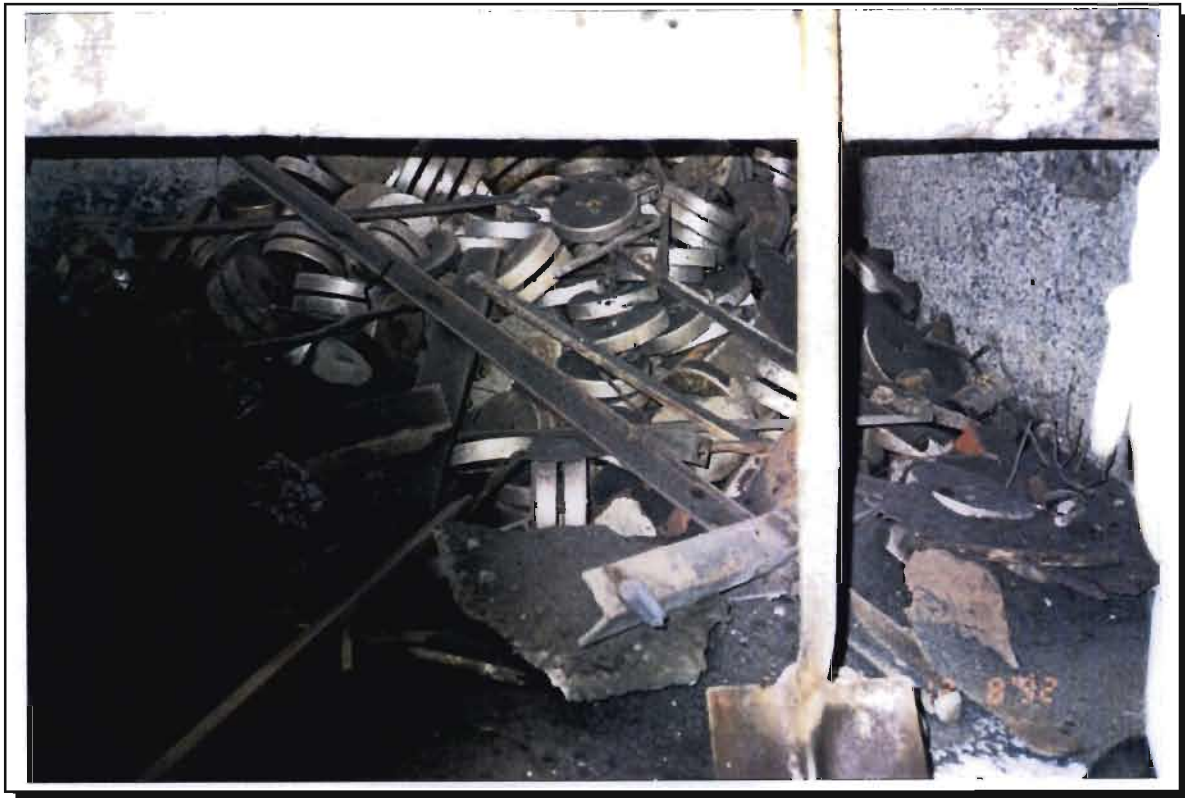
Photograph 10. Example of debris to be cleaned and left in separator.

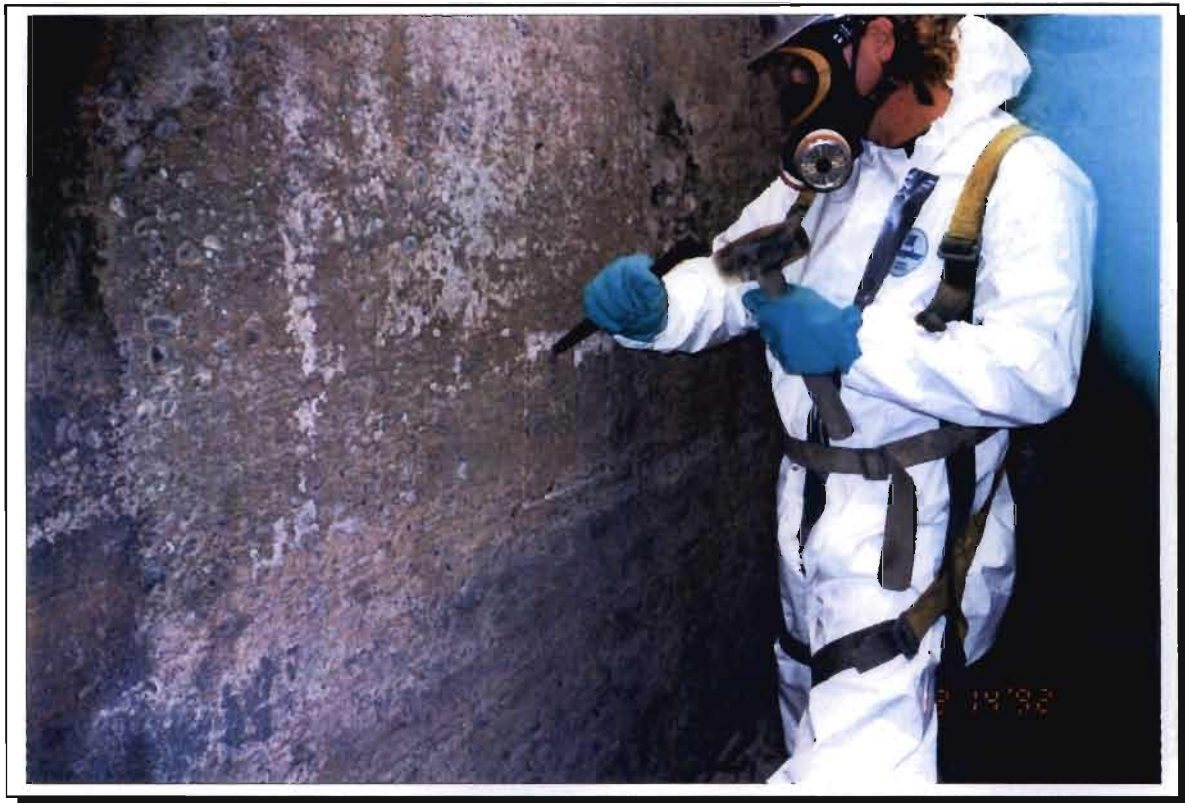
Photograph 11. Concrete chip sample.

The TPH results of all the samples, except Sample 5, exceeded 10,000 ppm. Based on visual observation of the walls and floor, it appeared that the decontamination efforts had been successful, although the laboratory data indicated that the desired level of decontamination had not been achieved. The condition of the concrete was poor throughout the separator. Spalling and general deterioration of the concrete was common. It is likely that the hydrocarbons had impregnated deeply into the body of the concrete. ARCO considered that further decontamination efforts would not be worthwhile. Therefore, ARCO proposed, by letter from Mr. D. Christensen to Mr. L. DiGuardia, USEPA, dated 5 January 1993, to partially demolish and backfill the separator as planned and to

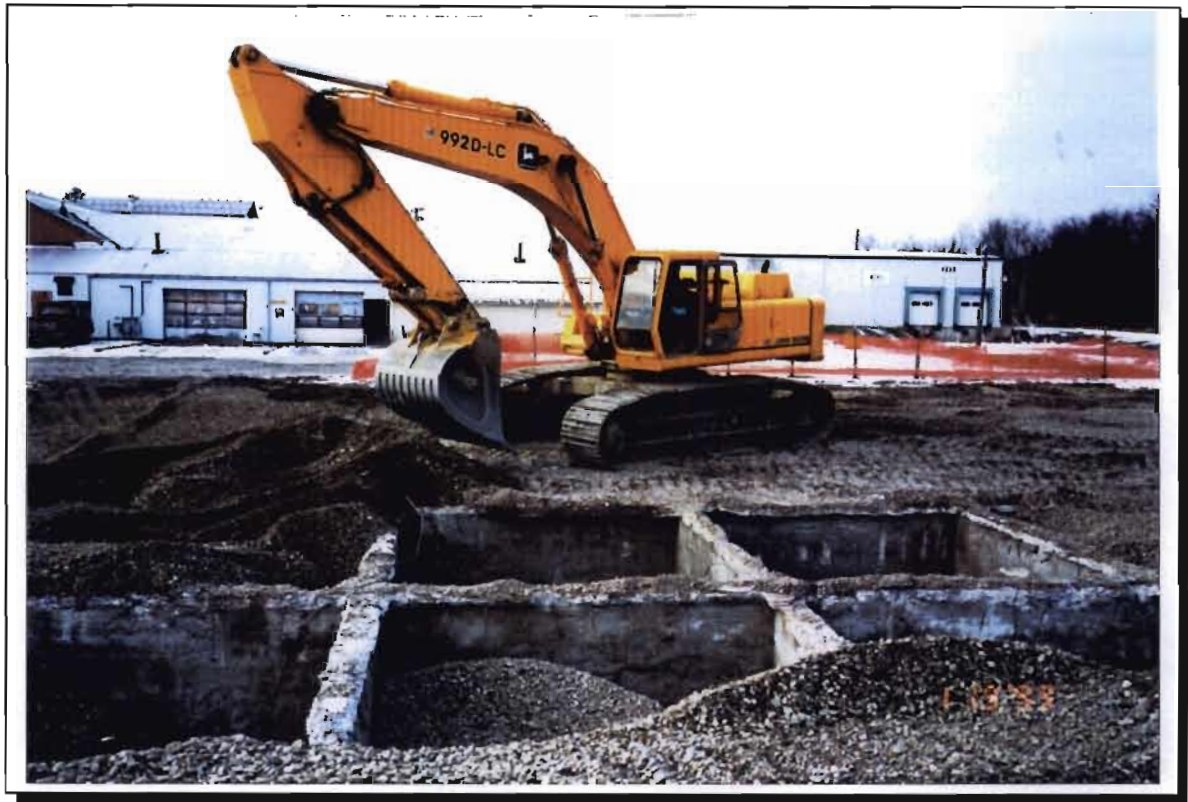
Photograph 12. Backfilling of separator with cell walls demolished below grade.

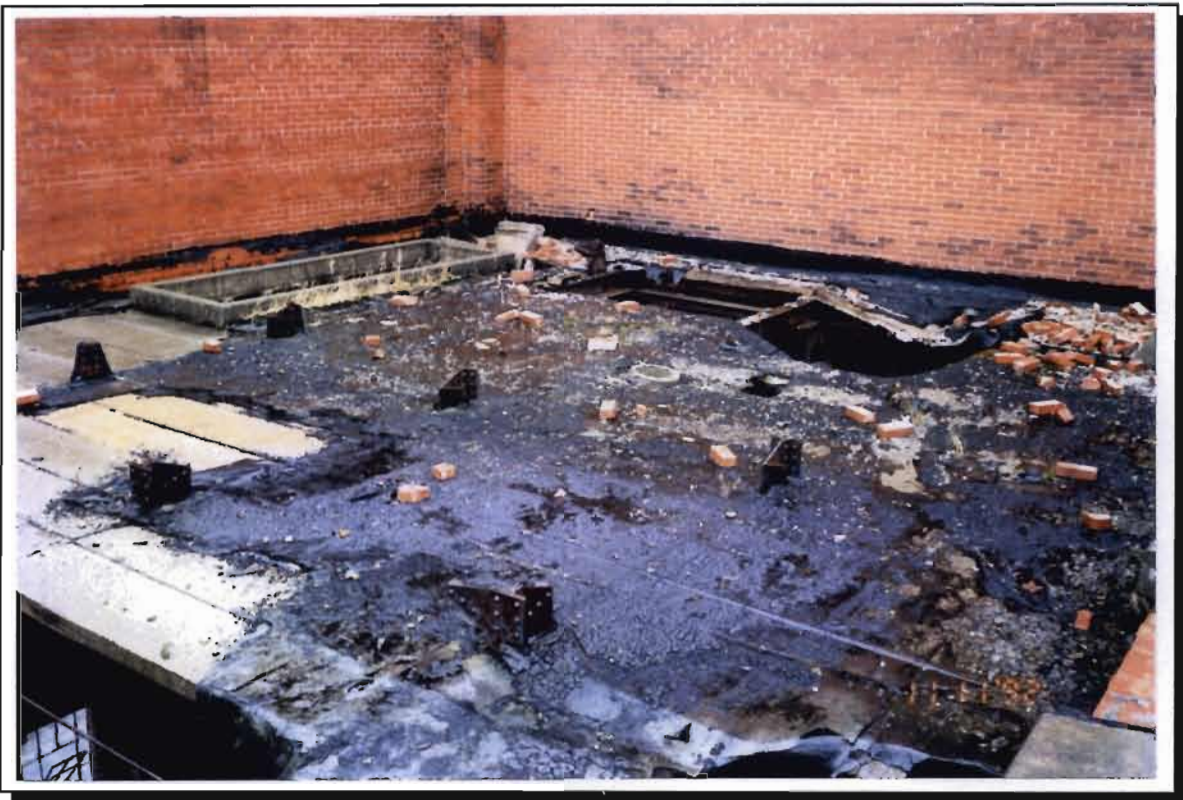
Photograph 2. Powerhouse roof on west side of building showing; (i) poor condition of roof; (ii) bricks from parapets; and (iii) non-friable asbestos material on some roof panels.

E&M Engineers and Surveyors pc., (E&M) of Bradford, Pennsylvania, was contracted by OHM to assess the integrity of the roof and parapets. E&M inspected and load tested the roof and inspected the roof parapets on 14 October 1992 and between 9 and 11 November 1992. E&M concluded that while areas of the roof were in acceptable condition, other areas of the roof and portions of the parapet were unsafe.

Asbestos Control Management, Inc. (ACM) of Olean, New York, was also retained by OHM to conduct an asbestos inspection of the powerhouse roof. Samples had not previously been obtained from the roof to determine if the roofing materials contained asbestos. ACM obtained seven samples of the roofing material from three different areas of the roof on 26 October 1992. All the samples were found to contain chrysotile asbestos.

- posted asbestos danger signs on the powerhouse and storage buildings S1, S2, and S3;
- removed loose parapet bricks from the top of the powerhouse to make the zone around the perimeter of the building safe for personnel working around the outside of the powerhouse;
- removed stored and movable materials from inside storage buildings S1, S2, and S3 and the turbine room;
- erected barriers, consisting of two layers of 6-mil thick plastic stapled to a wooden frame, over the openings in the powerhouse walls;

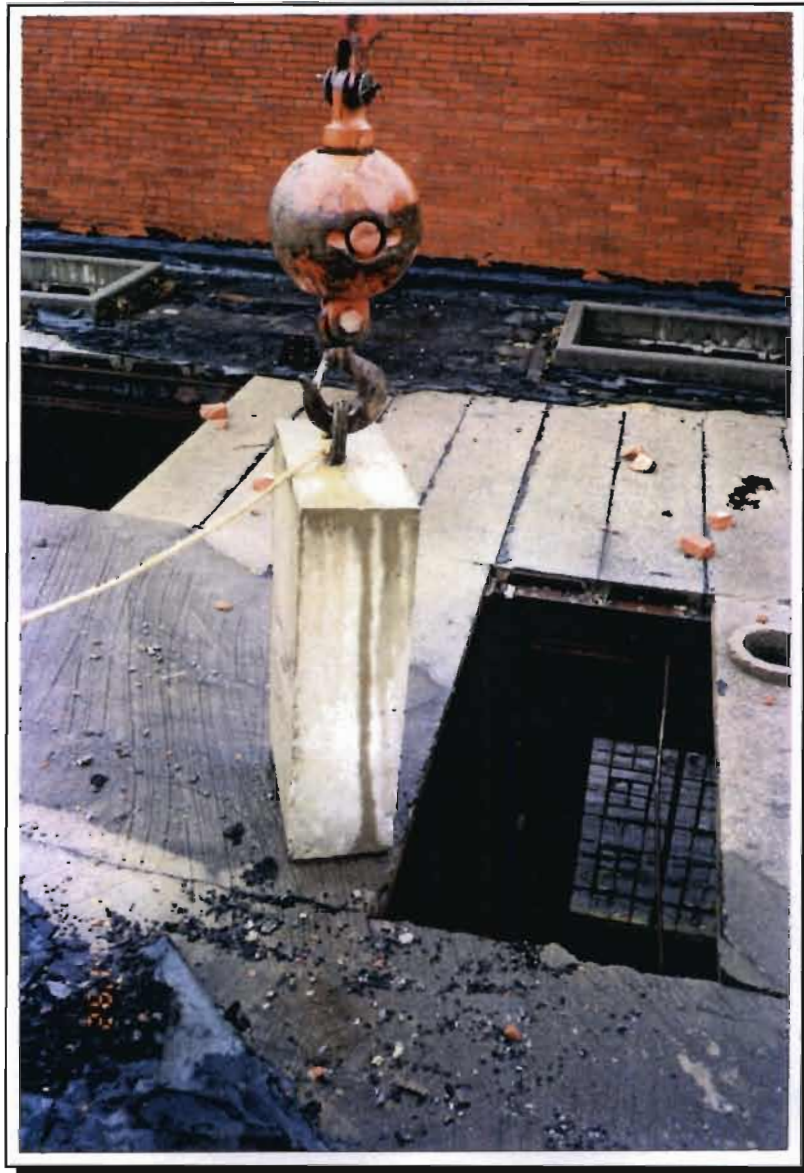
Photograph 3. Load testing roof.

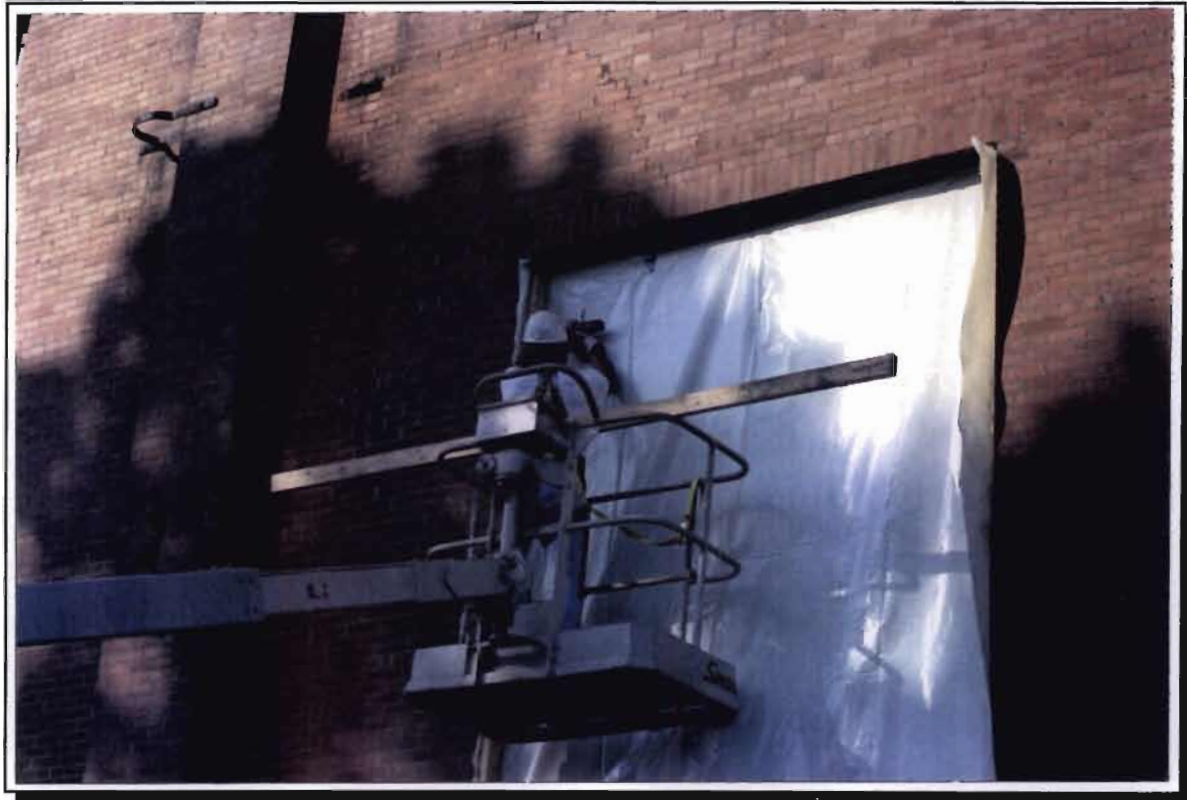
Photograph 4. Erecting plastic barriers over openings.

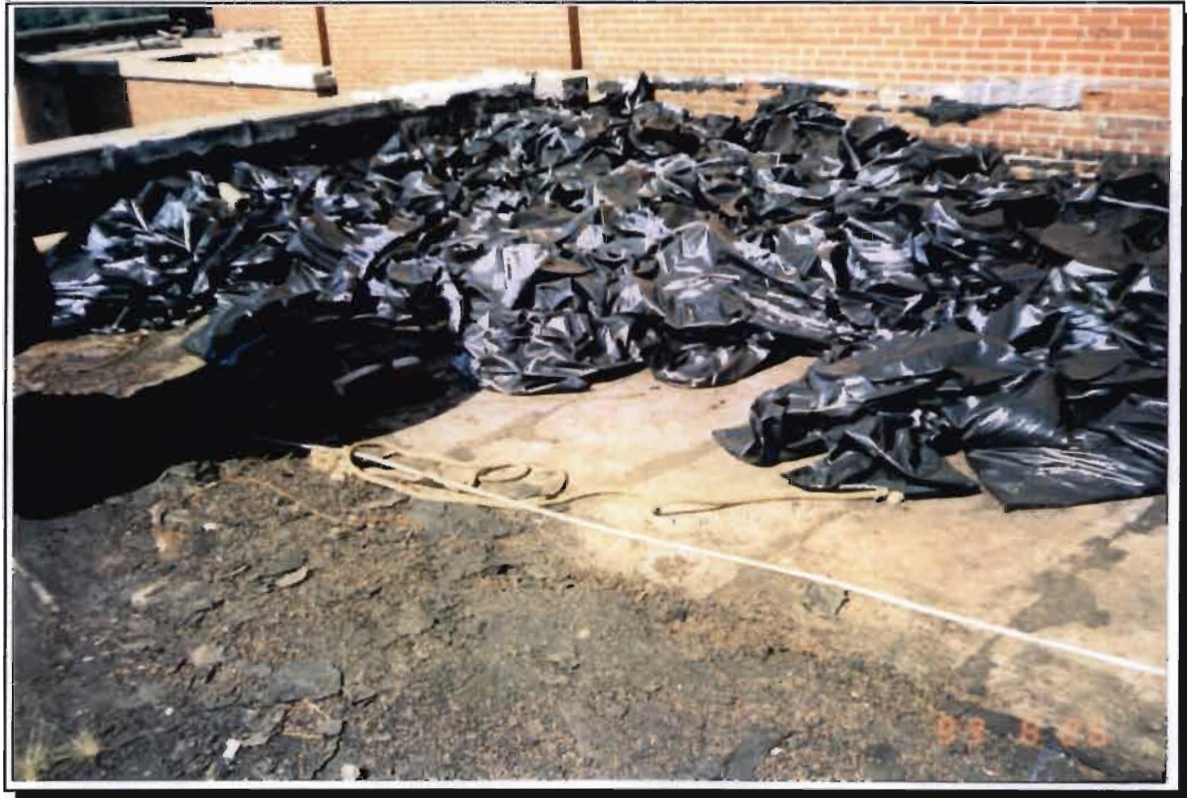
Photograph 5. ACM removal from turbine room roof.

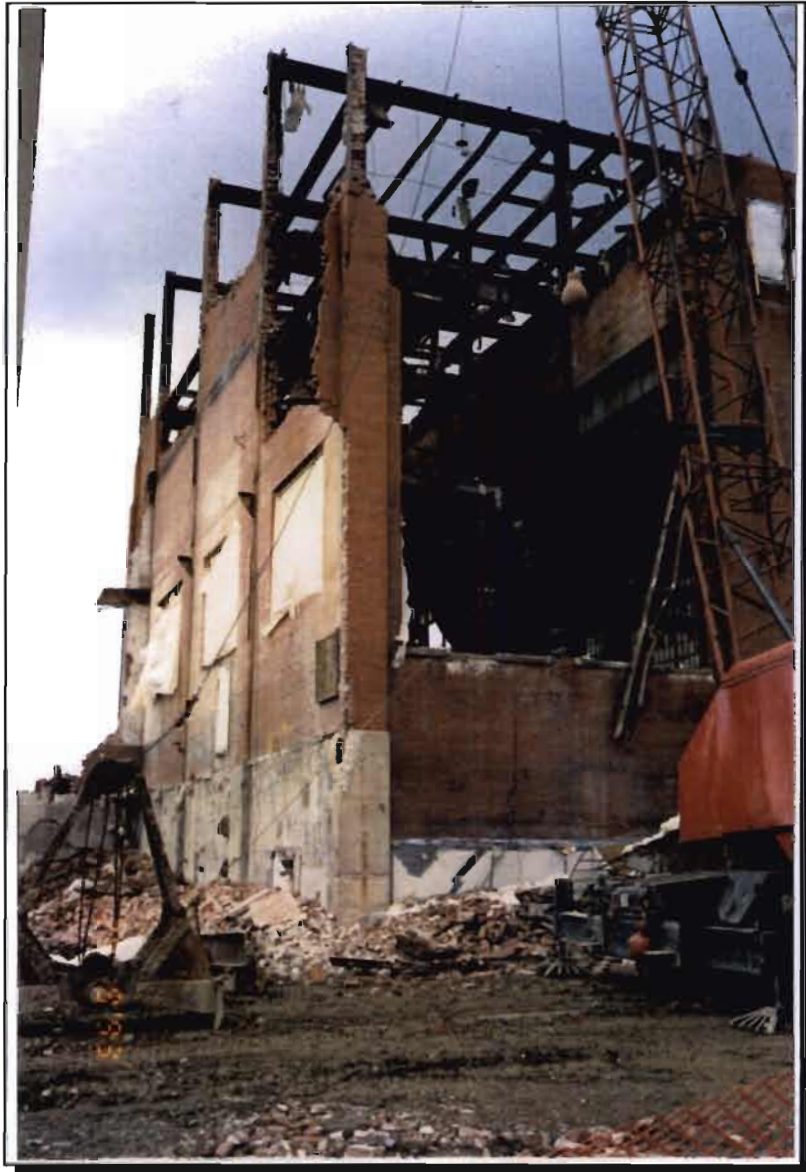
Photograph 6. Partial demolition of powerhouse.

The demolition was performed using: a crane with a wrecking ball or clam shell, a front end loader and a bulldozer. In addition, Kimmins personnel selectively cut steel members. During the demolition of the boiler and coal handling rooms, the structure was continually sprayed with amended water to suppress the generation of asbestos dust. No visible emissions were noted during the demolition. AET visually inspected the steel, which had been selectively cut and removed from the building, for asbestos which would require additional cleaning. AET did not observe any asbestos on the steel.

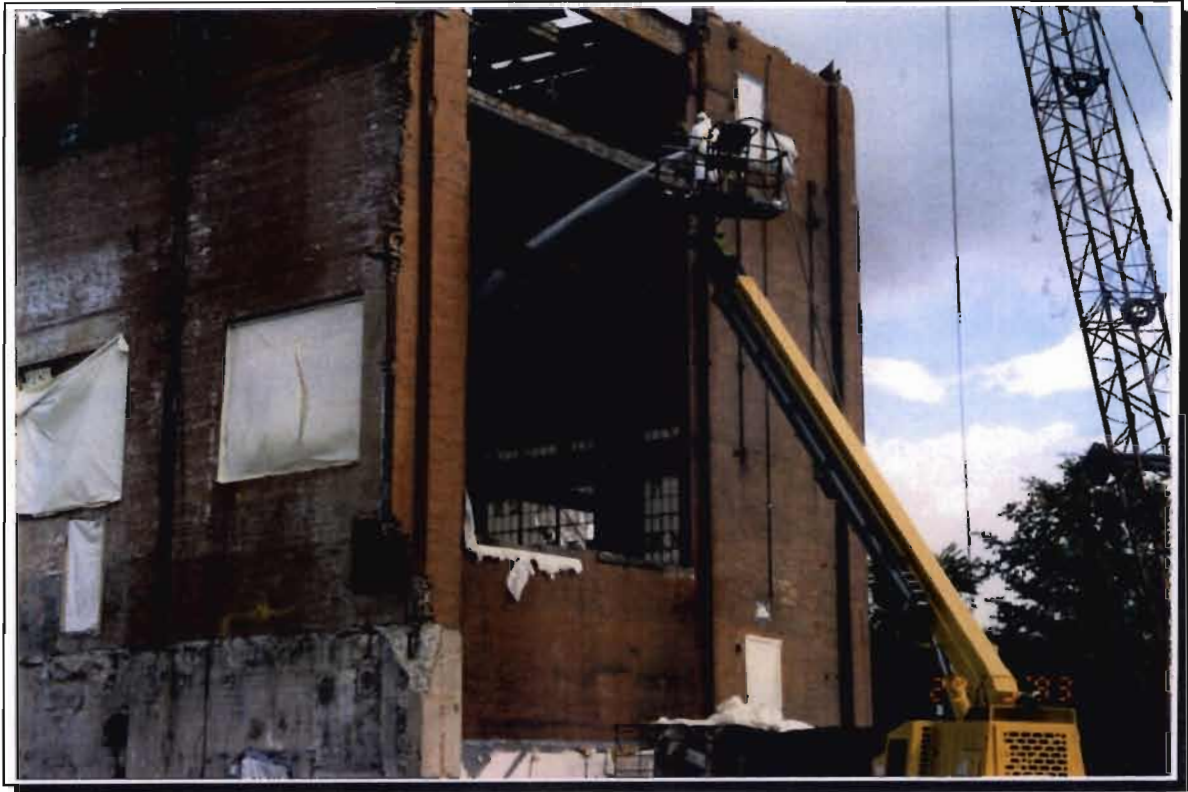
Photograph 7. Use of amended water to control dust.

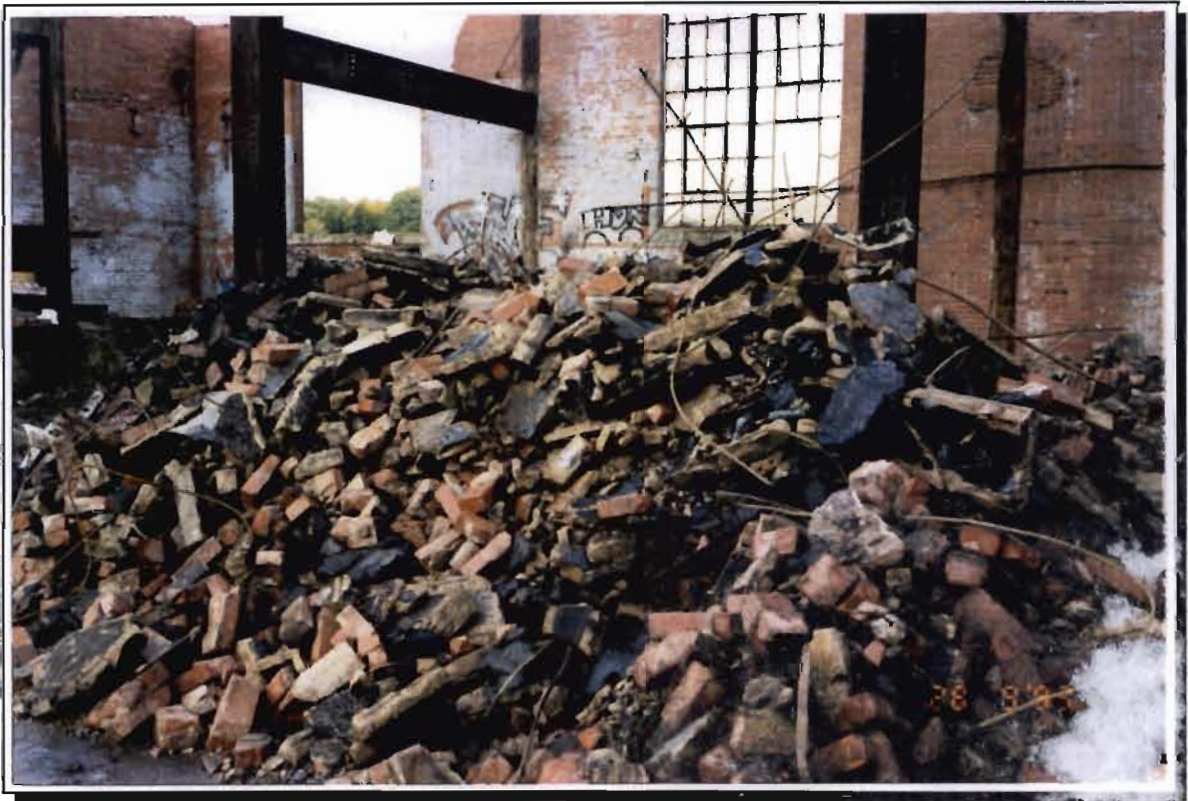
Photograph 8. Non-friable ACM mixed with clean debris at north end powerhouse.

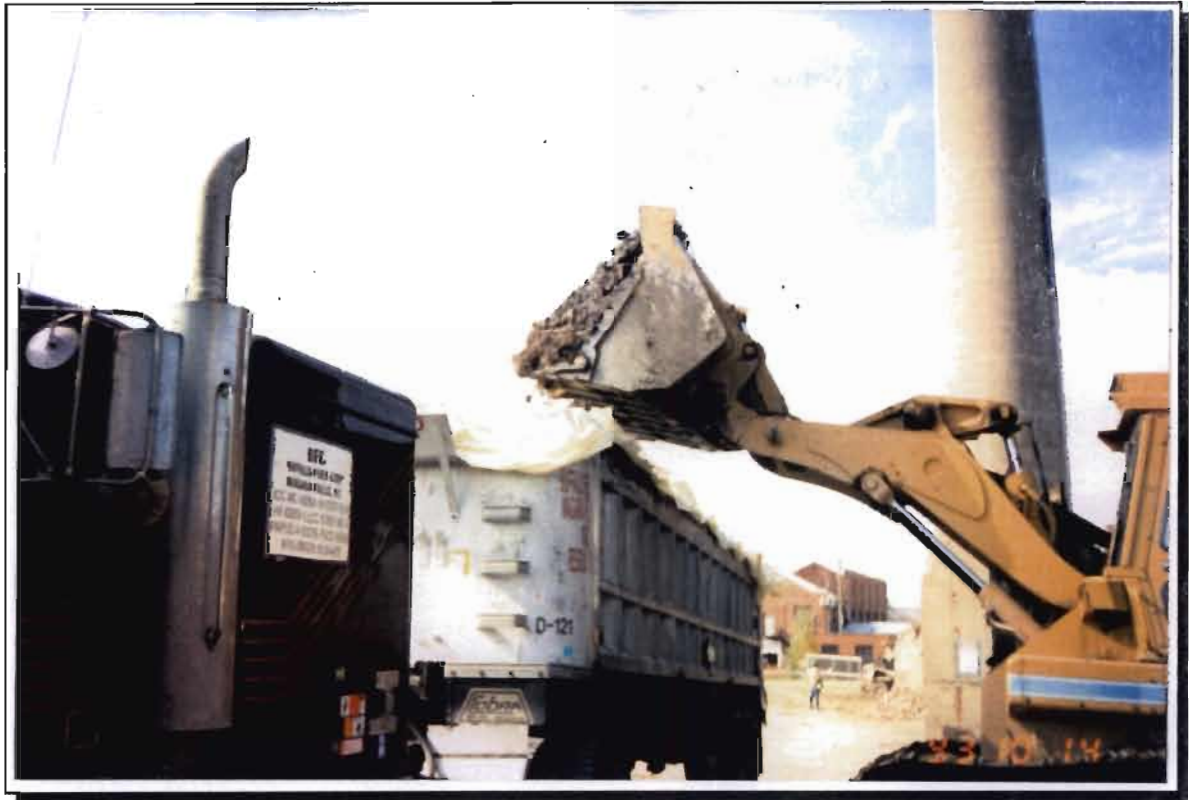
Photograph 9. Loading debris containing friable ACM into plastic lined units for transport to S&S Landfill.

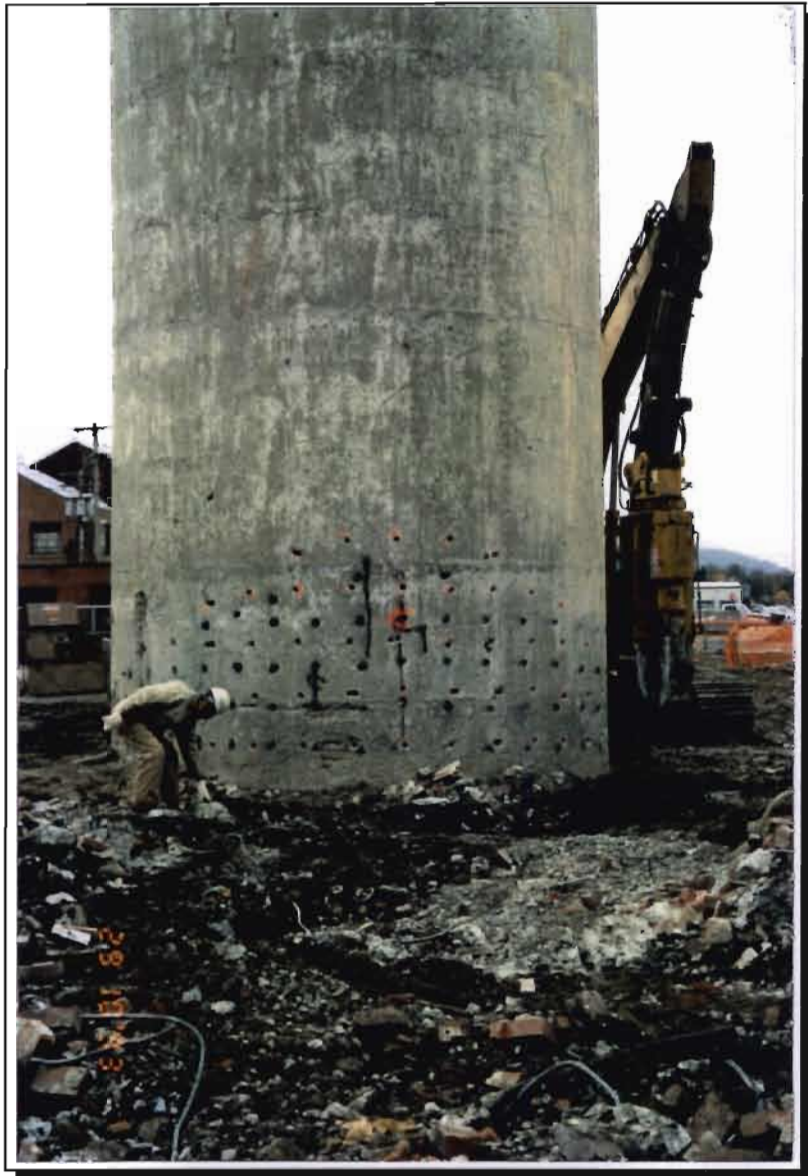
Photograph 10. Pattern of holes drilled on south side of smokestack for explosive charges.
