## CONSTRUCTION CERTIFICATION REPORT

*Building Demolition and Disposal  
Van Der Horst Plant Nos. 1 and 2  
Site Nos. 9-05-008 and 9-05-022  
Olean, Cattaraugus County*

New York State Department of Environmental Conservation  
Division of Hazardous Waste Remediation  
50 Wolf Road  
Albany, NY 12233

ERM-NORTHEAST  
175 Froehlich Farm Boulevard  
Woodbury, NY 11797

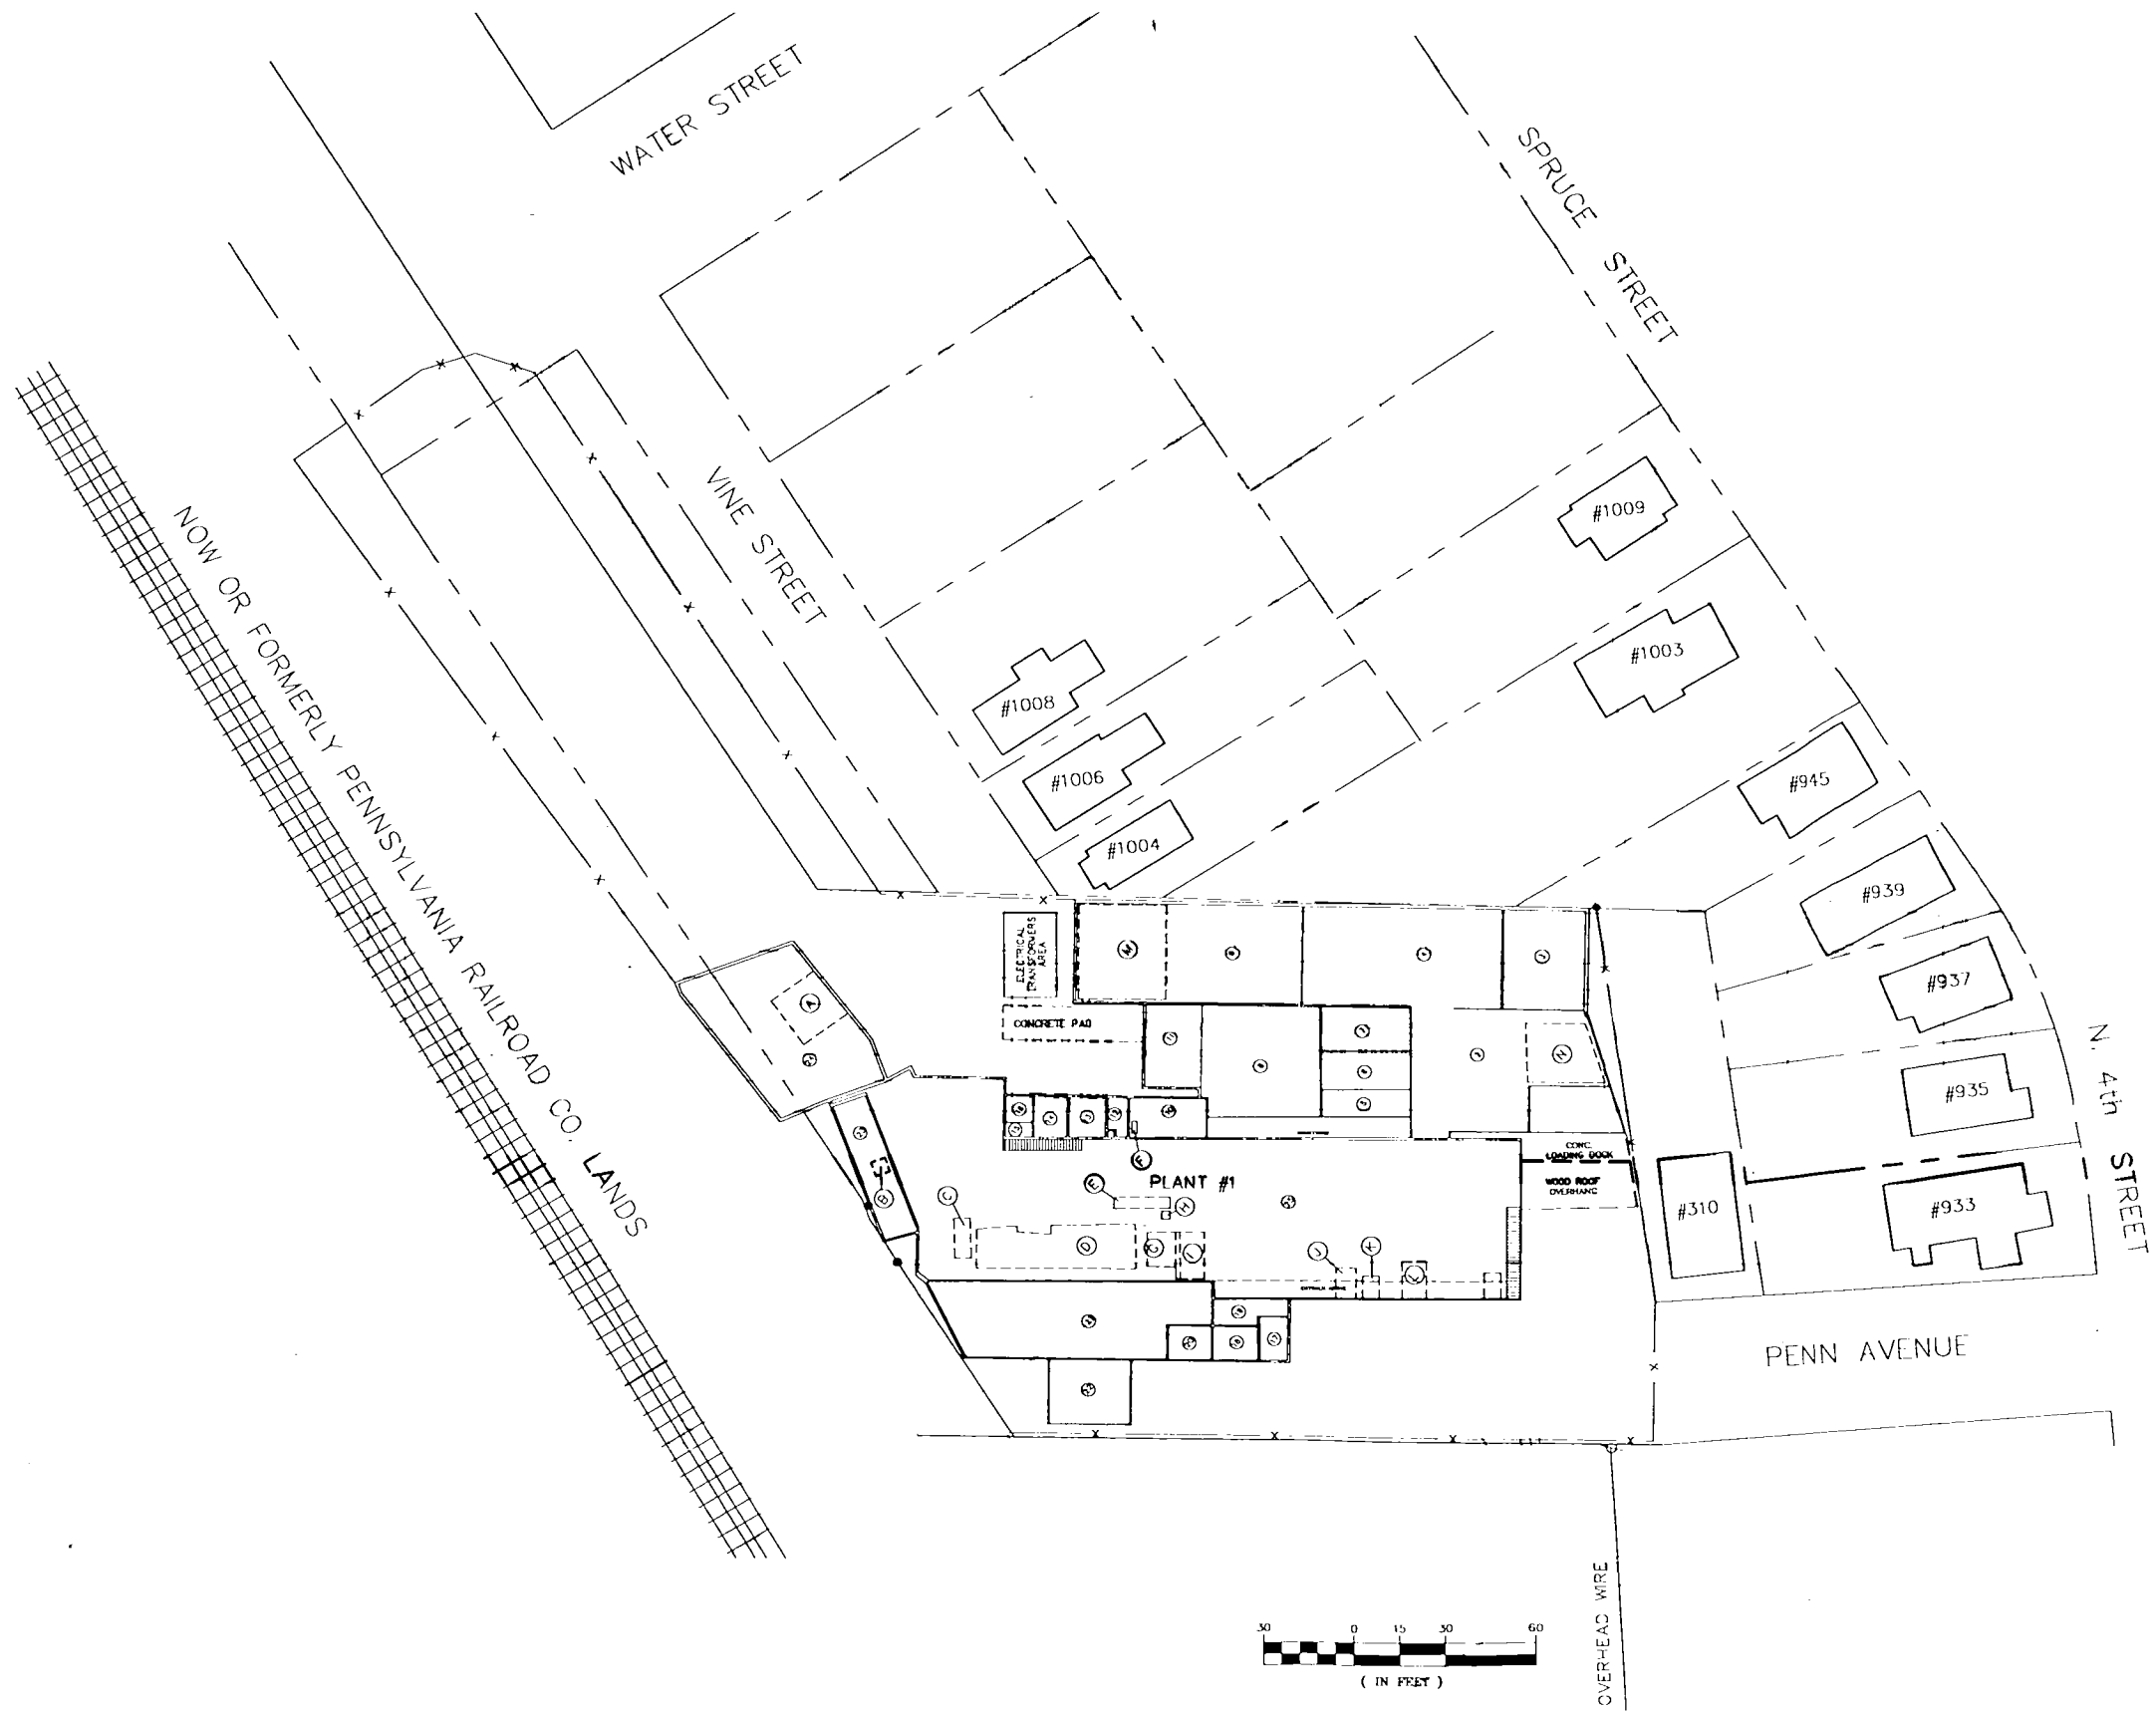
PLANT 1 SITE MAP

Manufacturing operations at Plant No. 1 were ceased in July, 1987. Figure 2-2 shows the conditions of the Plant No. 1 site prior to demolition activities, and is attached at the end of Section 2.0

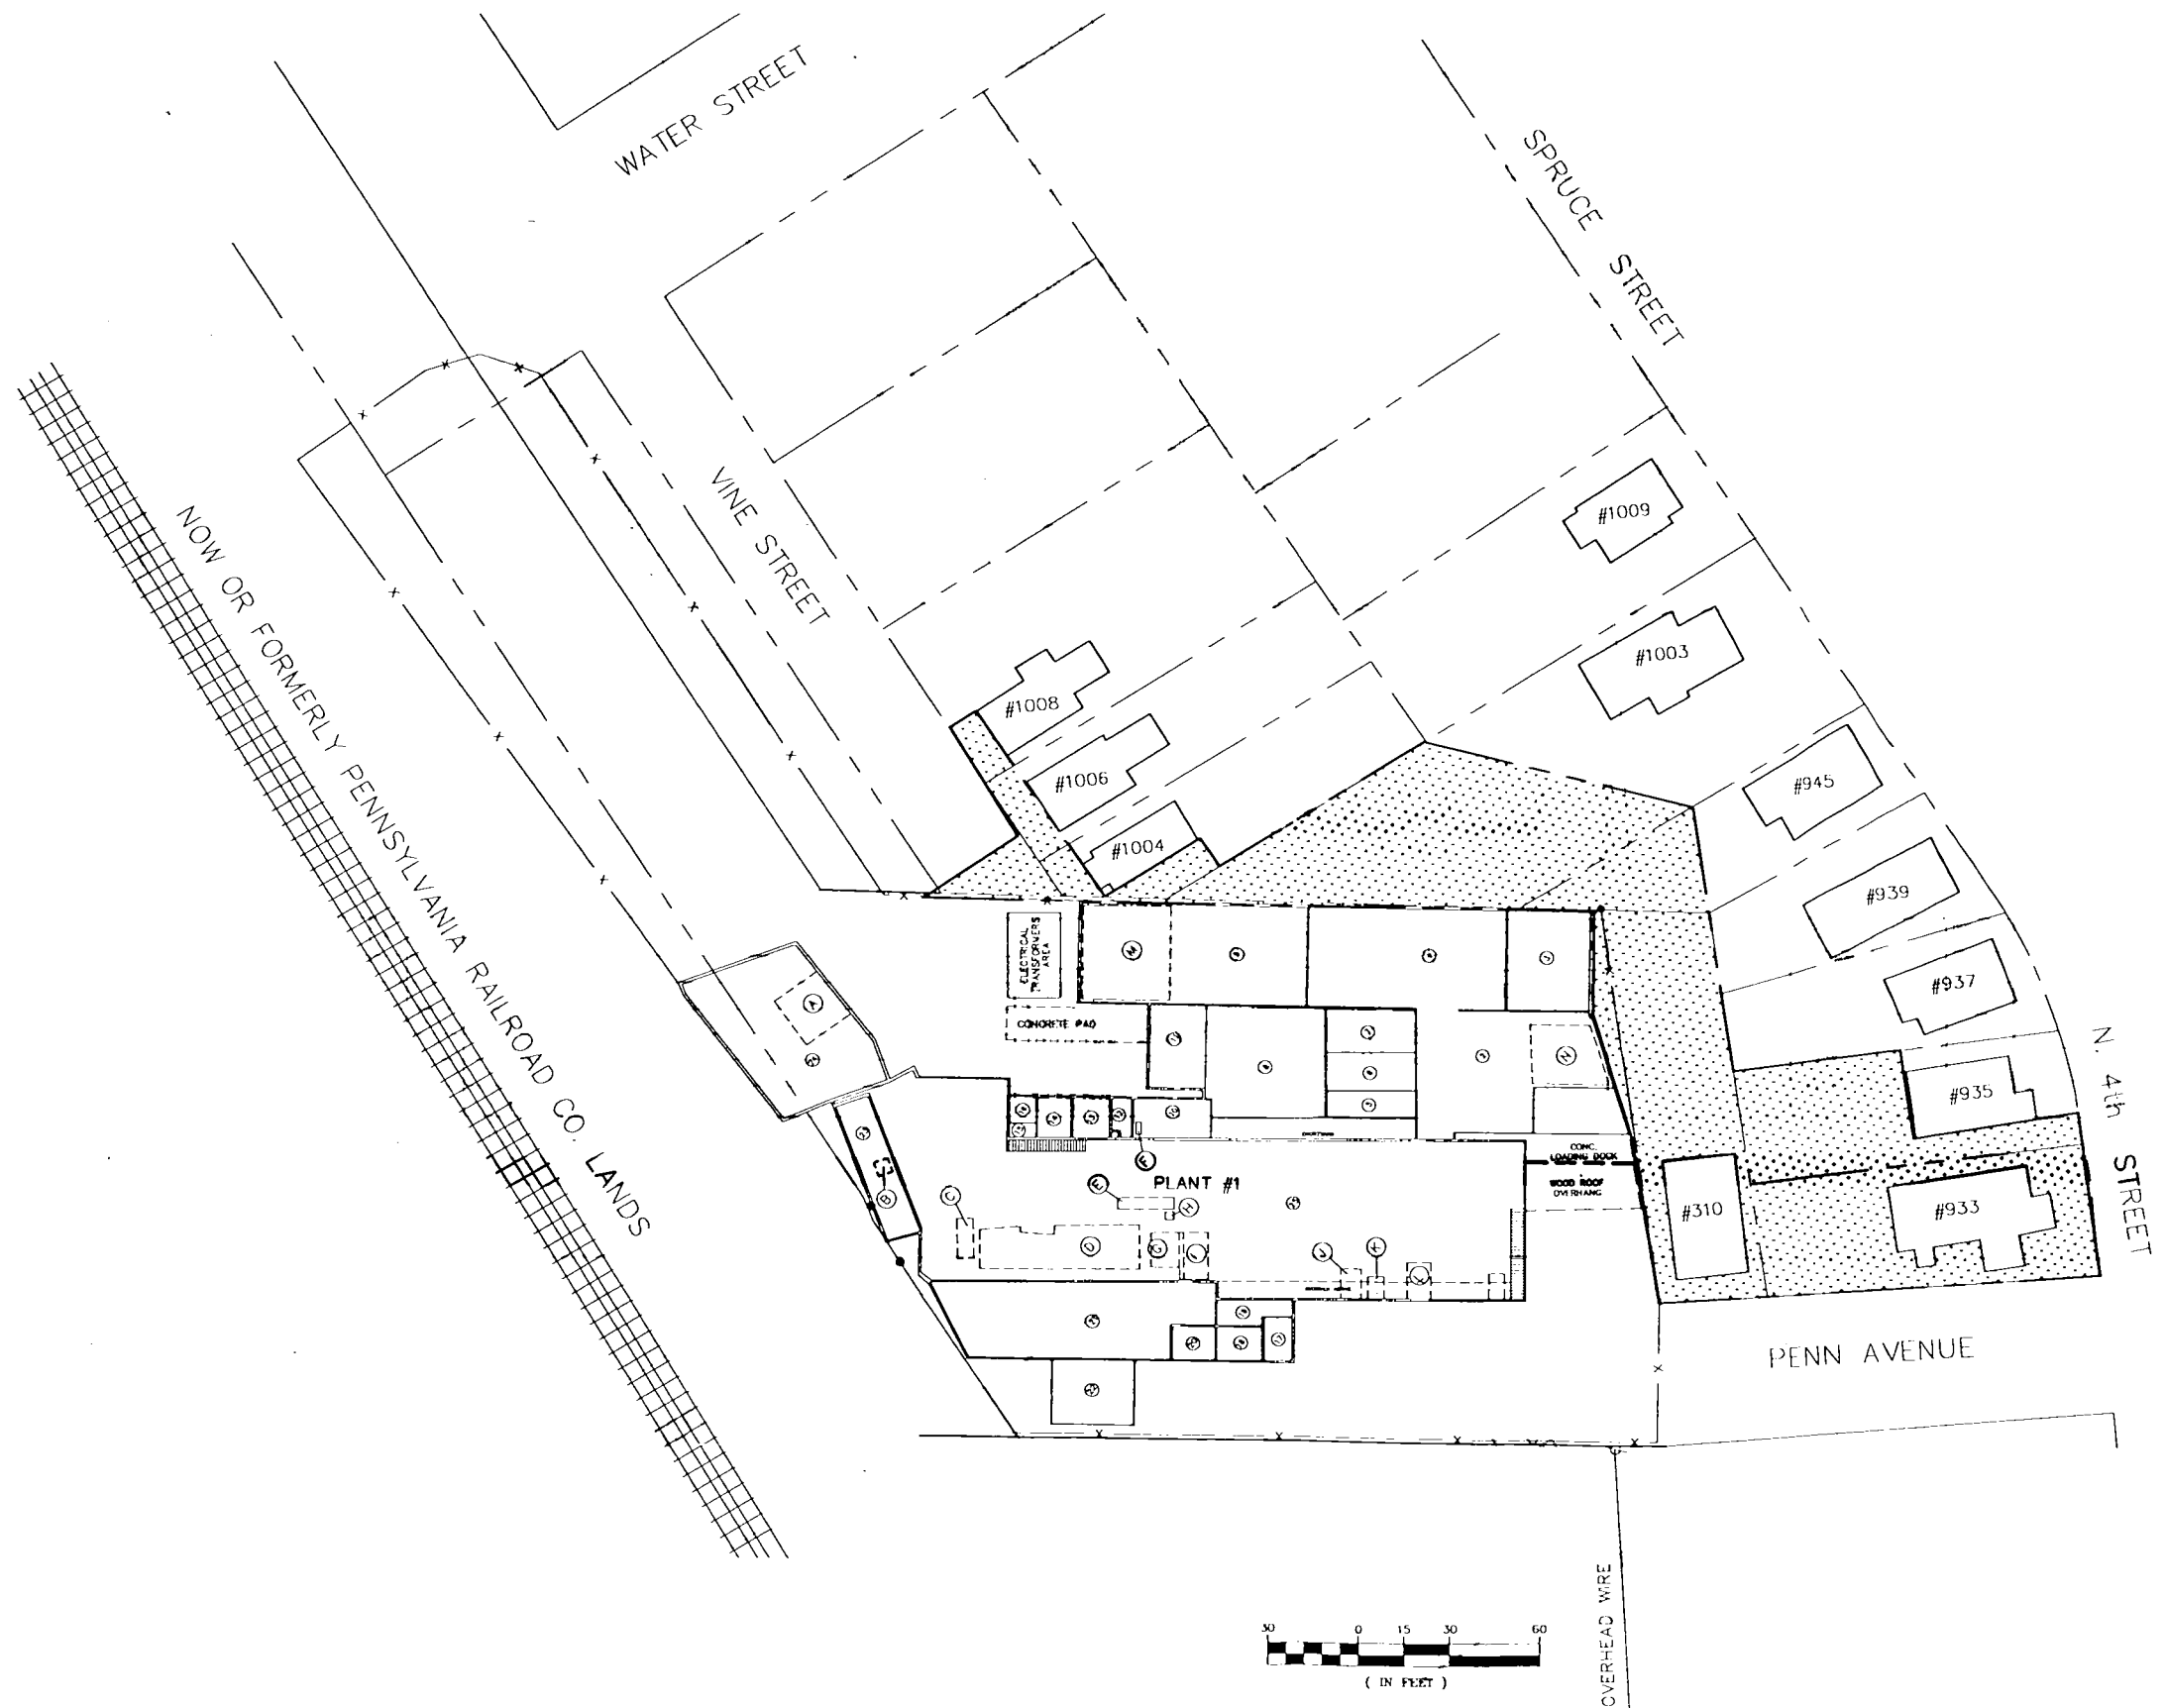
During previous site investigations, residential soil was found to be contaminated, to the initial limits identified on Figure 3-1 at the end of Section 3.0, and comprised approximately one half acre. Excavation was to extend initially to a depth of six inches, for an initial estimated quantity of 400 cubic yards of soil.

- LEGEND**
- ⊙ ROOM NUMBER
  - Ⓜ VAT DESIGNATION
  - #935 RESIDENCE
  - [Hatched Box] INITIAL LIMITS OF CONTAMINATED SOIL
