## **2018 PERIODIC REVIEW REPORT SPECIAL METALS CORPORATION DUNKIRK, NEW YORK NYSDEC Site Number 907031**

March 7, 2018

Re: 2018 Periodic Review Report (NYSDEC Site No. 907031)  
Special Metals Corporation  
100 Willowbrook Avenue  
Dunkirk, New York

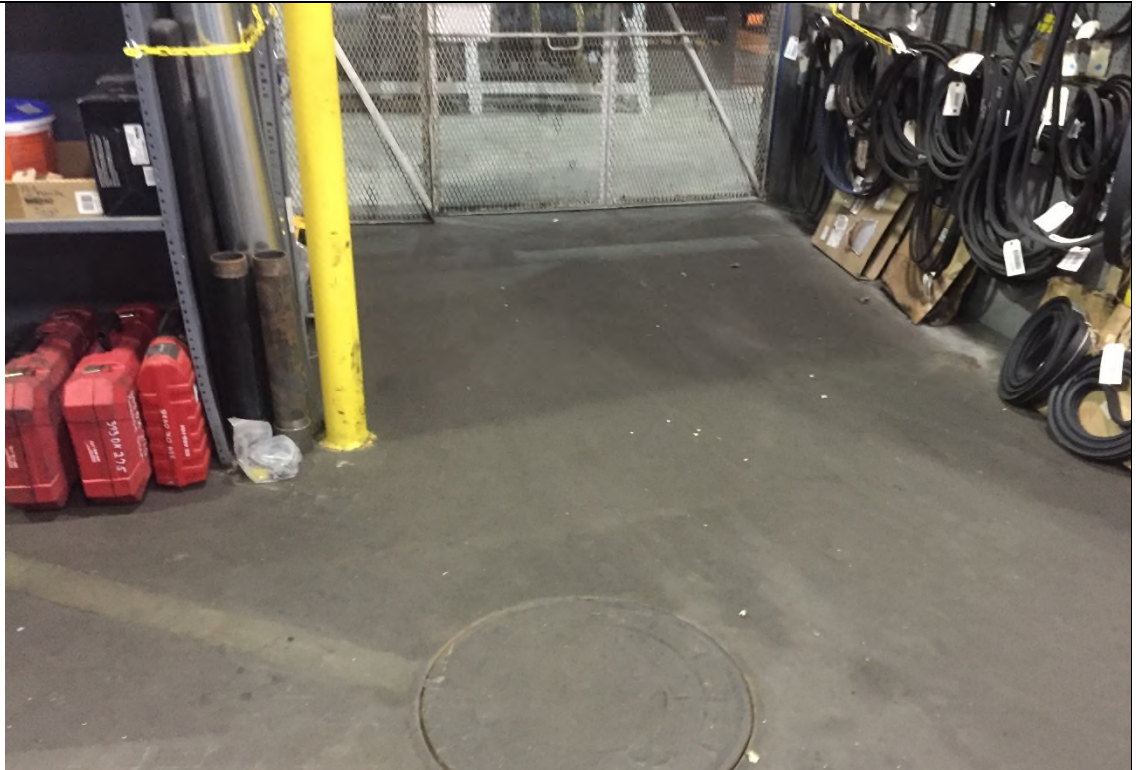
<b>Photo No.</b> 8	<b>Date:</b> 11-16-17

<b>Direction Photo Taken:</b>  North		
<b>Description:</b> Shop Floor.

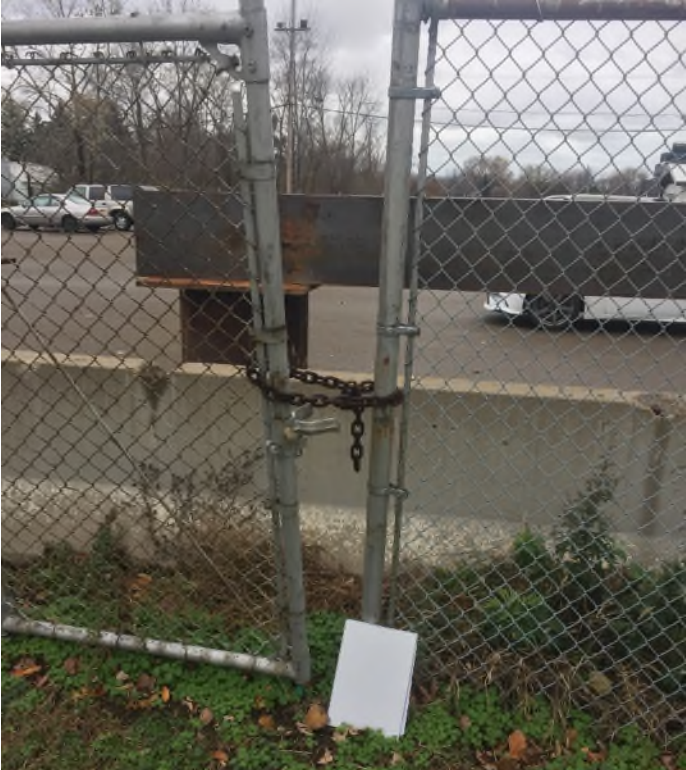
Locked gate along eastern fence of parking lot needs to be chained closed tighter to reduce gap.	
<b>INTRUSIVE ACTIVITIES PLANNED FOR AREA OF CONCERN</b>	<b>DATE</b>
<b>N/A</b>	
<b>ADDITIONAL NOTES &amp; COMMENTS</b>	
Site cover system is in good condition as is the grass coverage.

<b>Direction Photo Taken:</b>  West			
<b>Description:</b>  Gap in interior fence located along eastern side of parking lot.

GZA confirmed that the Site cover system is in place, complete, and in good condition. Vegetative cover was also observed to be acceptable, with no bare patches observed. The Site perimeter fence was confirmed present, completely surrounding the Site, and in good condition. A gap between two halves of a locked gate along an interior fence was observed. The gap was narrowed to an acceptable dimension (less than 6-inches) soon after being brought to the attention of the Site representative.
