ENGINEERING INVESTIGATIONS AT INACTIVE HAZARDOUS WASTE SITES

PHASE I INVESTIGATION

**E.I. DUPONT, SITE NUMBER 915019
CITY OF BUFFALO, ERIE COUNTY**

January 1990

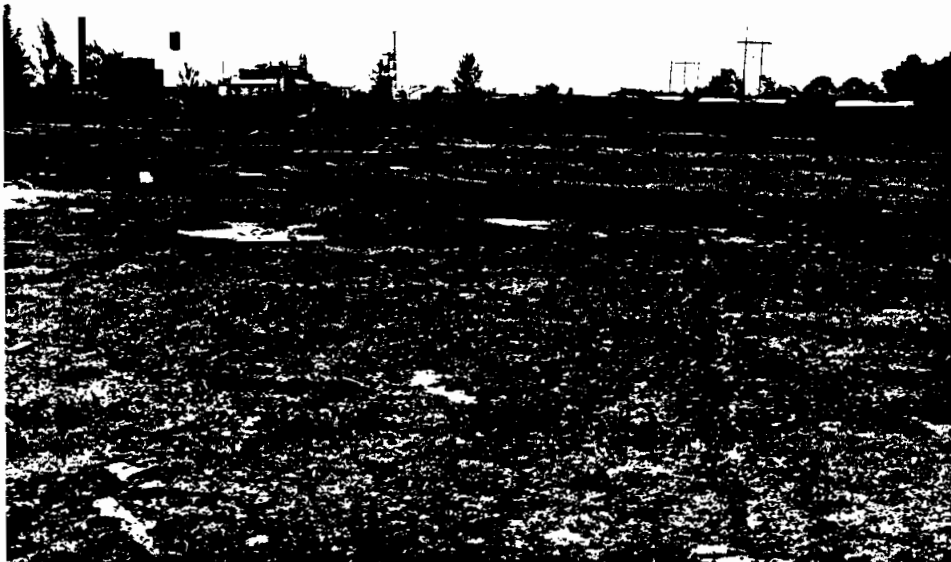
Photographer: M. Sienkiewicz
Date/Time: 9/24/87 14:00
Lens: Type: 35-70 mm
SN: 301285
Frame No.: 13
Comments*: View to west
DuPont plant in background.
Landfill in foreground is
barren, and used for dump-
ing of demolition debris.

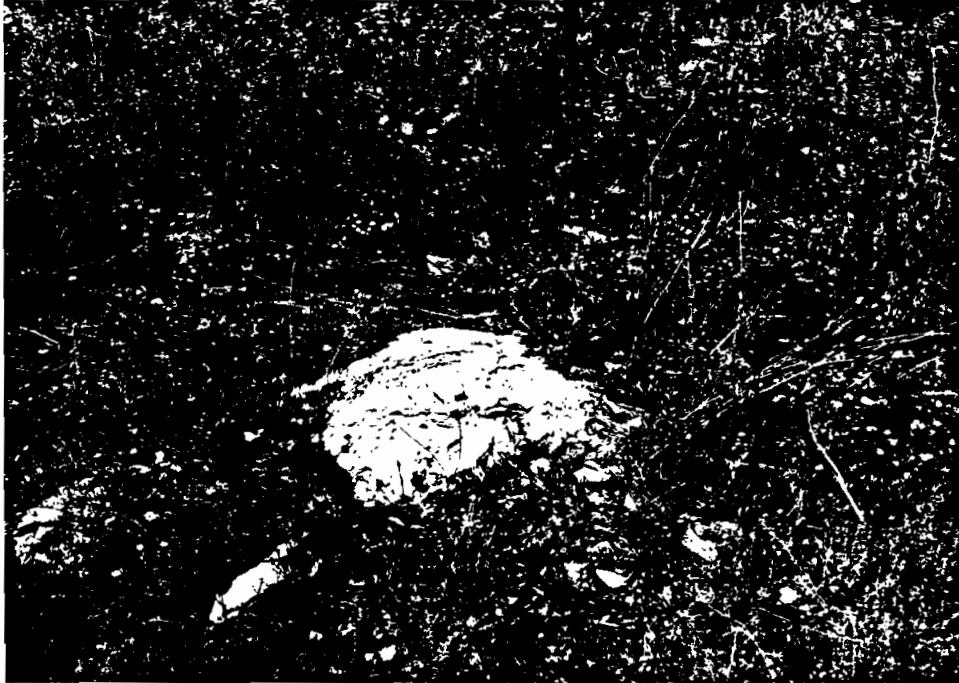
Photographer: M. Sienkiewicz
Date/Time: 9/24/87 14:00
Lens: Type: 35-70 mm
SN: 301285
Frame No.: 14
Comments*: Exposed solid waste.

A Phase II investigation including an extensive groundwater monitoring program is recommended to determine the extent of the contamination plume and the pathways of migration and if the landfill was the source of these contaminants. It is also important to determine if the site has been properly closed.

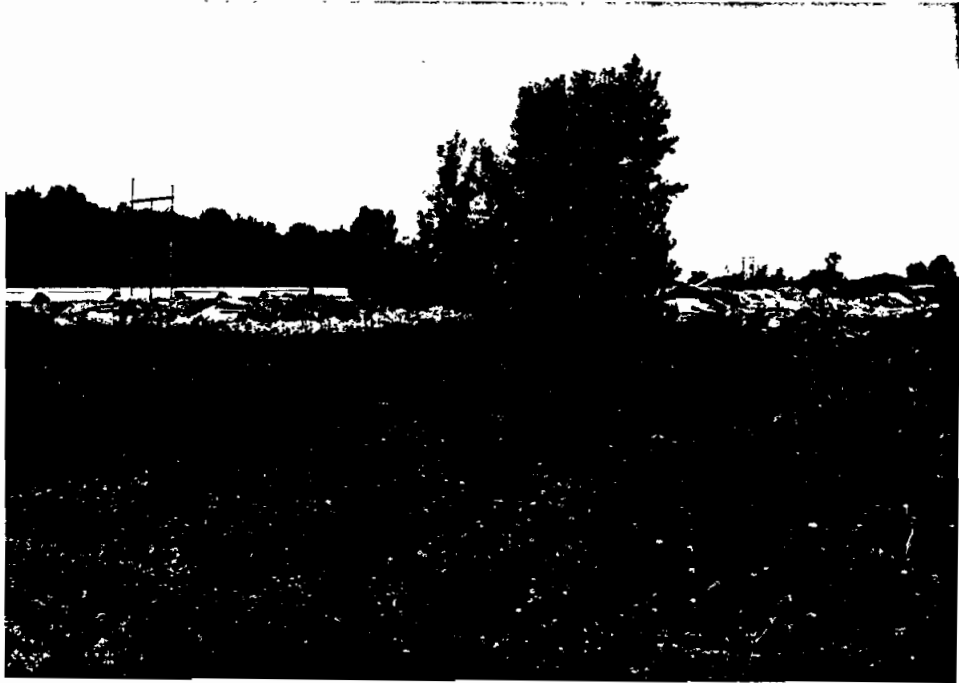
Photographer: M. Sienkiewicz
Date/Time: 9/24/87 14:00
Lens: Type: 35-70 mm
SN: 301285
Frame No.: 15
Comments*: Demolition debris.
