ENGINEERING INVESTIGATIONS AT INACTIVE HAZARDOUS WASTE SITES

PHASE I INVESTIGATION

MACNAUGHTON-BROOKS
717 ELK STREET
NYS SITE NUMBER 915034
CITY OF BUFFALO
ERIE COUNTY
NEW YORK STATE

DATE OF SUBMITTAL: JANUARY, 1986

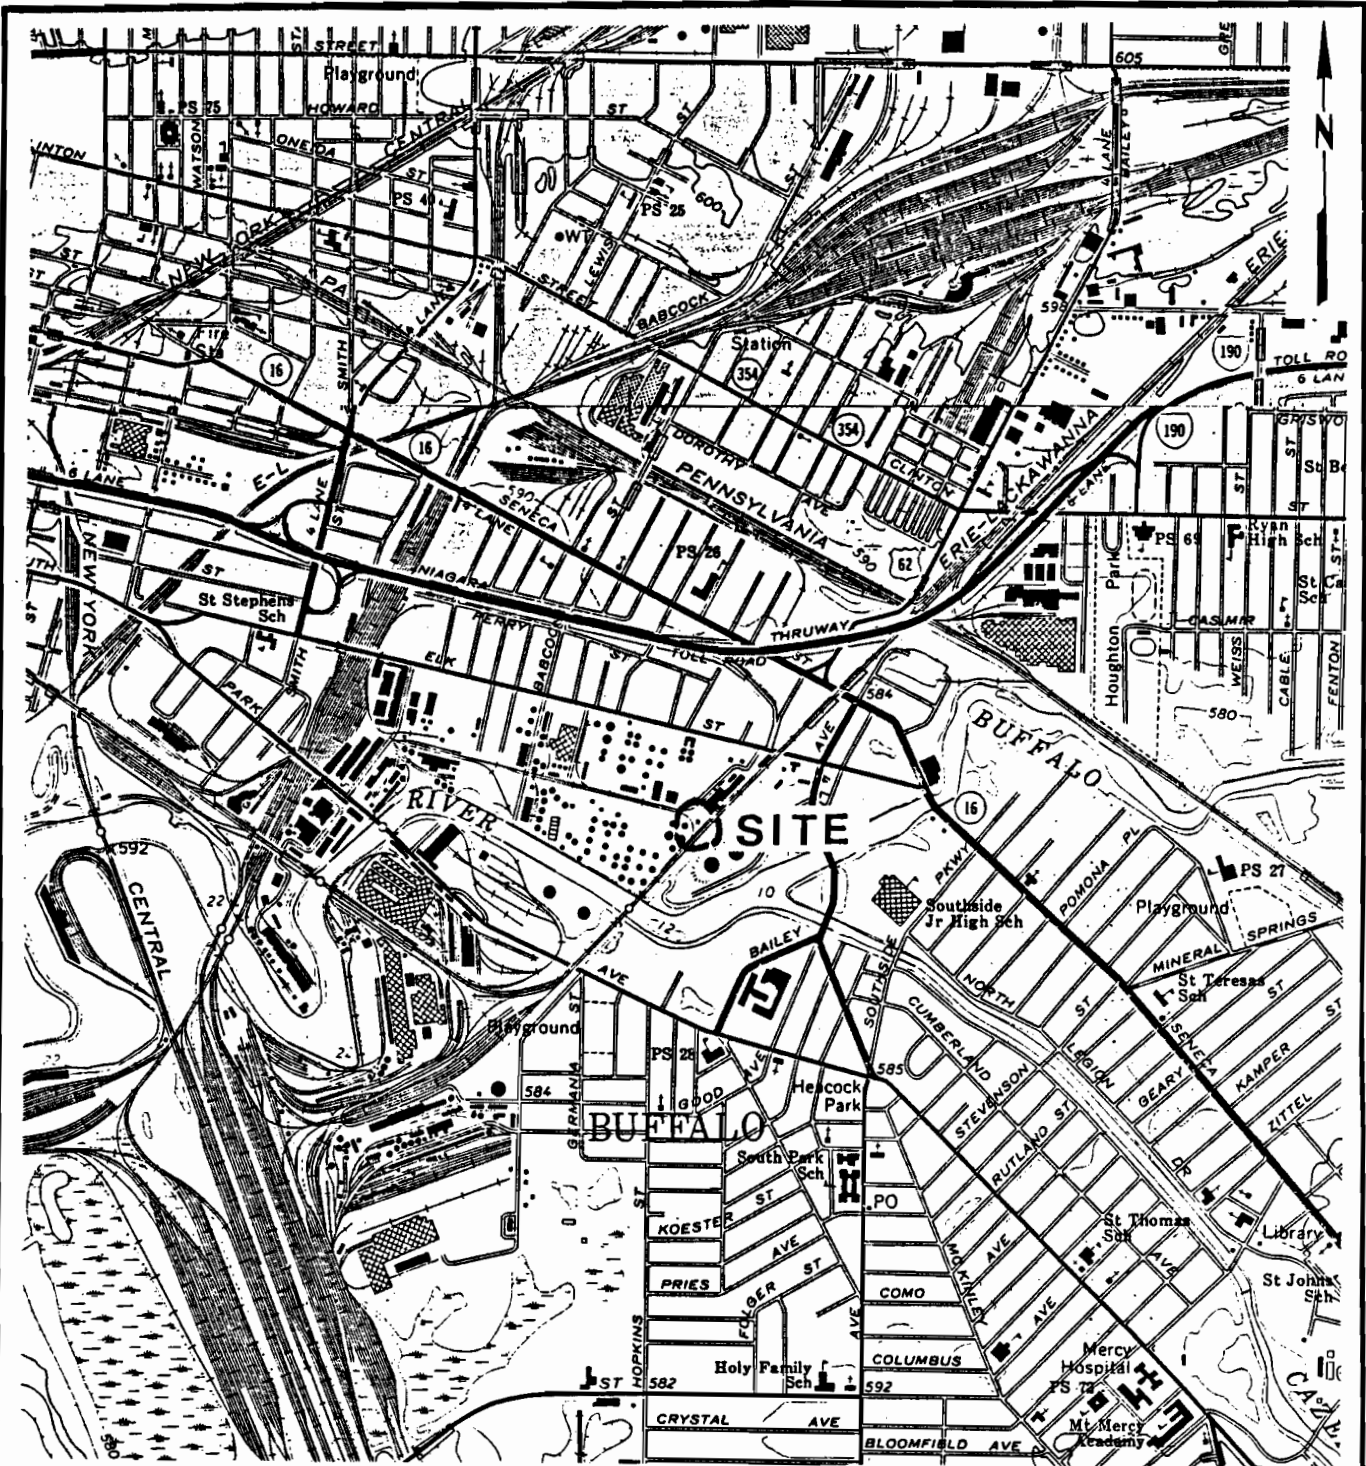
SITE LOCATION MAP
 McNAUGHTON BROOKS

LATITUDE: 42°51'49"
 LONGITUDE: 78°49'49"
