**FOURTH FIVE-YEAR REVIEW REPORT FOR
PFOHL BROTHERS LANDFILL SUPERFUND SITE
CHEEKTOWAGA COUNTY, NEW YORK STATE**

**U.S. Environmental Protection Agency
Region 2
New York, New York**

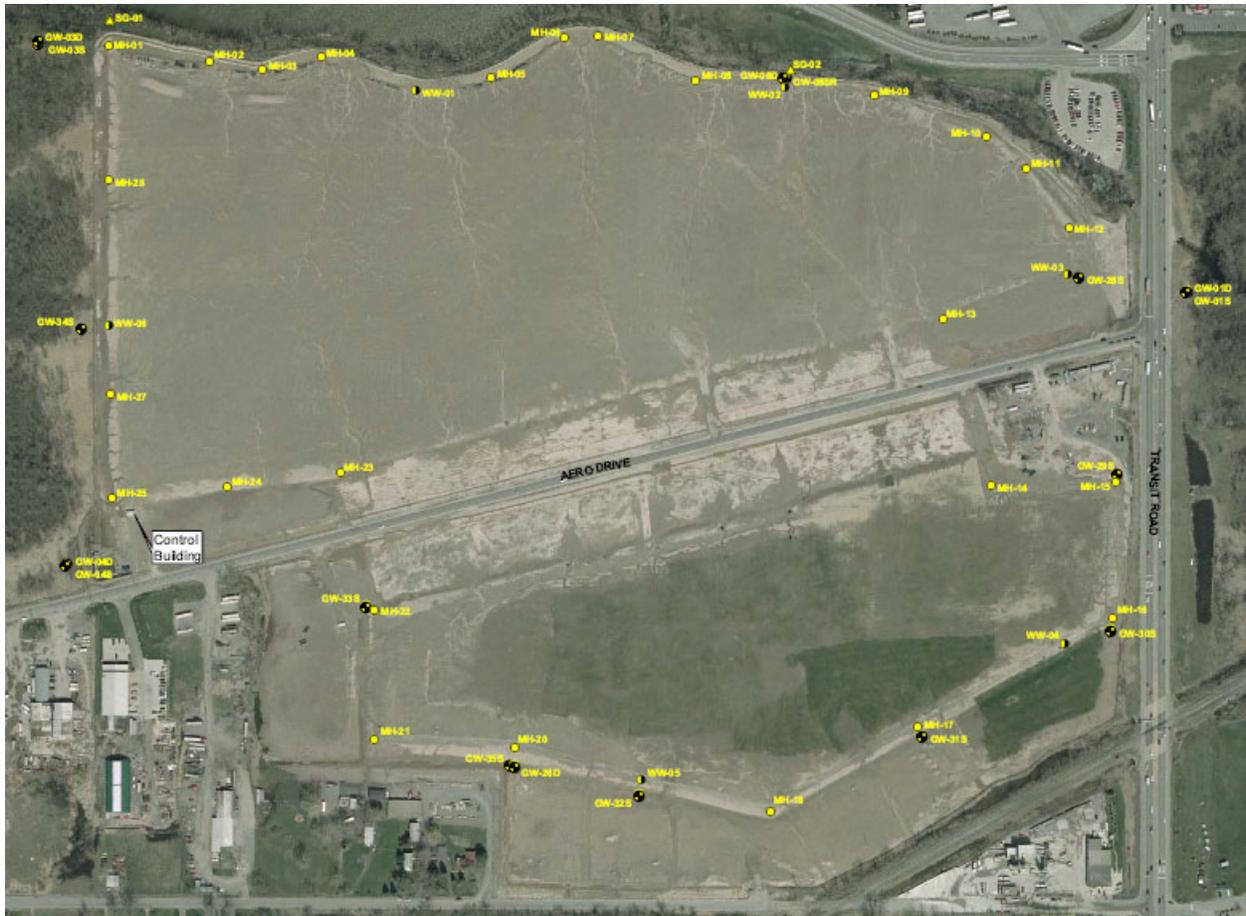
Figure 3—Monitoring Well Locations

Semiannual groundwater sampling was conducted during the review period using overburden and bedrock monitoring wells GW-01D, GW-01S, GW-03D, GW-03S, GW-04D, GW-04S, GW-07D, GW-07S, GW-08D, GW-08SR, GW-26D, GW-28S, GW-29S, GW-30S, GW-31S, GW-32S, GW-33S, GW-34S, and GW-35S (see Appendix A, Figure 3, attached).

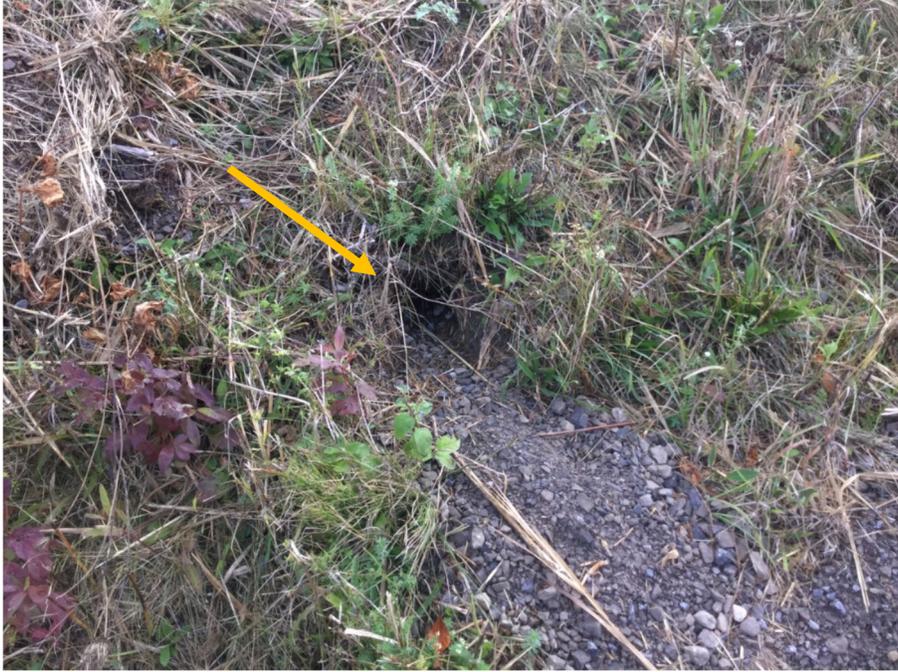
Animal burrow

The site inspection noted several areas where maintenance is required. Evidence of poor drainage in Area B requires corrections to the surface drainage. Woody growth needs to be cleared along the fence of landfill Area C. Damaged grounding rods and covers in Area B should be repaired. Animal burrows in Area B should be mitigated. Water depth gauges in two pump chambers are offline and do not run automatically and may require rewiring to communicate with the Control House. Sheening observed at the wet wells and manholes along the western perimeter of Area B should be investigated further to confirm if it is naturally-occurring or from the landfill.

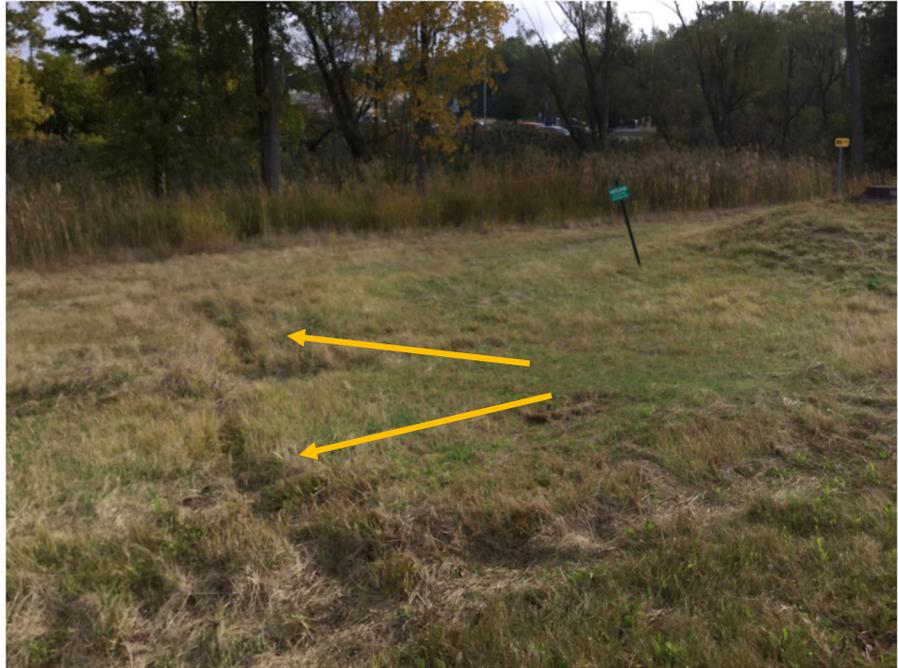
Rill development

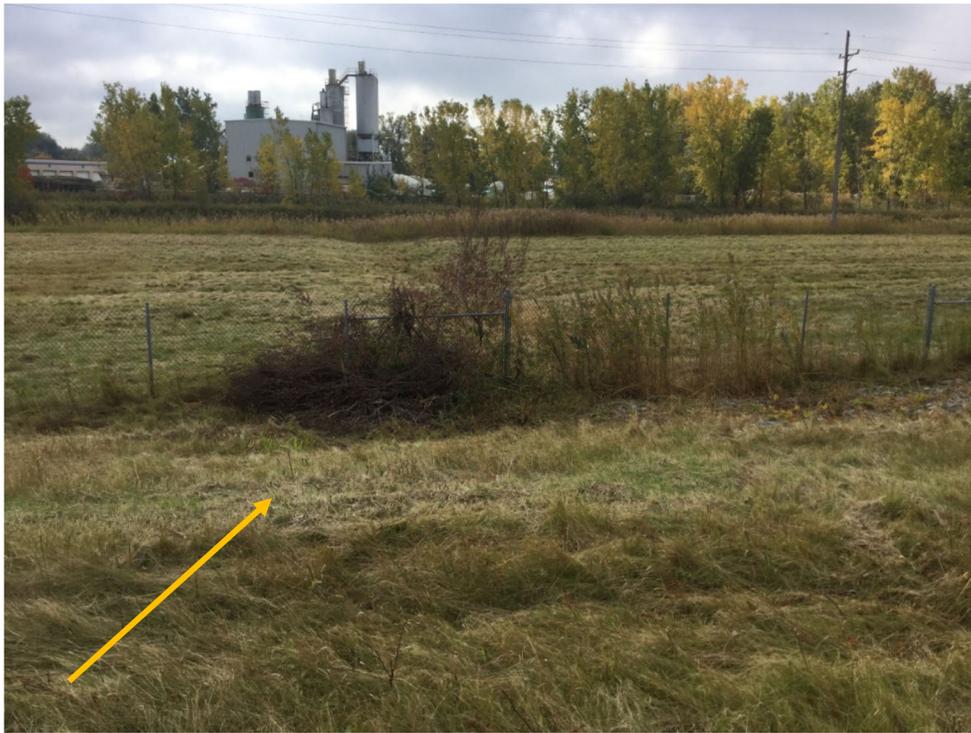
Woody vegetation on fence line

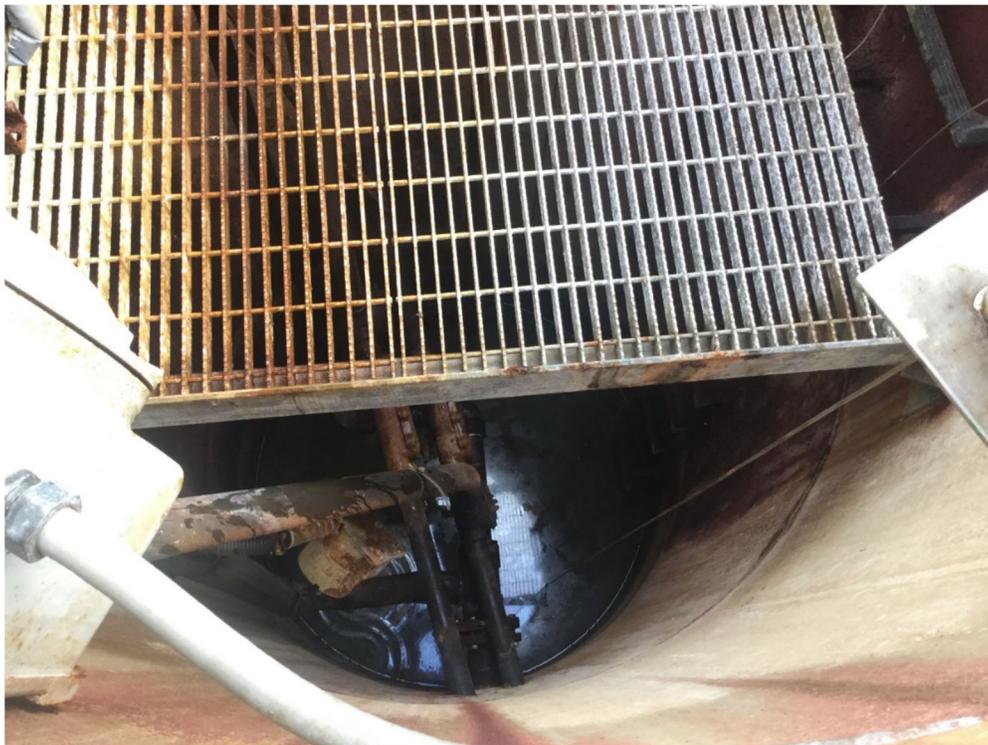
Sheening on the surface of the water at the bottom of Wet Well 6
