Re: 3773 Lake Shore Road, Blasdell, NY
Area B - Suspect Diesel-Impacted Soil/Fill
Pre-Remedial Site Investigation Report and Remedial Work Plan

PRE-REMEDIAL SITE INVESTIGATION
3773 LAKE SHORE ROAD
HAMBURG, NEW YORK

AREA B - DIESEL-IMPACTED SOIL/FILL

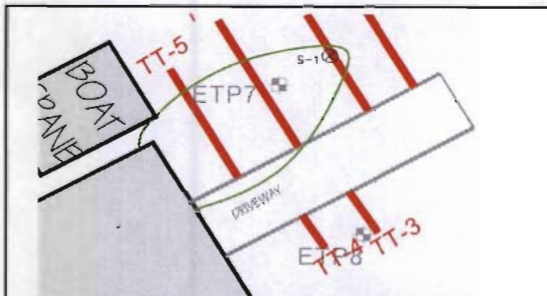
Project:	Pre-Remedial Site Investigation	TEST PIT I.D.:	Test Trench 3
Project No.:	0109 - 001 - 101	Excavation Date:	11/09/07
Client:	Harter, Secrest & Emery	Excavation Method:	Kubota excavator
Location:	3773 Lakeshore Rd., Blasdell, NY	Logged / Checked By:	TAB

0.0 - 2.0	Grey to brown, Moist to wet, FILL with some gravel, larger cobbles, slag pieces, and brick debris.		0.0 - 5.0	y	n
2.0 - 3.5	Grey, wet to moist, SILTY CLAY , with some trace sands.		0.0 - 5.0	y	n
COMMENTS:					
GROUNDWATER ENCOUNTERED:		<input checked="" type="checkbox"/> YES <input type="checkbox"/> NO	If yes, depth to GW: 3.0 - 4.0'		
VISUAL IMPACTS:		<input type="checkbox"/> YES <input checked="" type="checkbox"/> NO	Describe:		
OLFACTORY OBSERVATIONS:		<input type="checkbox"/> YES <input checked="" type="checkbox"/> NO	Describe:		
NON-NATIVE FILL ENCOUNTERED:		<input checked="" type="checkbox"/> YES <input type="checkbox"/> NO			
OTHER OBSERVATIONS:		<input type="checkbox"/> YES <input checked="" type="checkbox"/> NO	Describe:		
SAMPLES COLLECTED: NO		Sample I.D.:			
		Sample I.D.:			
		Sample I.D.:

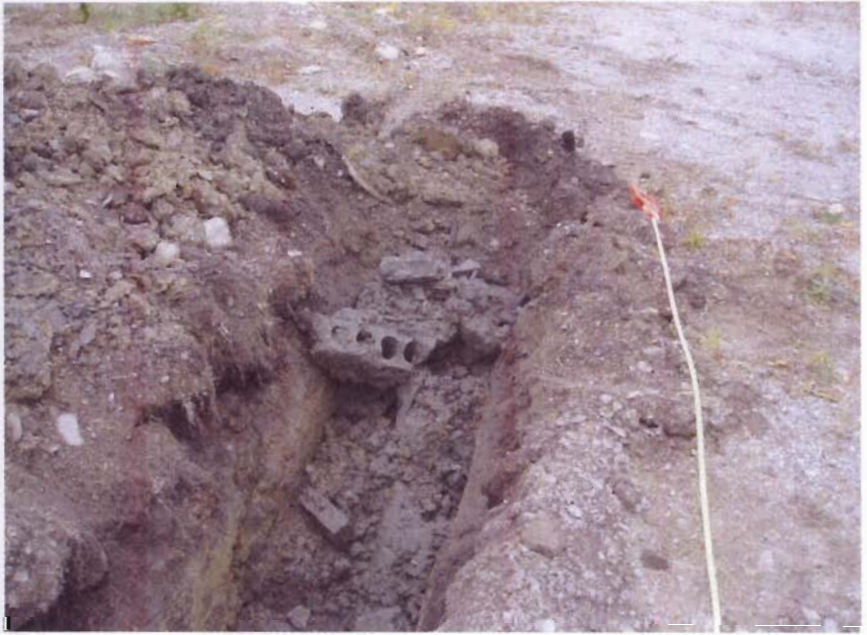
Client Name: Harter, Secrest & Emery		Site Location: 3773 Lake Shore Road	Project No.: 0109 - 001 - 101
Photo No. 1	Date 11/09/07

Direction Photo Taken: South			
Description: Test Trench 3.

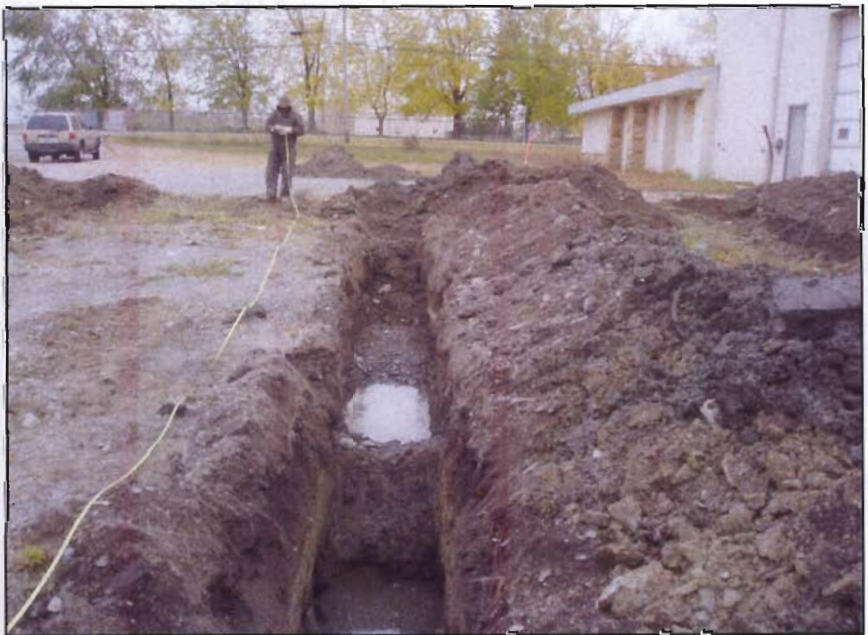
Photo No. 2	Date 11/09/07

Direction Photo Taken: South		
Description: Test Trench 2.

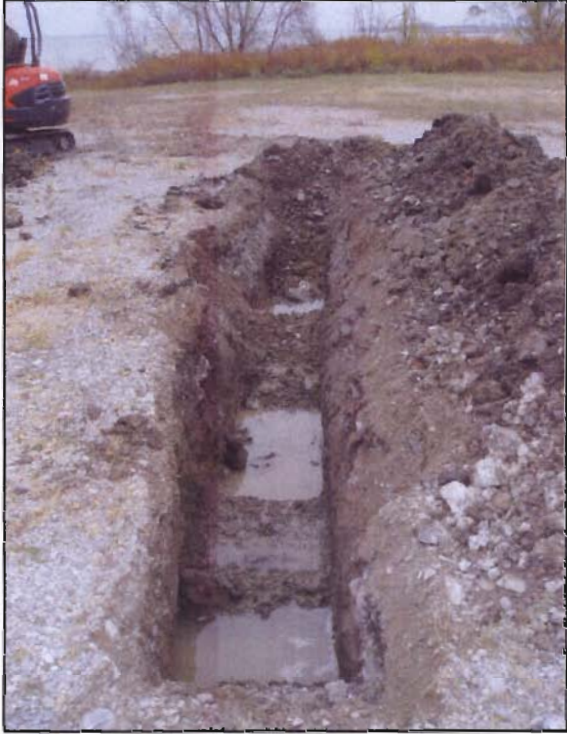
Client Name: Harter, Secrest & Emery		Site Location: 3773 Lake Shore Road	Project No.: 0109 - 001 - 101
Photo No. 3	Date 11/09/07

Direction Photo Taken: West			
Description: Test Trench 7

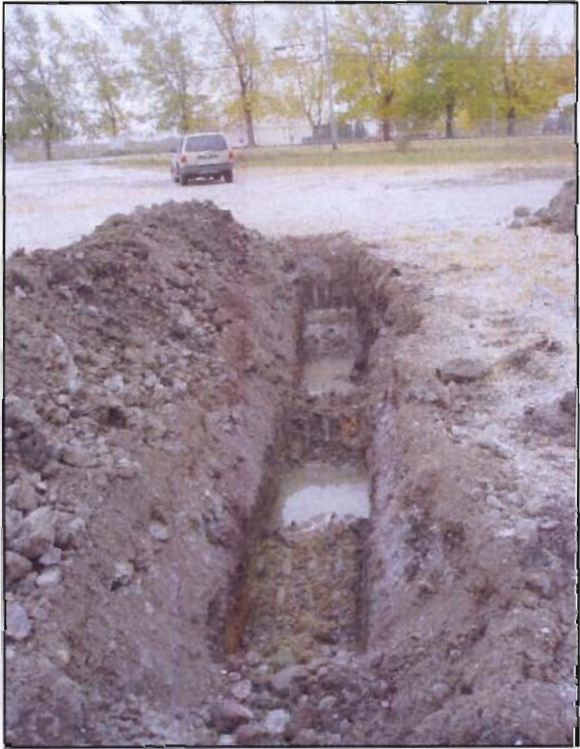
Photo No. 4	Date 11/09/07

Direction Photo Taken: North		
Description: Test Trench 5.

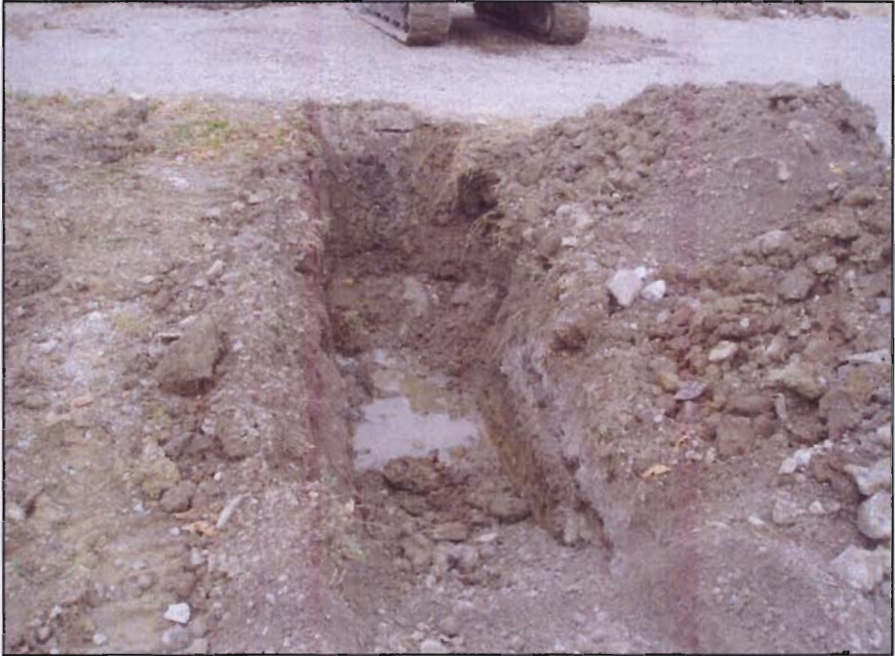
Client Name: Harter, Secrest & Emery		Site Location: 3773 Lake Shore Road	Project No.: 0109 - 001 - 101
Photo No. 5	Date 11/09/07

Direction Photo Taken: North			
Description: Test Trench 3

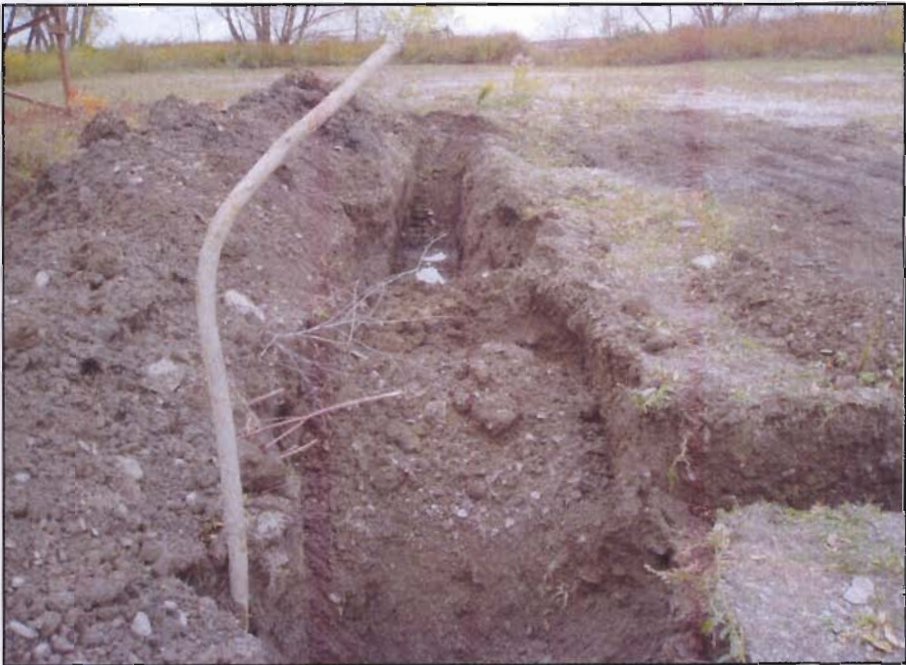
Photo No. 6	Date 11/09/07

Direction Photo Taken: South		
Description: Test Trench 6.
