FIELD INVESTIGATION TEAM ACTIVITIES AT
UNCONTROLLED HAZARDOUS SUBSTANCES
FACILITIES — ZONE I

NUS CORPORATION
SUPERFUND DIVISION

FINAL DRAFT
SITE INSPECTION REPORT
SPAULDING FIBRE COMPANY
TONAWANDA, NEW YORK

MAY 31, 1988

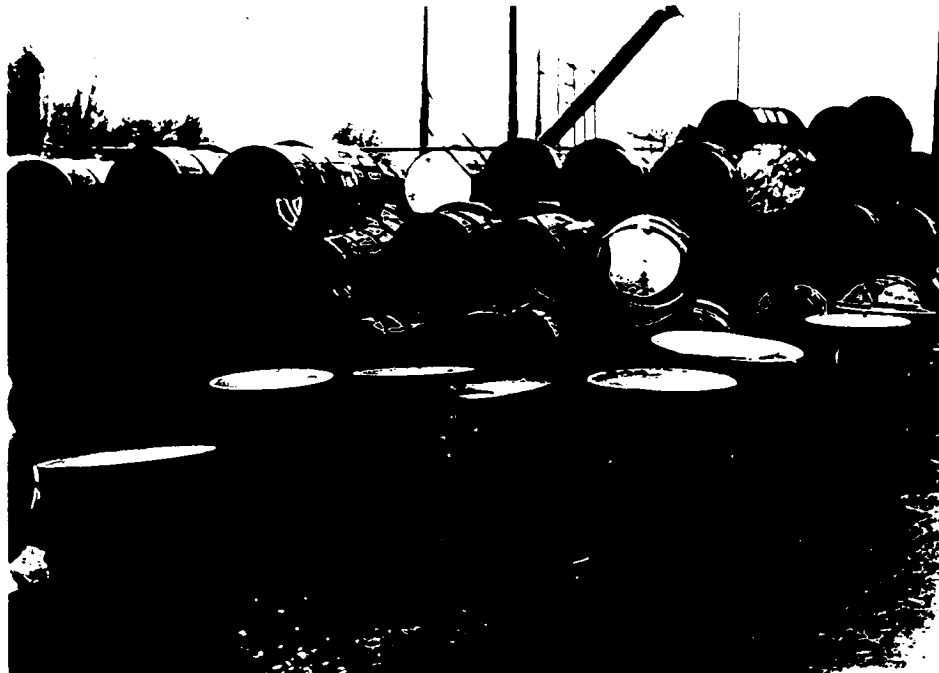
1P-2

During the site inspection by FIT, stained soil and signs of chemical spills were noted in the empty drum storage area. Readings of up to 350 ppm on an OVA flame ionization detector occurred at the soil sample locations, and soil analysis shows high concentrations of numerous contaminants. There are numerous references in NYSDEC files to improper waste disposal. Excessive amounts of phenol and other wastes were discharged into storm sewers that discharge into the Niagara River. Drinking water intakes are 1 mile from the site. The surrounding population within 1 mile could potentially come into direct contact with the waste.

April 28, 1987 1332
Empty drum storage area on the north side of the plant.
Photo direction - northeast.
Photographer: Alan J. Cherepon

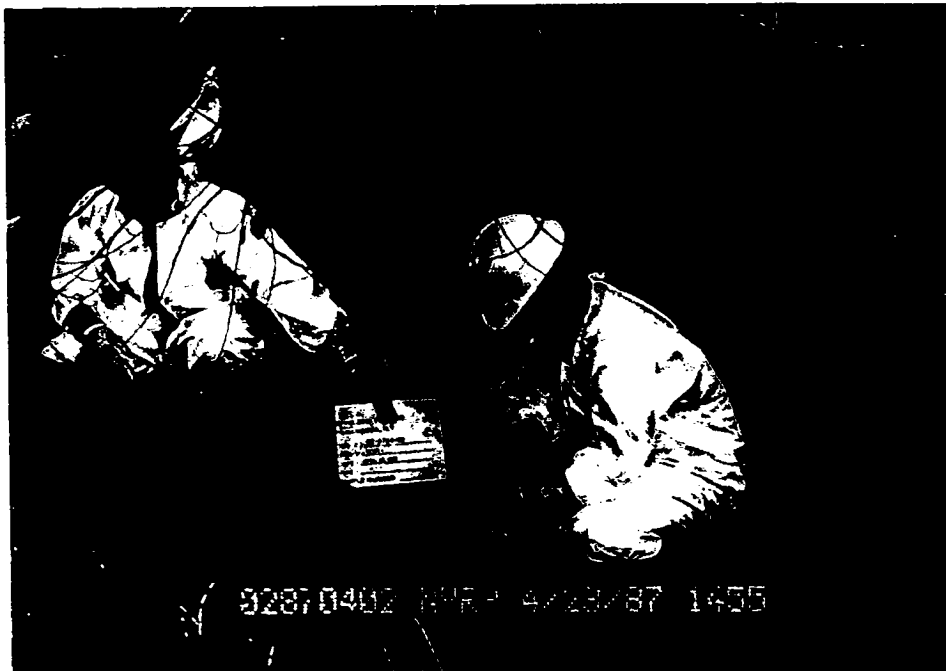
1P-6

Surface water sample NYR9-SW1, drainage ditch behind the grinding oil tank, south of the drum landfill, on the south side of the plant. Sampler: Bill Schnitzerling Photo direction northwest. Photographer: Alan J. Cherepon

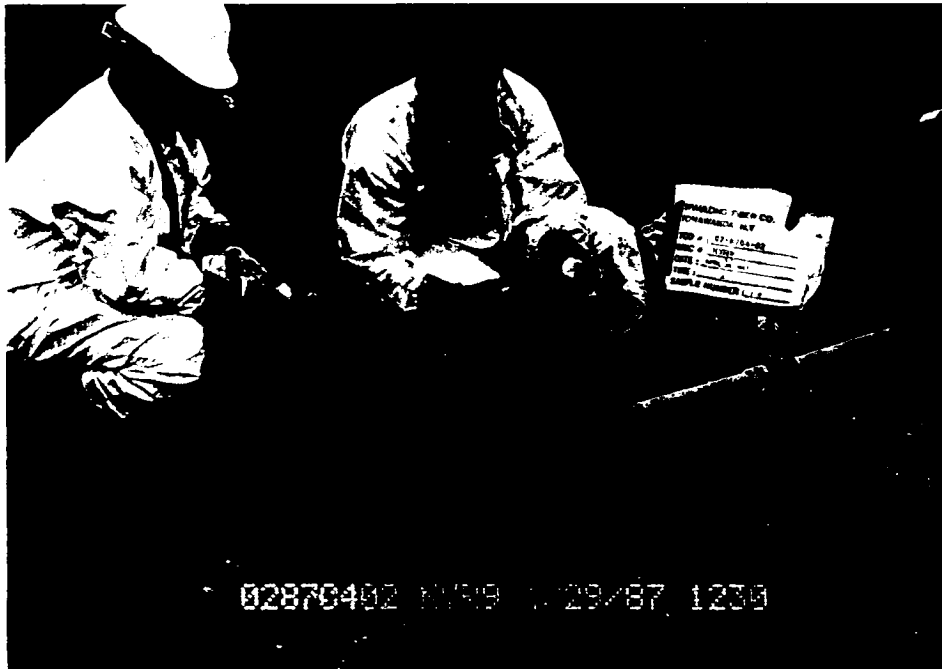
1P-10

April 29, 1987 1230
Soil sample NYR9-S4, auger from 0-2 feet, alongside the building south of the hazardous waste storage building. Samplers: Randy Rice and Bill Schnitzerling.
Photographer: Alan J. Cherepon

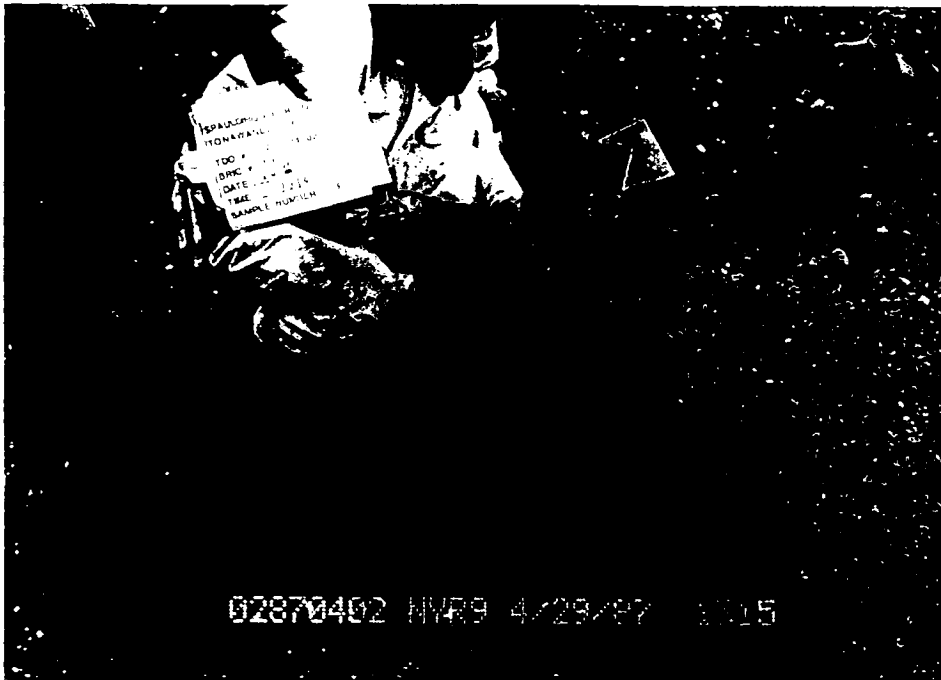
1P-11

April 29, 1987 1315
Soil sample NYR9-S5, auger sample from 0-2 feet, filled-in lagoon north of the asbestos landfill on the west side of the plant. Sampler: Randy Rice
Photographer: Alan J. Cherepon

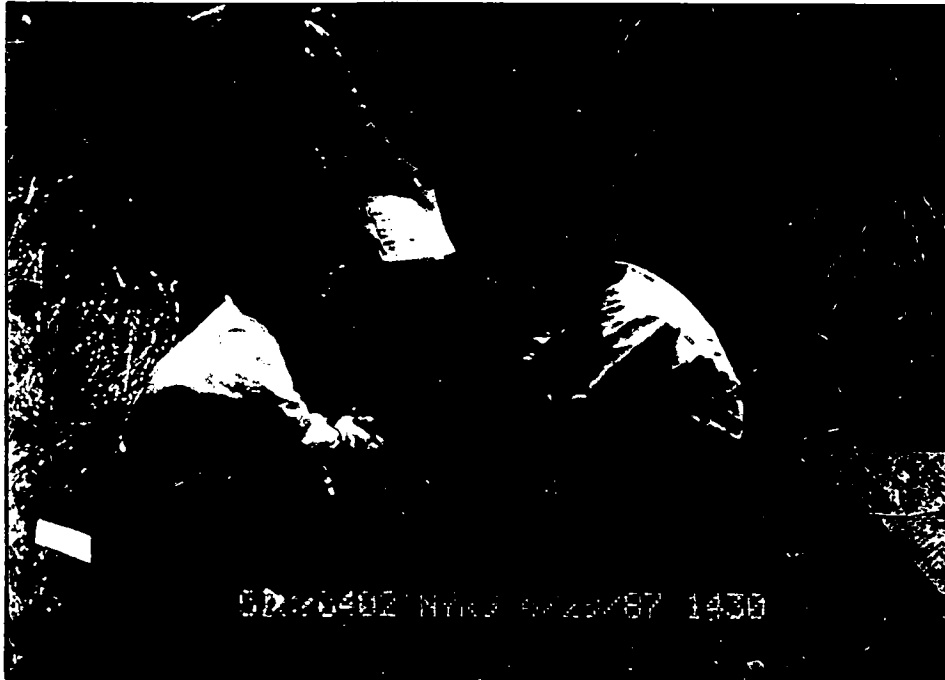
1P-13

April 29, 1987 1430
Soil sample NYR9-S7, auger sample from 0-2 feet, low area next to drain covers north of the empty drum storage area, on the north side of the plant. Samplers: Randy Rice and Bill Schnitzerling
Photographer: Alan J. Cherepon

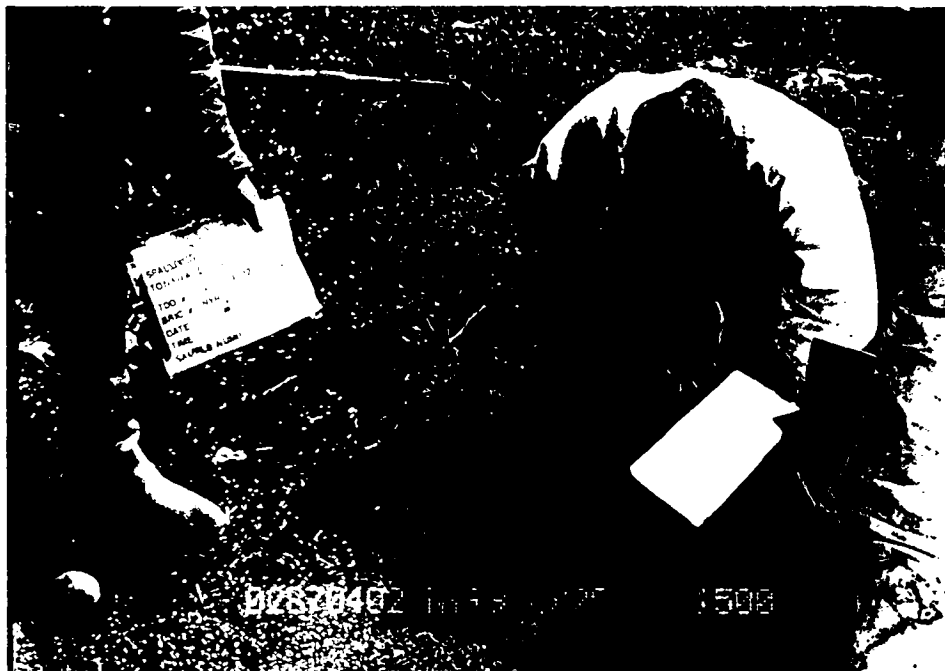
1P-14

April 29, 1987 1500
Soil sample NYR9-S8, auger sample from 0-2 feet, near methanol and alcohol storage tanks on the north side of the plant. Sampler: Bill Schnitzerling. Photo direction - northeast.
Photographer: Alan J. Cherepon
