**SUPPLEMENTAL REMEDIAL INVESTIGATION/
RCRA FACILITY INVESTIGATION**

**SPAULDING COMPOSITES COMPANY
310 WHEELER STREET
TONAWANDA, NEW YORK**

MAY 24, 1999

**LEADER ENVIRONMENTAL, INC.
2300 Wehrle Drive
Williamsville, New York 14221
(716) 565-0963**

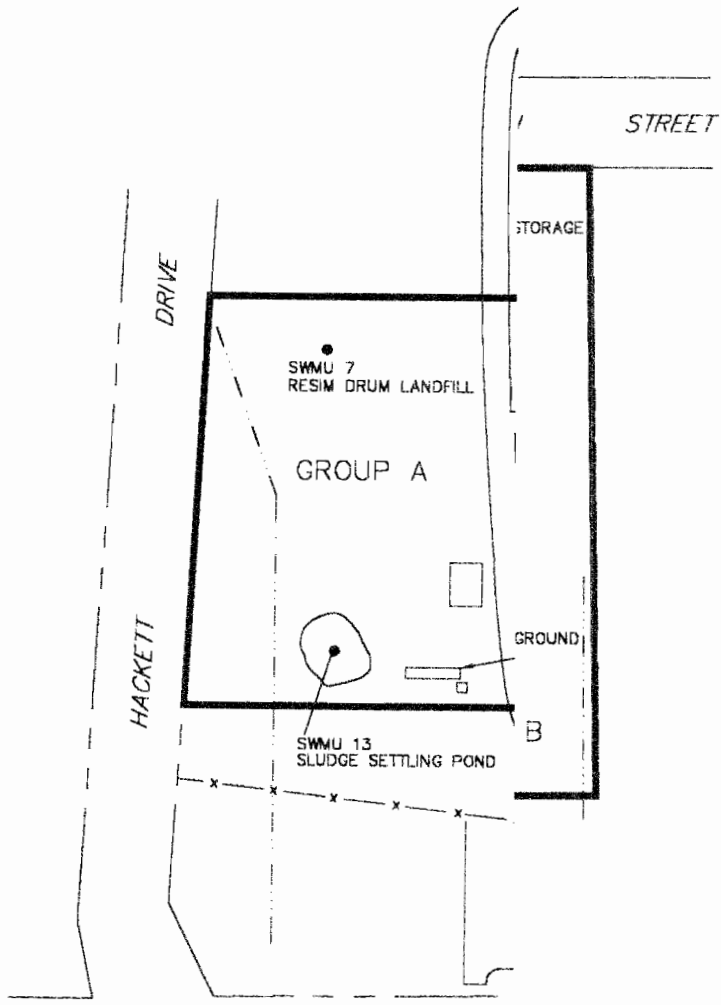
PROJECT 214.002	SCALE GRAPHIC
FIGURE 1-2

NOTE: FIGURE DEVELOPED FROM SWMUS/AREA 1 CONCERN AND SWMU GROUPS, FIGURE 1.3, PROVIDED BY SPAULDING COMPOSITES COMPANY, TONAWANDA, NEW YORK DATED 12/97

TITLE
SWMUS/AOC SAMPLING LOCATIONS

The locations of the above SWMUs are shown on Figure 1-2. The samples of surface water and soil were collected on December 16 and 17, 1998 (hand-written field notes documenting these efforts are available at Leader's Williamsville, New York Office, if needed). NYSDEC was notified of the field work and was present on-Site during the sampling, though the agency did not obtain any splits of the collected samples. Any deviations from the above scope of work are discussed in Sections 3.0 and 4.0 of this report, and were based upon field conditions and subject to NYSDEC approval in the field.

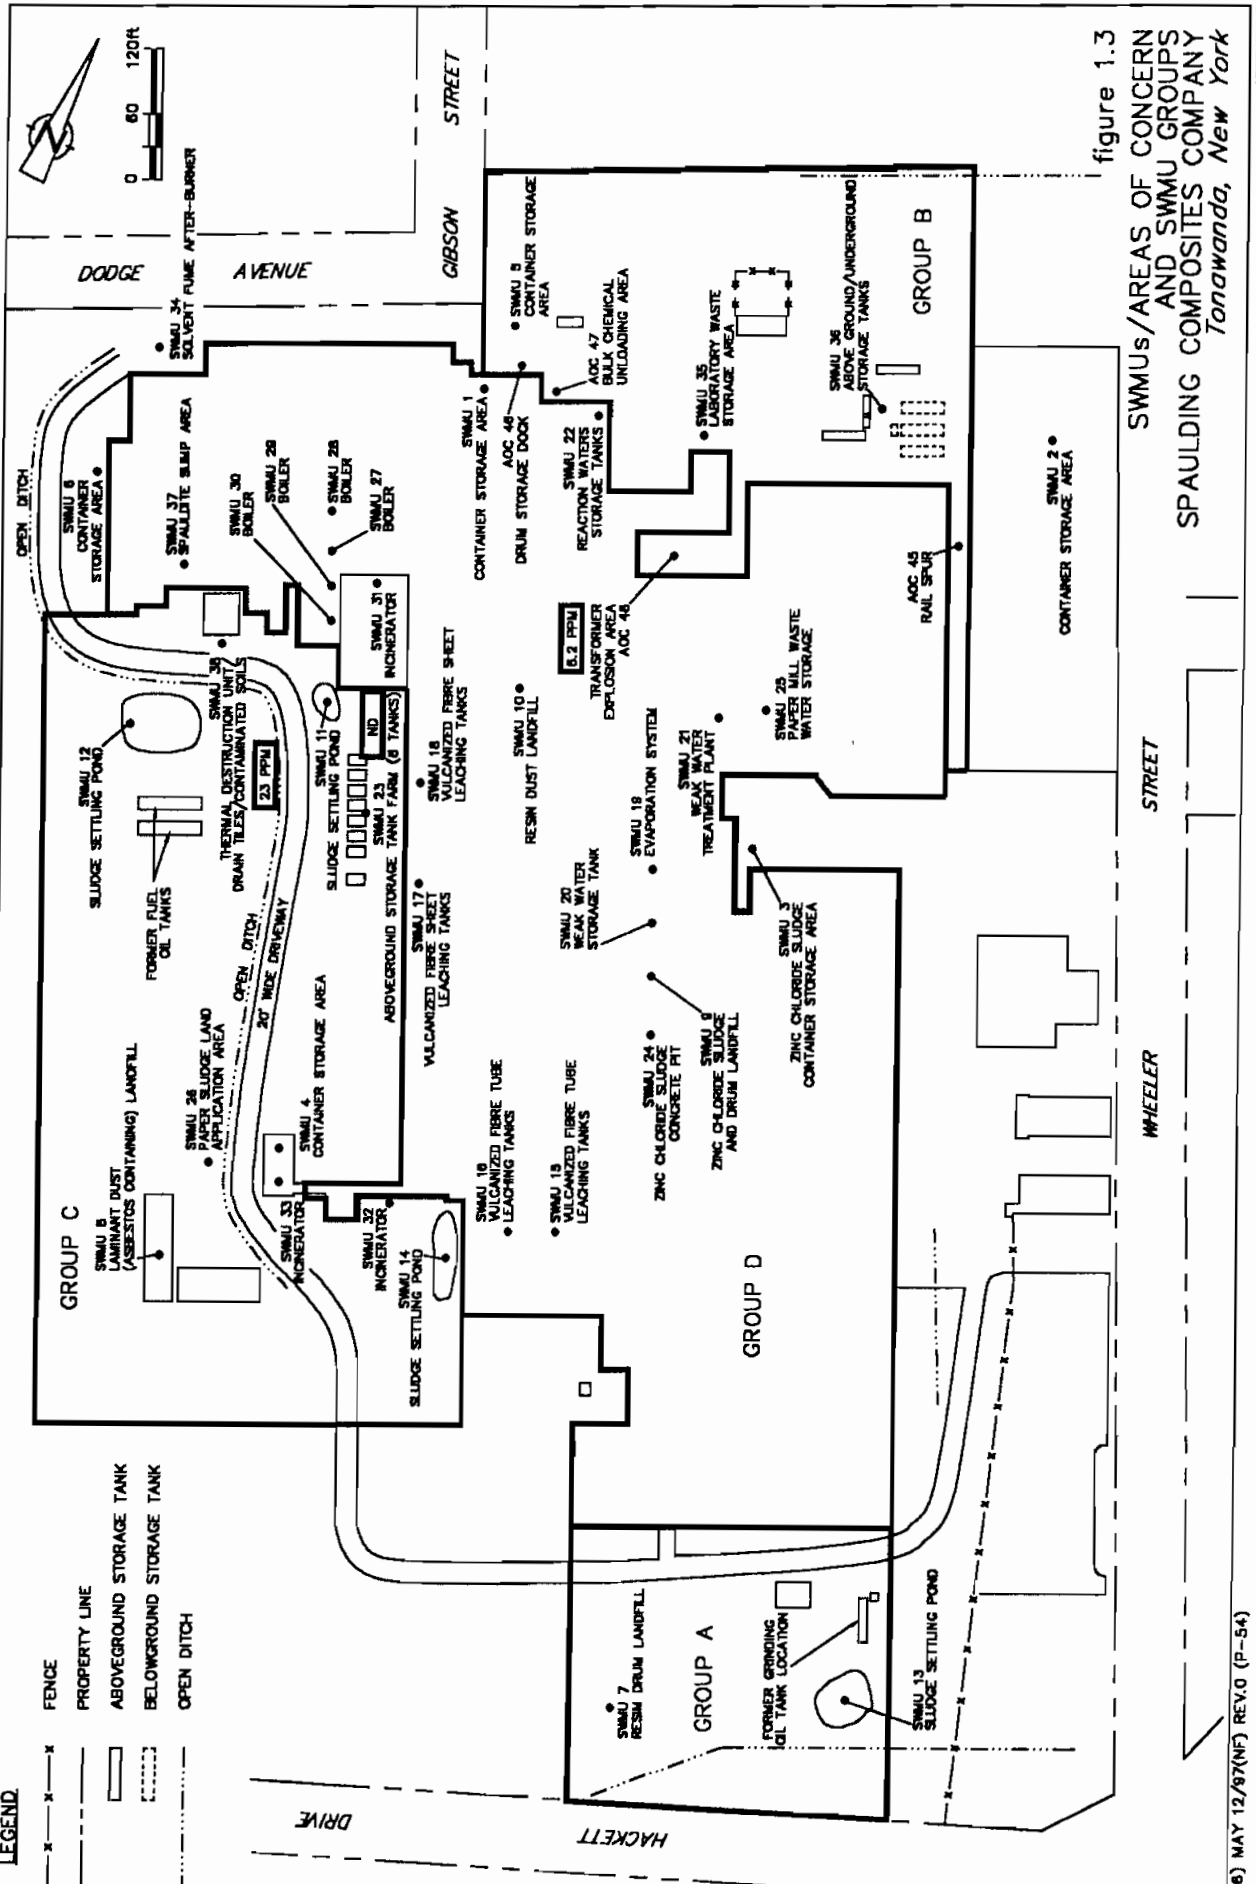
figure 1.3
 SWMUs/AREAS OF CONCERN
 AND SWMU GROUPS
 SPAULDING COMPOSITES COMPANY
 Tonawanda, New York

LEADER ENVIRONMENTAL'S TREATABILITY STUDIES
 SAMPLING LOCATIONS AND PRE-TREATMENT ANALYTICAL RESULTS

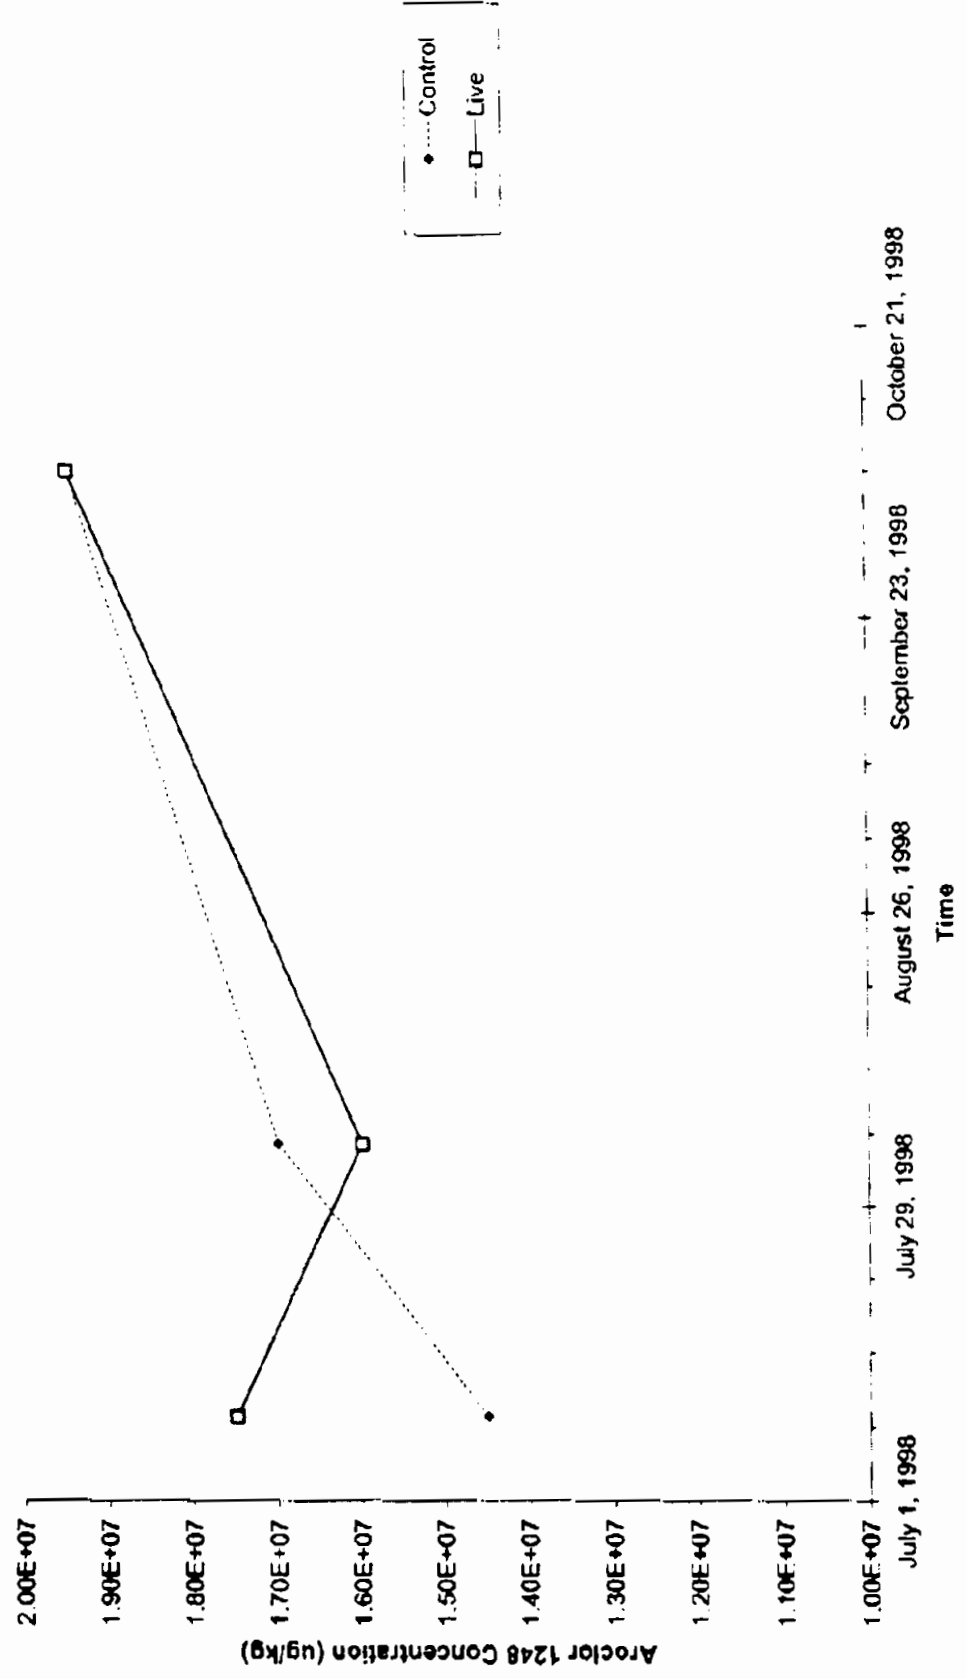
Figure 1. PCB Aroclor 1248 Concentration vs. Time in Soils Undergoing Anaerobic Bacterial Treatment

The soils under conditions 1) and 2) were incubated at 20 °C to 30 °C for several months, and were sacrificed and analyzed periodically. The soils under condition 3) were reacted with the proprietary treatment solution for approximately two days and then analyzed.

location adjacent to the Therminol Building revealed a high concentration of arochlor 1248 (19,000 ppm). AGRA performed two treatability studies: one study using anaerobic bacteria with nutrients, and a second study using white rot fungi. In neither treatability study was a reduction in PCBs obtained; however, the white rot fungi method may still be applicable to the Site and will be included in Leader's review of remedial alternatives.

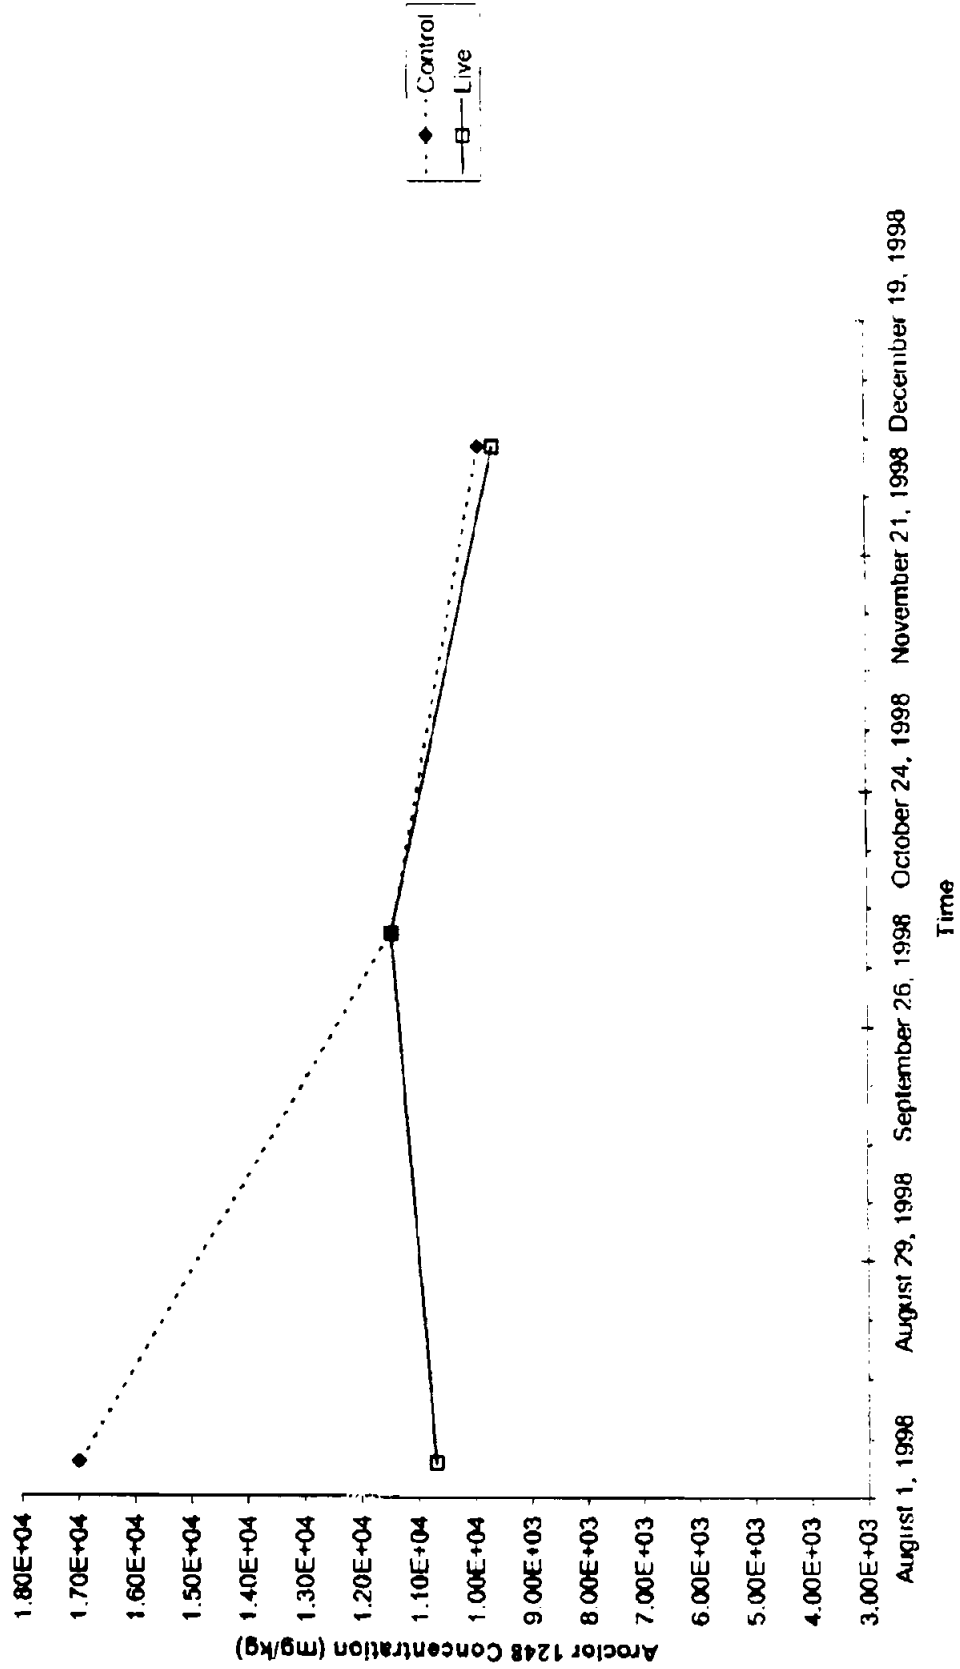
Figure 2. PCB Aroclor 1248 Concentration vs. Time in Soils Undergoing Aerobic Fungal Treatment

The medium was prepared in early August 1998. Wood chips on which a white rot fungus had been grown were mixed with the soil. One set of soils was sterilized for use as a control. The soils were incubated at 20 to 30 °C in unsealed reactors for four-and-a-half months, with gentle mixing and maintenance weekly. Duplicate soil reactors were periodically sacrificed and analyzed for PCBs.

Attached on Table 2 and Figure 2 is the summary of the results for the aerobic white rot fungal treatment study. No increase in loss of Aroclor 1248 in the non-sterile soils ("live") was evident.

White rot fungi is able to degrade lignin, a complex compound that provides the structure of plants and wood. Given this ability, research has found that when the fungi, nitrogen, and PCBs are mixed together, the fungi is able to destroy the complex structure of the PCBs. AGRA's treatability study involved adding wood chips (the culturing media for the fungus) to the soil, and did not involve adding nitrogen. Thus, white rot fungus might still be a remedial alternative. The anaerobic degradation of PCBs has been documented to take place very slowly, and thus will no longer be considered as an alternative.

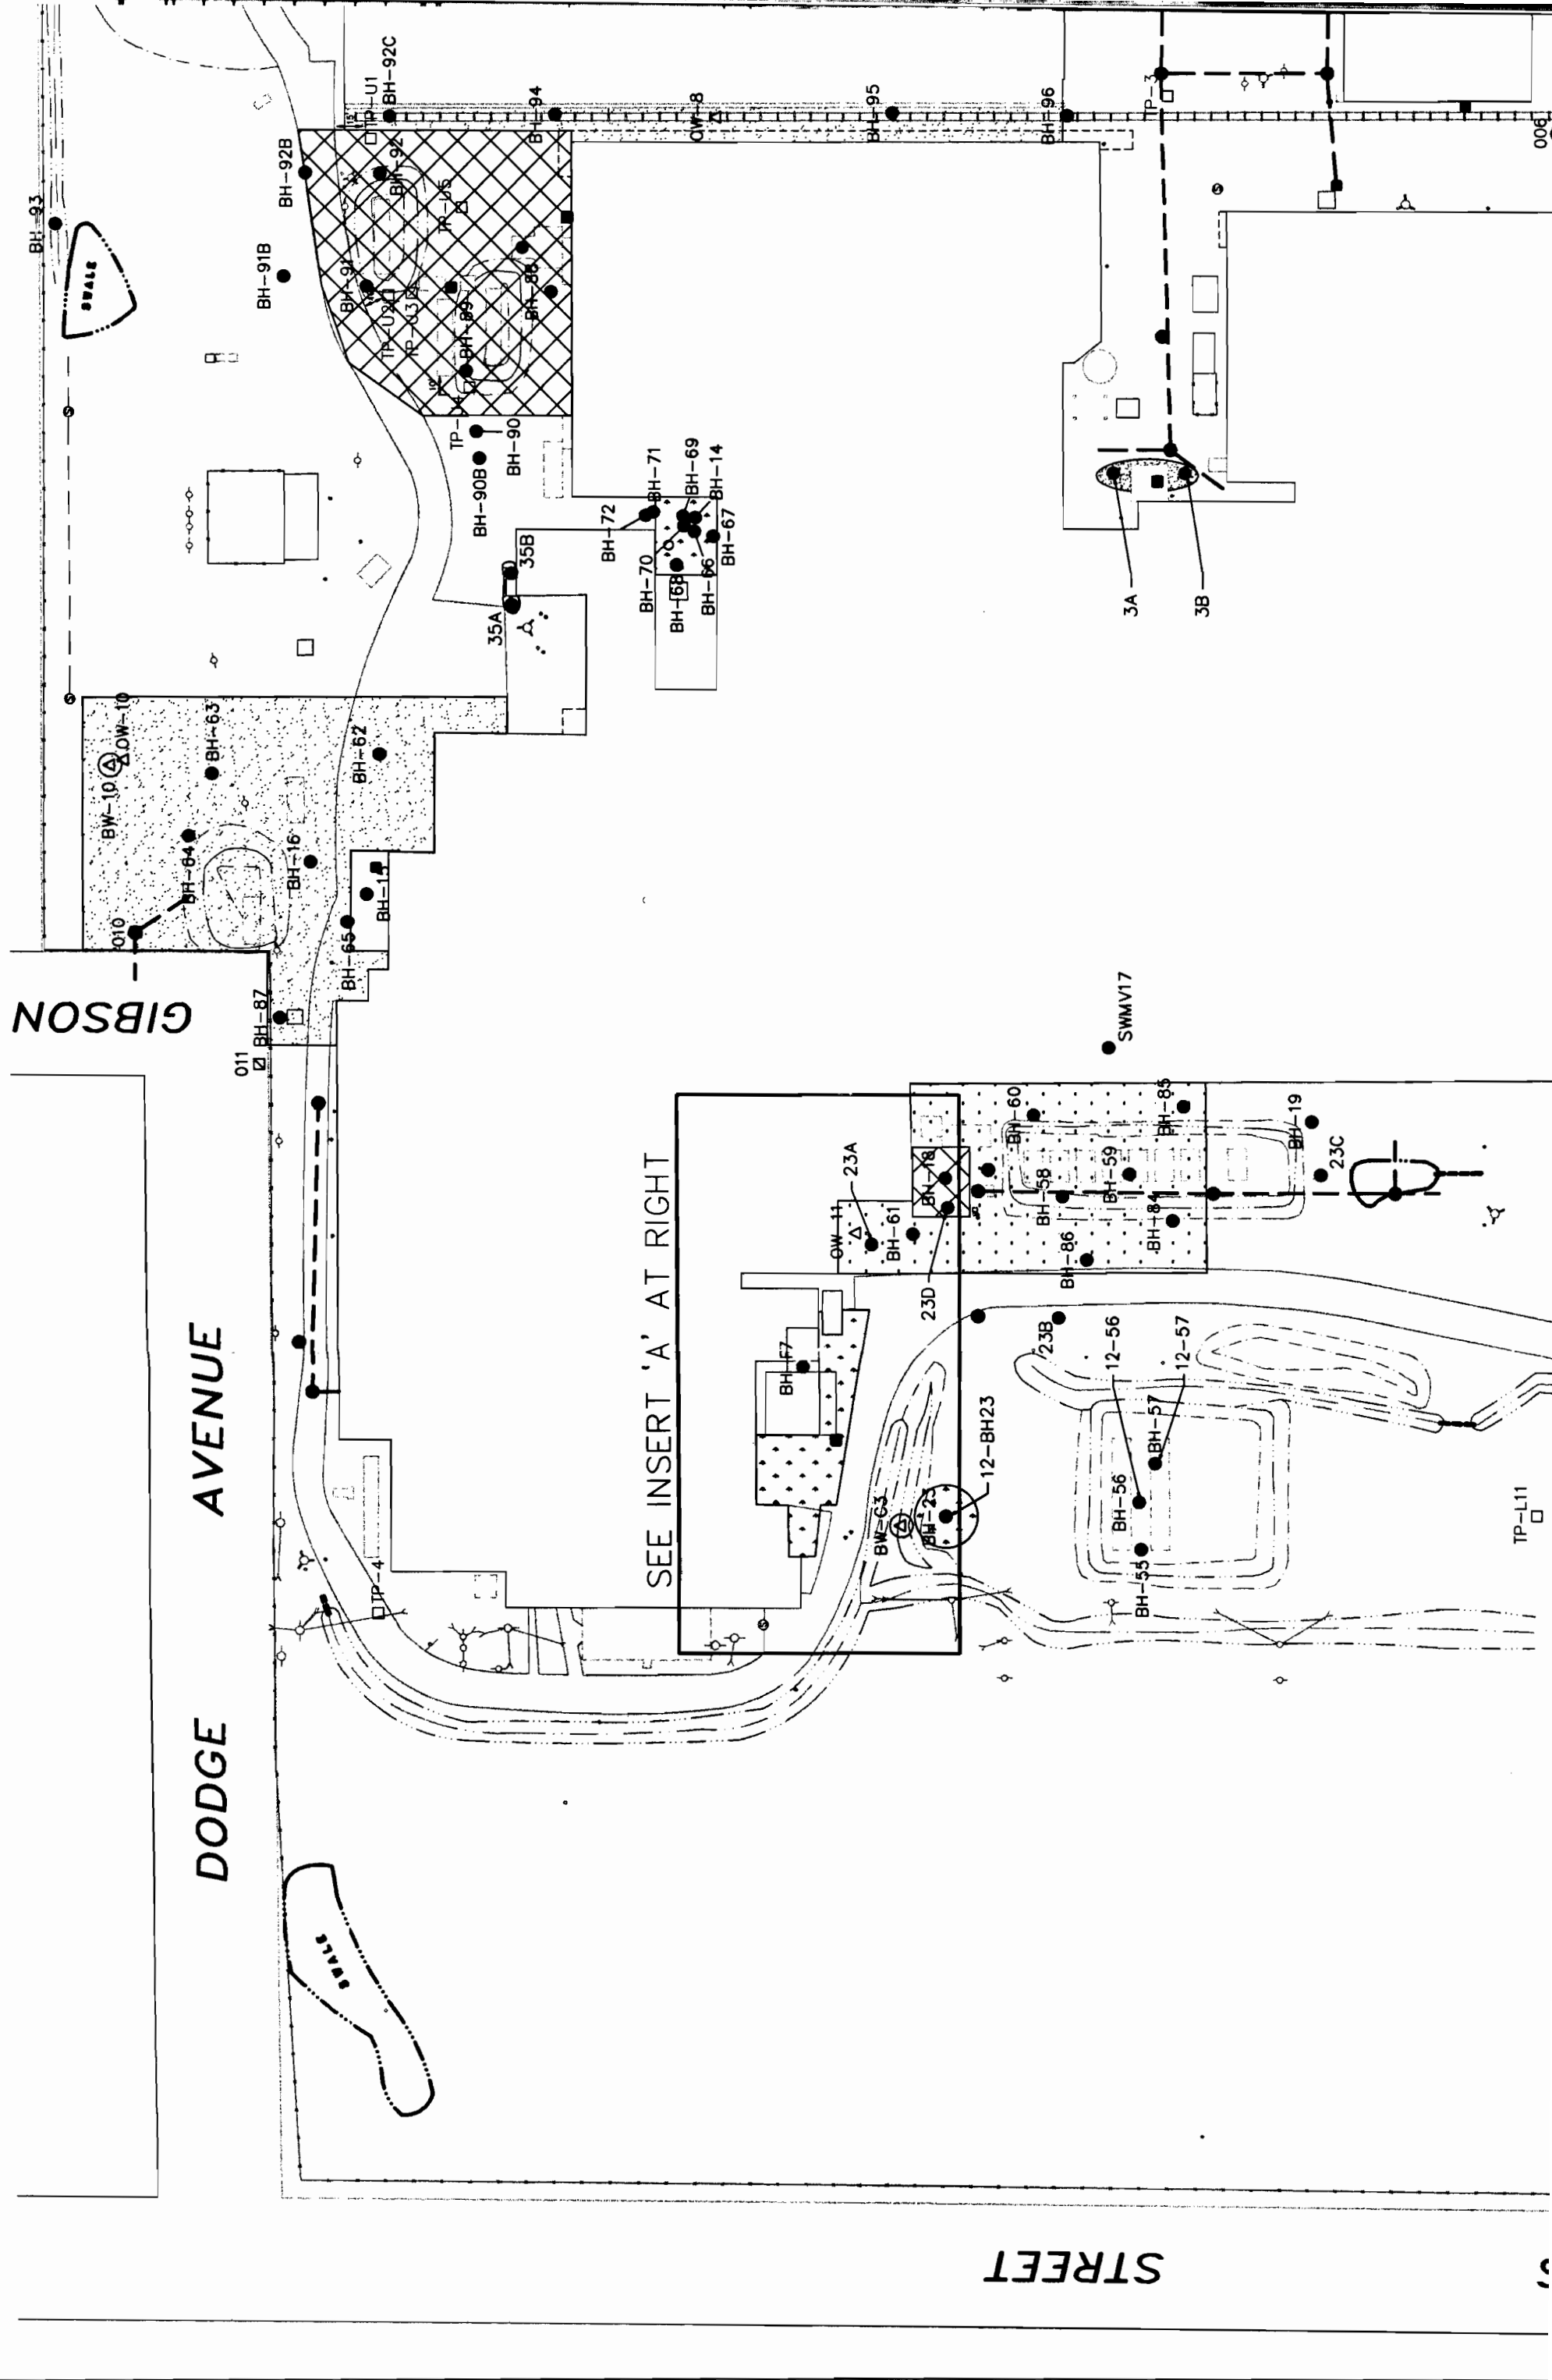
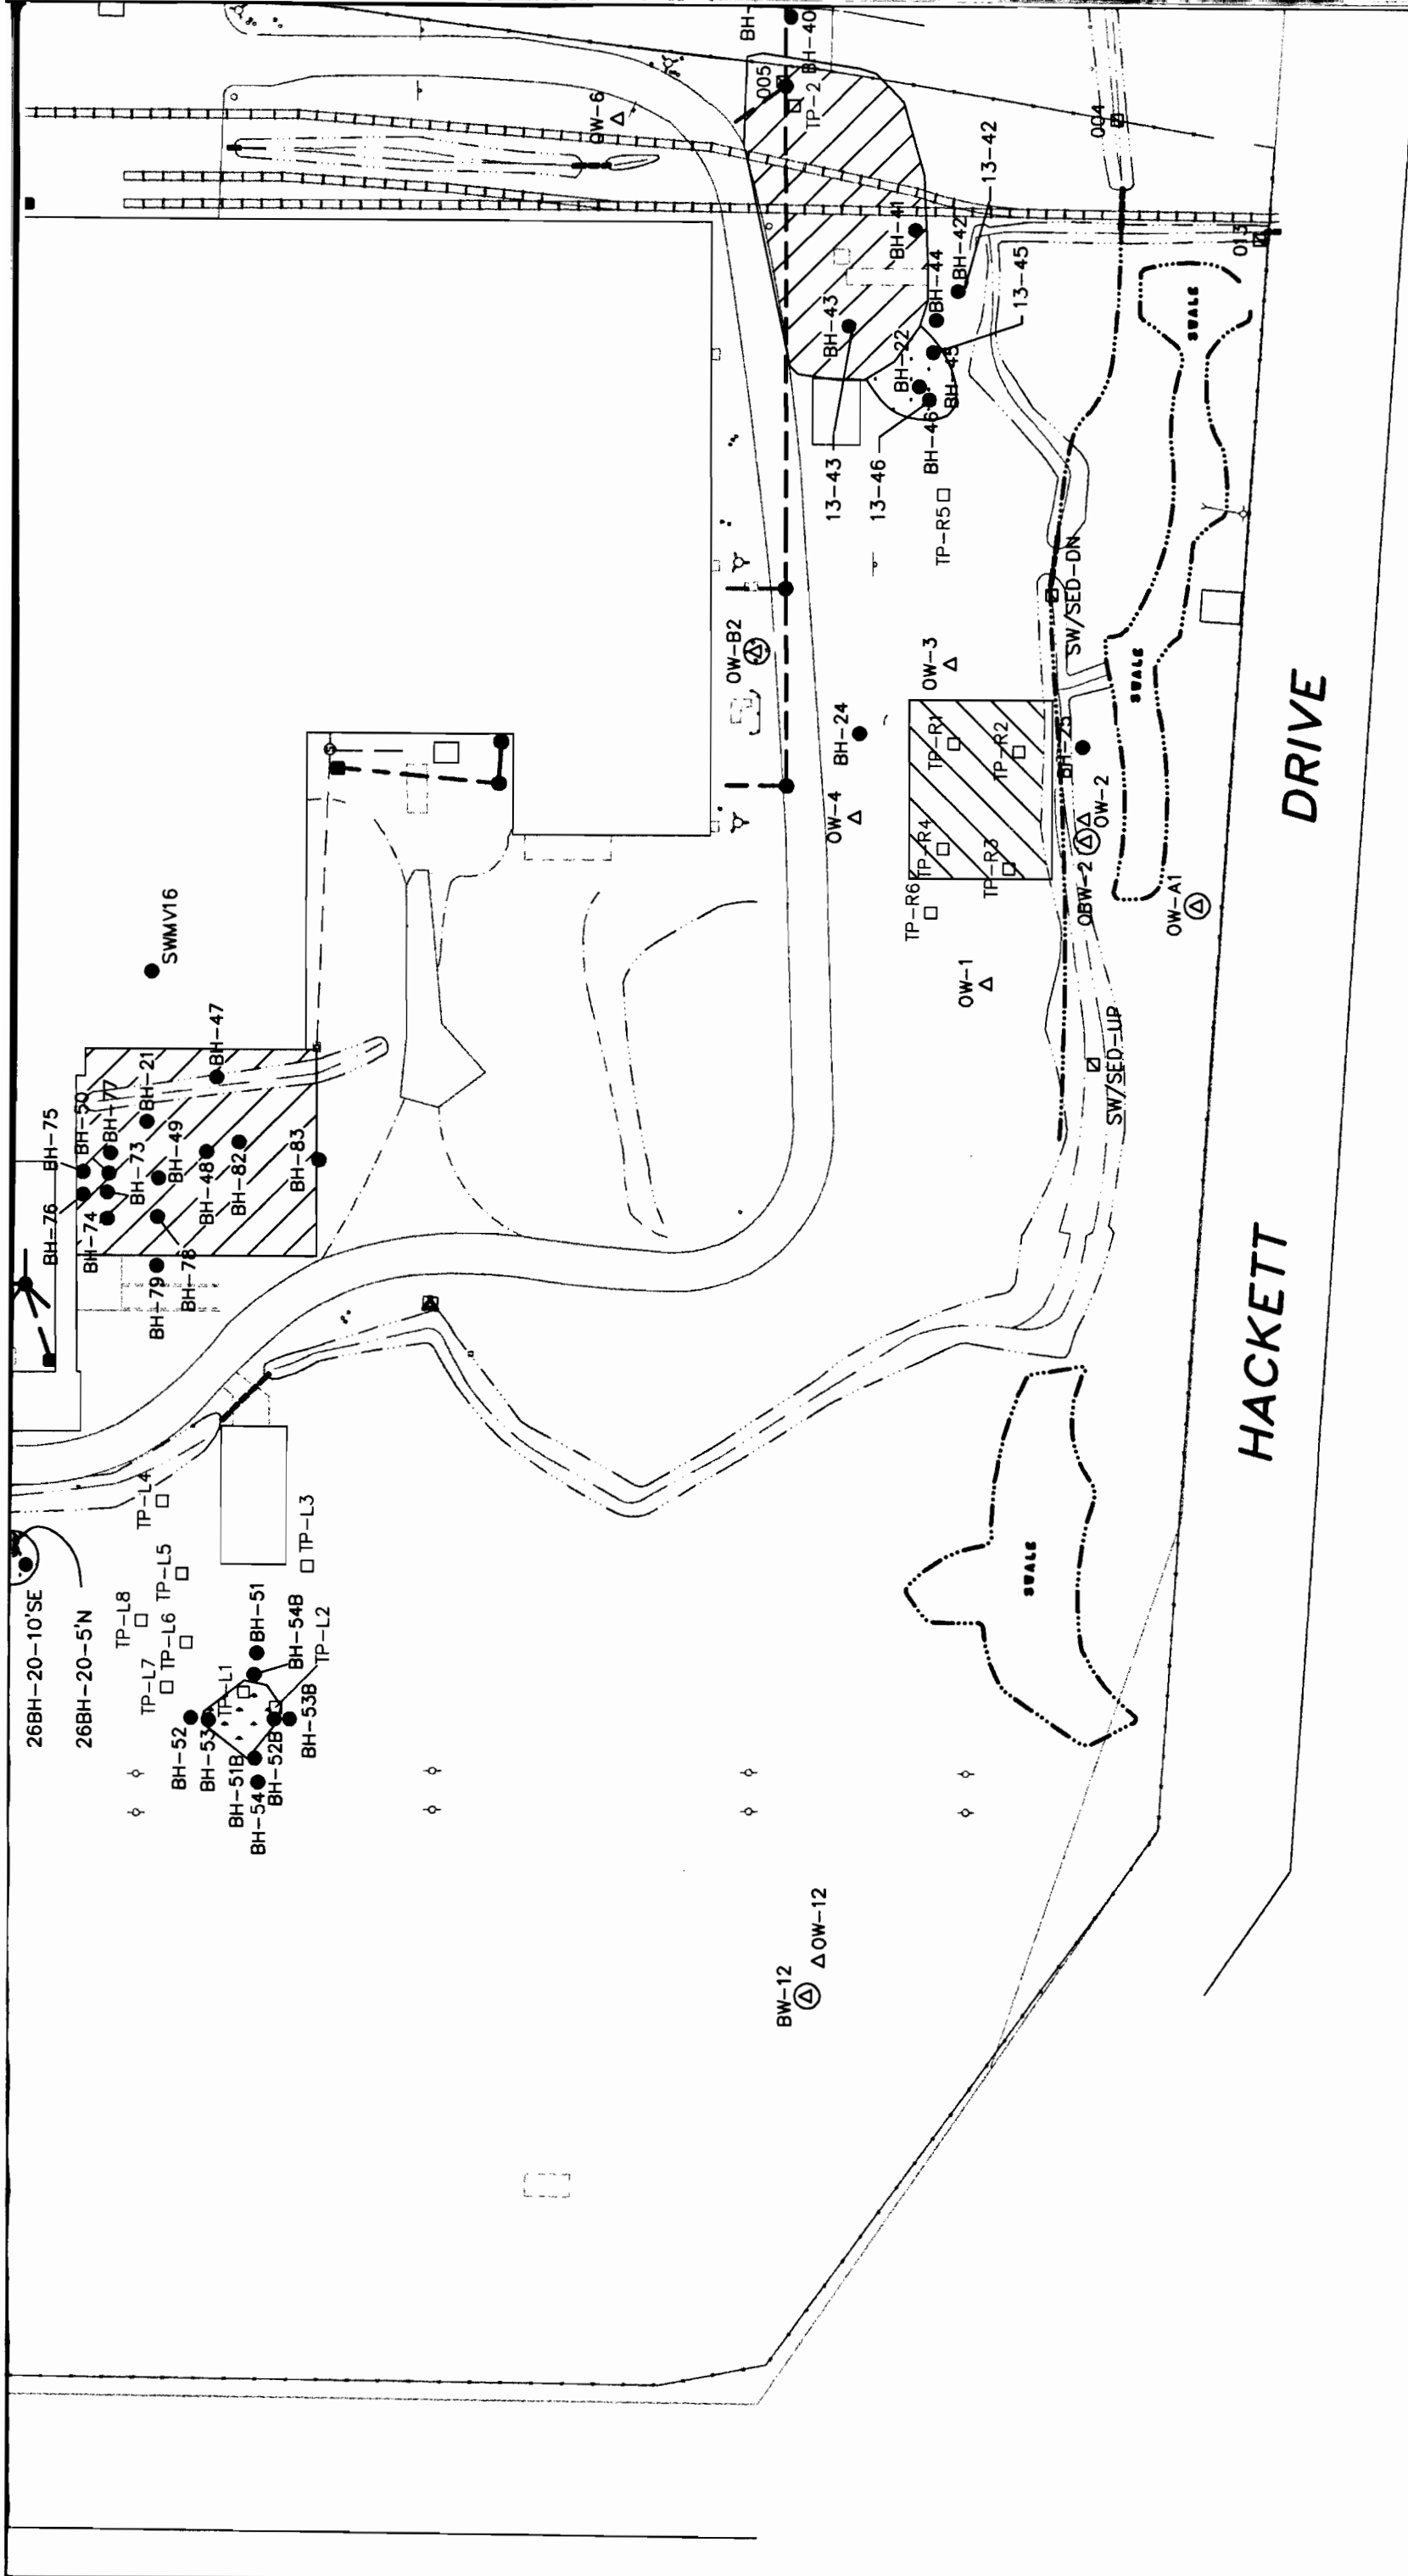
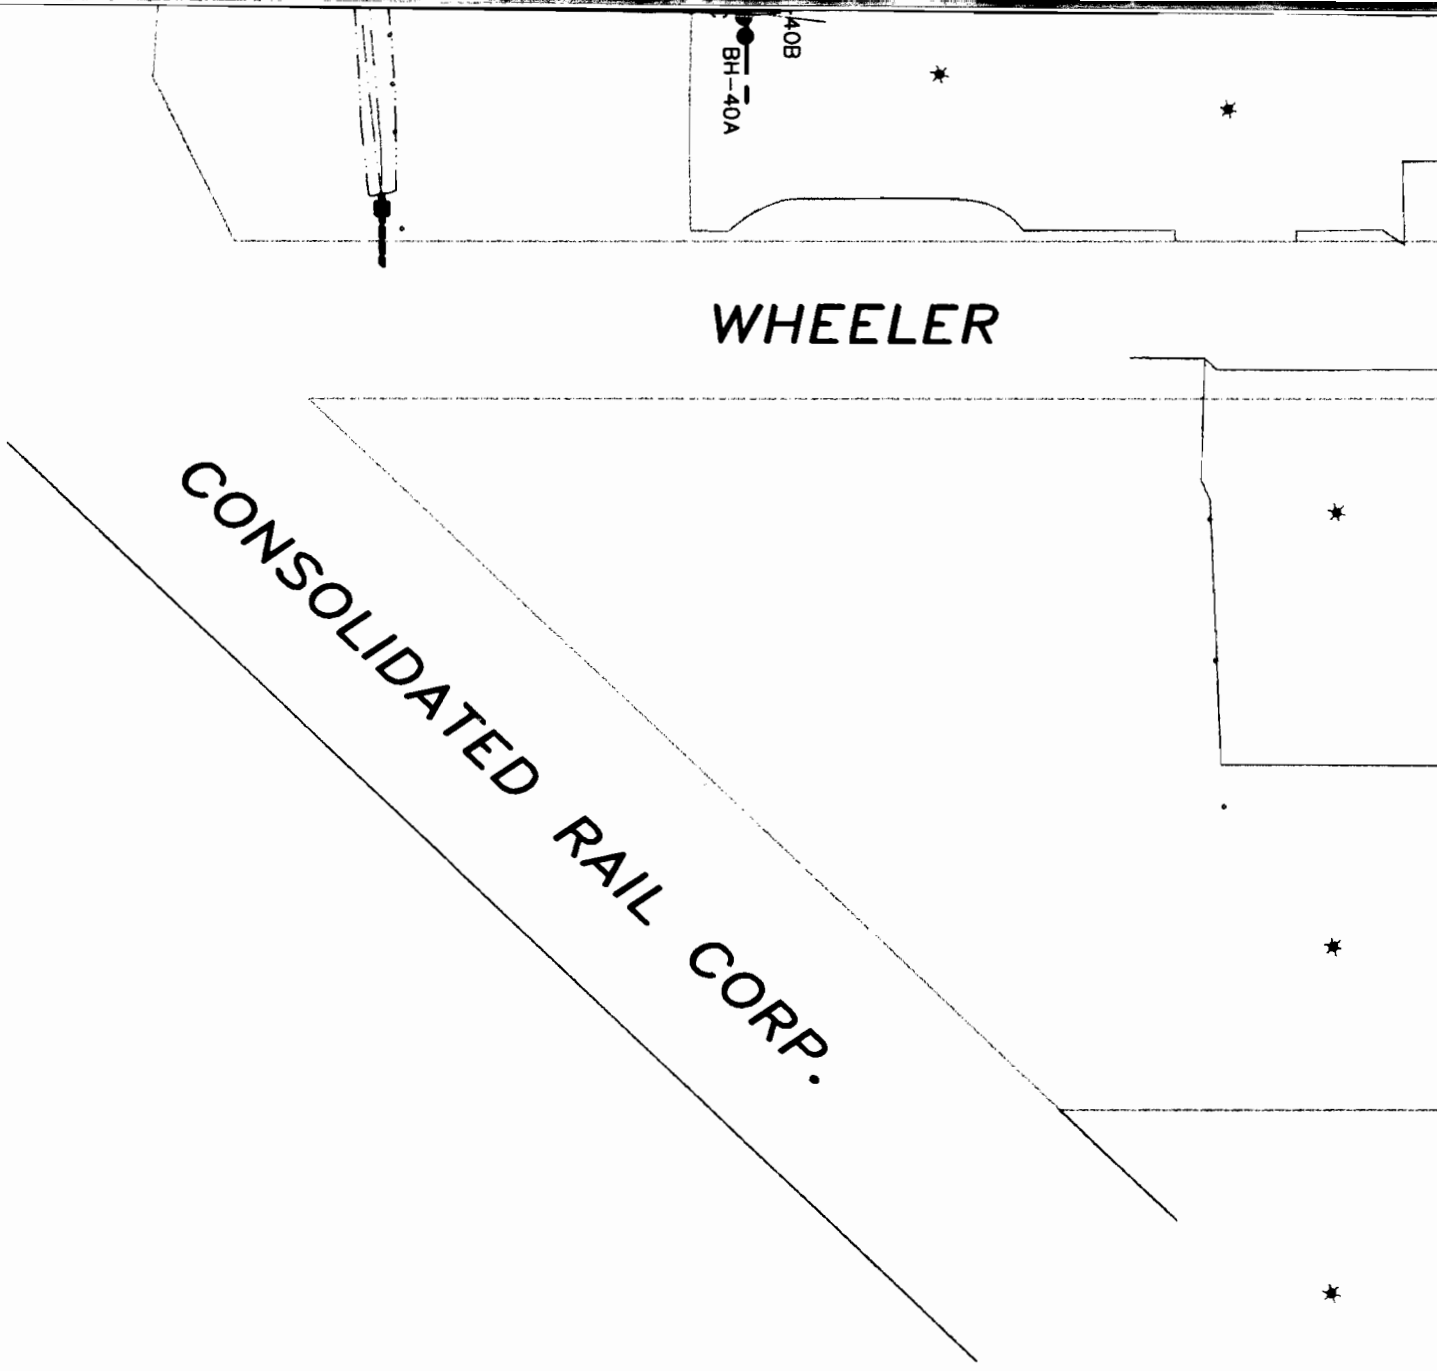
6	<i>Updated Approximate Limits of Impacted Soils from CRA RFI/RI Report</i>
---	--

NOTE FIGURE OBTAINED FROM CRA 1998
FINAL RFI/RI REPORT AND UPDATED TO
INCLUDE ADDITIONAL AREAS OF SURFACE
SOIL ABOVE APPLICABLE GUIDANCE VALUES
BASED ON SUPPLEMENTAL RFI/RI DATA.
