**PETITION TO DELIST
SKW PROPERTY PORTION OF
THE VANADIUM CORPORATION OF AMERICA SITE
FROM REGISTRY OF
INACTIVE HAZARDOUS WASTE DISPOSAL SITES**

**CC Metals and Alloys, Inc.
Witmer Road
Niagara Falls, NY**

LAN Ref. #2.3269.23
February 26, 2001

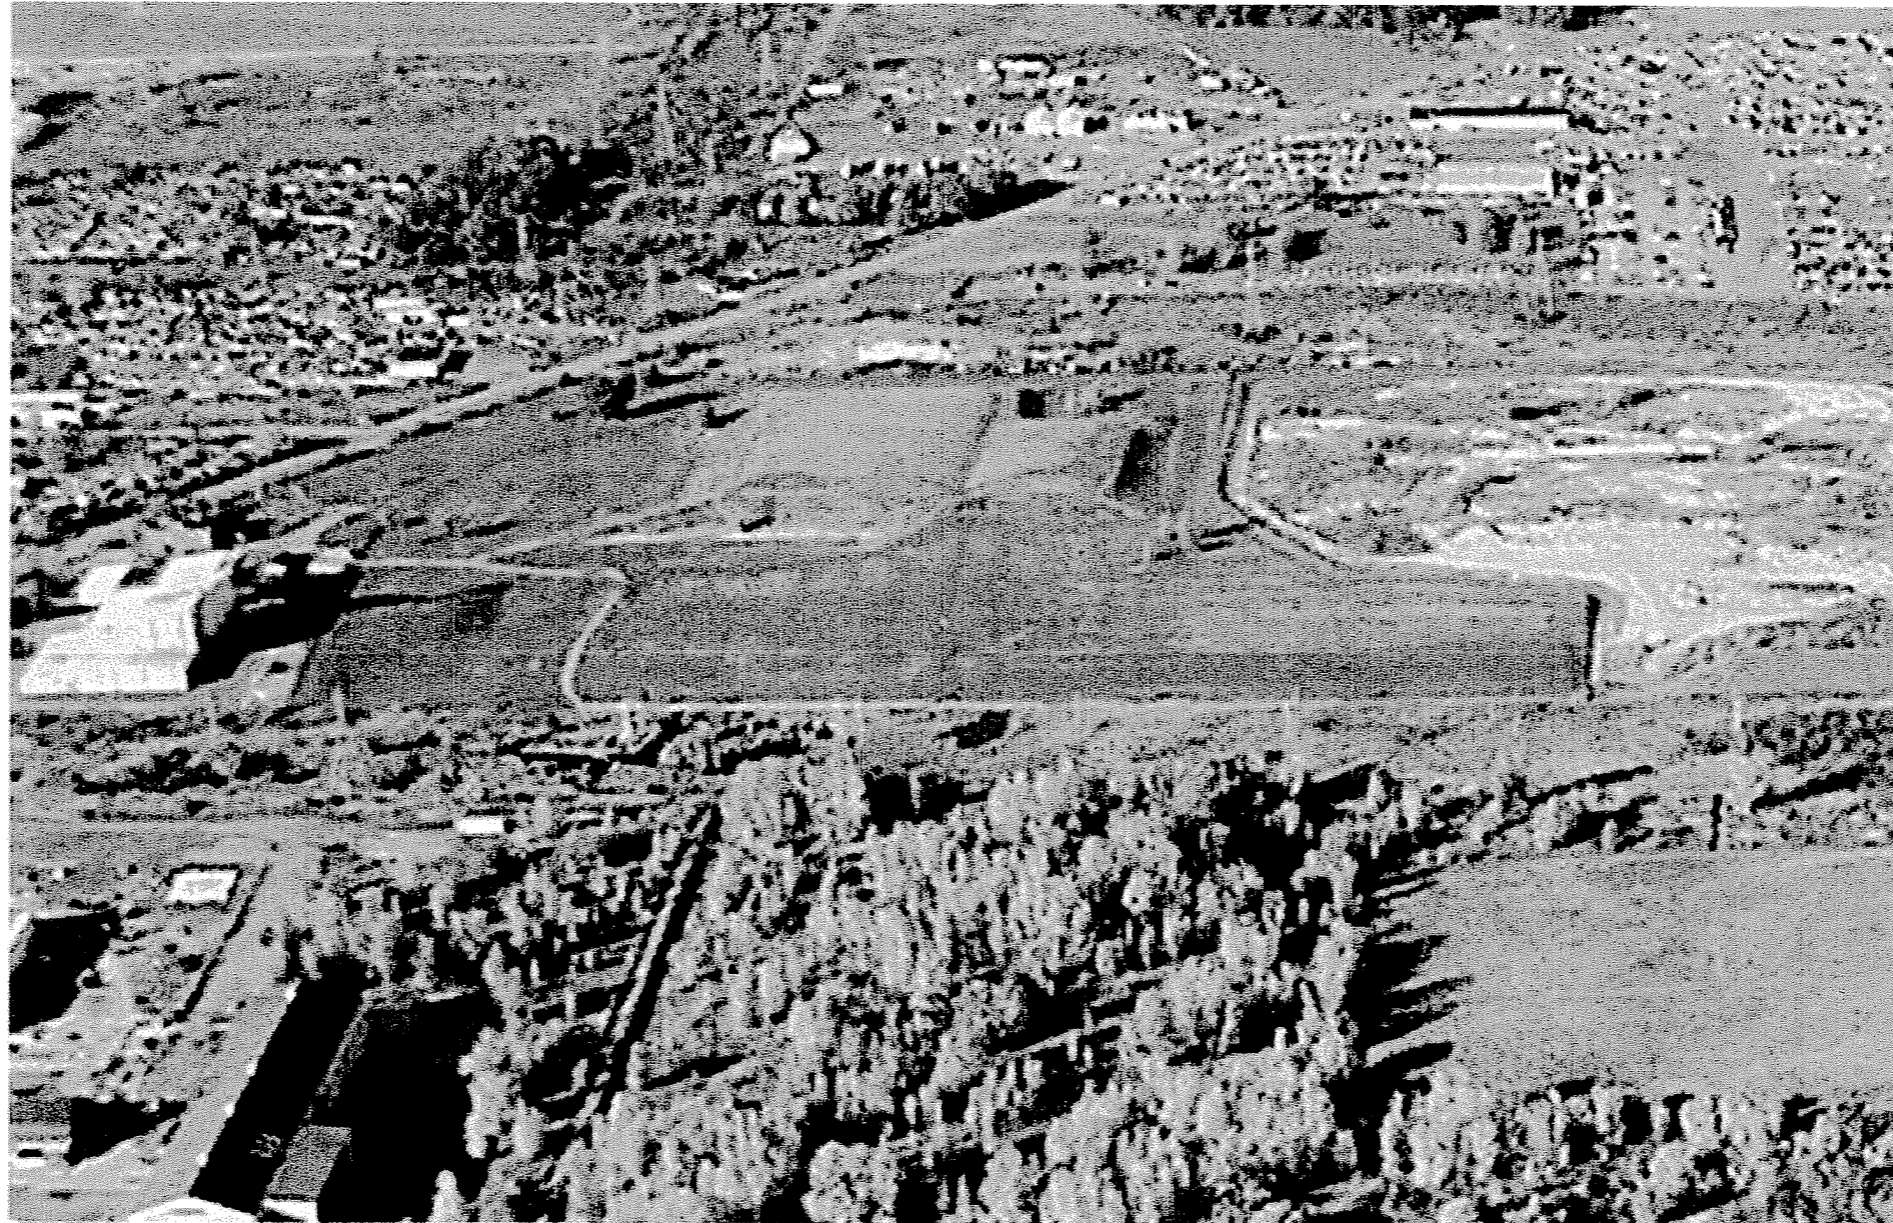
November 1999
Oblique Aerial Photo
SKW and Surrounding Properties

Attachment 2 contains a 1989 aerial photograph that depicts the Department's estimated boundaries of the Vanadium Site. Also contained in Attachment 2 is a 1999 aerial photograph that shows the SKW Property after the IRM was completed. Attachment 3 contains a property location map showing the boundaries of the 37 acres that comprise the SKW Property. Attachment 3 also contains a survey map showing the SKW and Airco properties.
