REPORT ON

ANCILLARY MEASURES FOR
CORRECTIVE MEASURES IMPLEMENTATION
BELL AEROSPACE TEXTRON
WHEATFIELD, NEW YORK

January 1997

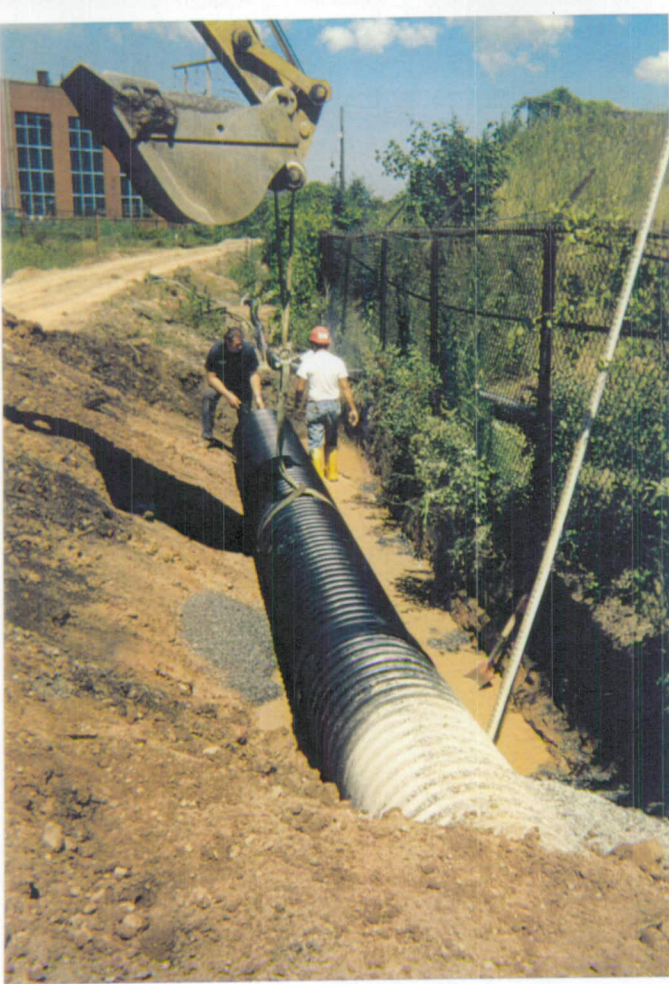
<u>Photograph #</u>	<u>Description of Photograph</u>
1.	Looking north - station 0+25, sewer construction.
2.	Looking east - station 3+50, sewer construction.
3.	Sewer connection to drop inlet at Walmore Road.
4.	Pump for temporary re-routing of ARC discharge - station 0+00.
5.	ARC discharge event prior to completion of storm sewer.
6.	Looking south - station 3+00 final grading and seeding.
7.	Looking northeast - station 2+90 final grading and seeding.
8.	Looking east - station 3+10 final grading and seeding.
9.	Looking north - station 0+00 completed sewer.
10.	Looking east - station 2+90 completed sewer.

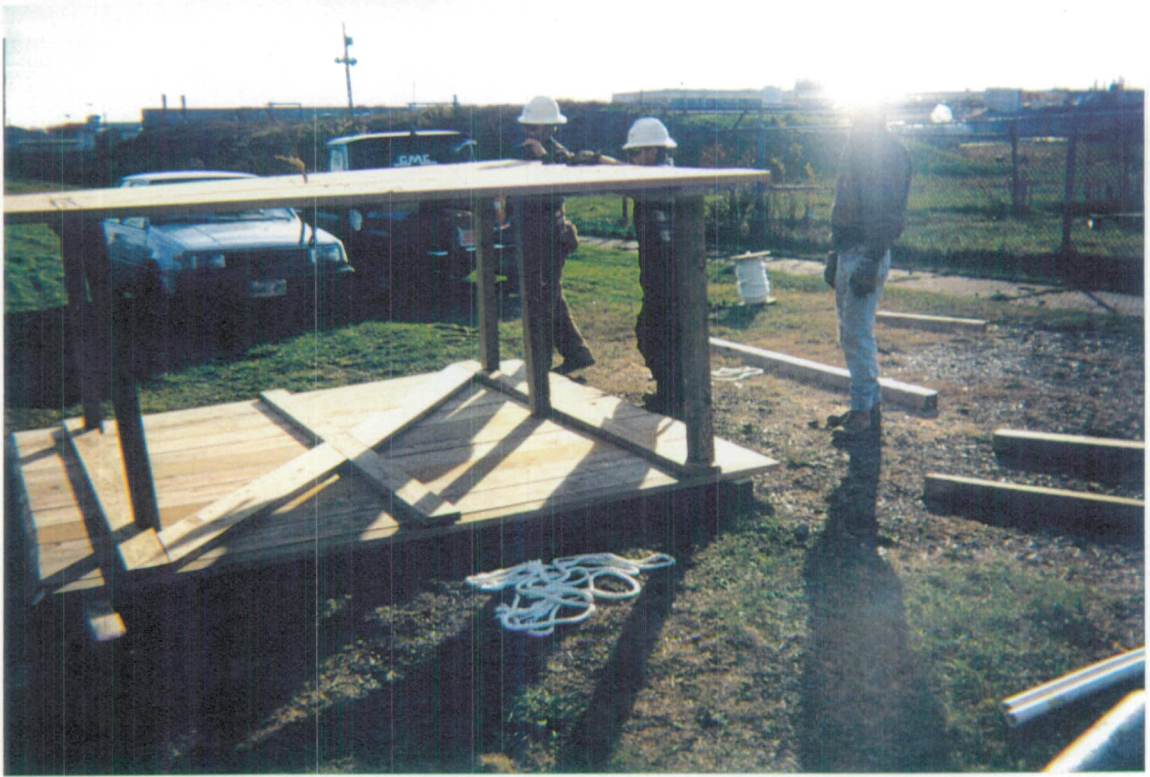
<u>Photograph #</u>	<u>Description of Photograph</u>
1.	Construction of slurry barrier forms.
2.	Initial placement of slurry barrier form.
3.	Vacuumping stone backfill from within forms.
4.	Advancing forms by backhoe pressure.
5.	Forms in-place above exposed sewer pipe.
6.	Forms in-place above exposed sewer pipe.
7.	Pouring slurry mix within forms.
8.	Slurry mix in-place within forms (initial pour).
