ENGINEERING INVESTIGATIONS AT INACTIVE HAZARDOUS WASTE SITES

PHASE I INVESTIGATION

TOWN OF LOCKPORT LANDFILL, SITE NUMBER 932077
TOWN OF LOCKPORT, NIAGARA COUNTY

September 1989

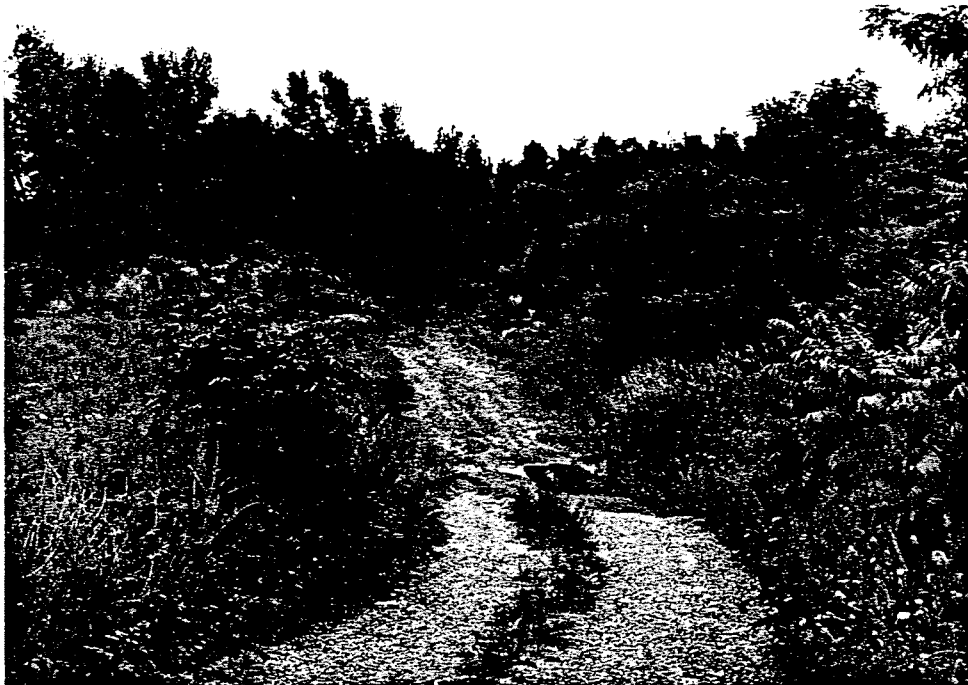
Comments*: View from Canal

Road looking south down land-
fill access road.

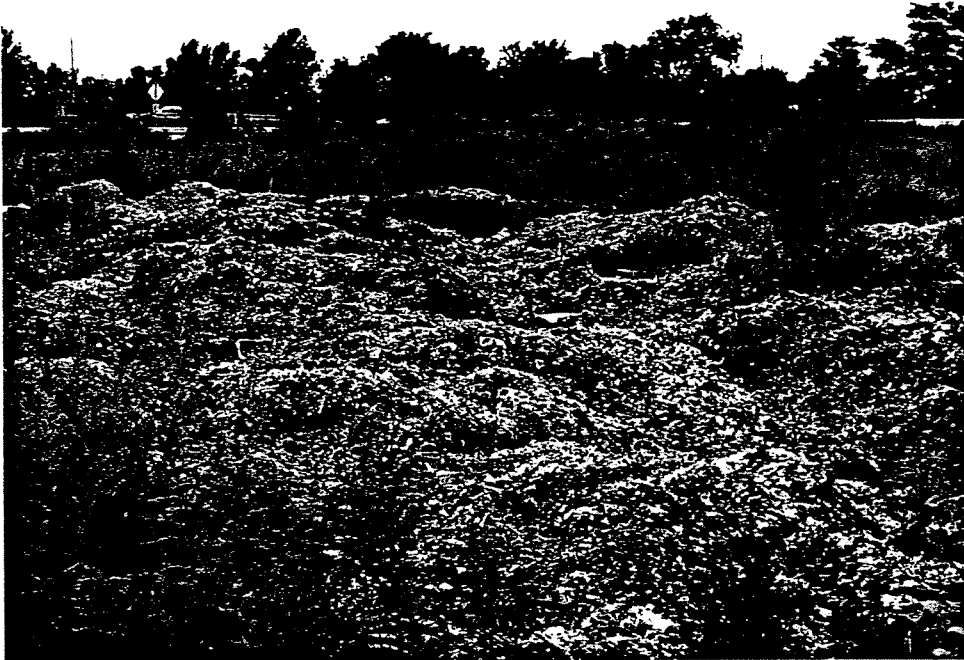
Photographer: Jon Sundquist
Date/Time: 6/17/87 14:05
Lens: Type: _____
SN: _____
Frame No.: 8
Comments*: Photo shows brush waste (wood chips) disposed of on site. View looking northwest from site.

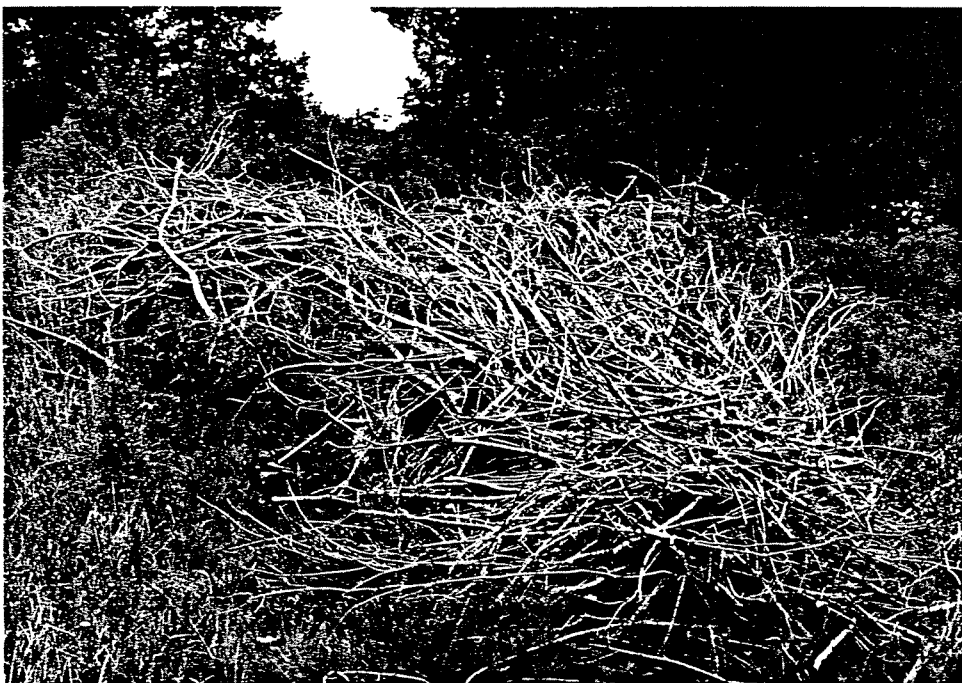
Photographer: Jon Sundquist
Date/Time: 6/17/87 14:10
Lens: Type: _____
SN: _____
Frame No.: 9
Comments*: Photo notes tree brush deposited on site.
