**Stratigraphy Assessment  
Niagara Falls Air Reserve  
Station  
Niagara Falls, New York**

**Contract Number: F30617-94-D-0008-5021  
Project No.: RVKQ 98-0904**

**July 1999**

**United States Air Force Reserve Command  
914<sup>th</sup> Airlift Wing**

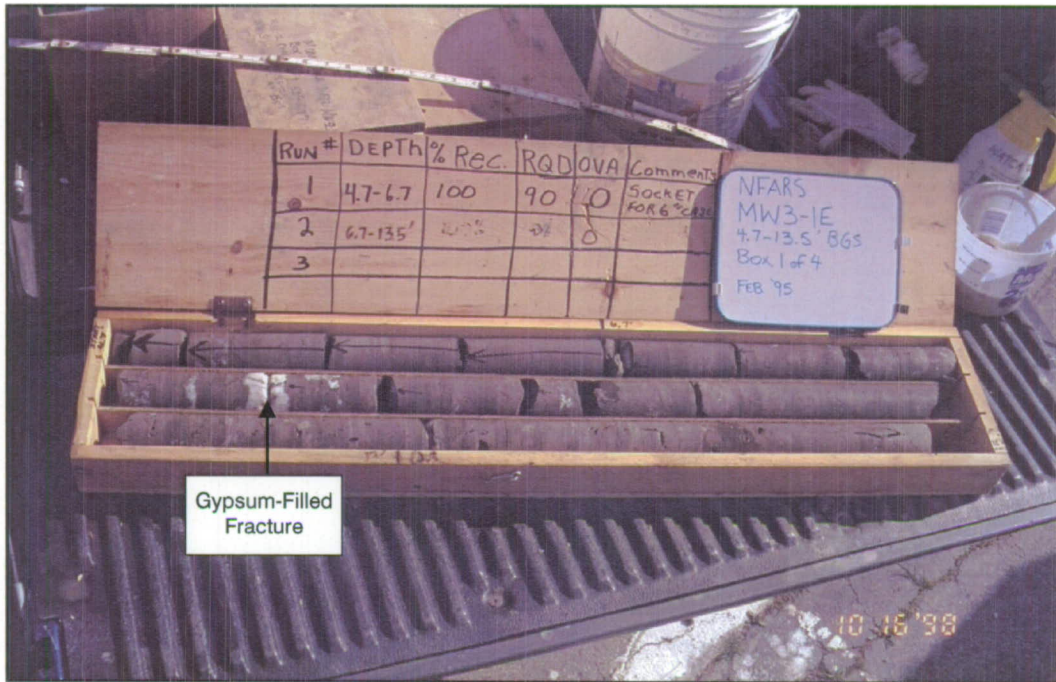
**Photo 7** NFARS Rock Core MW3-1E

*Example of gypsum-filled fracture.*

Examples of the stratigraphic features described above are shown in Photos 1 through 8 (see Appendix A).
