**Immediate Investigative Work  
Assignment  
Ward Road Properties  
Town of Wheatfield, Niagara County**

**April 1998**

New York State Department of Environmental Conservation  
Region 9  
270 Michigan Ave.  
Buffalo, New York 14203-2999

**Immediate Investigative Work Assignment  
(IIWA)  
Ward Road Properties  
Unlisted Site**

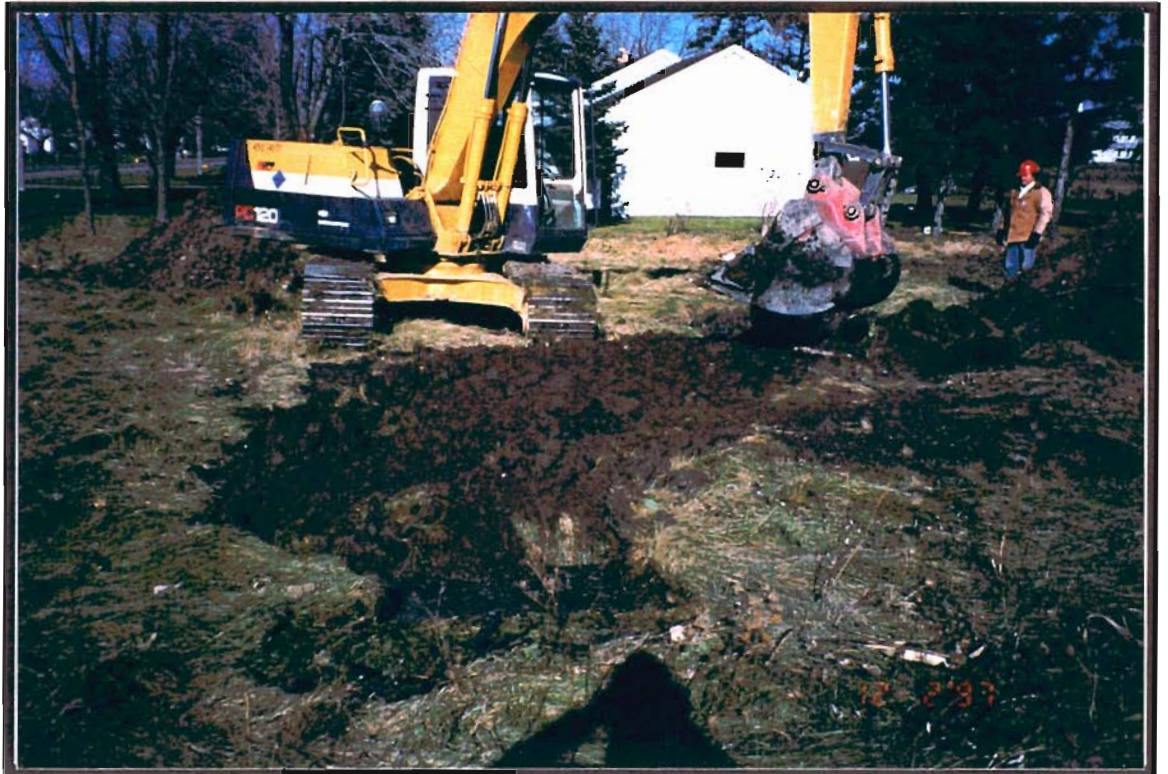
**Photo Number:**  
Frame 4

**Subject:**  
Backfilling Test Pit  
K2 (1st)

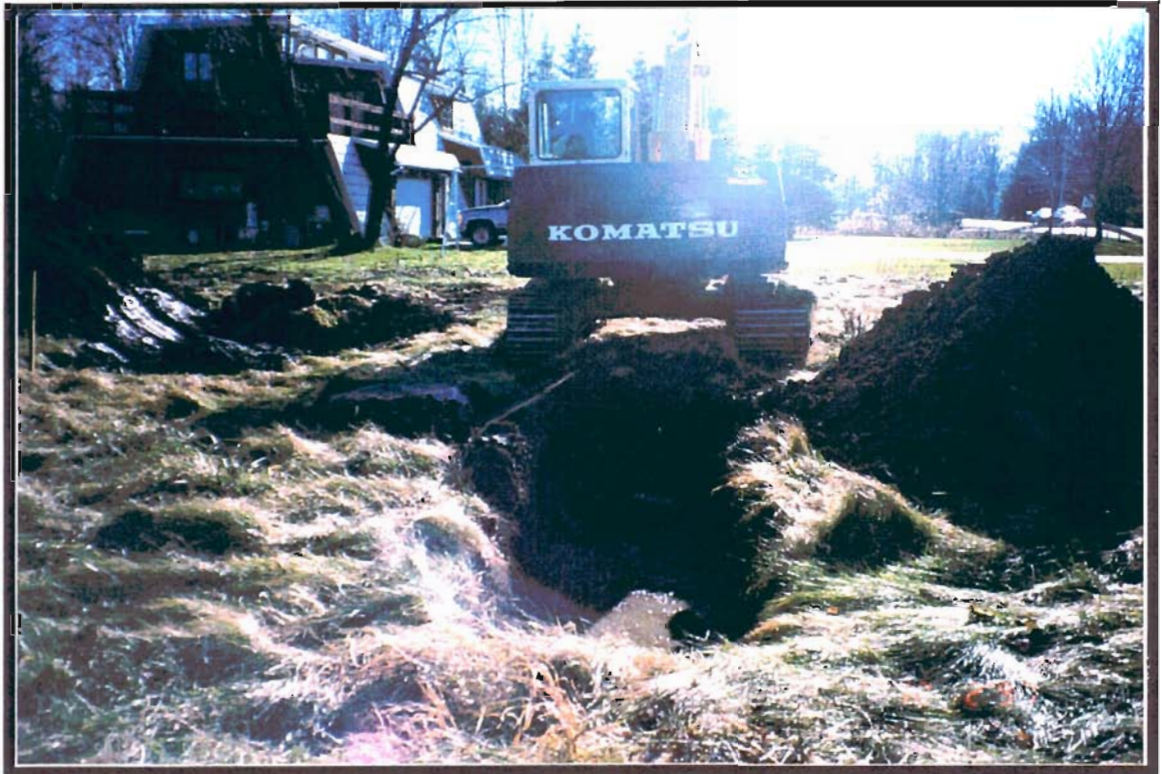
**Photo Number:**  
Frame 6

**Subject:**  
Excavation of  
Trench L

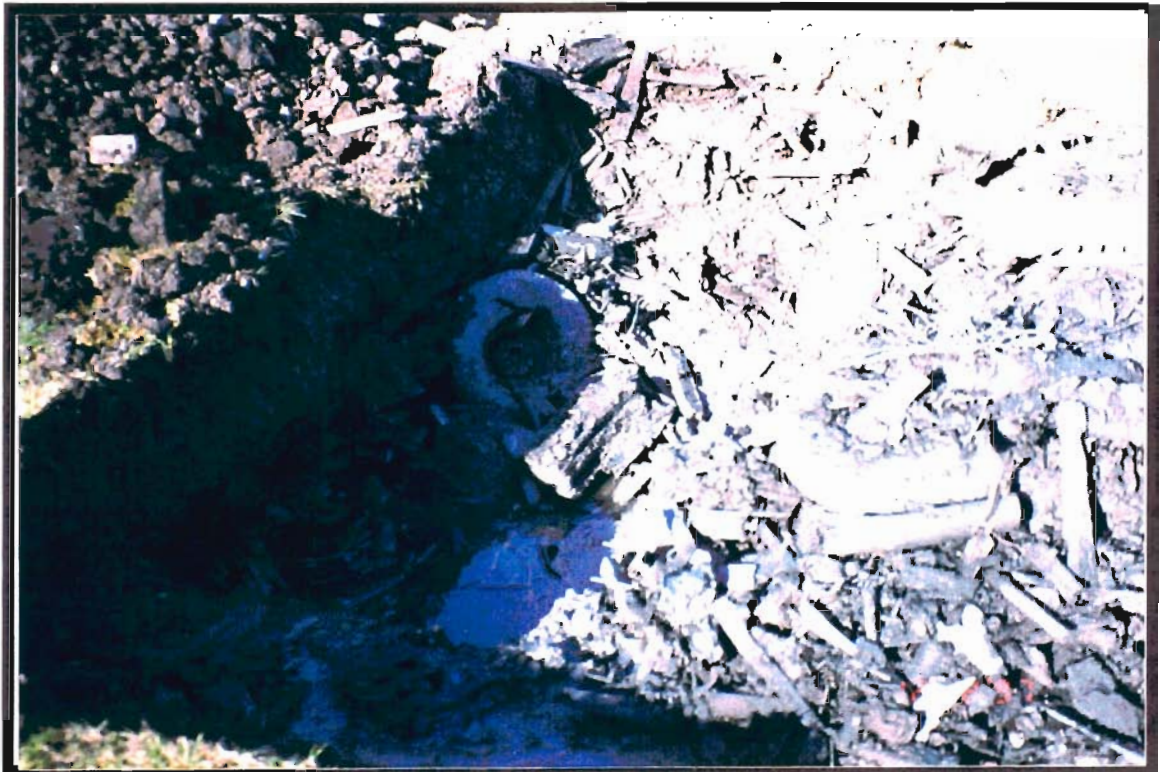
**Photo Number:**  
Frame 15

0 - 1	<u>Grass and Topsoil:</u> silty sand, brown, moist;
1 - 1.5	<u>Clay:</u> brown, wet, areas with coarse gravel;
1.5 - 5.5	<u>Fill:</u> loose, wet to saturated, wood (scrap and logs), gravel, metal debris (corrugated sheeting, car parts, wire), plastic;
- 5.5	<u>Silty Clay:</u> brown/gray, moist.

**Subject:**  
Test Pit F/I showing  
soil column and  
buried debris

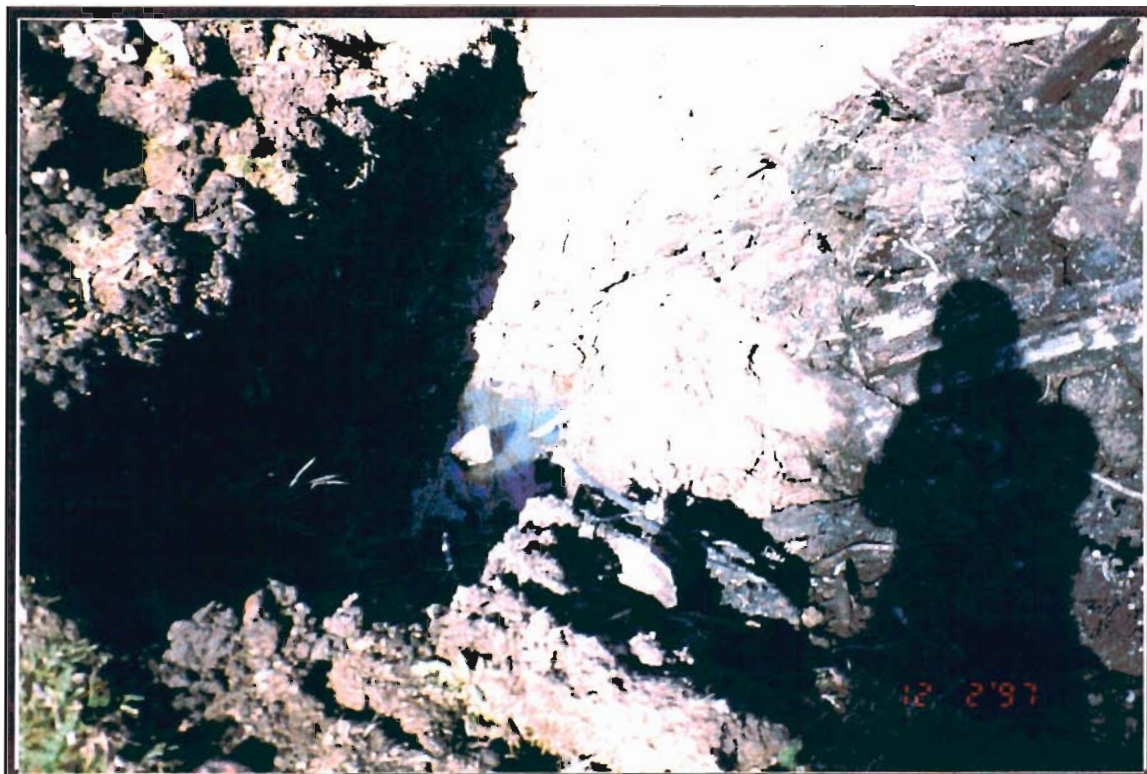
**Photo Number:**  
Frame 17

Also on the Walck property, a strong petroleum-like odor was noted at Test Pit G. However, no evidence of soil contamination from chemical or petroleum products was observed. Screening for volatile organics with a flame ionization detector (FID) indicated that volatiles other than methane were present in the test pit at an estimated 50 parts per million (ppm). These levels dissipated quickly after the initial readings.

**Subject:**  
Open Test Pit G  
showing debris and  
water

4. The xylene found in the solids sample TP-G-FILL and in the water sample TP-G-GW, and the chlordane found in Sample TP-G-FILL, are at depths where the public health hazard arising from human contact is unlikely. To maintain this protection, the existing soil cover, particularly in the vicinity of Test Pit G on the Walck Property, should not be disturbed;

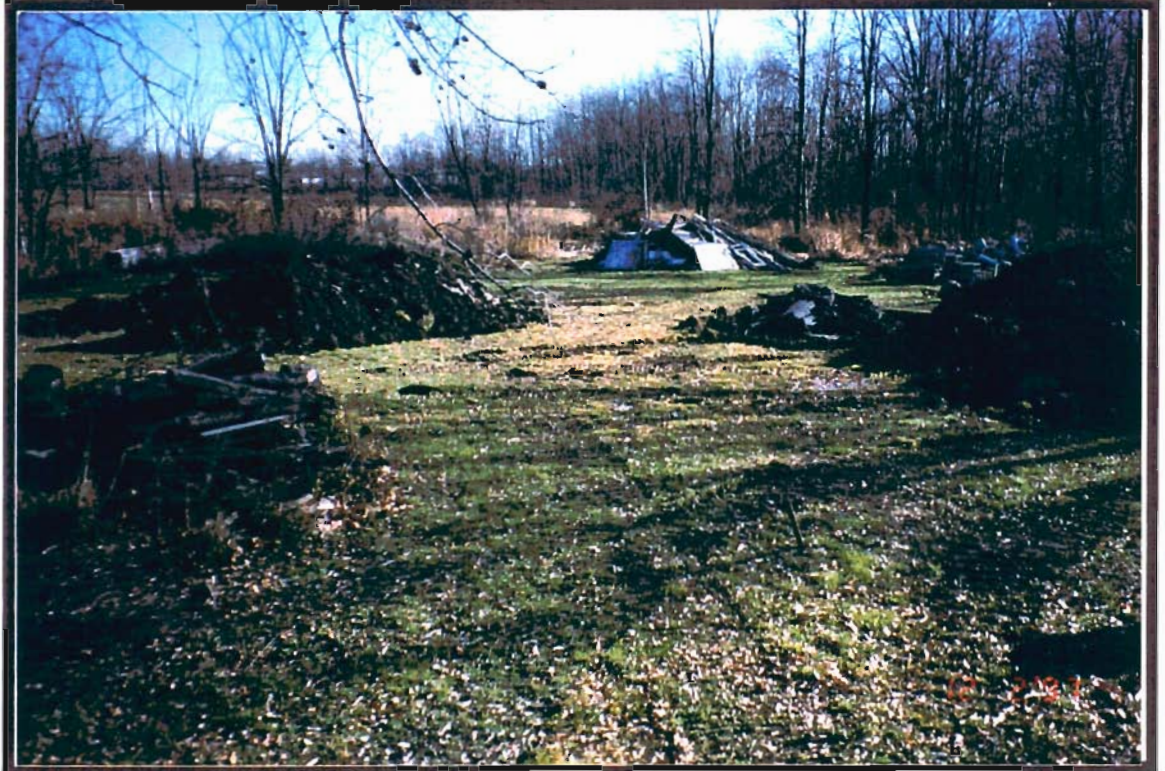
**Photo Number:**  
Frame 23

**Subject:**  
Backyard area, view  
from north and of  
house garage, shows  
rear garage and test  
pits
