## 2013 ANNUAL MONITORING / INSPECTION REPORT

**SNPE- VDM Creek Bank Corrective Actions**

**VanDeMark Chemical Inc. – Lockport, New York**

**Project No. 093-89168**

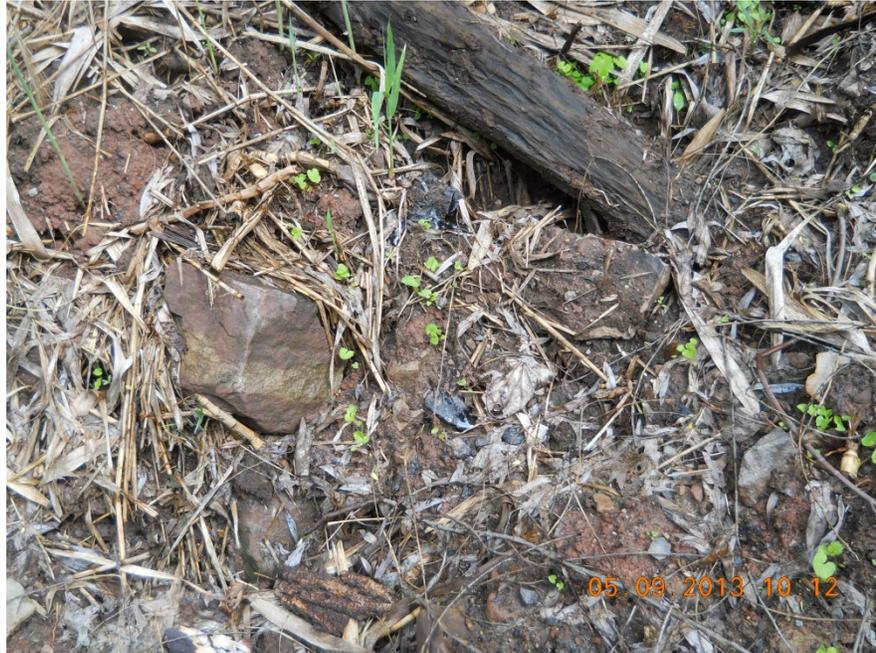
**PHOTO 1**

Several locations of small quantities of coal tar accumulations were observed north of the slurry wall during the May 2013 inspection period, including:

- Two locations approximately 17 ft. and 9 ft. west of observation sump OS-1 (or 36 ft. and 27 ft., respectively, west of piezometer PZ-4);
- One location approx. 11-15 ft. west of piezometer PZ-4 (approx. 4-6 ft. north of collection trench gravel northern edge);
- One location approx. 5 ft. west of piezometer PZ-1 at the creek edge (most likely existing material); and,
- One location approx. 30 ft. west of piezometer PZ-1 approximately halfway down creek bank in an area of previously remediated coal tar outbreak.

Observed coal tar outbreak along embankment on north side of collection trench during May 2013 inspection event.

All accumulations were observed to be less than 6 inches wide in any dimension and localized at the surface. In conjunction with the final site restoration activities scheduled in May 2013 with Severson (the Corrective Measures contractor), Golder recommended and SNPE agreed to the removal of the observed DNAPL accumulations for disposal in accordance with the original contract provisions. The removals were performed and the total amount removed for disposal amounted to less than 10 pounds of mixed DNAPL residuals mixed with soil.

The results of the May inspection described in Section 2.2.1 indicated that the lower Creek Bank Area had accumulated small quantities of DNAPL residuals that were not present at the conclusion of remedial activities in November of 2012. Due to the accessibility of these accumulations and previous scheduling of the remedial contractor to be on-site for final restoration, Severson was tasked to manually remove and dispose of the accumulated DNAPL residuals and associated impacted soils. The five small areas of DNAPL accumulation noted in the May 2013 inspection report (Appendix A) were all surficial and readily removed with a shovel and placed in a 5-gallon bucket. This material was estimated to be less than 10 pounds total and transferred into an open top drum. The drum was disposed of at Modern Landfill as a non-hazardous industrial waste under the approved coal tar/soil profile previously obtained for the corrective measures work performed in the fall of 2012.

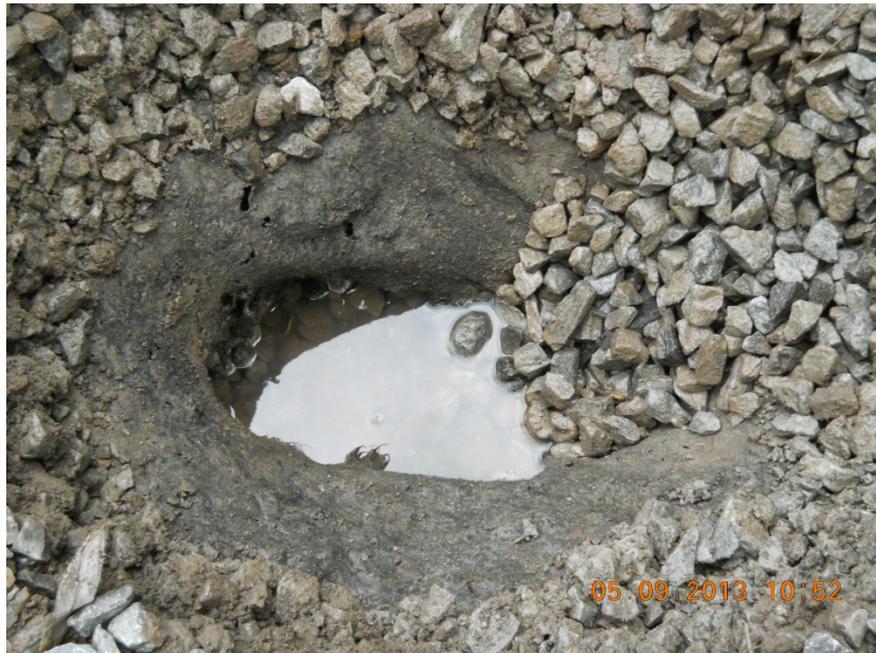
**PHOTO 2**

- One test pit located approximately 14-ft. east of piezometer PZ-4 to a depth of 2.5-ft below ground surface (bgs); groundwater encountered at 2-ft bgs, no DNAPL observed based on absence of sheen on water surface; and,
- One test pit located approximately 11-ft. west of piezometer PZ-4 to a depth of 1.5-ft bgs; groundwater encountered at 10 to 12-inches bgs, no DNAPL observed based on absence of sheen on water surface.

Test pit hand dug into DNAPL collection trench gravel during May 2013 inspection event; groundwater observed with no coal tar or sheen present on water surface.

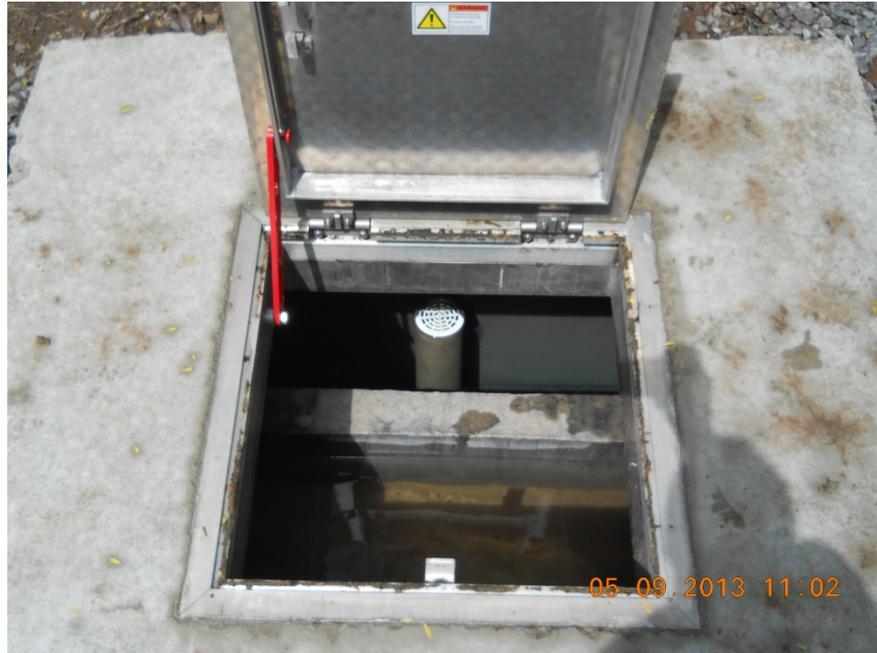
**PHOTO 3**

Collection trench filter sump hatch during May 2013 inspection event.

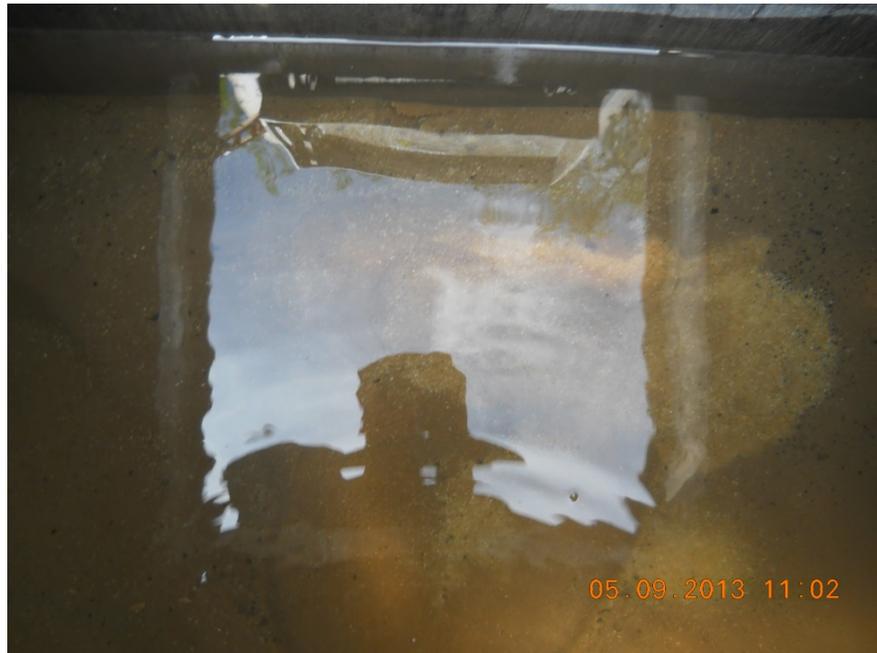
**PHOTO 4**

During the May 2013 inspection period, there was no observation of DNAPL present on the surface of accumulated water in the overflow filter sump. There was no erosion or disturbance of the drainage sump filter media, with only negligible sediment present on the top of the sand media. The overflow section (filtered water discharge chamber) of the sump structure was clear and free of any sediment or solids.

Filter bed material on floor of filter sump in excellent condition during May 2013 event. No observed DNAPL on filter surface and negligible sediment was present.

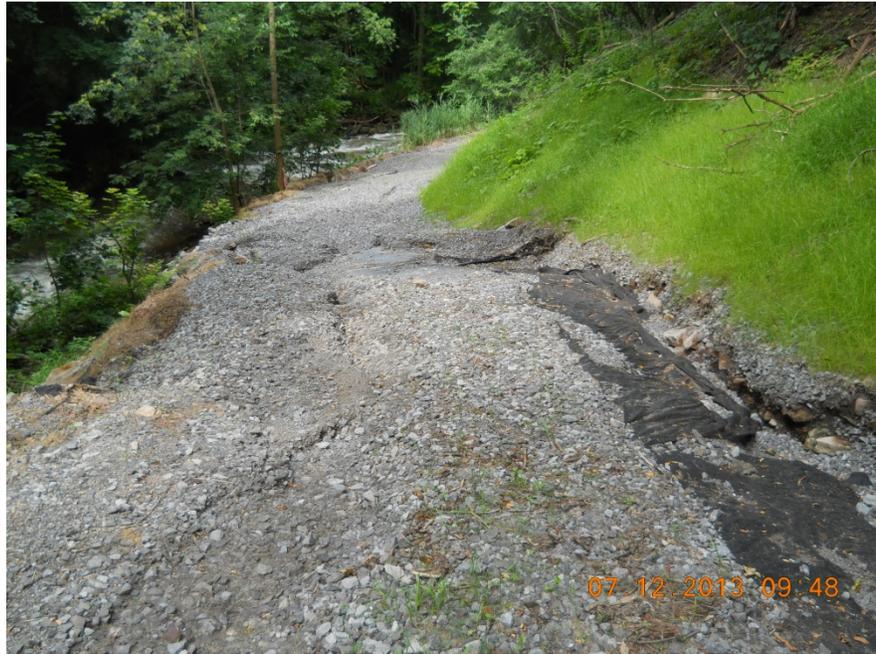
**PHOTO 5**

New DNAPL accumulations were not observed during the July 2013 inspection period along the upgradient slope and toe area of the creek bank north of the DNAPL collection trench, as well as the downgradient portion adjacent to the creek; however, as a result of a severe weather event near the end of June 2013, the creek bank access road exhibited significant erosion, including:

- Section of washed out gravel along access road approx. 100 to 150 ft. from paved portion of upper access road;
- Washed out gravel along access road along downslope to lower creek area, with exposed grout curtain surface visible beneath gravel roadbed; and,
- Areas of gravel washout accumulated adjacent to the edge of the Creek.

Access road erosion observed along downslope to lower creek area during July 2013 inspection event, looking southwest.

In August 2013, Severson performed repairs to the creek bank access road area where significant erosion was noted during the July 2013 inspection period. Repairs included placement of new, coarser gravel along the steep downslope portion of the access road, as well as along the lower creek area along the north side of the creek bank and removal of accumulated gravel adjacent to the Creek.

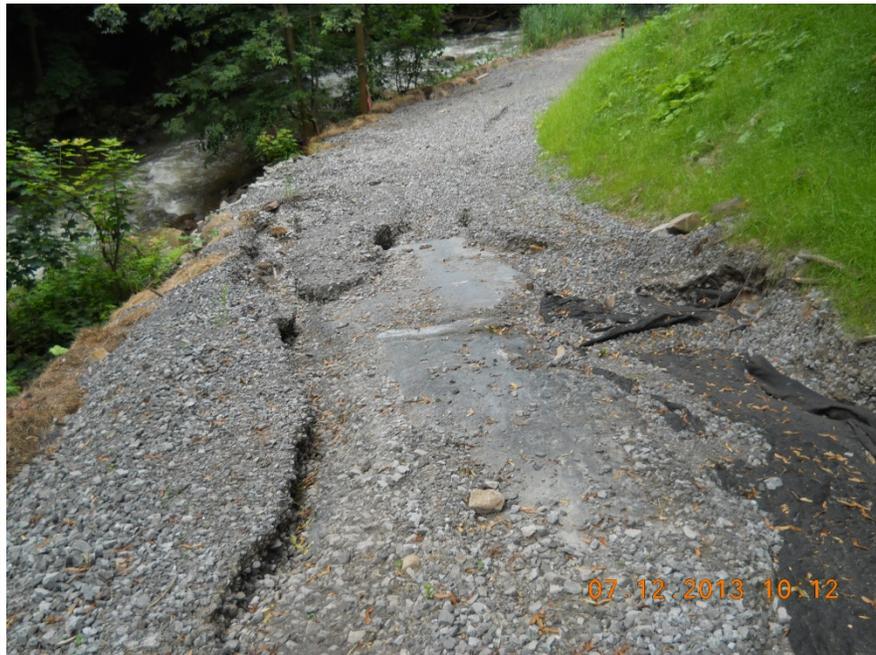
**PHOTO 6**

Access road erosion observed along downslope to lower creek area during July 2013 inspection event, with exposed grout curtain surface visible beneath gravel roadbed, looking southwest.

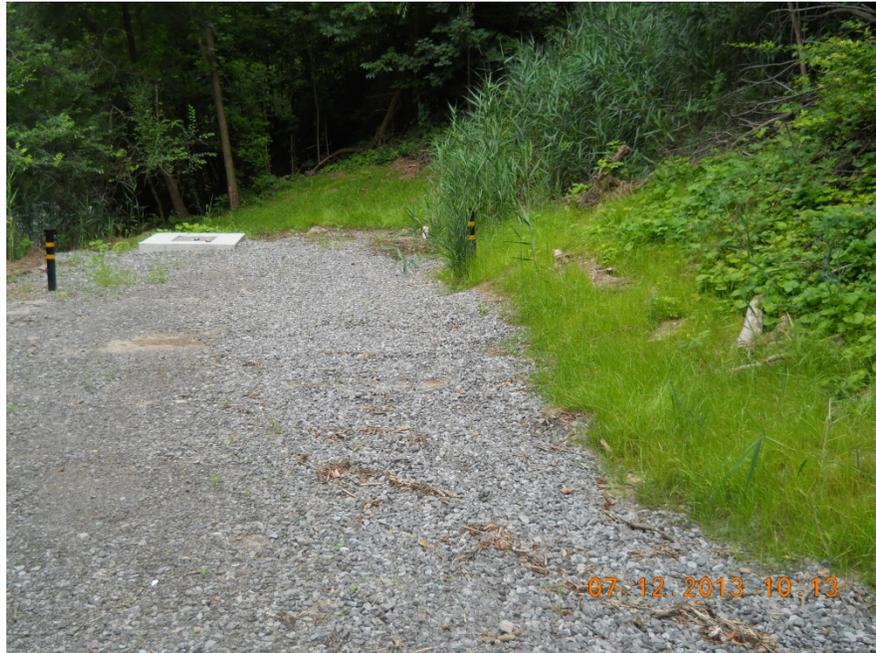
**PHOTO 7**

Condition of access road observed at lower creek area during July 2013 inspection event, with piezometers and filter sump at west end of collection trench alignment, looking west.

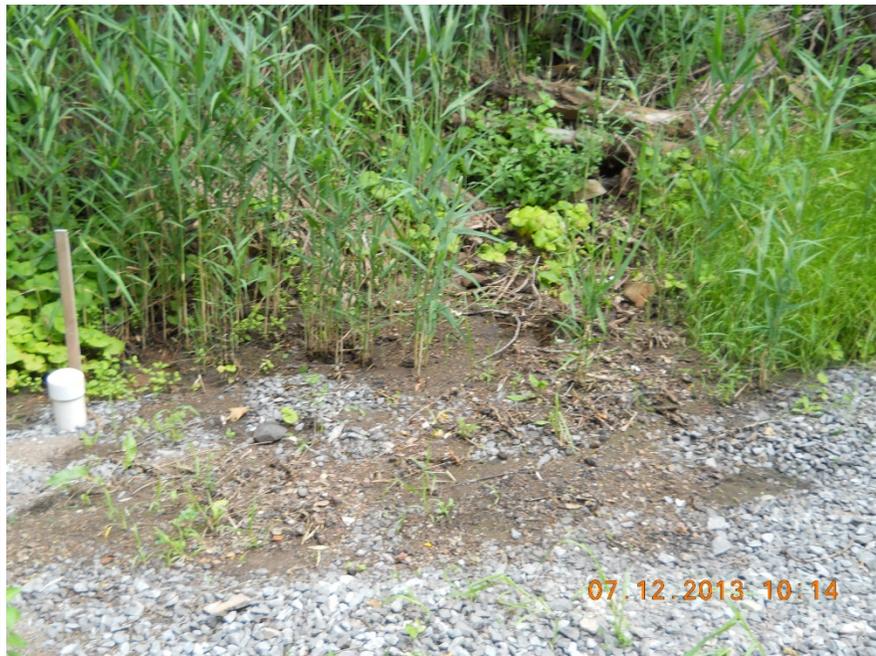
**PHOTO 8**

Condition of embankment toe on north side of collection trench alignment observed at lower creek area during July 2013 inspection event, with no new DNAPL accumulations observed, looking north.

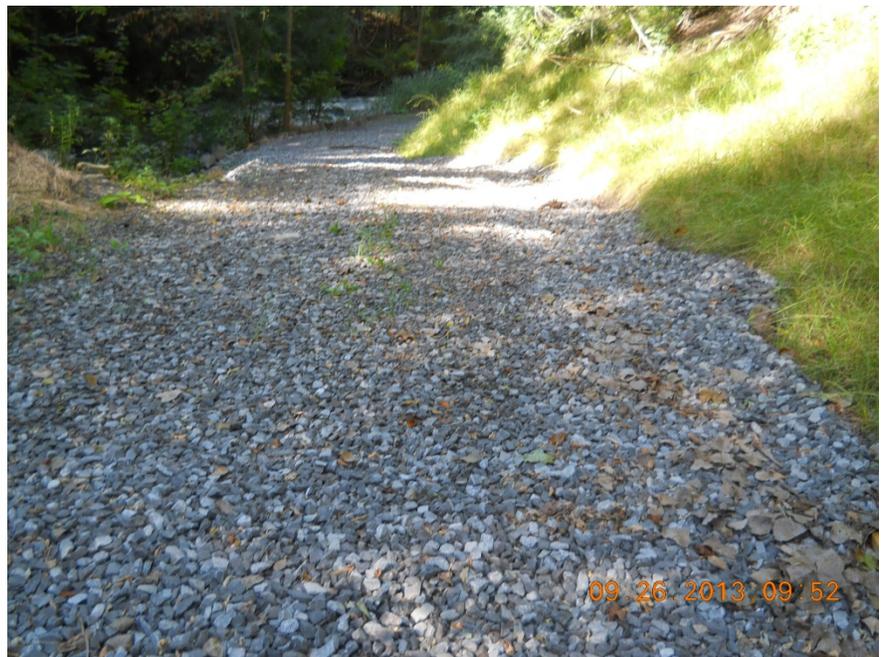
**PHOTO 9**

Following the access road repairs at the site, Golder personnel returned in September 2013 for a follow-up inspection. The access road was observed to be in satisfactory condition with the placement and re-grading of new gravel. In addition, no new DNAPL accumulations were observed during the September 2013 inspection period along the upgradient slope and toe area of the creek bank north of the DNAPL collection trench, although heavy foliage at the time of inspection may have limited full observation of possible small outbreaks. New DNAPL accumulations were not observed along the downgradient portion adjacent to the Creek.

Condition of downslope access road as observed during September 2013 monitoring event, following repairs made in August 2013, looking southwest.

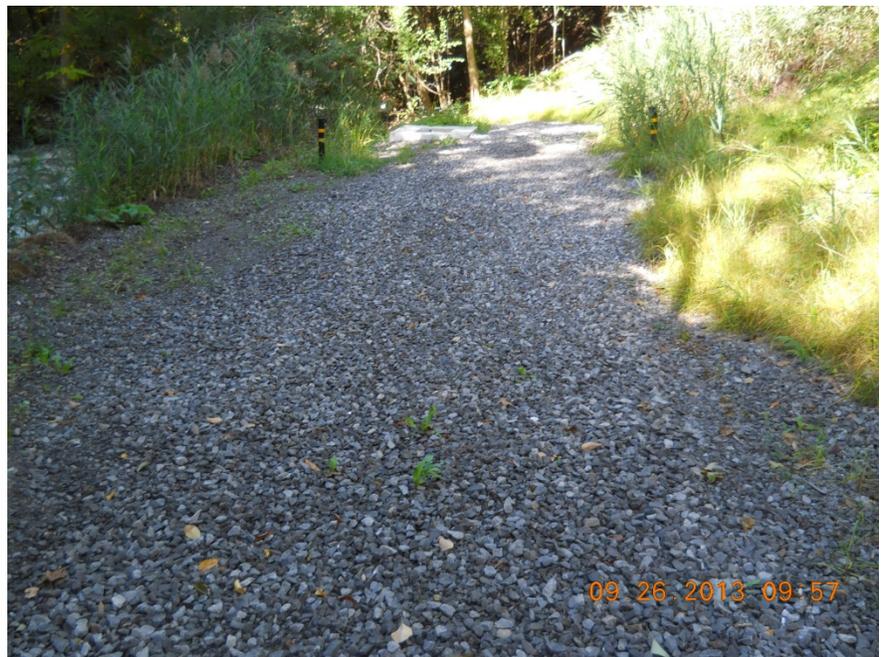
**PHOTO 10**

Condition of lower access road as observed during September 2013 monitoring event, following repairs made in August 2013, looking west.

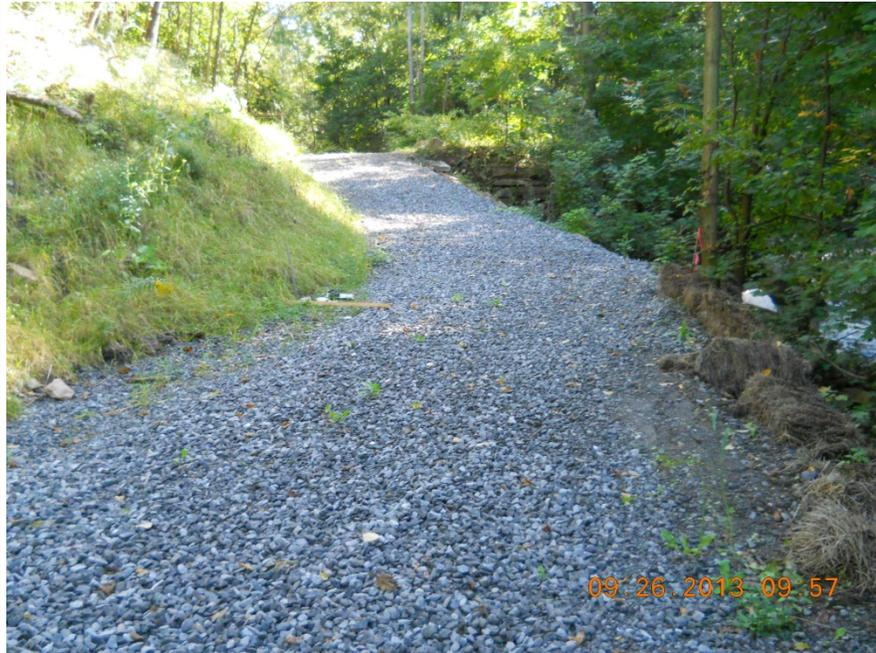
**PHOTO 11**

Repaired condition of downslope access road as observed during September 2013 monitoring event, following repairs made in August 2013, looking east.

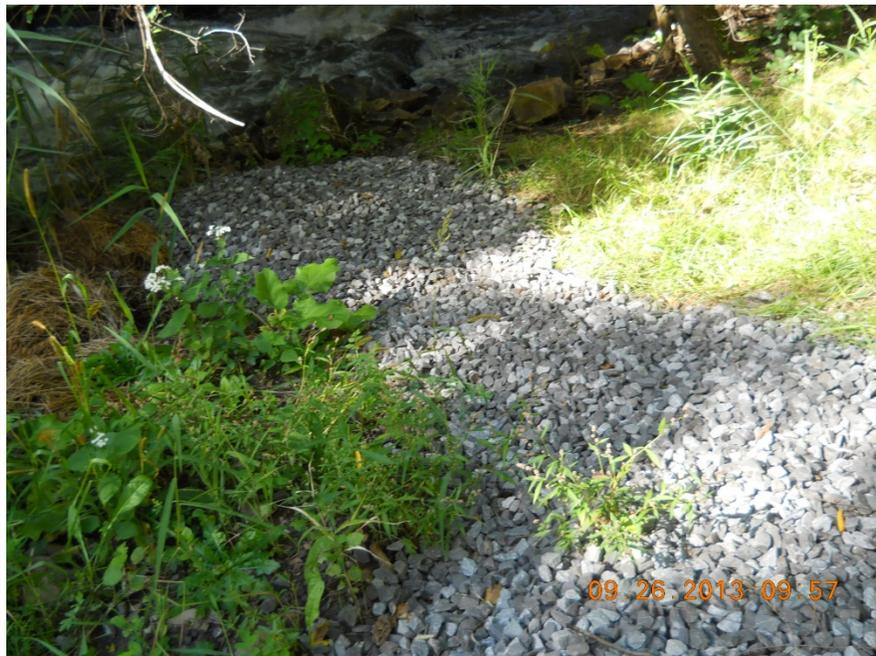
**PHOTO 12**

Repaired condition of lower creek area along north side of creek bank as observed during September 2013 monitoring event, following repairs made in August 2013, looking south.
