ETE Sanitation And Landfill
Town Of Gainesville, New York

Final Remedial Investigation Report

NYSDEC Site #9-61-005
Work Assignment #D002925-24

September 1998

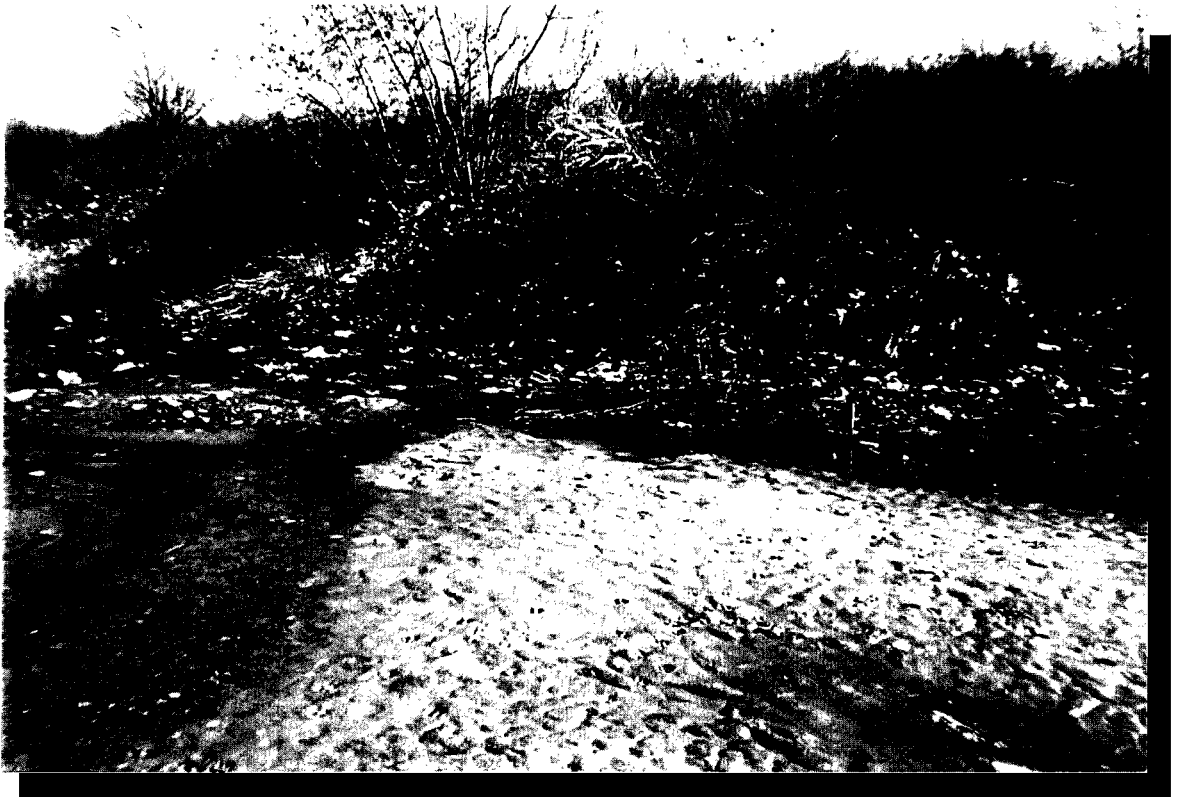
Photo #1
Iron stained soils visible along the landfill's north toe (looking south).

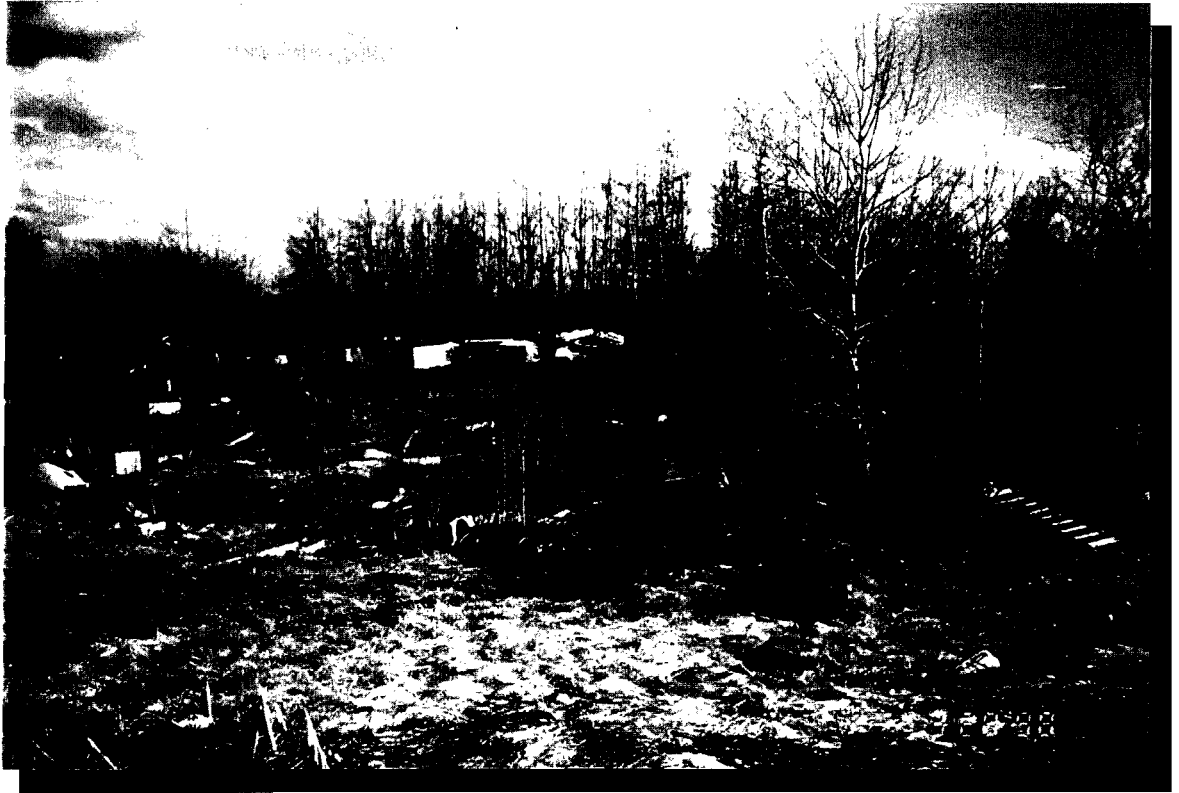
Photo #5
Surface waste littered over the southeast portion of the landfill (looking southeast towards the Town of Gainesville Highway Department garage obscured by the berm).

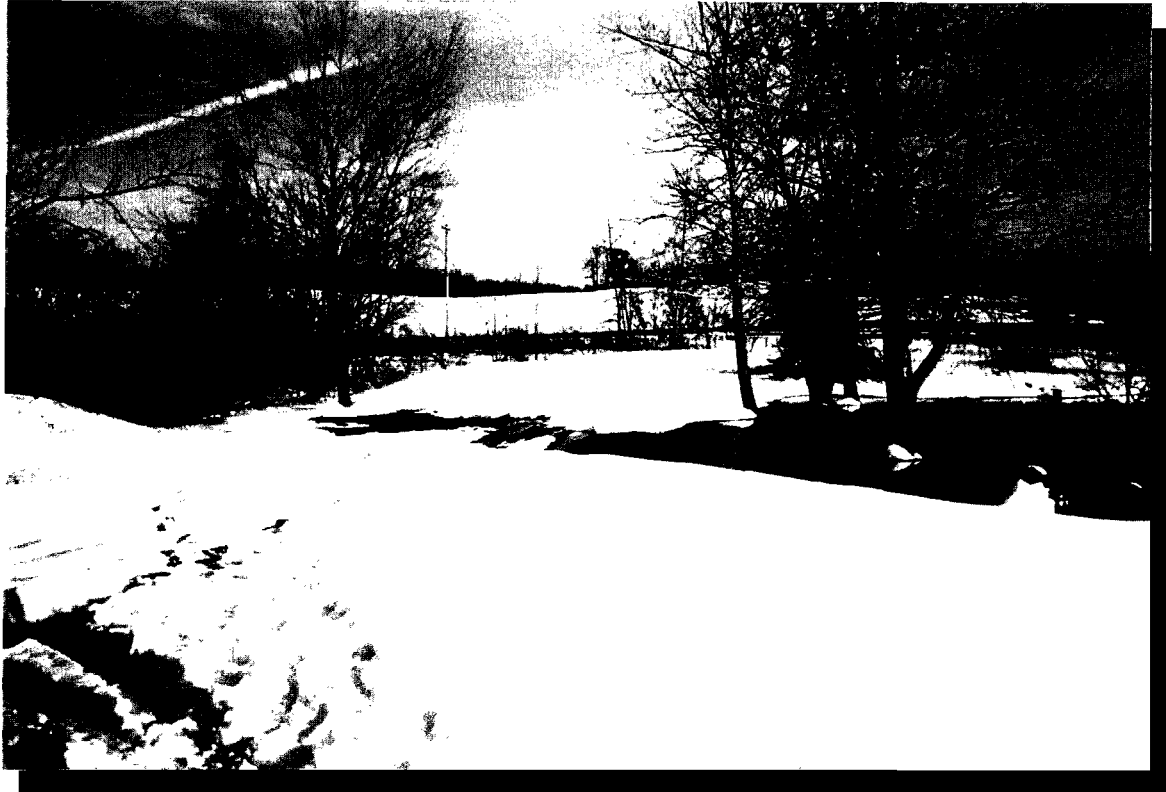
Photo #7
The South Pond overflow (looking south).

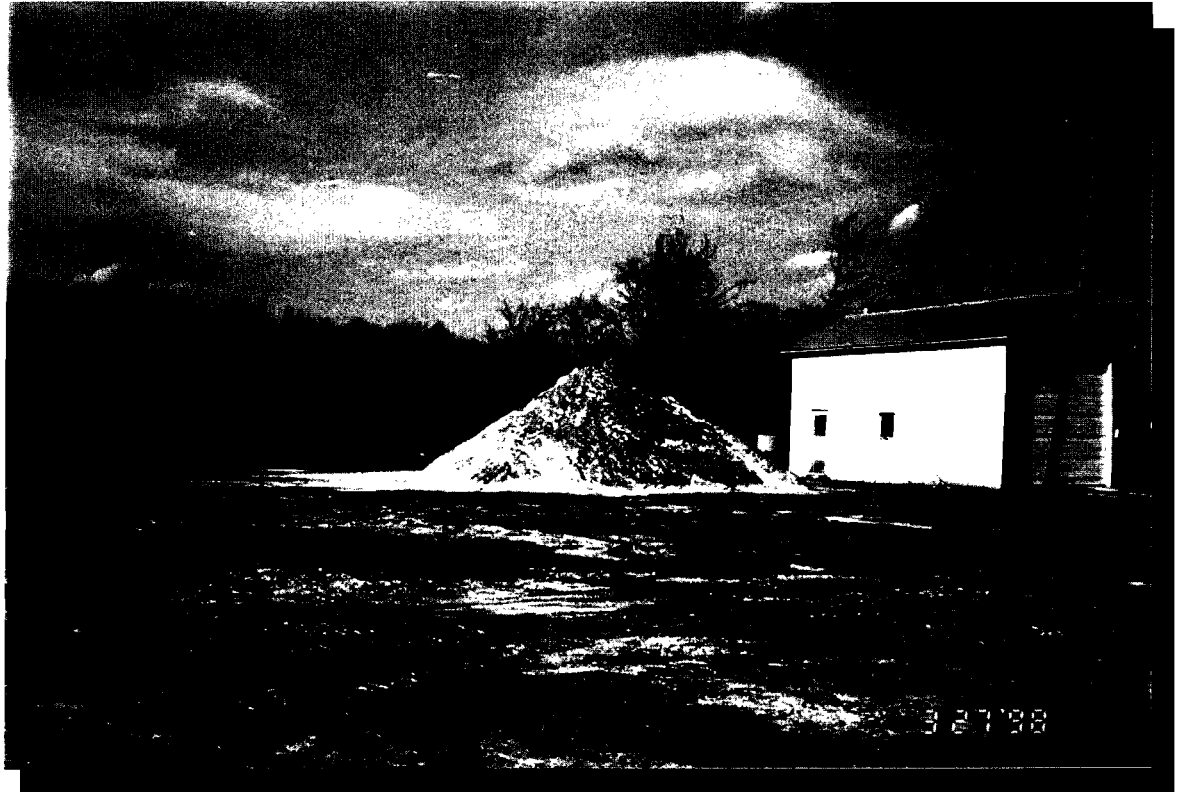
Photo #9
Uncovered road salt and salt precipitate visible near the Town of Gainesville garage (looking northeast).

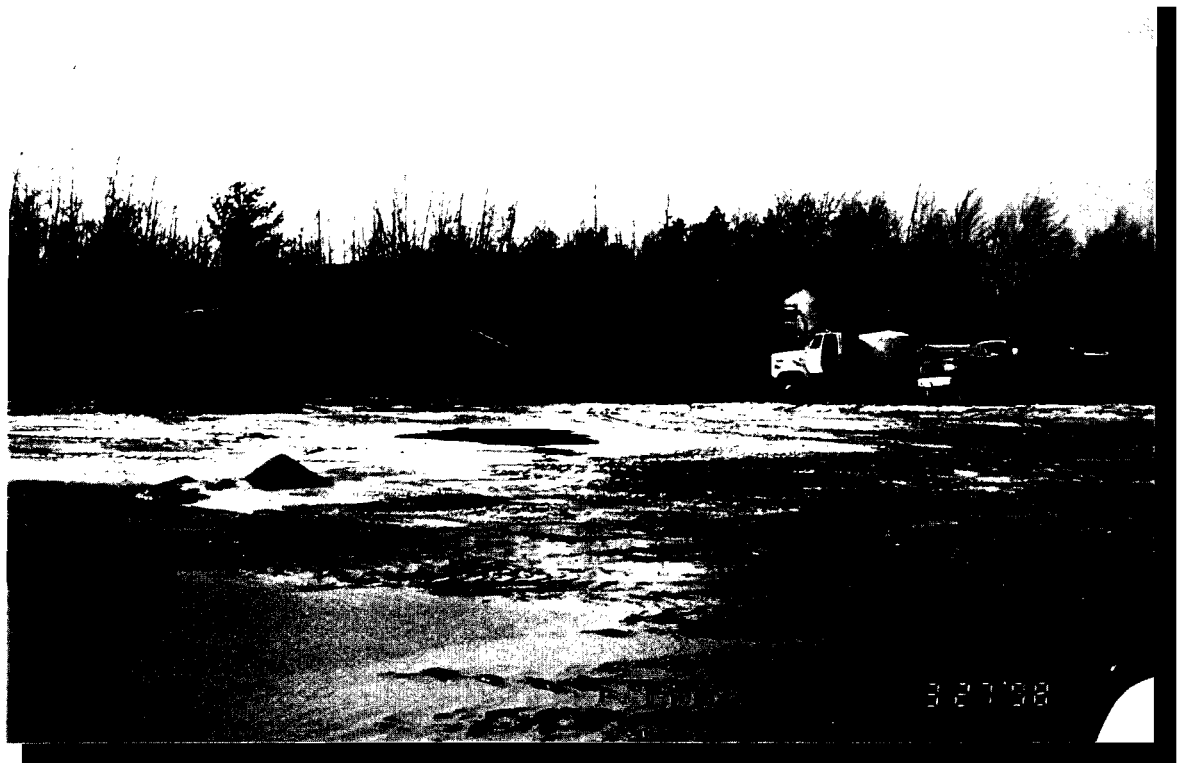
Photo #10
Salt precipitate visible in the Town of Gainesville Highway Department's operations area (looking northwest).
