**SITE INVESTIGATION/
REMEDIAL ALTERNATIVE REPORT**
Richard L. Hanson, Jr. - Fire Training Center
NYS Route 5, Village of Yosts,
Montgomery County, New York

Completion Date – November 7, 2002

Richard L. Hanson Jr. Fire Training Center
Site Investigation/Remedial Alternatives Report

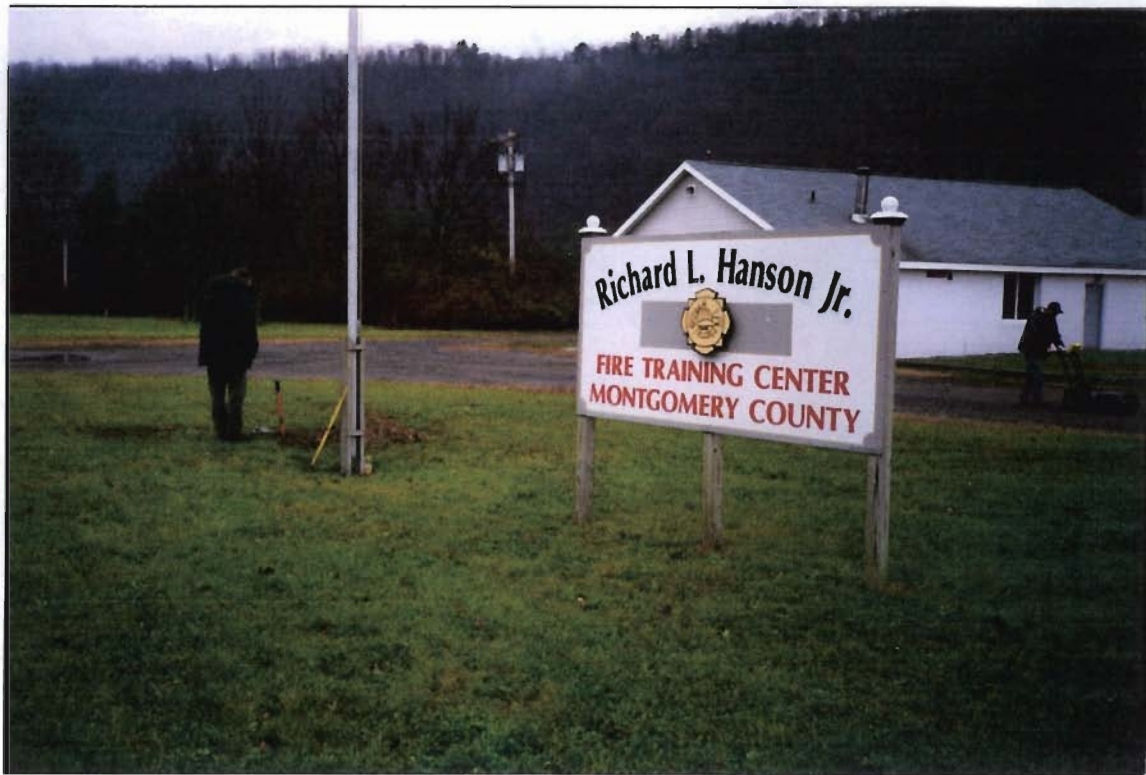
General Site Photo

Note: red shovel handle at UST location and fire training center in the background.

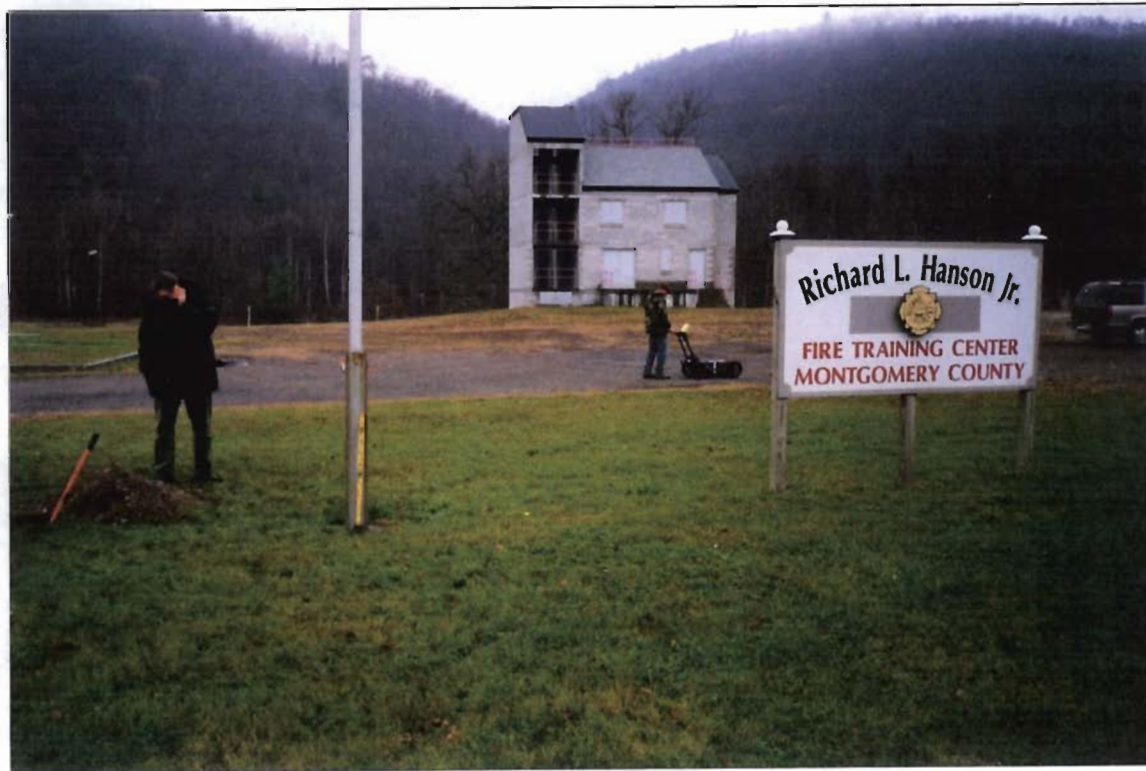
General Site Photo

Note: Ground Penetrating Radar equipment and fire training tower in the background.

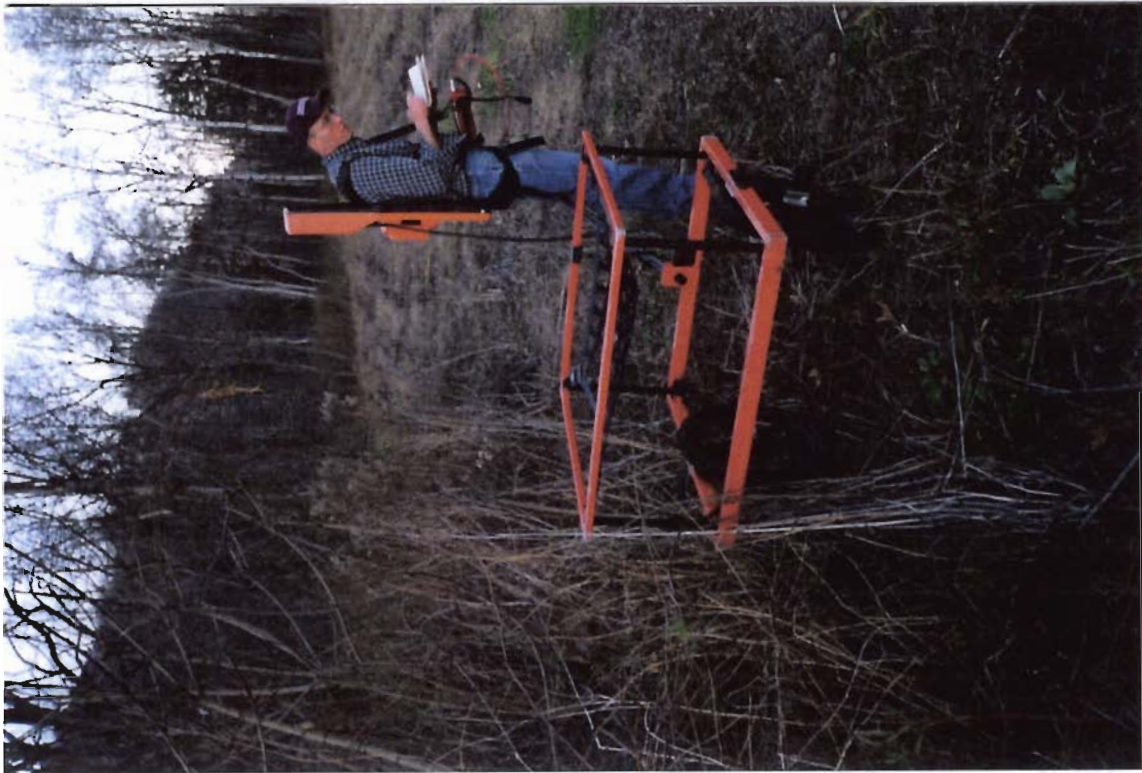
Hager-Richter Geosciences, Inc. geophysicist James Coffman surveying with an EM61 time domain electromagnetic induction metal detector.

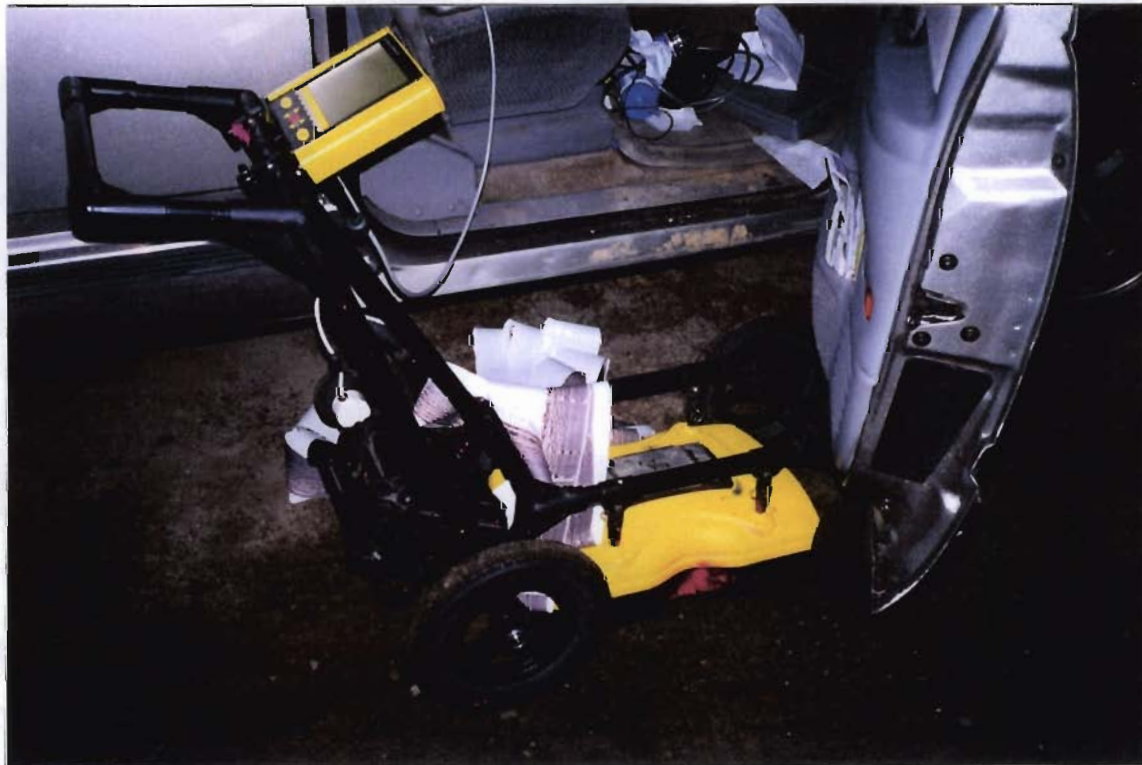
Hager-Richter's Smart Cart Noggin Plus digital subsurface imaging radar system (ground penetrating radar) downloading data to a laptop computer.

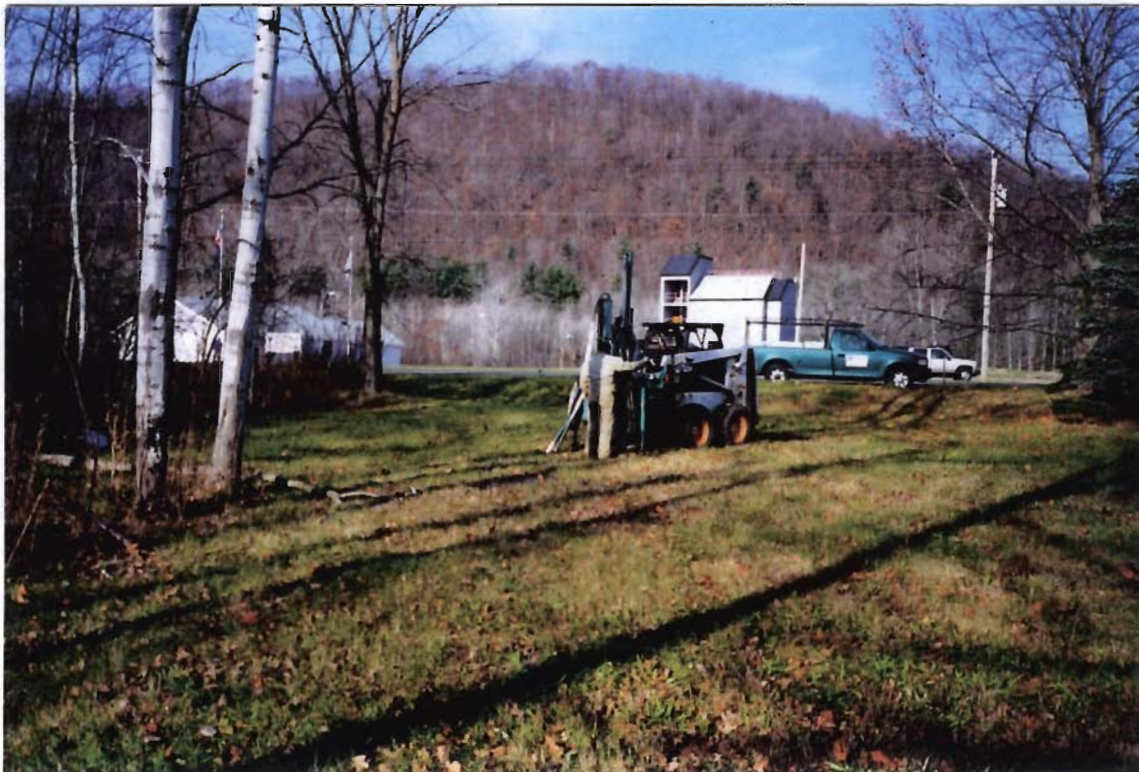
PES Hydrogeologist John Johnson advancing a macro-core soil sample at the location of monitoring well MW-18.

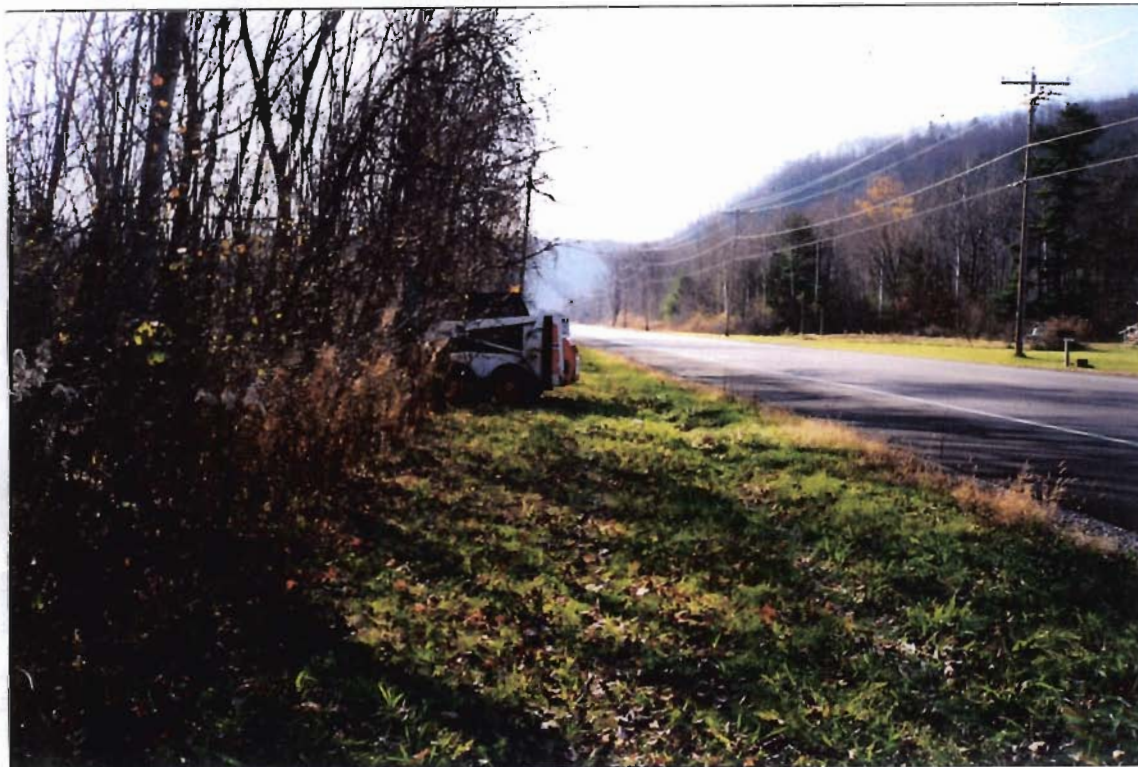
Installation of monitoring well MW-19 located along NYS Route 5.

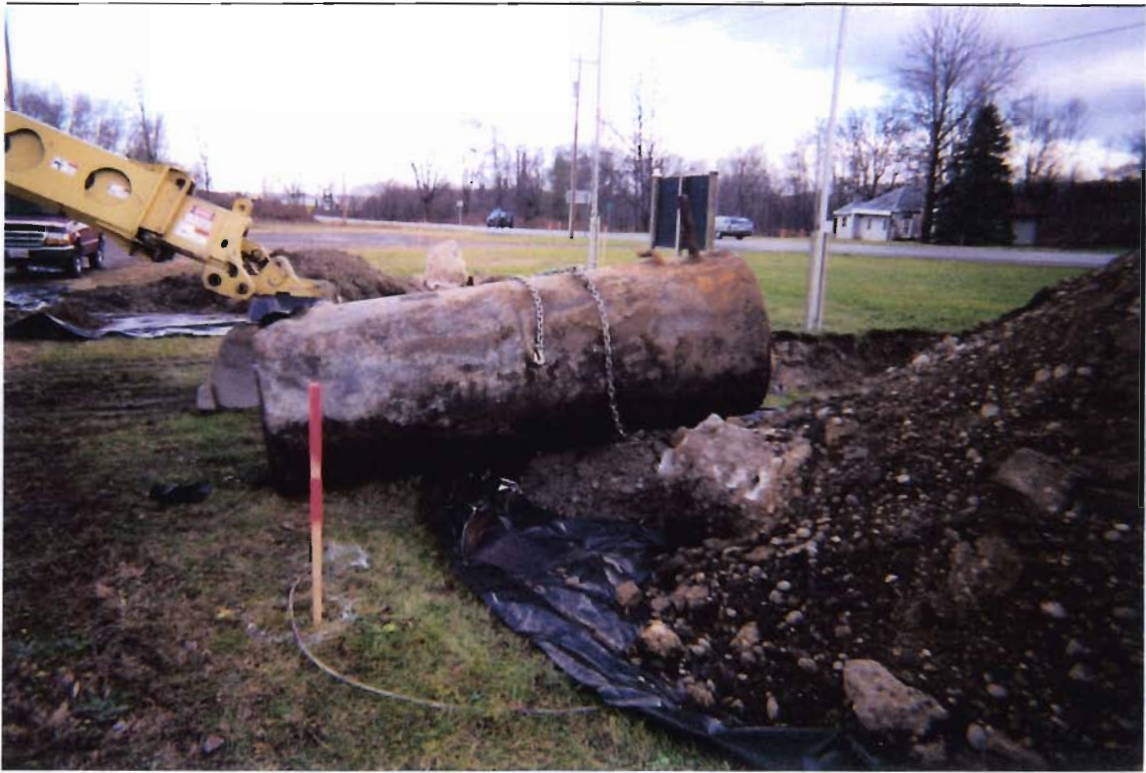
Residual product/tank bottoms were measured/recorded in the UST prior to commencement of the closure process. According to EES approximately 762 gallons of residual heating oil and/or water were evacuated from the UST. The top of the subject UST was exposed, prior to PES mobilizing to the site. Copper product distribution plumbing was observed attached to the UST during the closure process. Based on the piping configuration, the subject UST was assumed to have been utilized as a heating oil storage tank for a historic structure. It should be noted that the fill port and ventilation piping were historically removed prior to discovering the UST and that the resulting piping attachment points were unsecured.

1,000 gallon heating oil UST
Note: contaminated soil excavated from the tank pit and stockpiled on plastic.

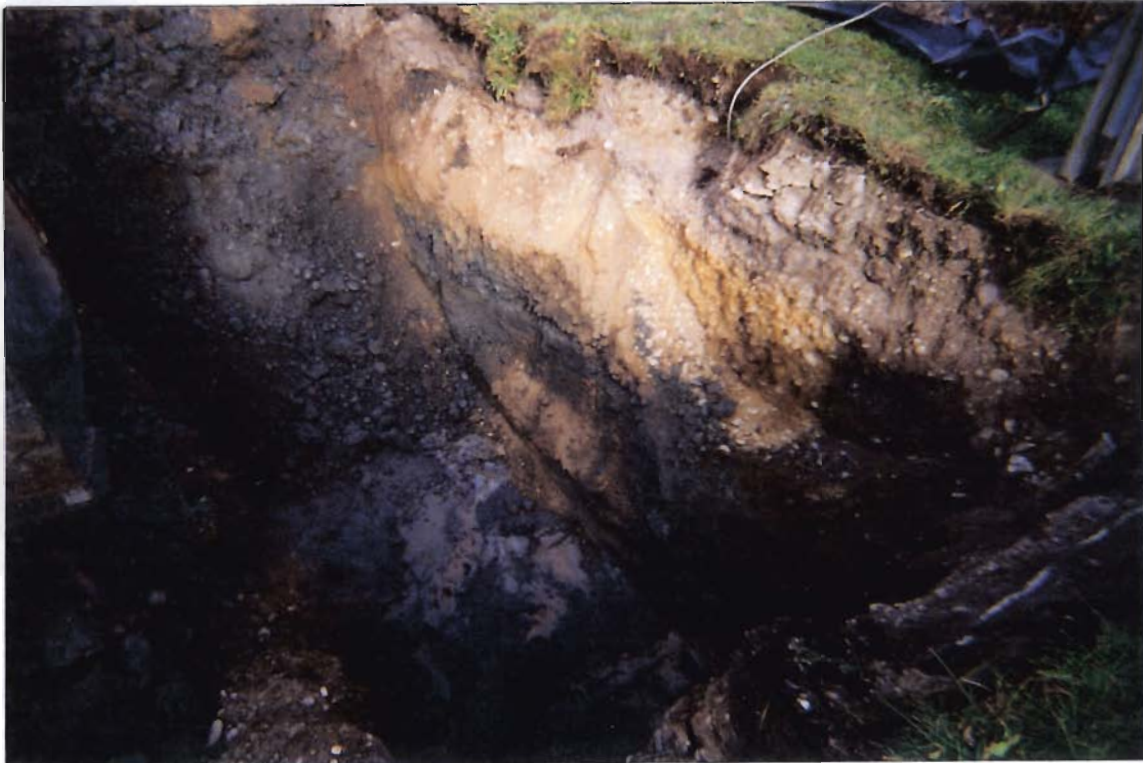
During the closure process MC utilized a rubber-tired grade-all type excavator to remove soil and/or fill material from the tank pit area. In general, native soils exposed in the tank excavation consisted of brown to black petroleum-stained, fine to medium grained sand with lesser occurrences of coarse sand, fine to coarse gravel, silt and clay. The silt and clay content increases with depth and is typically interbedded into discreet layers with the sands. In general, depths of the excavation during the tank removal phase did not exceed eight (8) feet B.G. Minor groundwater was observed seeping into the tank excavation from the base of the sidewalls during the closure process.

Significantly elevated PID responses (150-180 ppm) were obtained for soil collected from adjacent to the UST at depths of 3-6 feet B.G. Visual (stained) and olfactory (odor) evidences of fugitive hydrocarbon impact were observed in excavated/screened soil from the tank grave. Minor amounts of groundwater were encountered/observed in association with the excavation.

Subsurface conditions after excavation of contaminated soil.
Note: residual contamination and stained soil in the sidewalls of the tank excavation.

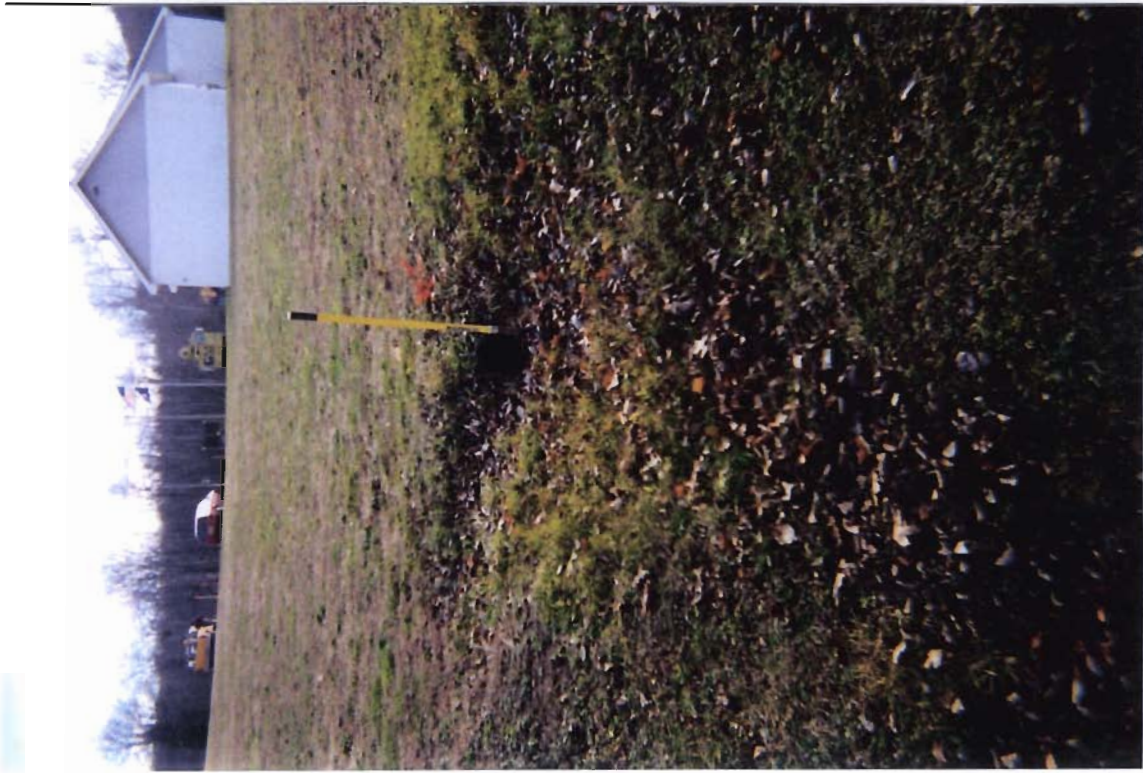
At the request of Mr. Ralph Keating, of the NYS DEC, soil samples were also collected from the base (effluent) of the drainage pipes (Outfall 1 & 2) that convey waters away from the foundations associated with the Hanson Fire Training Center and Fire Tower and to the ponds located at the north end of the Site.

Note: Outfall-1 conveys drainage from the Hanson Fire Training Center north towards a large pond.

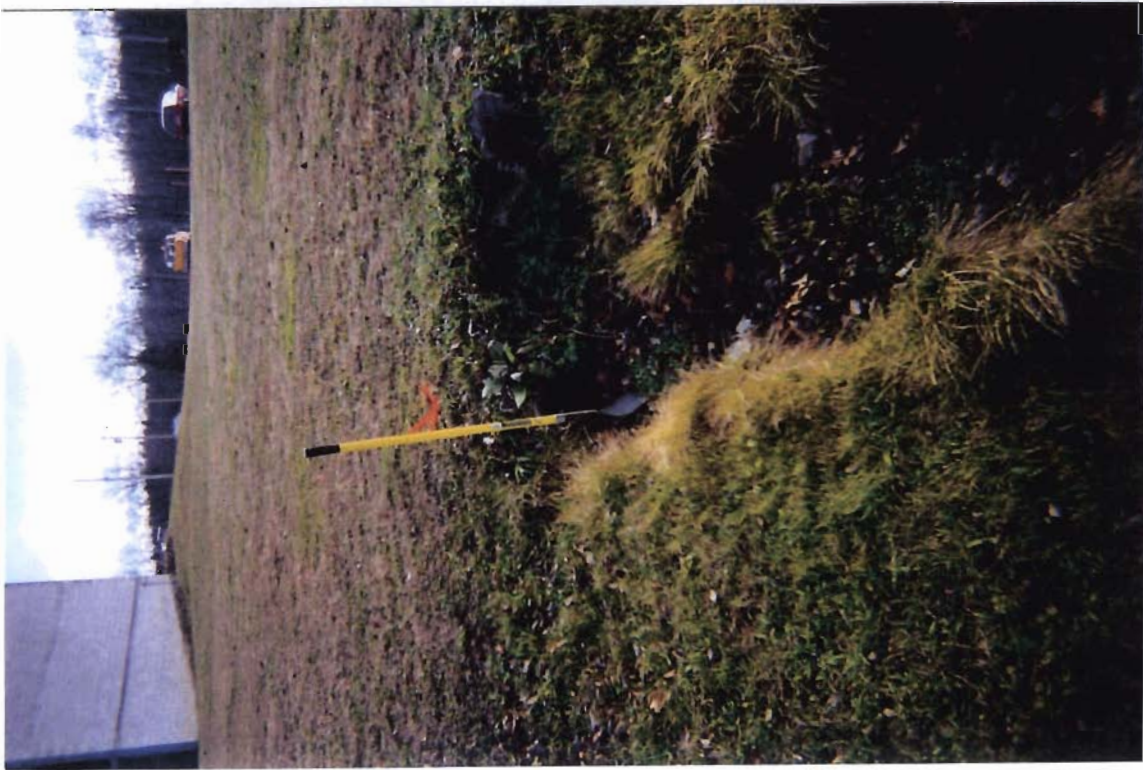
Note: Outfall-2 conveys drainage from the Hanson Fire Training Tower to the same pond.

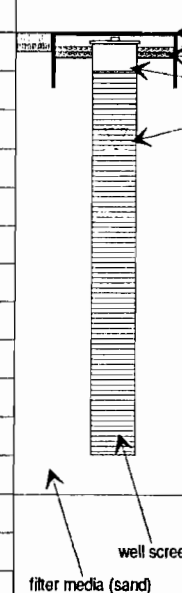
Geoprobe Macro-core-1	ND	Grass and black, moist loamy topsoil (0-6").
2		2 1/4'			Black, moist, fine-coarse SAND and GRAVEL (6"-4').
4				Geoprobe Macro-core-2	ND
6	4 1/4'	Brown/gray, saturated, mottled, CLAY (4.5-7').			
8			Geoprobe Macro-core-3	ND	Brown, saturated, fine SAND (7-8').
10	4 1/4'	Gray, saturated, fine SAND (8-9.5').			
12					Gray, saturated, mottled, CLAY (11.5-12').
14					
16					
18					
20					
22					
24					
26					
28					
30
