**Re: Port-Greenbelt Shoreline Improvement Project  
NFTA Project No. 12PL0202  
NYSDEC SAC #C302569 / NYSDOT PIN 5757.71  
Bell Slip Design Analysis Report  
Phase I Corrective Action for Bank Stabilization**

## DESIGN ANALYSIS REPORT BELL SLIP PHASE I - CORRECTIVE ACTION FOR BANK STABILIZATION

**BELL SLIP  
DESIGN ANALYSIS REPORT**

**CORRECTIVE ACTION FOR BANK STABILIZATION  
PHASE I**

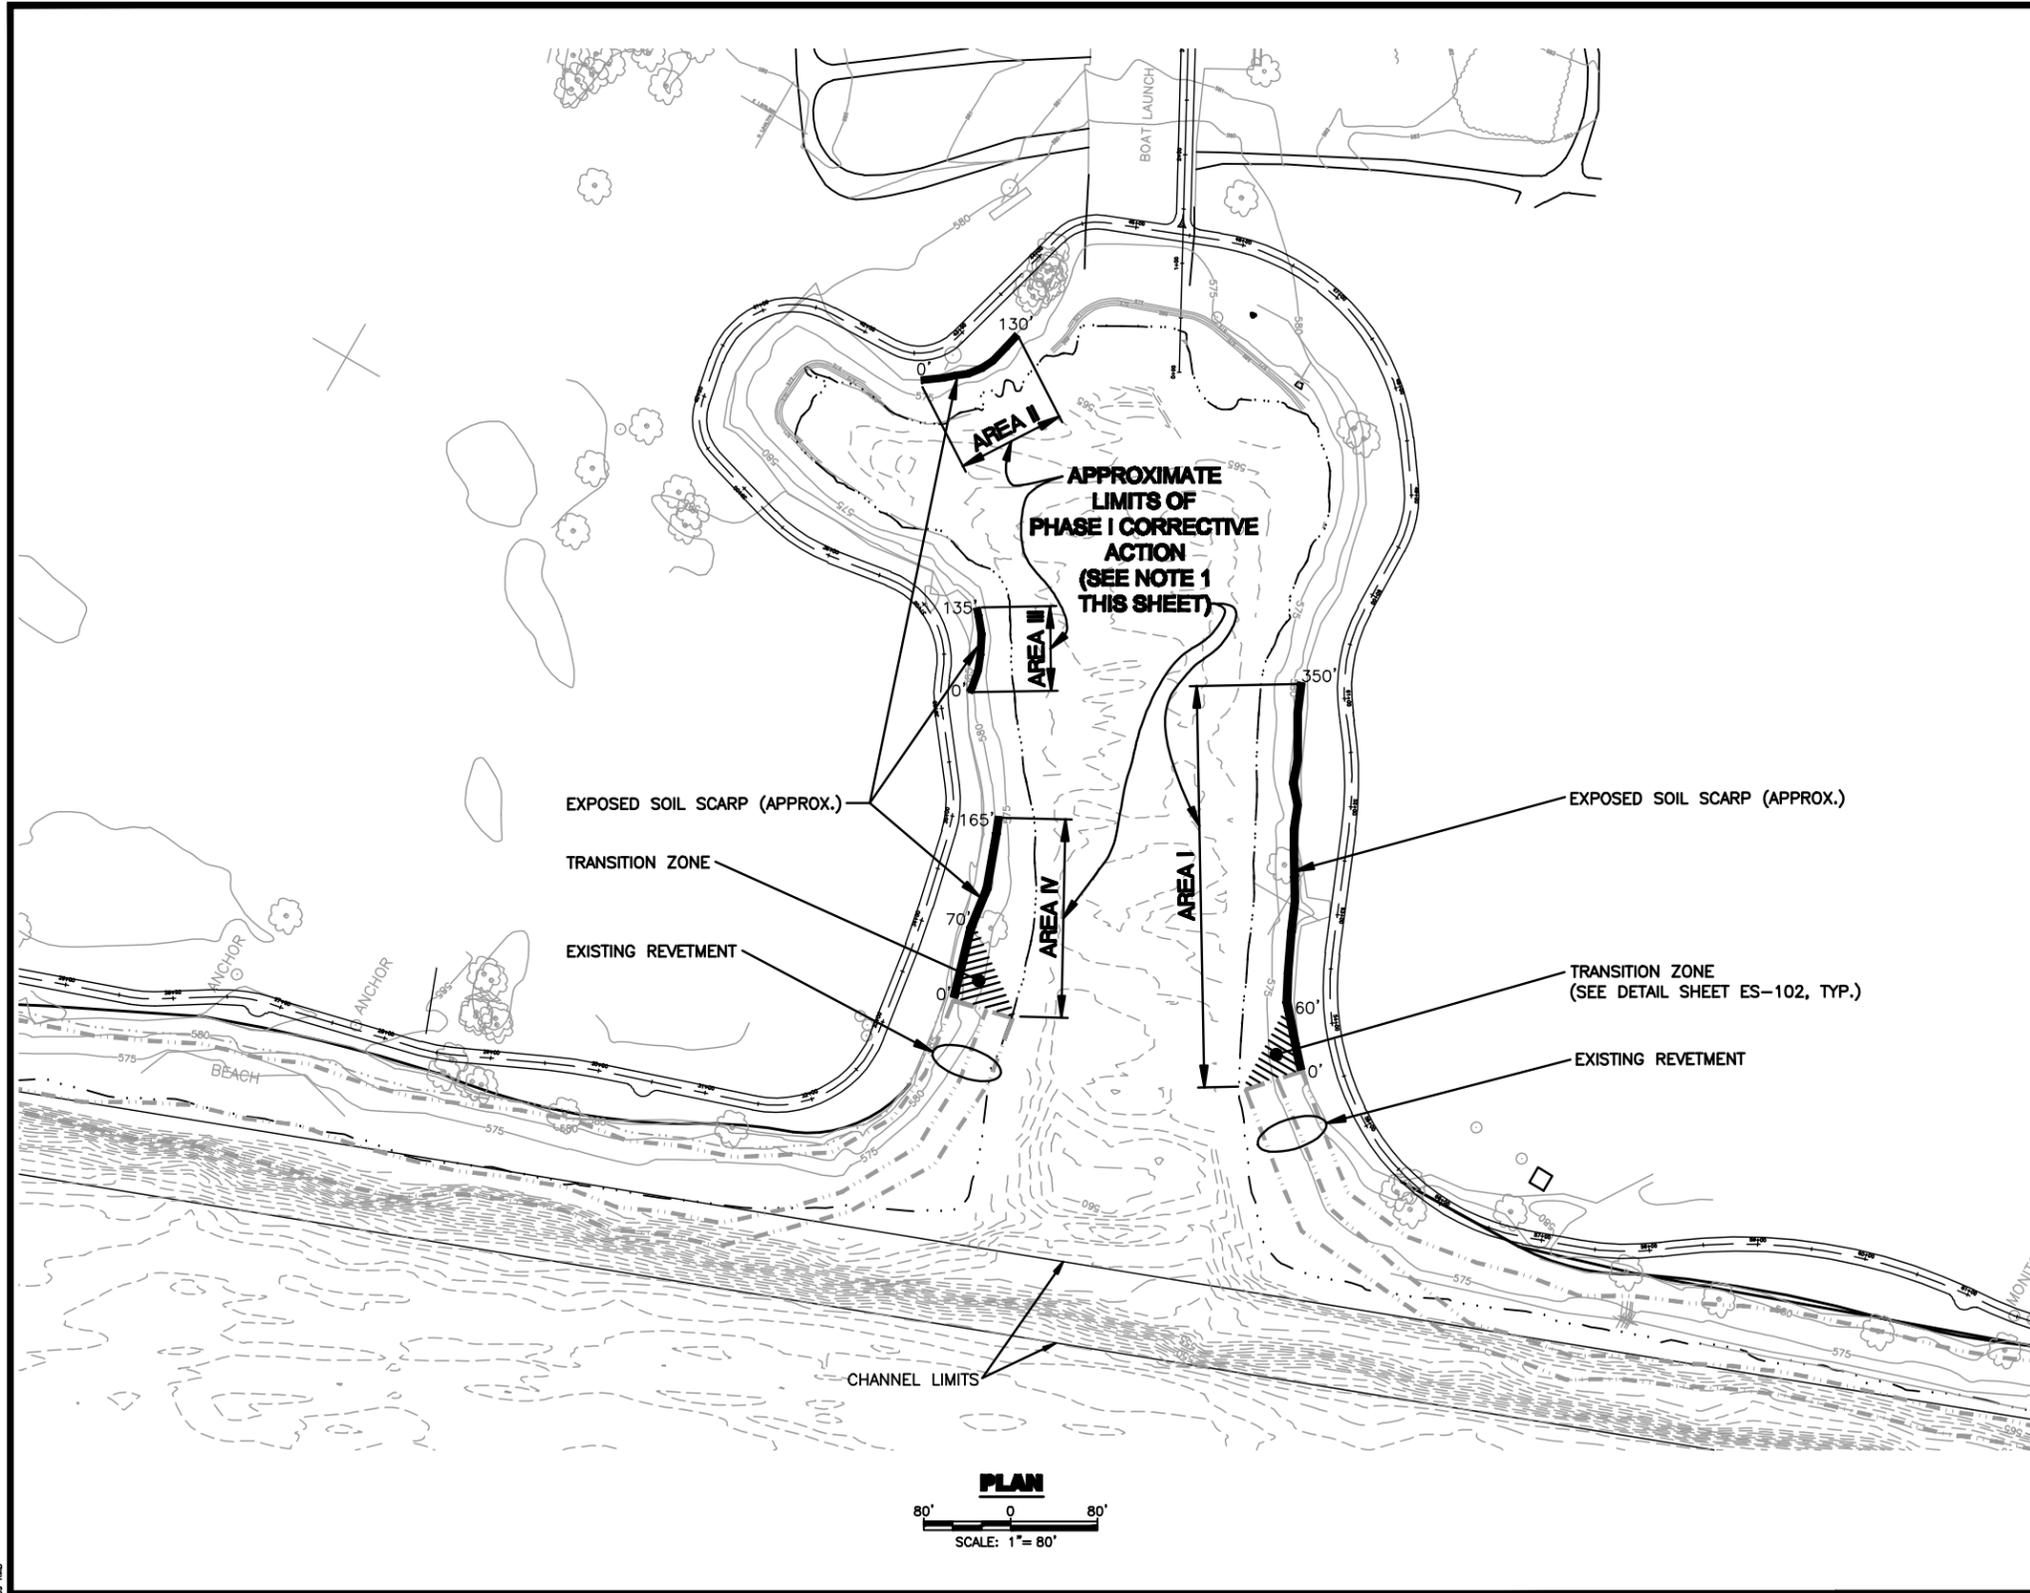
- NOTES**
- LIMITS OF EXPOSED SOIL SCARPS ARE APPROXIMATE. ONLY AND WILL BE DETERMINED BY VISUAL INSPECTION IN THE FIELD. (ESTIMATED LENGTHS: AREA I - 350'; AREA II - 130'; AREA III - 120'; AREA IV - 175'. TOTAL LENGTH - 775').

- A BENCH IS TO BE EXCAVATED IMMEDIATELY ADJACENT TO THE EXPOSED SOIL SCARP WIDE ENOUGH TO ACCOMMODATE THE TWO TO THREE ROWS OF ARMOR STONE. THE BENCH SHOULD BE SLOPED SLIGHTLY TOWARD THE REAR OF THE EXCAVATION. REMOVE DEBRIS, INCLUDING LARGE ROCKS, ROOTS, CLODS, AND STICKS AS NECESSARY TO CREATE A SMOOTH SURFACE FOR PLACEMENT OF THE ARMOR STONES. THE SCARP FACE SHALL BE TRIMMED ONLY AS NECESSARY TO CREATE A RELATIVELY SMOOTH, NEAR VERTICAL FACE. ANY EXCAVATED MATERIAL SHALL BE USED, TO THE EXTENT PRACTICABLE, IN CONSTRUCTING THE BENCH. ANY EXCESS STONE RUBBLE SHALL BE PLACED AT THE DOWNSLOPE TOE OF THE ARMOR STONE.

- All exposed soil scarps will be protected by installation of a limited armor stone revetment. Preliminary inspection has identified four primary areas of exposed soil scarps totaling about 775 lineal feet. (Estimated lengths: AREA I - 350'; AREA II – 130'; AREA III – 120'; AREA IV – 175'. Total Length – 775'). The actual limits of work will be determined by NFTA personnel in the field by visual inspection.

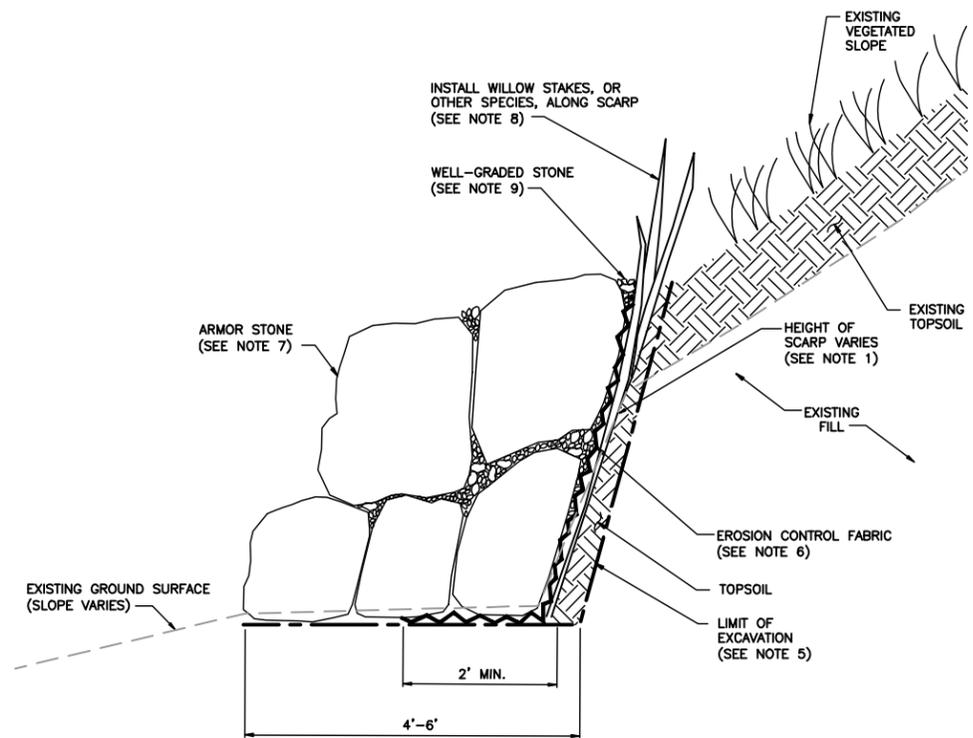
**TYPICAL CORRECTIVE ACTION DETAIL  
(SCARP > 3' HEIGHT)**

- INSTALL A 'NATURAL' FIBER EROSION CONTROL FABRIC (ROLANKA BioD-MAT (90) OR EQUIVALENT) AT BACK OF EXCAVATION. PIN THE FABRIC (TEMPORARILY) AT THE TOP OF THE REAR EXCAVATION SURFACE AND DRAPE IT DOWN THE SLOPE AND ABOUT TWO FEET ONTO THE FLOOR OF THE EXCAVATED BENCH.

- INSTALL ARMOR STONE ON THE BENCH. THE STONES ARE TO BE POSITIONED A FEW INCHES FROM THE BACK EXCAVATED SURFACE TO ALLOW INSTALLATION OF WILLOW STAKES. THE STONES ARE TO BE CLOSELY SPACED WITH OVERLAPPING VERTICAL AND HORIZONTAL JOINTS. FOR AREAS WHERE THE SCARP EXCEEDS 3 FEET IN HEIGHT, INSTALL ADDITIONAL LAYER(S) OF ARMOR STONE SUCH THAT IT EXTENDS TO, OR SLIGHTLY ABOVE, THE TOP SURFACE OF THE VEGETATED SLOPE. THE ACTUAL AMOUNT OF STONE WILL BE DETERMINED IN THE FIELD BASED ON SITE CONDITIONS.

- AFTER PLACING THE FIRST ROW OF ARMOR STONE ADJACENT TO THE SCARP, PULL THE EROSION CONTROL FABRIC AWAY FROM THE REAR SOIL SLOPE AND INSTALL WILLOW STAKES BETWEEN THE FABRIC AND THE SOIL SLOPE AT BACK OF EXCAVATION. SELECT LENGTHS SUCH THAT THEY EXTEND FROM THE BENCH TO ABOUT ONE TO TWO FEET ABOVE THE SLOPE. STAKES SHALL CONSIST OF UPLAND WILLOW FOR DRIER AREAS (I.E. >3' ABOVE LAKE LEVEL) AND SANDBAR WILLOWS FOR WETTER AREAS (I.E. <3' ABOVE LAKE LEVEL). PLACE AT SPACING OF TWO PER LINEAL FOOT. TREAT THE STAKES WITH ROOTING HORMONE PRIOR TO INSTALLATION. BACKFILL THE REMAINING ANNULAR SPACE BETWEEN THE ARMOR STONES AND EXCAVATED SURFACE WITH MOIST TOPSOIL.

- CHINK VOIDS IN EACH LAYER OF ARMOR STONE WITH 6-INCH MINUS RUN-OF-CRUSH STONE IMMEDIATELY AFTER IT IS PLACED, AND PRIOR TO PLACEMENT OF SUBSEQUENT LAYERS.

- PLACE LAYER OF BEDDING STONE ON TOP OF ARMOR STONE AND GRADE TO MATCH EXISTING SLOPE AT REAR OF WORK AREA.
  - IN TRANSITION ZONES, LEAVE EXISTING STONE RUBBLE IN-PLACE. REMOVE ANY DEBRIS (E.G. DRIFTWOOD, PLASTIC, ETC.) AND GRADE TO CREATE A SMOOTH SURFACE FOR PLACEMENT OF ARMOR STONE. ADDITIONAL BEDDING STONE SHALL BE PLACED, AS NECESSARY, TO ENSURE A MINIMUM OF ONE FOOT OF BEDDING STONE SIZE ROCK BENEATH THE ARMOR STONE.

A description of the proposed Phase I Corrective Action is presented below in a step-by-step format. The rationale for selecting each component also is included. The proposed design is presented graphically on Drawing ES-102.

- A bench will be excavated immediately adjacent to the exposed soil scarp wide enough to accommodate two to three rows of armor stone (approximately 4 – 6 feet). The width of the bench will be adjusted based on the height of the exposed soil scarp. The higher the scarp, the more armor stone that will be required to cover the scarp face and accordingly, the wider the bench to provide support for the armor stone. The bench will be sloped slightly toward the rear of the excavation to prevent rolling or rotational movement of the armor stones toward the water. The Contractor will remove debris, including large rocks (> 6-inch size), roots, clods, and sticks as necessary to create a reasonably smooth surface for placement of the armor stones. The scarp face will be trimmed only as necessary to create a relatively smooth, near vertical face for placement of the willow stakes. Any excavated material will be used, to the extent practicable, in constructing the bench. No fine grained material will be left exposed on the slopes where it can be eroded and washed into the waters of the Slip. Any excess stone rubble will be placed at the downslope toe of the armor stone. This will help to minimize any erosion, washout or undercutting of the armor stone.

- The contractor will place a ‘natural’ fiber erosion control fabric (Rolanka BioD-Mat (90) or equivalent) at back of excavation on the prepared surface. The contractor will pin the fabric (temporarily) at the top of the rear excavation surface and drape it down the slope and about two feet onto the floor of the excavated bench. (This product was selected based on its use of natural coconut fiber, expected life of 4 – 7 years and a mesh opening of about 0.3 by 0.4 inches.) (Attachment C).

- The contractor will install armor stone consistent with the original contract specification Section 02487, on the bench. (This will simplify the construction as the armor stone is a standard contract item and is readily available in sufficient quantity from a local quarry in Lockport, NY. Additionally, the armor stone has performed satisfactorily over the past two years in the stone revetment installed on the Outer Harbor slopes. The contractor will position the stones a few inches from the back excavated surface to allow installation of willow stakes. The contractor will closely space and interlock the stones to the extent practicable during installation. In areas where the scarp exceeds 3 feet in height, the contractor will install additional layer(s) of armor stone such that they extend to, or slightly above, the top surface of the vegetated slope. In these areas, overlapping vertical and horizontal joints will be staggered. Additionally, the top of the armor stone will be matched to the top of scarp. Bedding stone will be used to fill in areas where the top of the armor stone is slightly lower than the top of the scarp. The actual amount of stone will be determined in the field based on site conditions.

- After placing the first row of armor stone adjacent to the scarp, the contractor will pull the erosion control fabric away from the rear soil slope and install willow stakes between the fabric and the soil slope at back of excavation. The contractor will select stake lengths such that they extend from the bench to about one to two feet above the slope. The stakes will consist of upland willow for drier areas (i.e. >3’ above lake level) and sandbar willows for wetter areas (i.e. < 3’ above lake level). URS will provide a qualified Landscape Architect, and/or Wetland Biologist to guide the selection process. The willow stakes will be placed at a spacing of two per lineal foot, to enhance the potential for surviving the winter, to increase habitat and to provide erosion control. The stakes will be treated with rooting hormone prior to installation to trigger some root growth this fall, if possible. The contractor will backfill the remaining annular space between the armor stones and excavated surface with moist topsoil. This will provide a better growing media for the Willow stakes, and enhance root growth.

- The contractor will ‘chink’ the voids in each layer of armor stone with 6-inch minus run-of-crush limestone immediately after each layer of armor stone is placed, and prior to placement of subsequent layers. This well-graded stone mixture (Attachment C) will act as a graded filter, thereby restricting the flushing of soil from upslope areas through the voids in the armor stone and ultimately into the waters of the Slip. This stone is durable, readily available, relatively low cost, and well-graded right from the quarry. (It was suggested that topsoil be added to the ‘chinking’ mixture and that individual willow stakes be installed in the open spaces between the armor stones in an effort to increase vegetative growth and habitat. However, the NYSDEC indicated that only the willow stakes at the scarp/armor stone interface need to be installed at this time. This was based on concerns of the topsoil washing out and resulting in siltation of the Muskellunge spawning areas, increased difficulty/cost of construction, and the fact that the next phase of the corrective action would focus on additional plantings/habitat issues.)

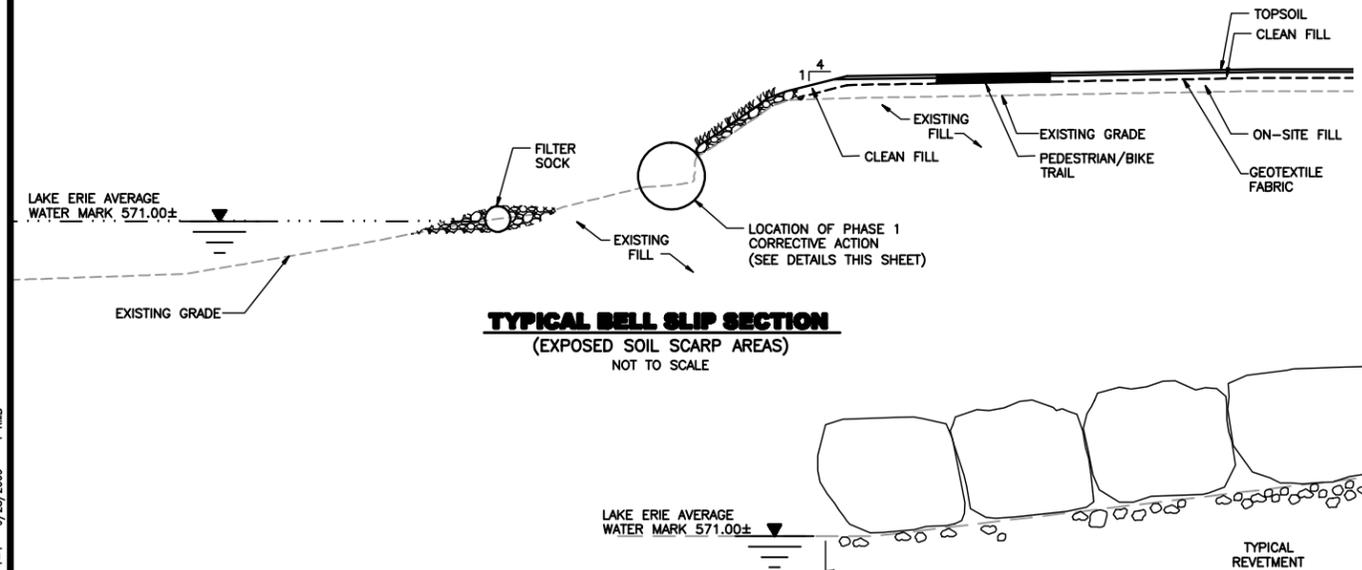
**TYPICAL BELL SLIP SECTION  
(EXPOSED SOIL SCARP AREAS)**

THIS PROJECT INCLUDES:  
PHASE I - CORRECTIVE ACTION CONSISTING OF HEAVY ARMOR STONE COMBINED WITH STONE FILTER MEDIA AND PLANTINGS TO STABILIZE EXISTING EXPOSED SOIL SCARPS.

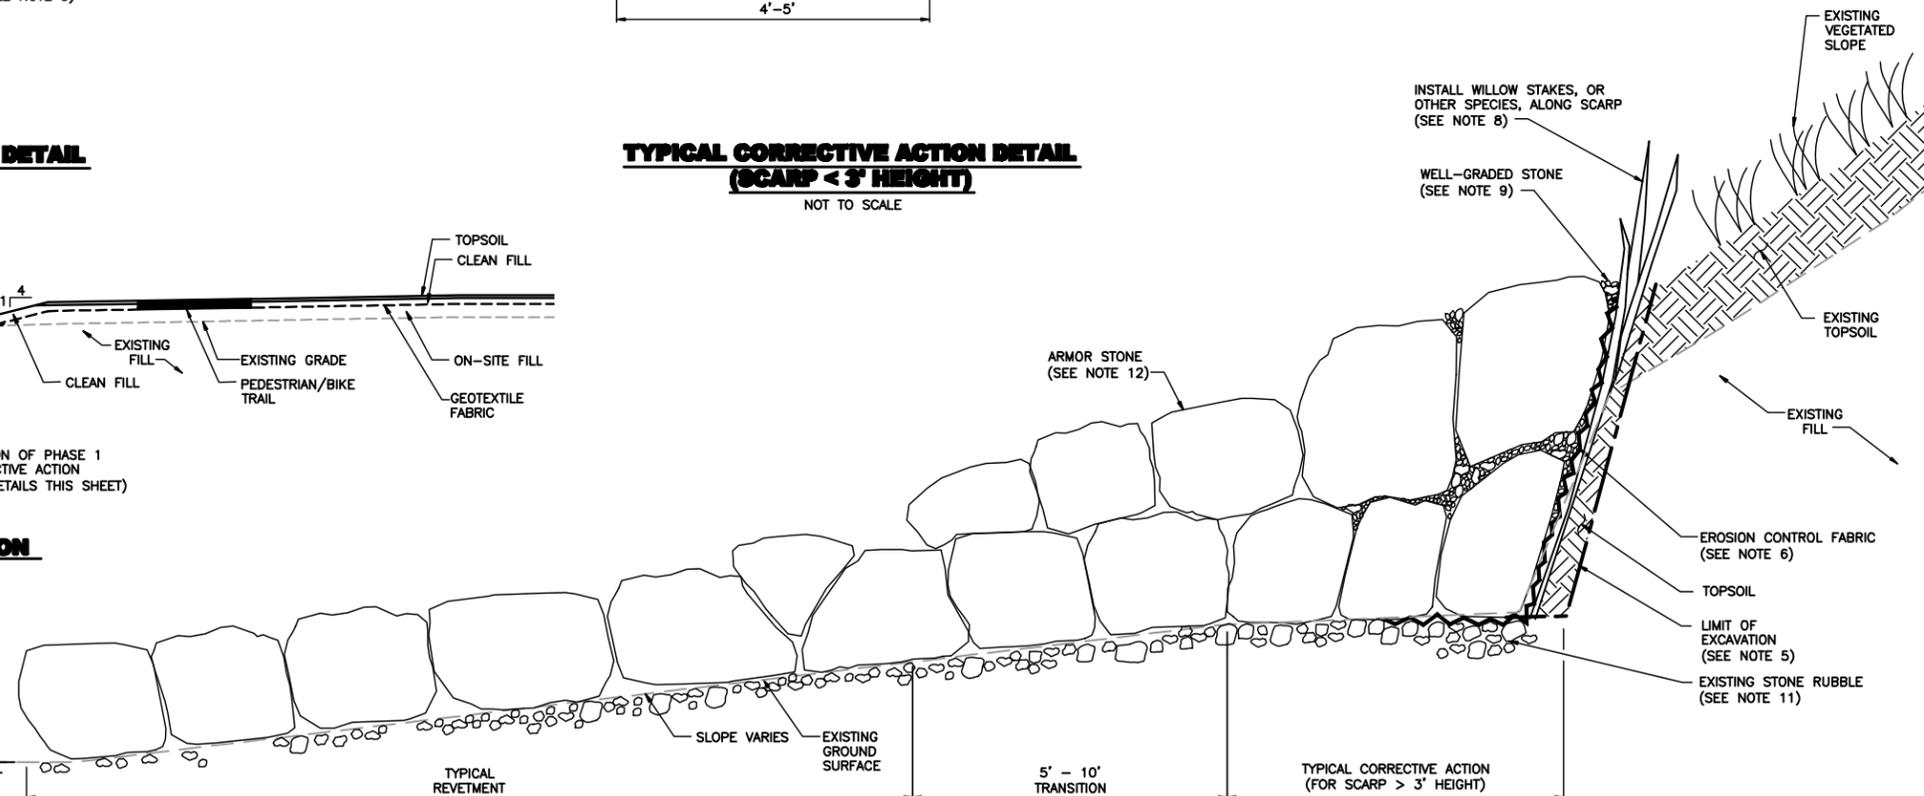
**TYPICAL TRANSITION ZONE DETAIL**

- ARMOR STONE IN TRANSITION ZONES IS TO BE PLACED TO AVERAGE 3-FOOT THICKNESS IN ACCORDANCE WITH EXISTING SPECIFICATIONS. USE EXISTING STONE RUBBLE AS SUB-BASE TO THE EXTENT PRACTICABLE (SEE NOTE 11). ARMOR STONES ARE TO BE INTEGRATED INTO EXISTING STONE REVETMENT TO CREATE A CONTINUOUS REVETMENT.

- The contractor will create transition zones tying the existing stone revetment on the Outer Harbor slopes into the Phase I corrective action on both the north and south sides of the Bell Slip. These zones will extend from the edge of the existing stone revetment for about 60 – 70 feet inland. The intent of these zones is to smooth out the wave action at the end of the existing revetment, and reduce the erosive forces on the slope. In these transition zones, the contractor will leave in place the existing stone rubble (typ. 4 – 12 inches in size) on the slope. The contractor will remove any non-stone debris (e.g. driftwood, plastic, etc.) and grade the stone rubble to create a smooth surface for placement of armor stone. The contractor will place additional bedding stone, as necessary, to ensure a minimum of one foot of bedding stone-size rock exists beneath the armor stone.

- The contractor will place the armor stone in the transition zones to an average 3-foot thickness in accordance with existing specifications. The contractor will use the existing stone rubble as sub-base to the extent practicable (see note above). The new armor stones will be integrated into existing stone revetment to create a continuous revetment.

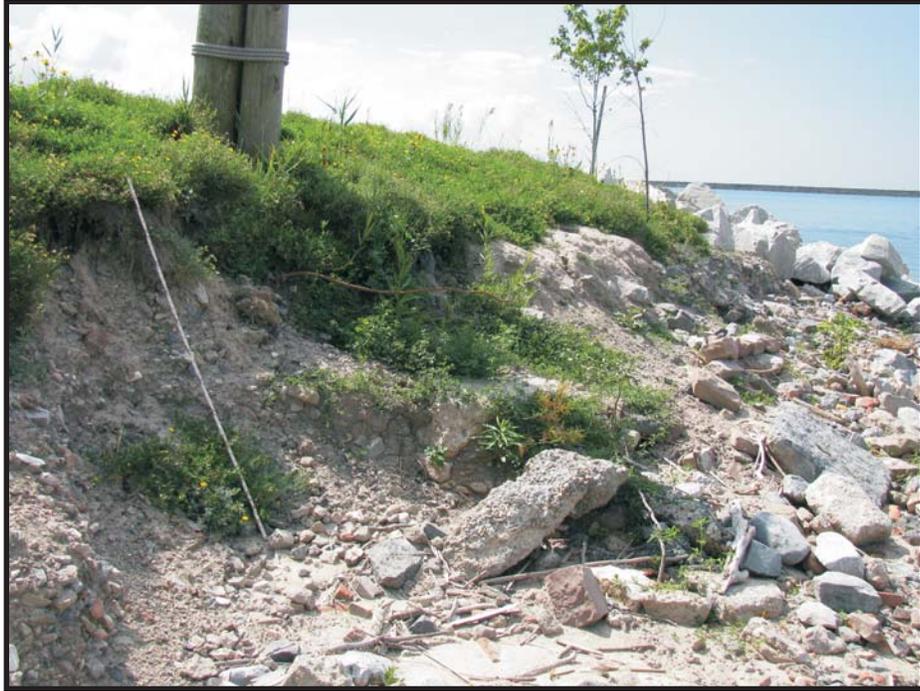
Photo 5: Western portion of Area I, near outer stone revetment (looking west).

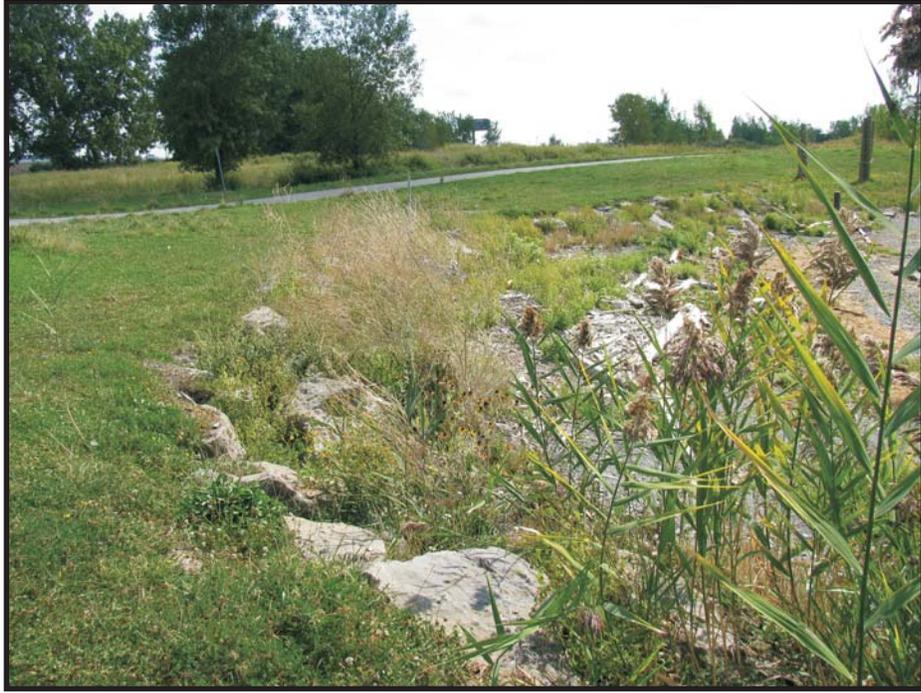
Photo 9: Typical in-filled armor stone at eastern end of slip (looking south).

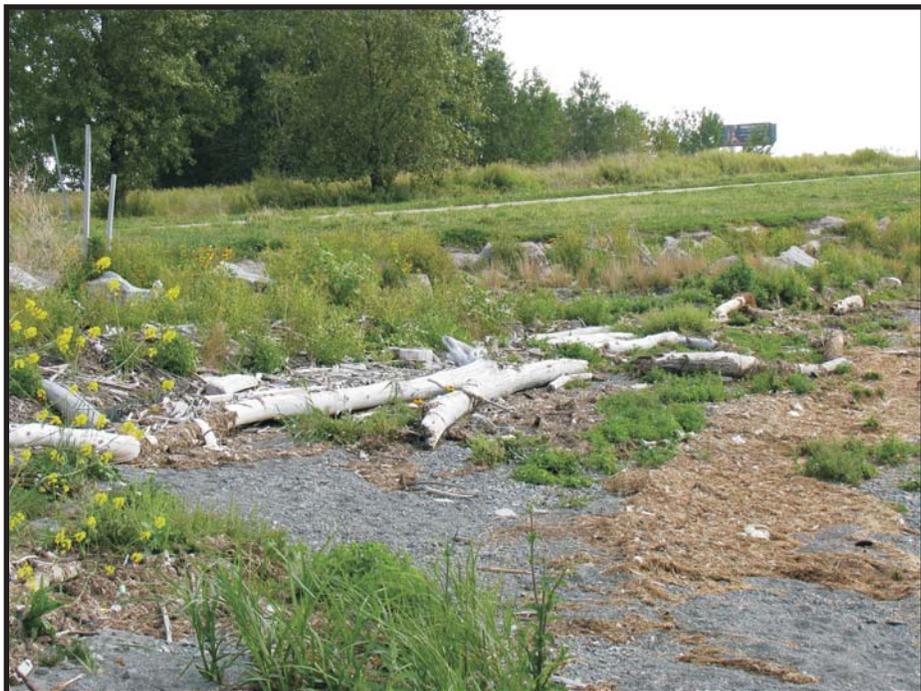
Photo 10: Typical in-filled armor stone at east end of slip (looking southeast).

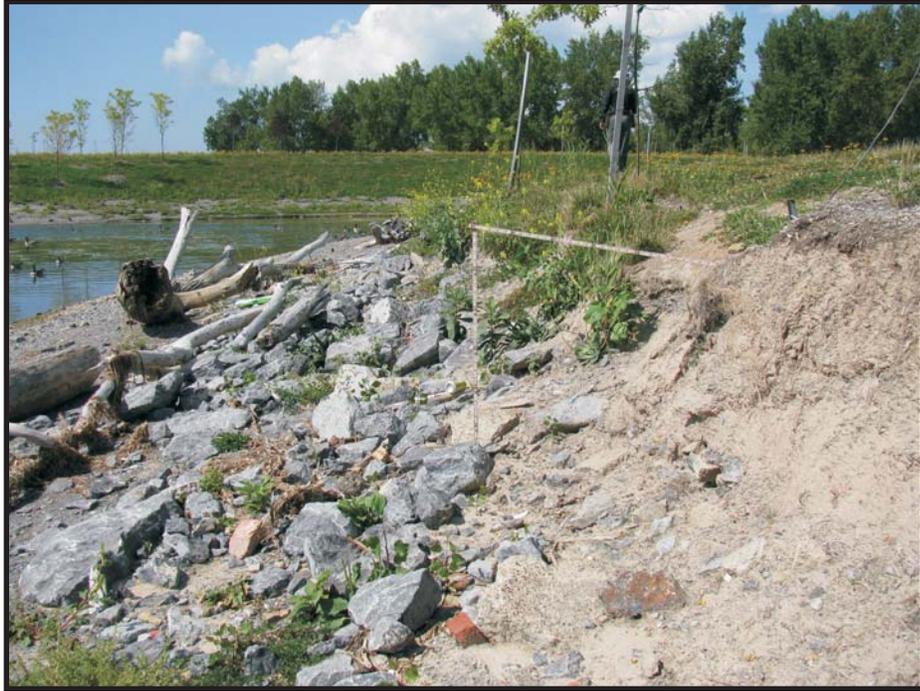
Photo 11: Typical exposed soil scarp in Area II (looking north).

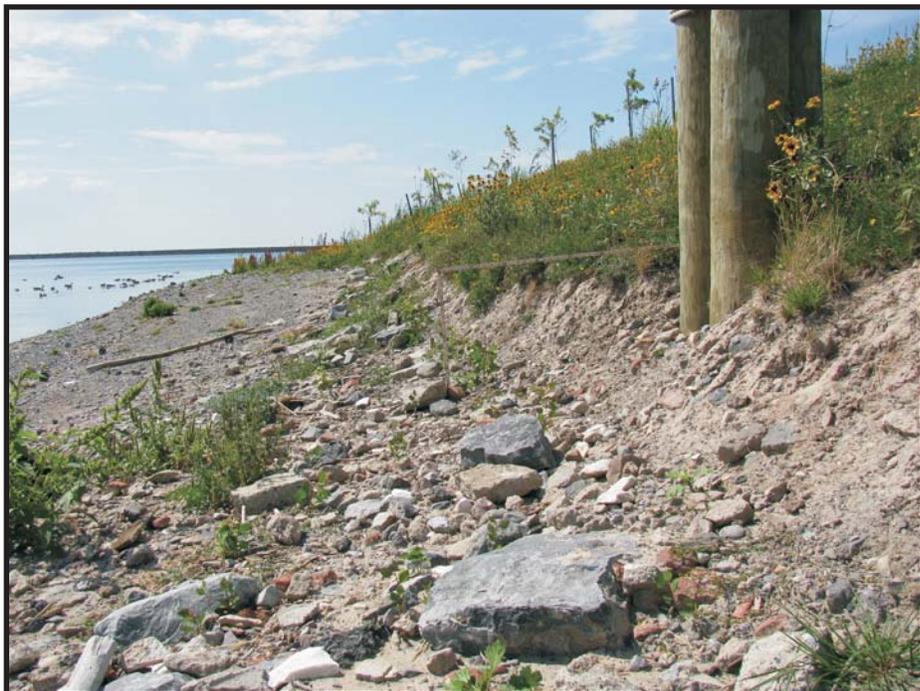
Photo 12: Typical exposed soil scarp in Area III (looking west).

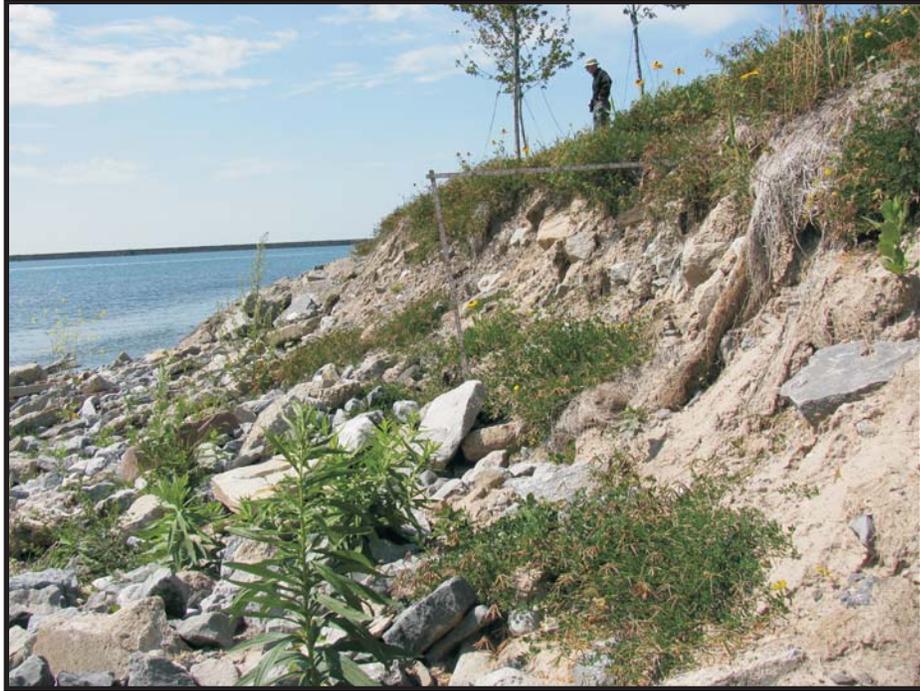
Photo 13: Typical exposed soil scarp in Area IV (looking west).

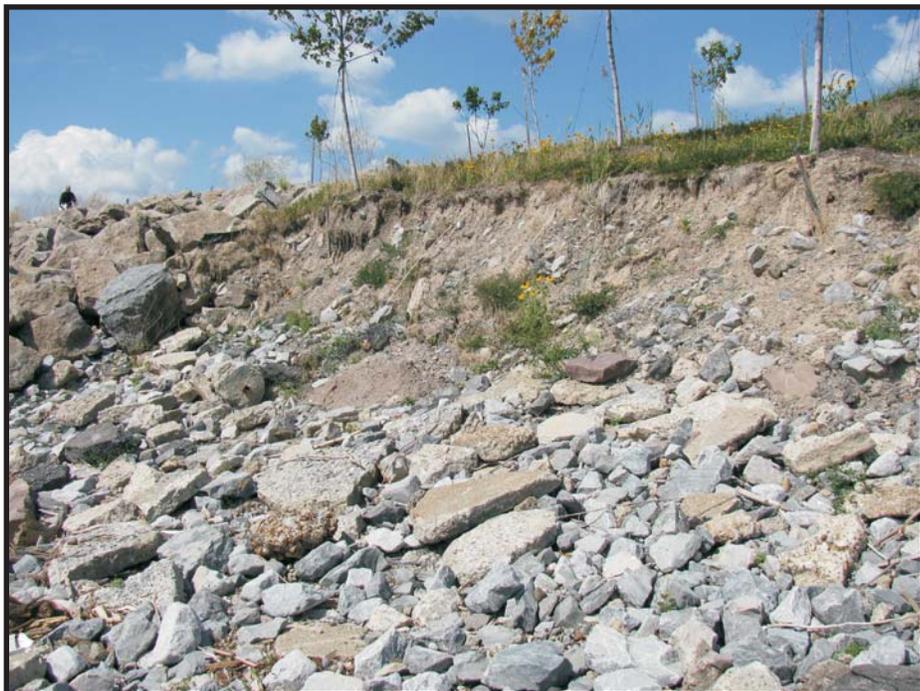
Photo 14: Western end of Area IV near stone revetment (looking northwest).
