**PHASE I ENVIRONMENTAL SITE ASSESSMENT
OF**

**LONG ISLAND PARTY RENTALS
175 ROGER AVENUE
INWOOD, NEW YORK 11096**

ATC PROJECT NO. 15.75316.0002

June 19, 2005

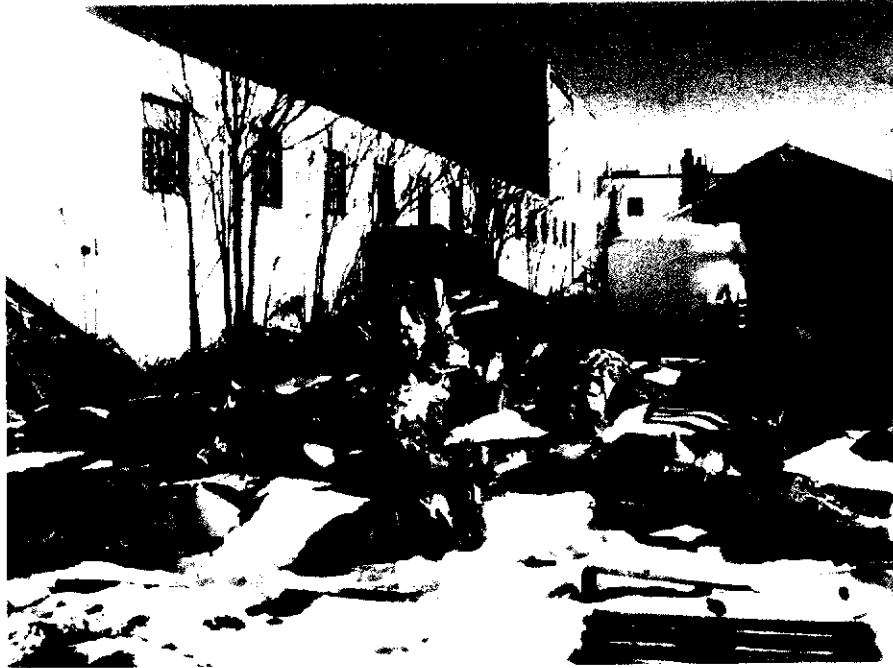
Photo 11: View of suspected location of gasoline USTs, along the southern perimeter of the Site

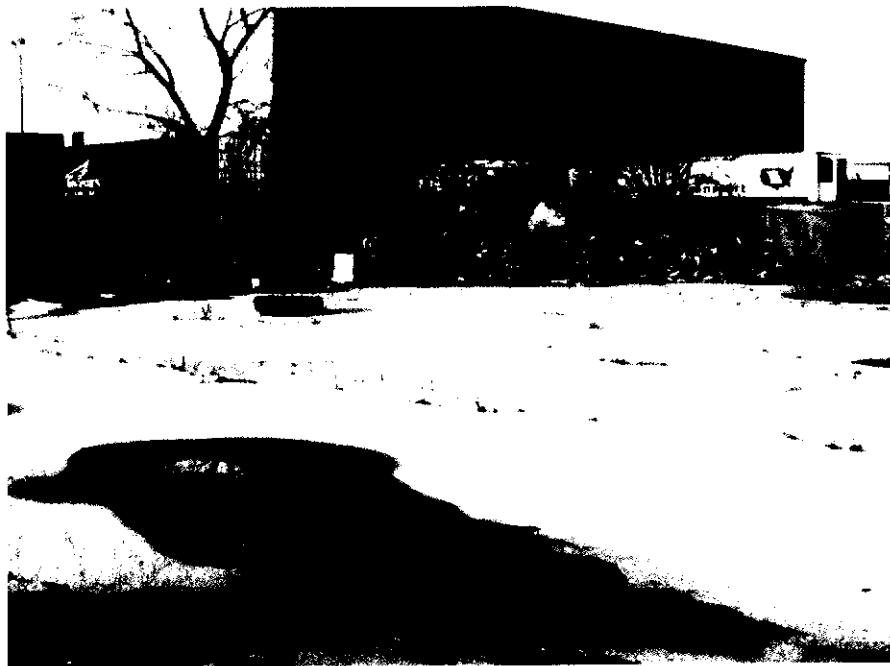
- ATC observed several roofing debris piles and used tires throughout the rear parking area on the western portion of the Site. ATC also observed several piles of garbage consisting of pieces of wood, used tires, plastic containers, furniture, wooden pallets, and pieces of metal located in an area labeled "hazardous material storage area" on the northwest exterior portion of the Site. Several roll-off dumpsters containing trash was also observed on the western portion of the Site.

Photo 12: View of used tires and roofing debris piles on the western parking area of the Site
