PERIODIC REVIEW REPORT (PRR)

(Reporting Period 4/1/2018 to 4/30/2021)

363 BOND STREET
Brooklyn, New York
Block 452, Lot 1
NYSDEC Site No. C224173

June 2021
100287505

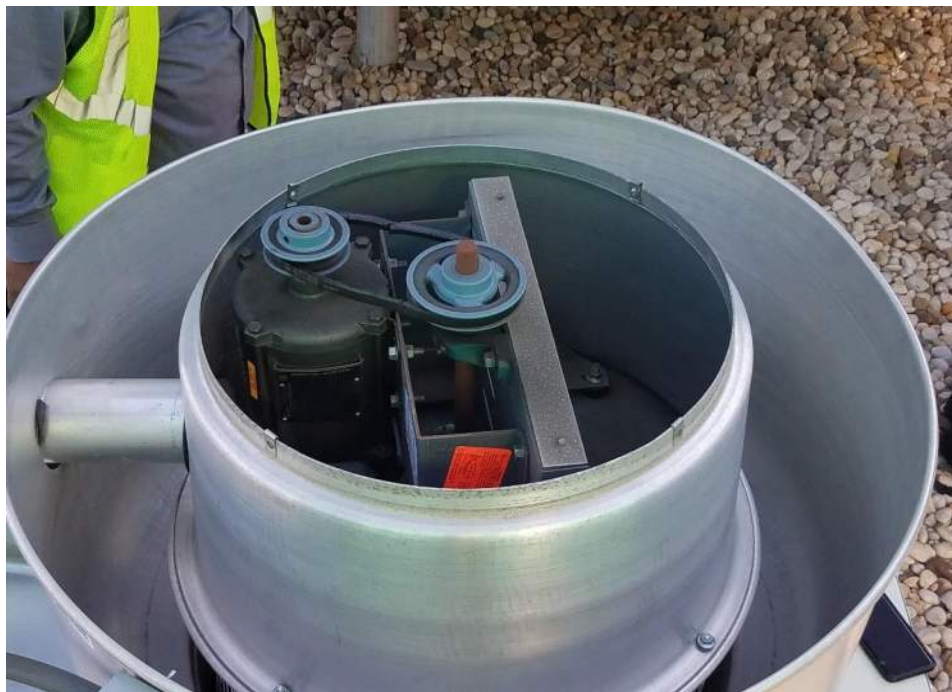
Photo 4: Inspection of V2 fan. 6 October 2020.

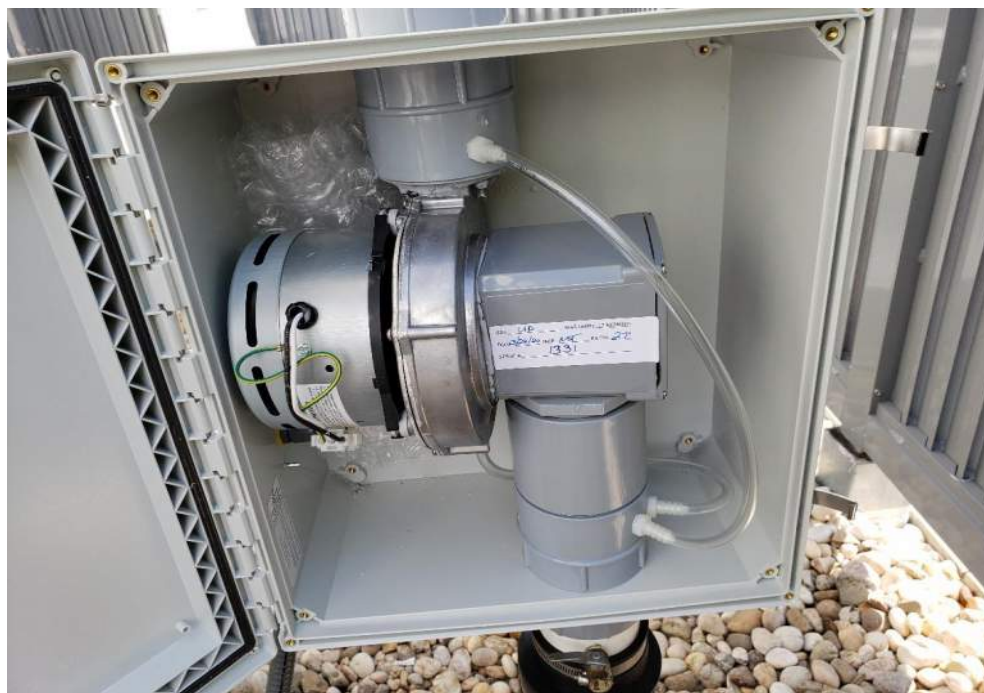
Photo 6: Interior components of V1 Obar fan. 9 October 2020.

On 8 October 2020, under Langan's oversight, AWT Environmental Services, Inc. (AWT) installed two Obar GBR 76 UD 120-volt fans to replace the Ametek Rotron regenerative blowers at V1 and V2. System performance was evaluated on 8 October 2020 using a TSI 9515 VelociCalc which obtained

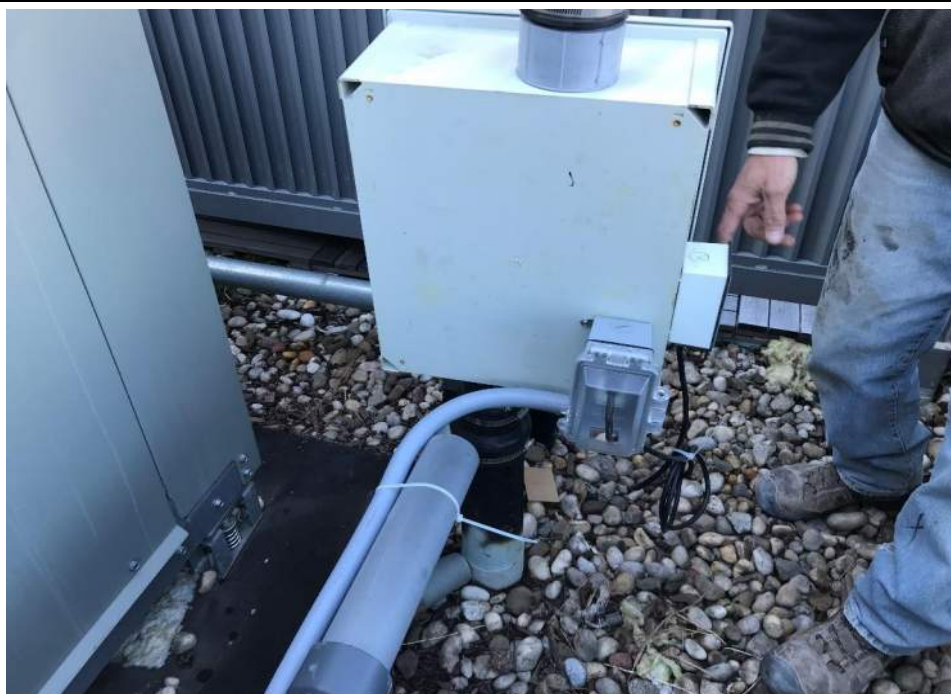
Photo 8: New Obar fan installation at V3. 30 March 2021.

On 15 April 2021, it was observed that the V3 Obar GBR 76 UD 120-volt fan was not operational. Langan completed an inspection of the V3 riser location blower and determined that the breaker had tripped within the fan housing unit. The breaker was reset and the fan was operational. On 19 April 2021, it was again observed that the V3 Obar GBR 76 UD 120-volt fan was not operational due to a fuse tripped within the fan housing unit. To prevent the fuse from tripping again, the vacuum was reduced to decrease the electrical demand on the circuit. The fan was checked on periodically throughout the day and was determined to be operating normally. As discussed in Section 5.2.2, all system components were operational during the SMDS inspection on 21 April 2021.

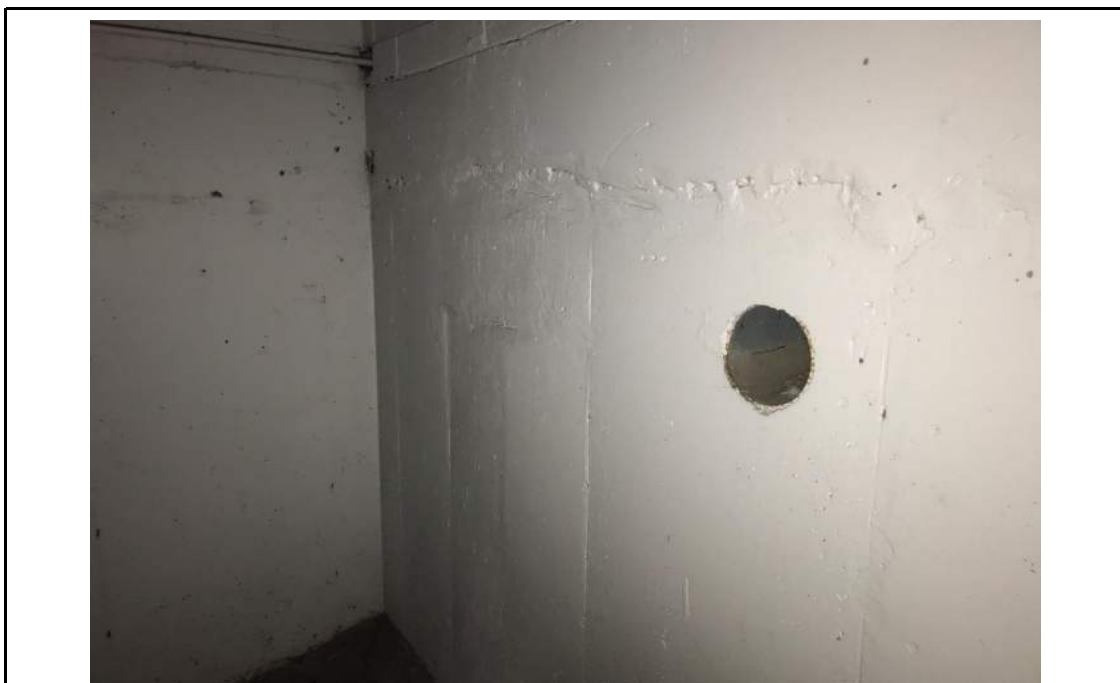
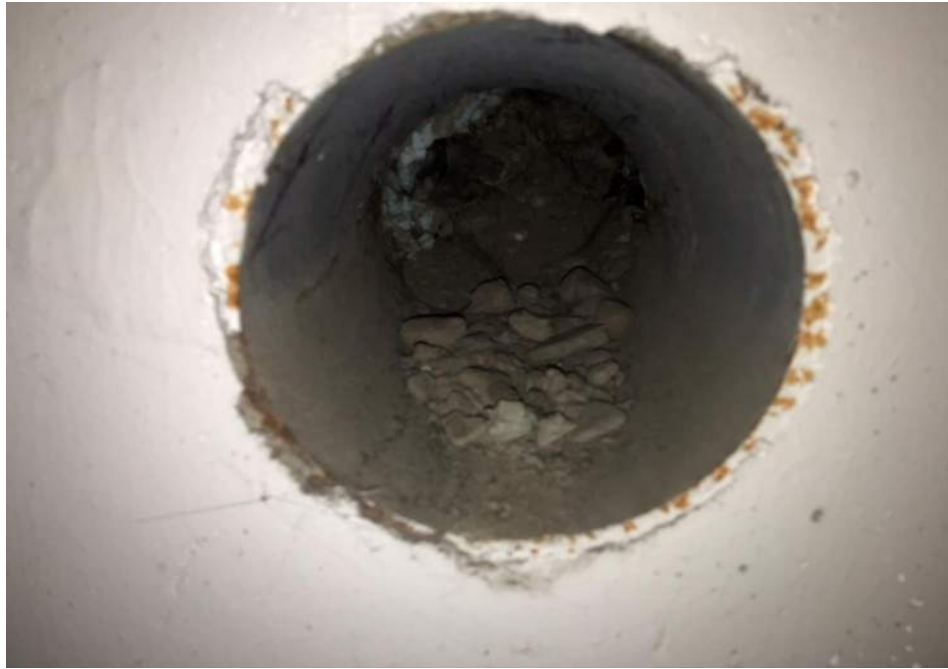
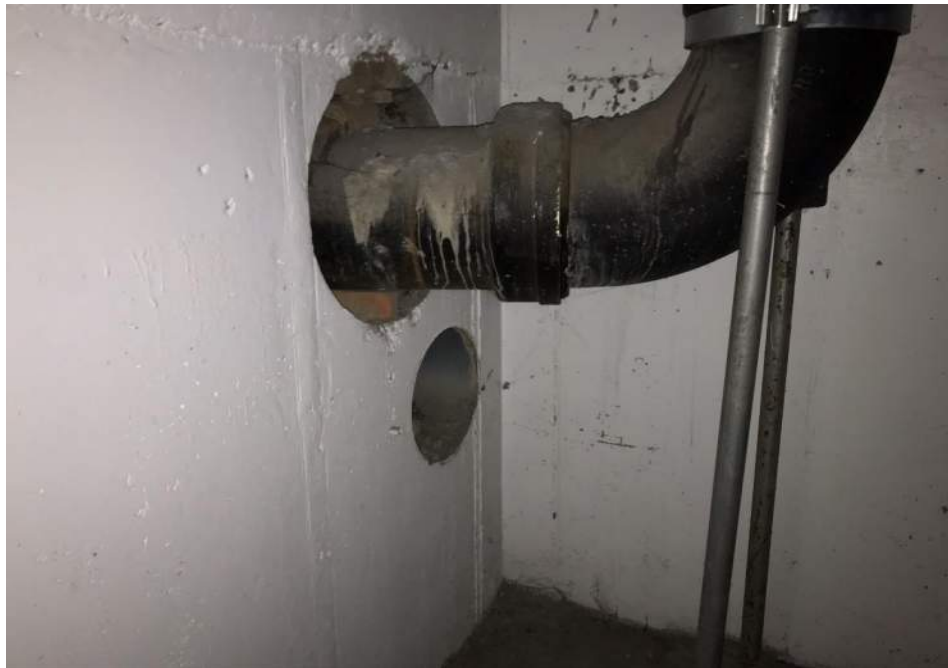
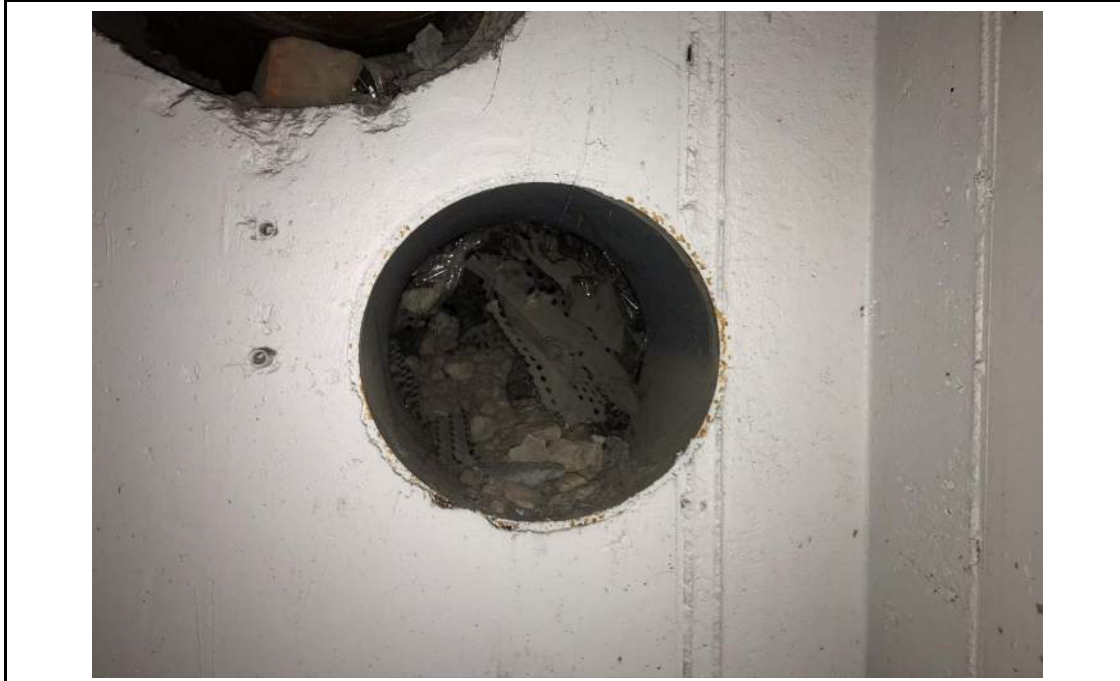
Breaches of the subgrade foundation walls and first floor slab were observed during the annual inspection events. Two approximately 6-inch diameter breach, likely associated with the installation of subgrade utilities, were observed along the southern foundation wall in the subgrade parking area, through which the recycled concrete aggregate (RCA) subgrade and vapor collection layer that had been previously placed below the first floor concrete slab was exposed. Additionally, a breach was observed in the first floor concrete slab in a mechanical room in the southeast portion of the site within a 30-inch manhole surrounding the 18-inch sump that had been installed as part of the contingent groundwater treatment system. The previously installed 15-mil Stego Wrap Vapor Barrier was visible but appeared to be intact. These breaches will be repaired and the repairs will be documented in the PRR for the next reporting period.

Photo 6: Hole observed in subgrade parking lot concrete foundation wall (beneath the first floor), facing south. 6 February 2020.

Photo 7: Hole observed in subgrade parking lot concrete foundation wall (beneath the first floor), facing southeast. 6 February 2020.

Photo 8: Hole observed in subgrade parking lot concrete foundation wall (beneath the first floor), facing south. 6 February 2020.

Photo 9: Hole observed in subgrade parking lot concrete foundation wall (beneath the first floor), facing south. 6 February 2020.

As described in Section 5.2.3, breaches of the composite cover system were observed in the southern foundation wall and in the southeast corner of the first floor concrete slab. Two minor breaches of the concrete cover were observed in the southern foundation wall in the subgrade parking area associated with the installation of subgrade utilities, through which the RCA subgrade and vapor collection layer (beneath the 15-mil Stego Wrap Vapor Barrier) that had been previously placed below the first floor concrete slab was exposed. A breach of the concrete slab was also observed in a mechanical room in the southeast corner of the first floor concrete slab

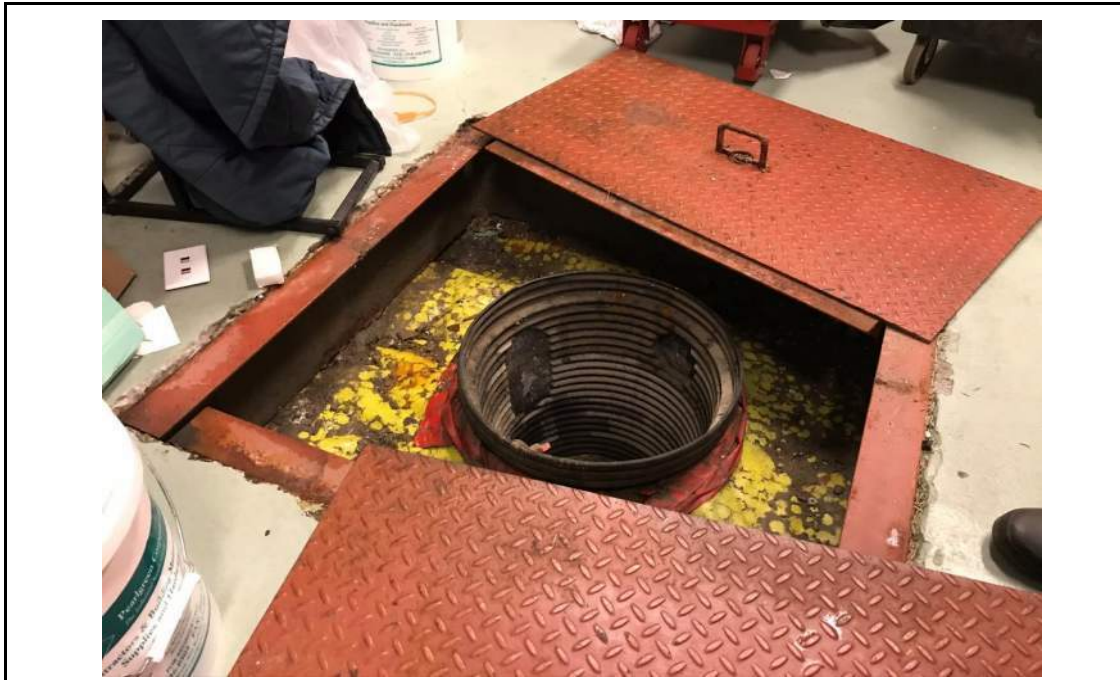
Photo 15: Breach observed in first floor concrete slab surrounding 18-inch sump for groundwater treatment system infrastructure, facing north. 6 February 2020.

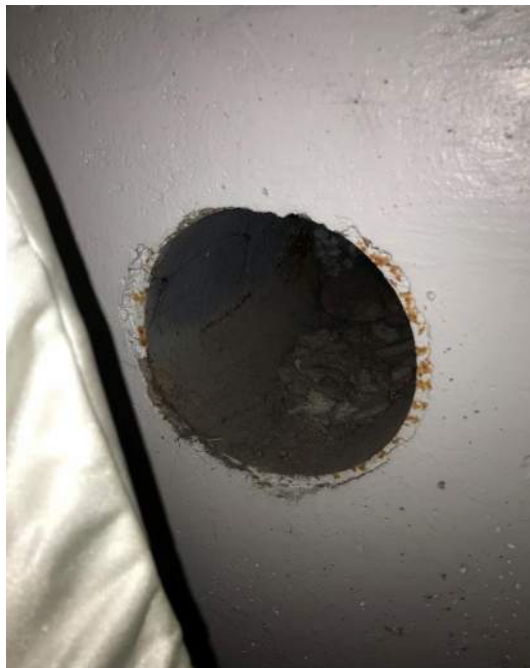
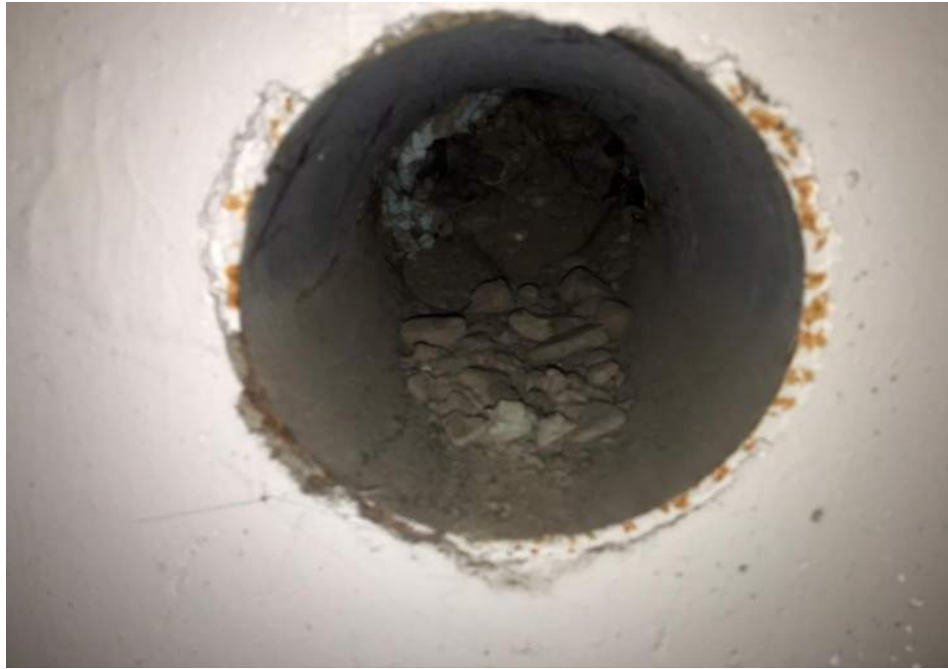
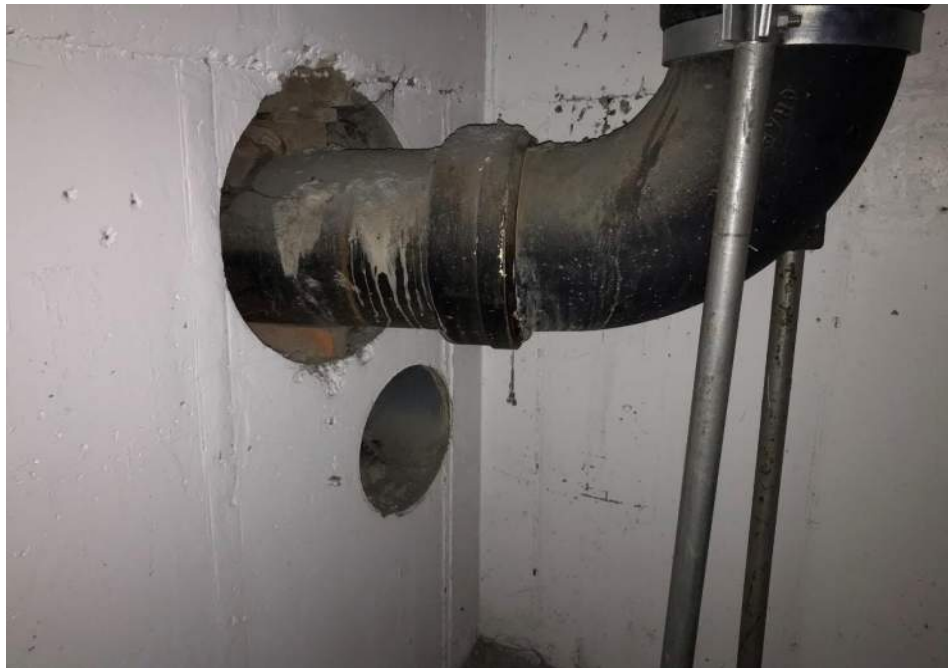
Photo 6: Hole observed in subgrade parking lot concrete foundation wall (beneath the first floor), facing south. 21 April 2021.

Photo 7: Hole observed in subgrade parking lot concrete foundation wall (beneath the first floor), facing southeast. 21 April 2021.

Photo 8: Hole observed in subgrade parking lot concrete foundation wall (beneath the first floor), facing south. 21 April 2021.

Photo 9: Hole observed in subgrade parking lot concrete foundation wall (beneath the first floor), facing south. 21 April 2021.

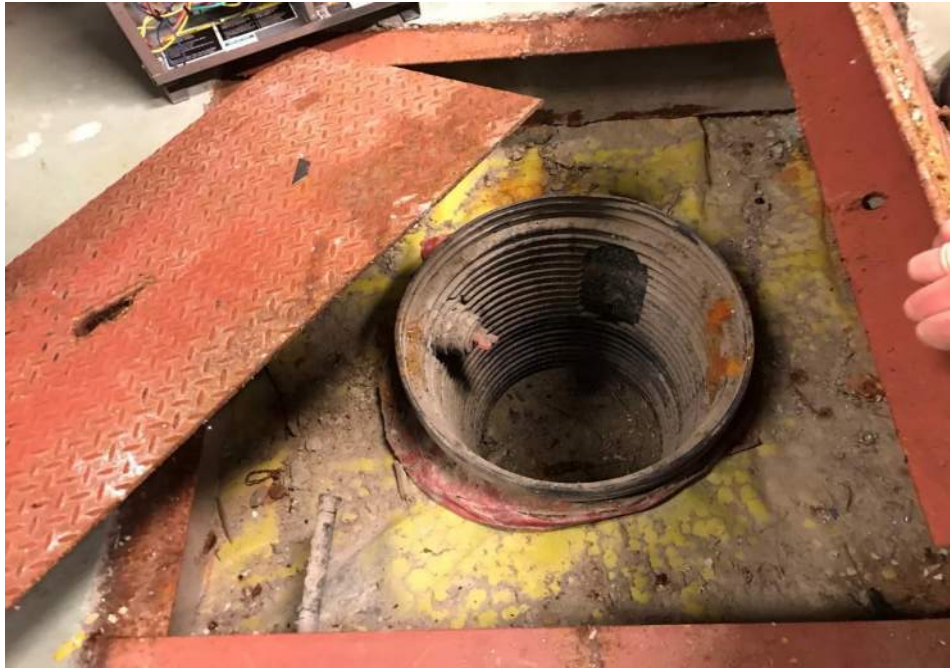
Photo 15: Breach observed in first floor concrete slab surrounding 18-inch sump for groundwater treatment system infrastructure, facing north. 21 April 2021.
