# Spill # 0601852 Underground Tank Closure Report 49-55 Dupont St., Brooklyn, New York 11222

Prepared on Behalf of: 49 Dupont Realty Corporation

Prepared By: Alberto Baruffi Advanced Site Restoration, LLC

July 2006

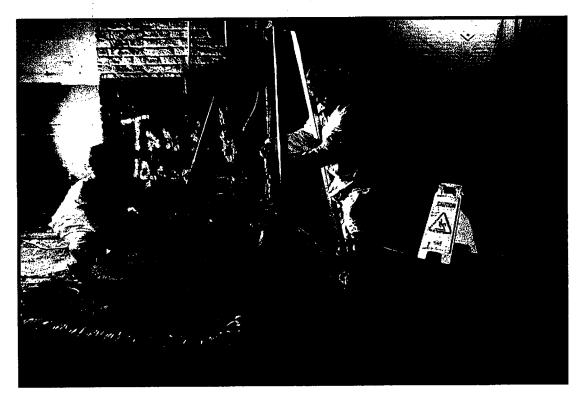
ASR personnel being lowered into pit with harness

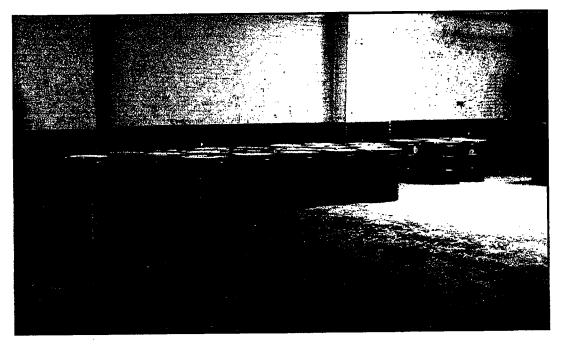
Storage of 55 gallon drums on site

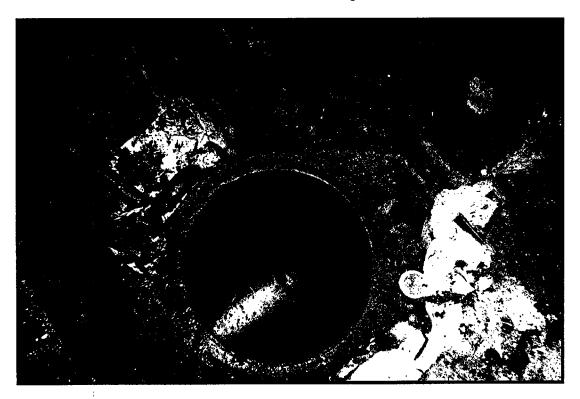
Tank after cleaning

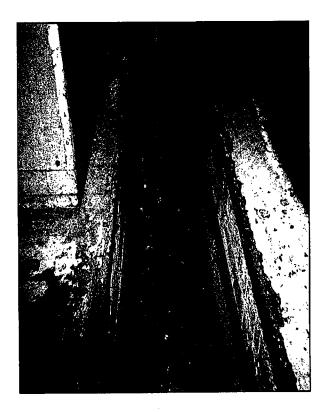
Trenches prior to cleaning

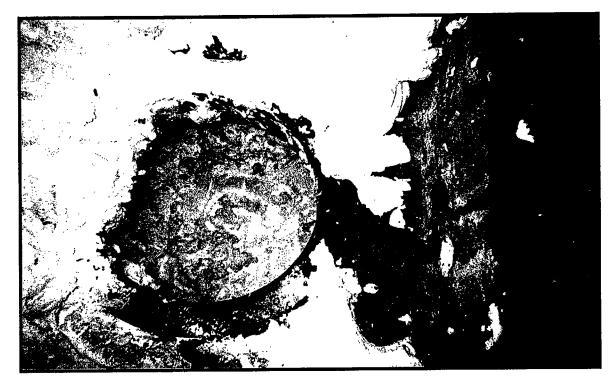
Tank filled with the foam product
