<b>CLIENT:</b>	473 President LLC	<b>DATE:</b>	Tuesday, April 26, 2022
<b>PROJECT No.:</b>	170361303	<b>WEATHER:</b>	Overcast, 52-58 °F, Wind: 3-7 mph NE
<b>PROJECT:</b>	473 President Street/President Street Portfolio	<b>TIME:</b>	06:45 – 17:30
<b>LOCATION:</b>	Brooklyn, New York	<b>BCP SITE Nos.:</b>	C224220/C224309
<b>EQUIPMENT:</b>	<b>PRESENT AT SITE:</b>		
ABI TM22 pile drilling rig	<b>Langan:</b> Jack Millman, TJ Malgieri		
Komatsu PC490LC excavator	<b>Urban Atelier Group (UAG):</b> Matthew Higgins/Matthew Barile		
MiniRAE 3000 photoionization detector (3)	<b>Kingdom Associates, Inc. (Kingdom):</b> Brian Keane		
TSI DustTrak II (2)	<b>Fenagh Engineering and Testing:</b> Louie Lactaoen		
	<b>Pillori Associates, P.A.</b>

Langan was on-site to document implementation of the New York State Department of Environmental Conservation (NYSDEC)-approved Remedial Action Work Plans (RAWP) for Brownfield Cleanup Program (BCP) Site Nos. C224220 (473 President Street) and C224309 (President Street Portfolio).

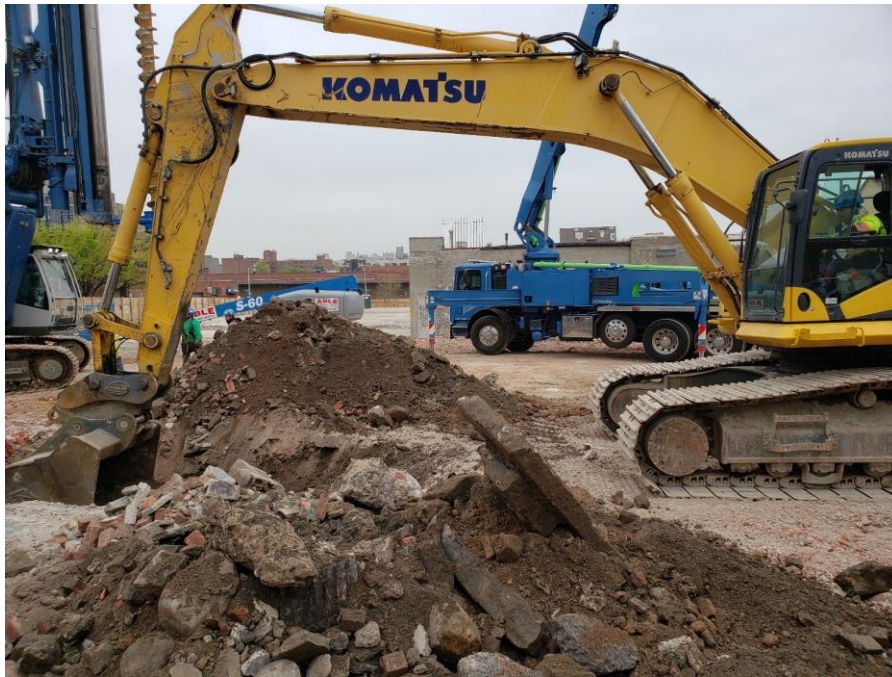
**Photo 1:** Kingdom excavating an area to pre-clear potential obstructions in the eastern part of the site (facing west)

- Kingdom excavated an about 12-foot-long by 6-foot-wide area to about 3 feet below grade surface (bgs) in the eastern part of the site to pre-clear potential obstructions prior to drilling a pile. Excavated fill consisted of sand with varying amounts of construction and demolition (C&D) debris, and was used to backfill the same excavation area. Visual, olfactory, and photoionization detector (PID) evidence of contamination was not observed.
- Kingdom used an ABI TM22 pile drilling rig to drill a foundation pile to 63 feet bgs in the eastern part of the site. The pile was grouted in place.

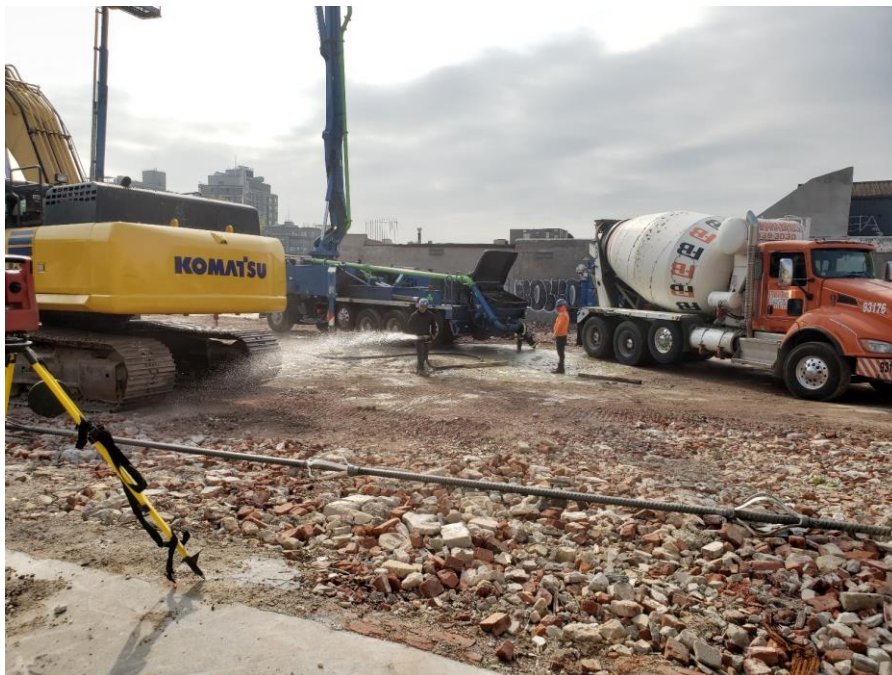
**Photo 2:** Kingdom spraying water to control dust in the work area (facing west)
