1607 SURF AVENUE

BLOCK No. 7062, LOT No. 28

SOIL SAMPLE LOCATION AND ANALYTICAL RESULTS MAP

Project No.	170599501	Figure	C-1
Date	7/1/2020		
Scale	1" = 50'		
Drawn By	IHB		
Submission Date

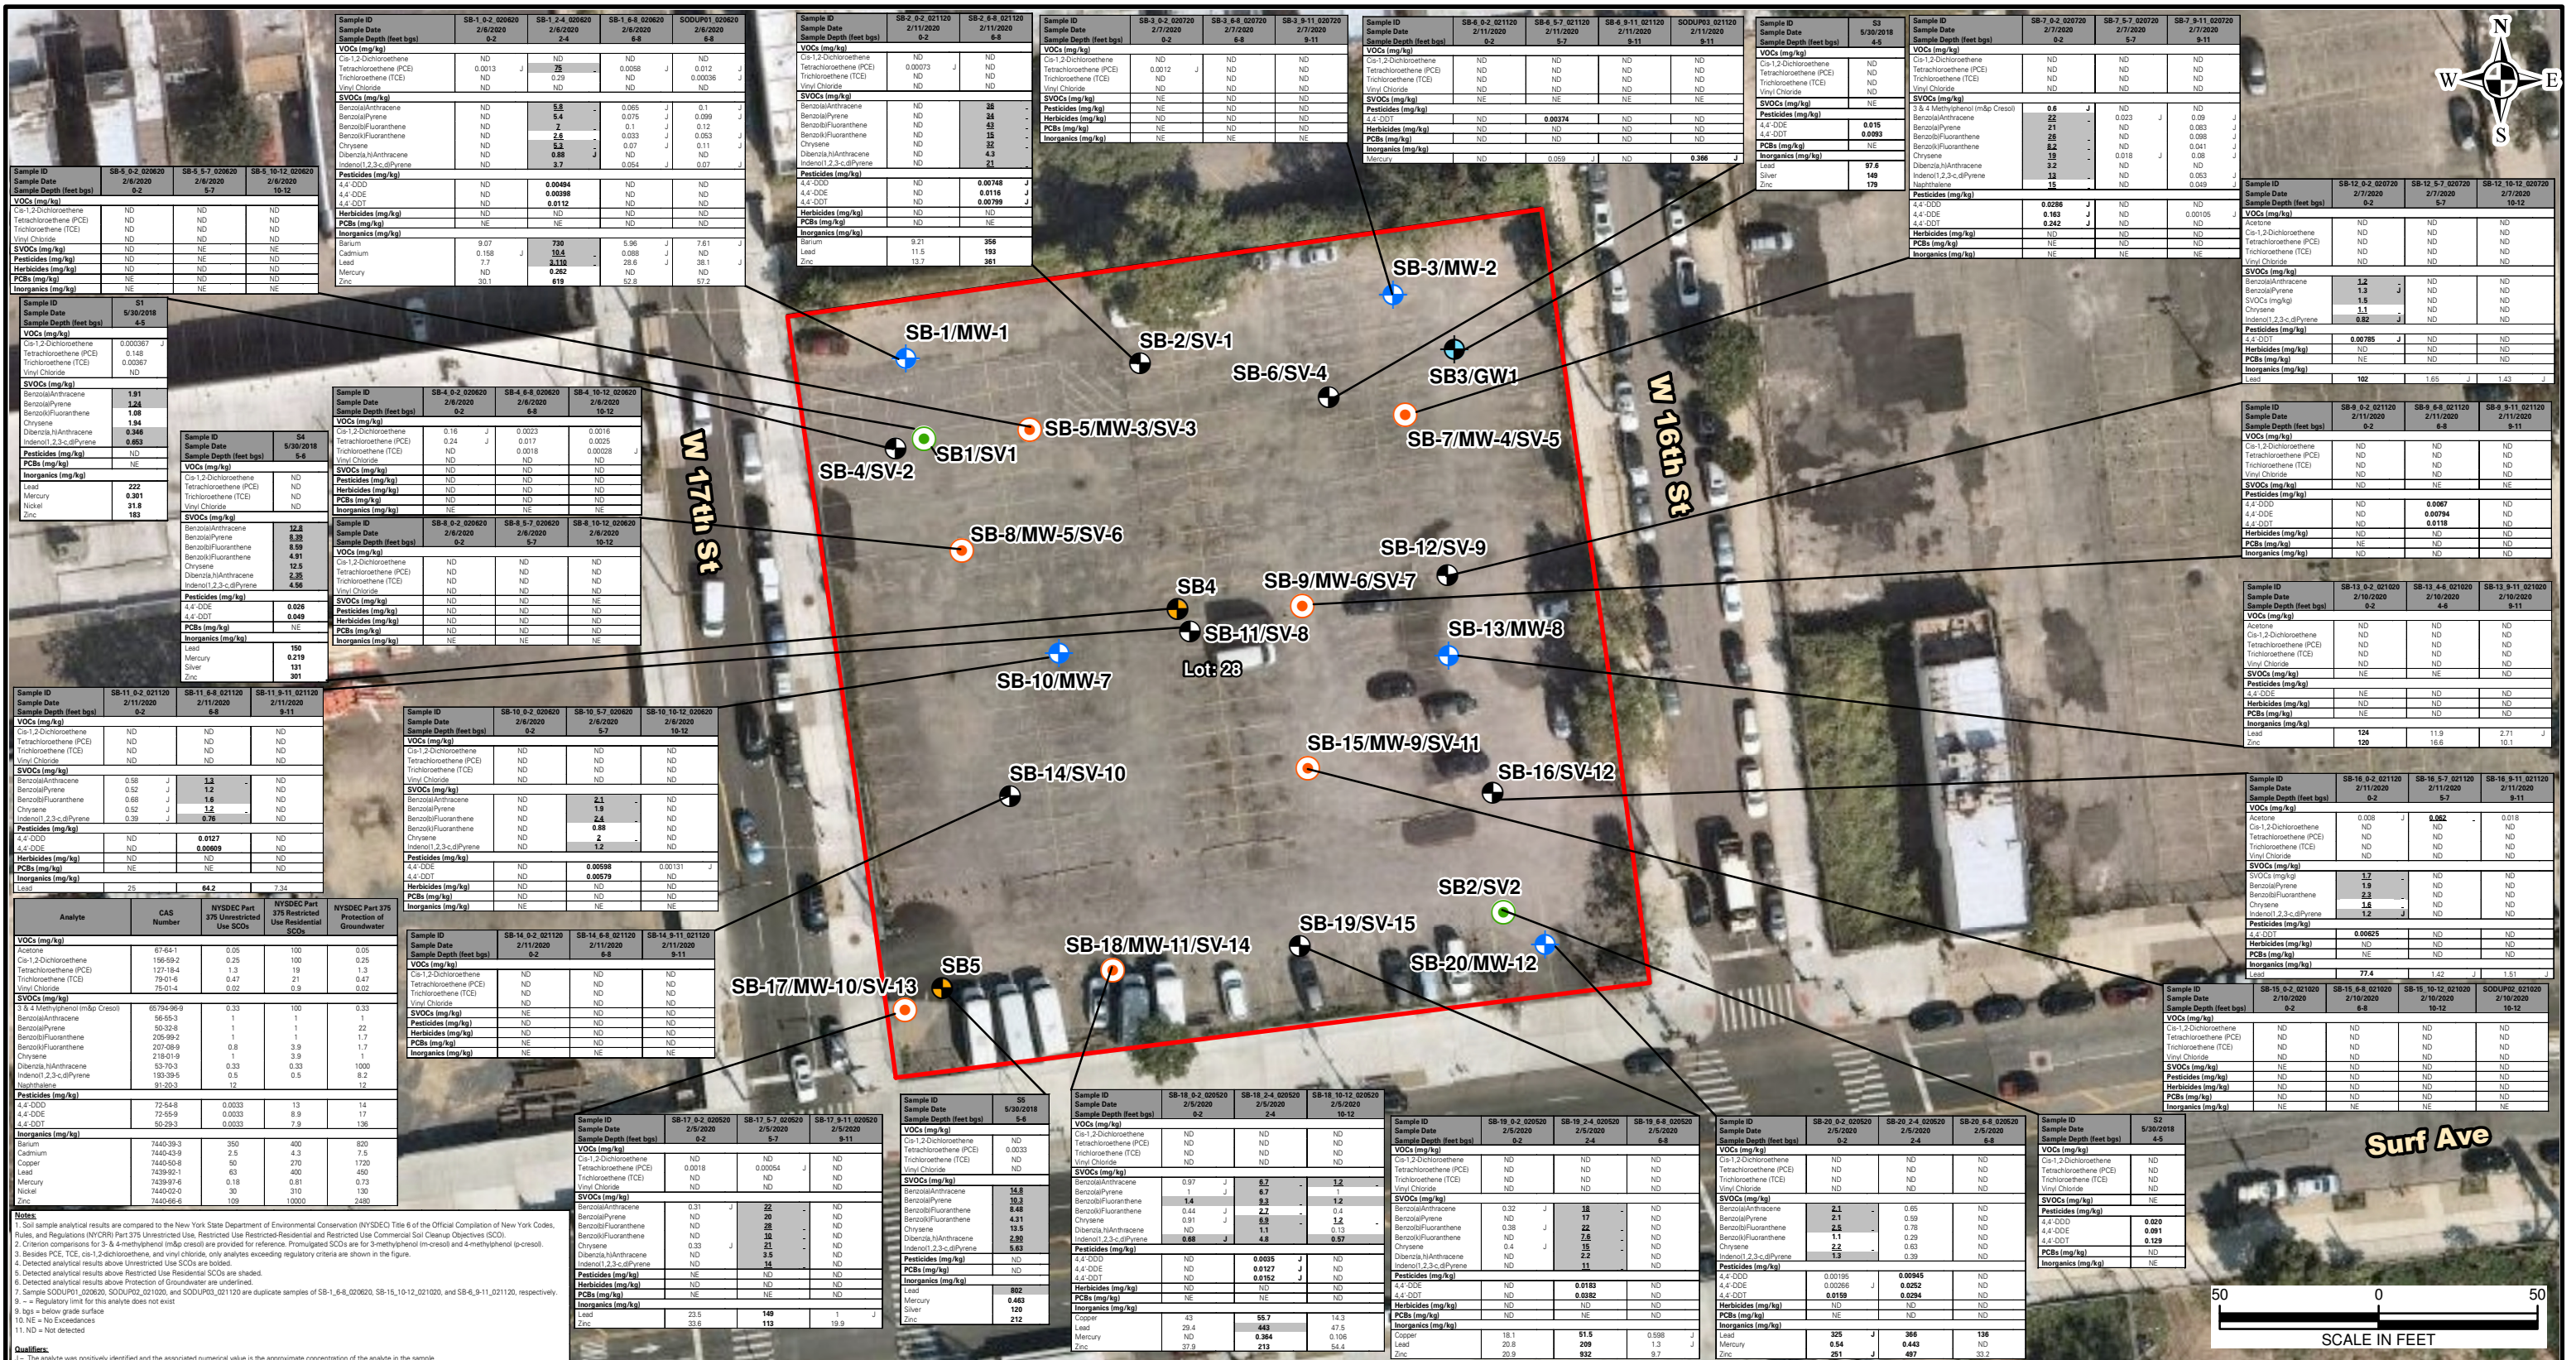
- Soil sample analytical results are compared to the New York State Department of Environmental Conservation (NYSDEC) Title 6 of the Official Compilation of New York Codes, Rules, and Regulations (NYCRR) Part 375 Unrestricted Use, Restricted Use, Restricted Residential and Restricted Use Commercial Soil Cleanup Objectives (SCOs).

- Besides PCE, TCE, cis-1,2-dichloroethene, and vinyl chloride, only analytes exceeding regulatory criteria are shown in the figure.
- Detected analytical results above Unrestricted Use SCOs are bolded.

- Detected analytical results above Restricted Use Residential SCOs are shaded.
- Detected analytical results above Restricted Use Commercial SCOs are underlined.

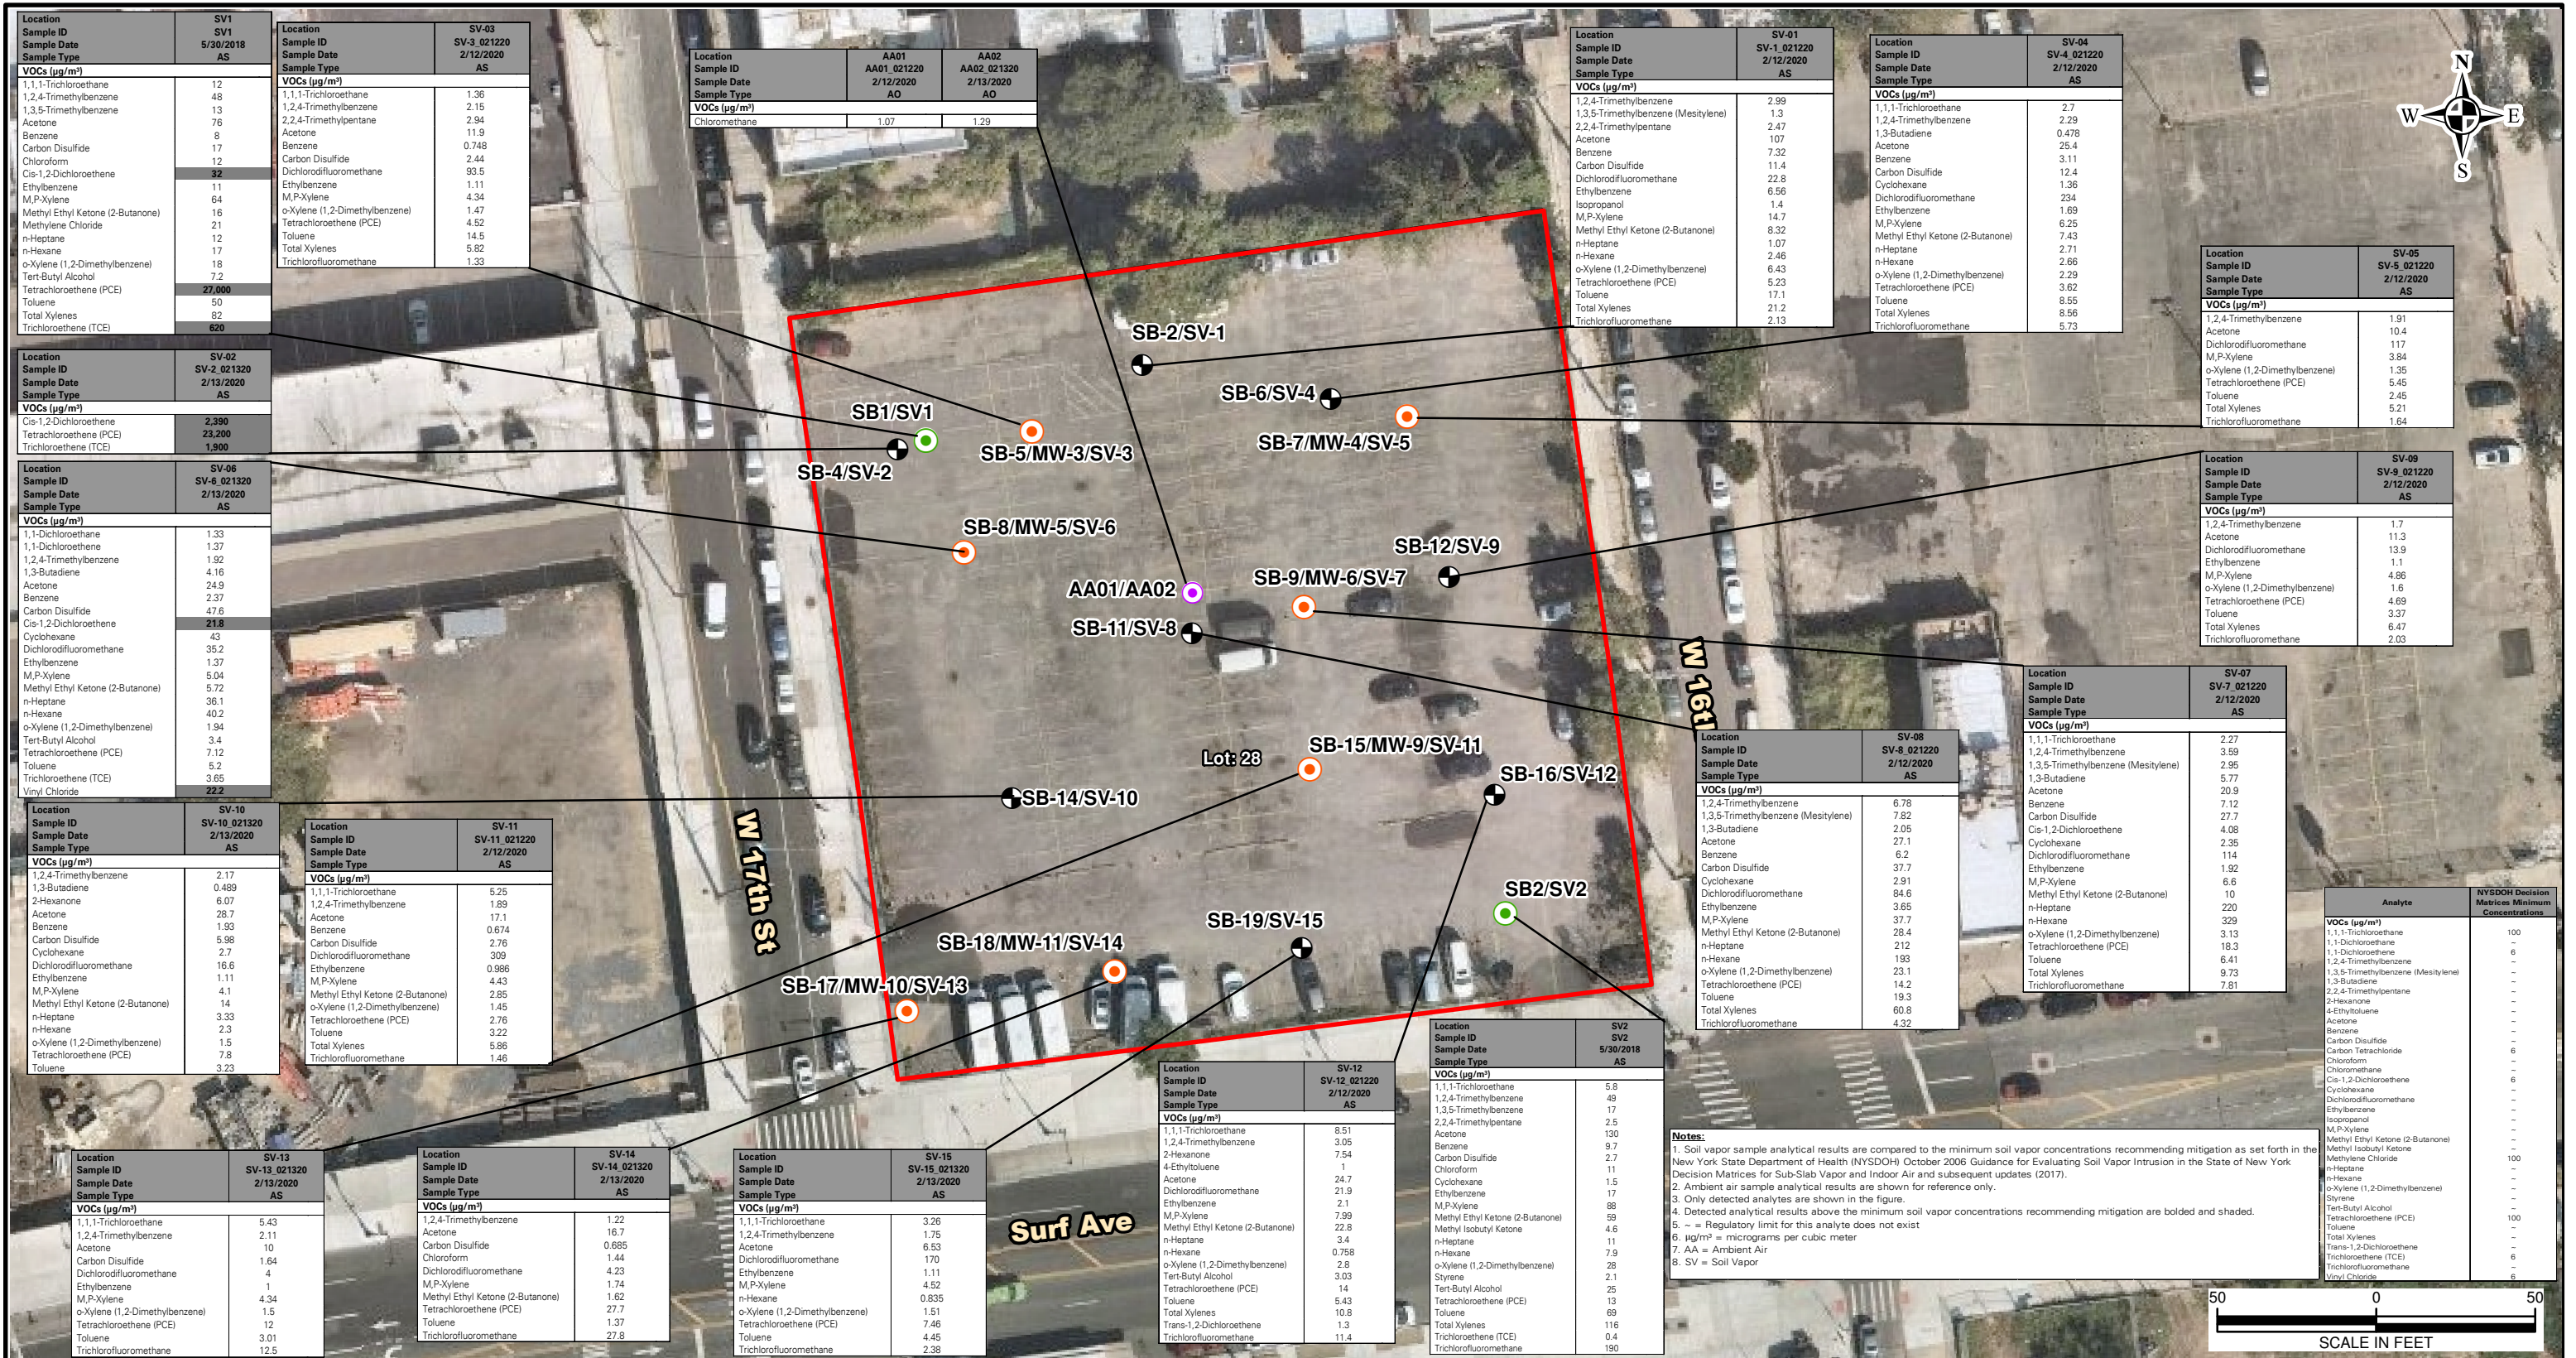
Project No.	170599501	Figure	C-3
Date	7/1/2020		
Scale	1" = 50'		
Drawn By	IHB		
Submission Date

SOIL VAPOR SAMPLE LOCATION AND ANALYTICAL RESULTS MAP
