## **Phase II Environmental Site Assessment**

**1249 to 1273 39<sup>th</sup> Street and 1268 to 1272 38<sup>th</sup> Street  
Brooklyn, New York**

**NYSDEC Spill No. 20-06350**

Merritt Project No. M19888

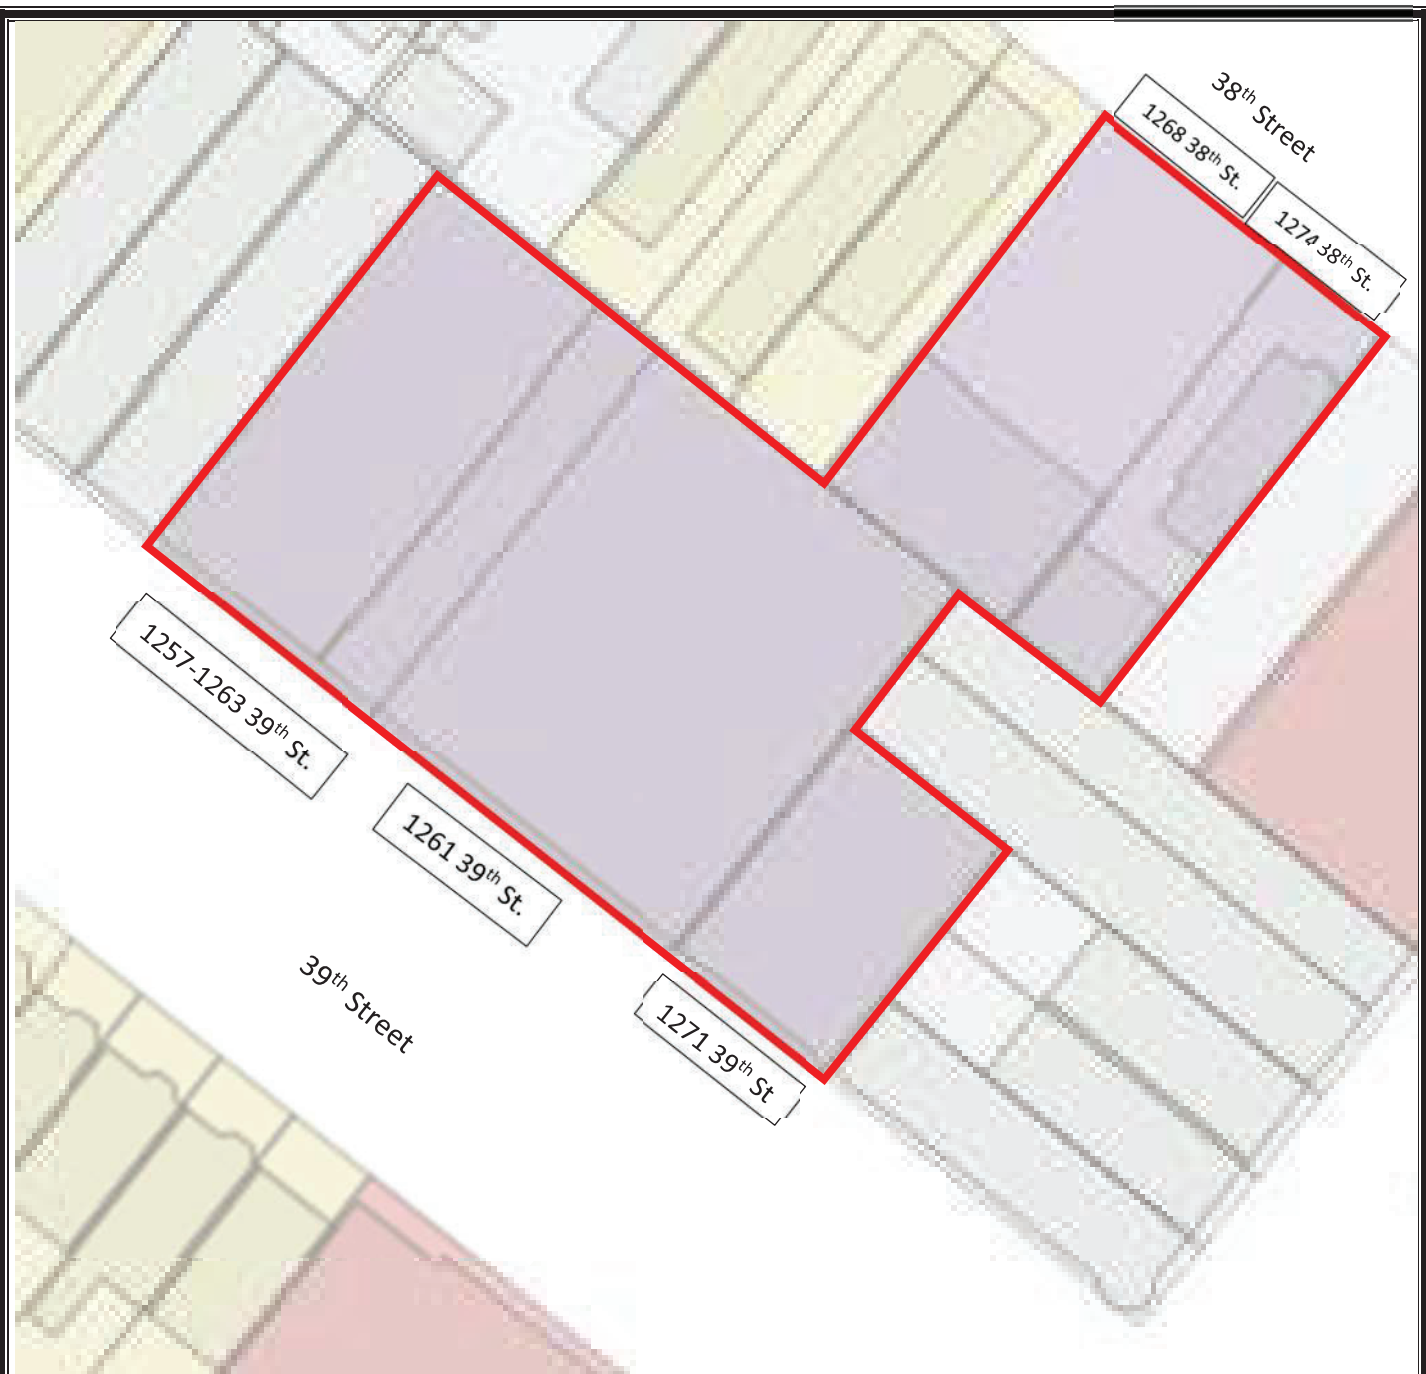
**Figure 2: Site Plan**  
68 East 38<sup>th</sup> Street  
Brooklyn, New York

**Figure 1** - Location Map depicts the location of the Subject Property on a street map of Brooklyn, New York. **Figure 2** - Site Plan depicts the configuration of the Subject Property and adjoining properties.
