975 Nostrand Avenue
BROOKLYN, NEW YORK

Final Engineering Report

NYSDEC Site Number: C224335

AKRF Project Number: 210225

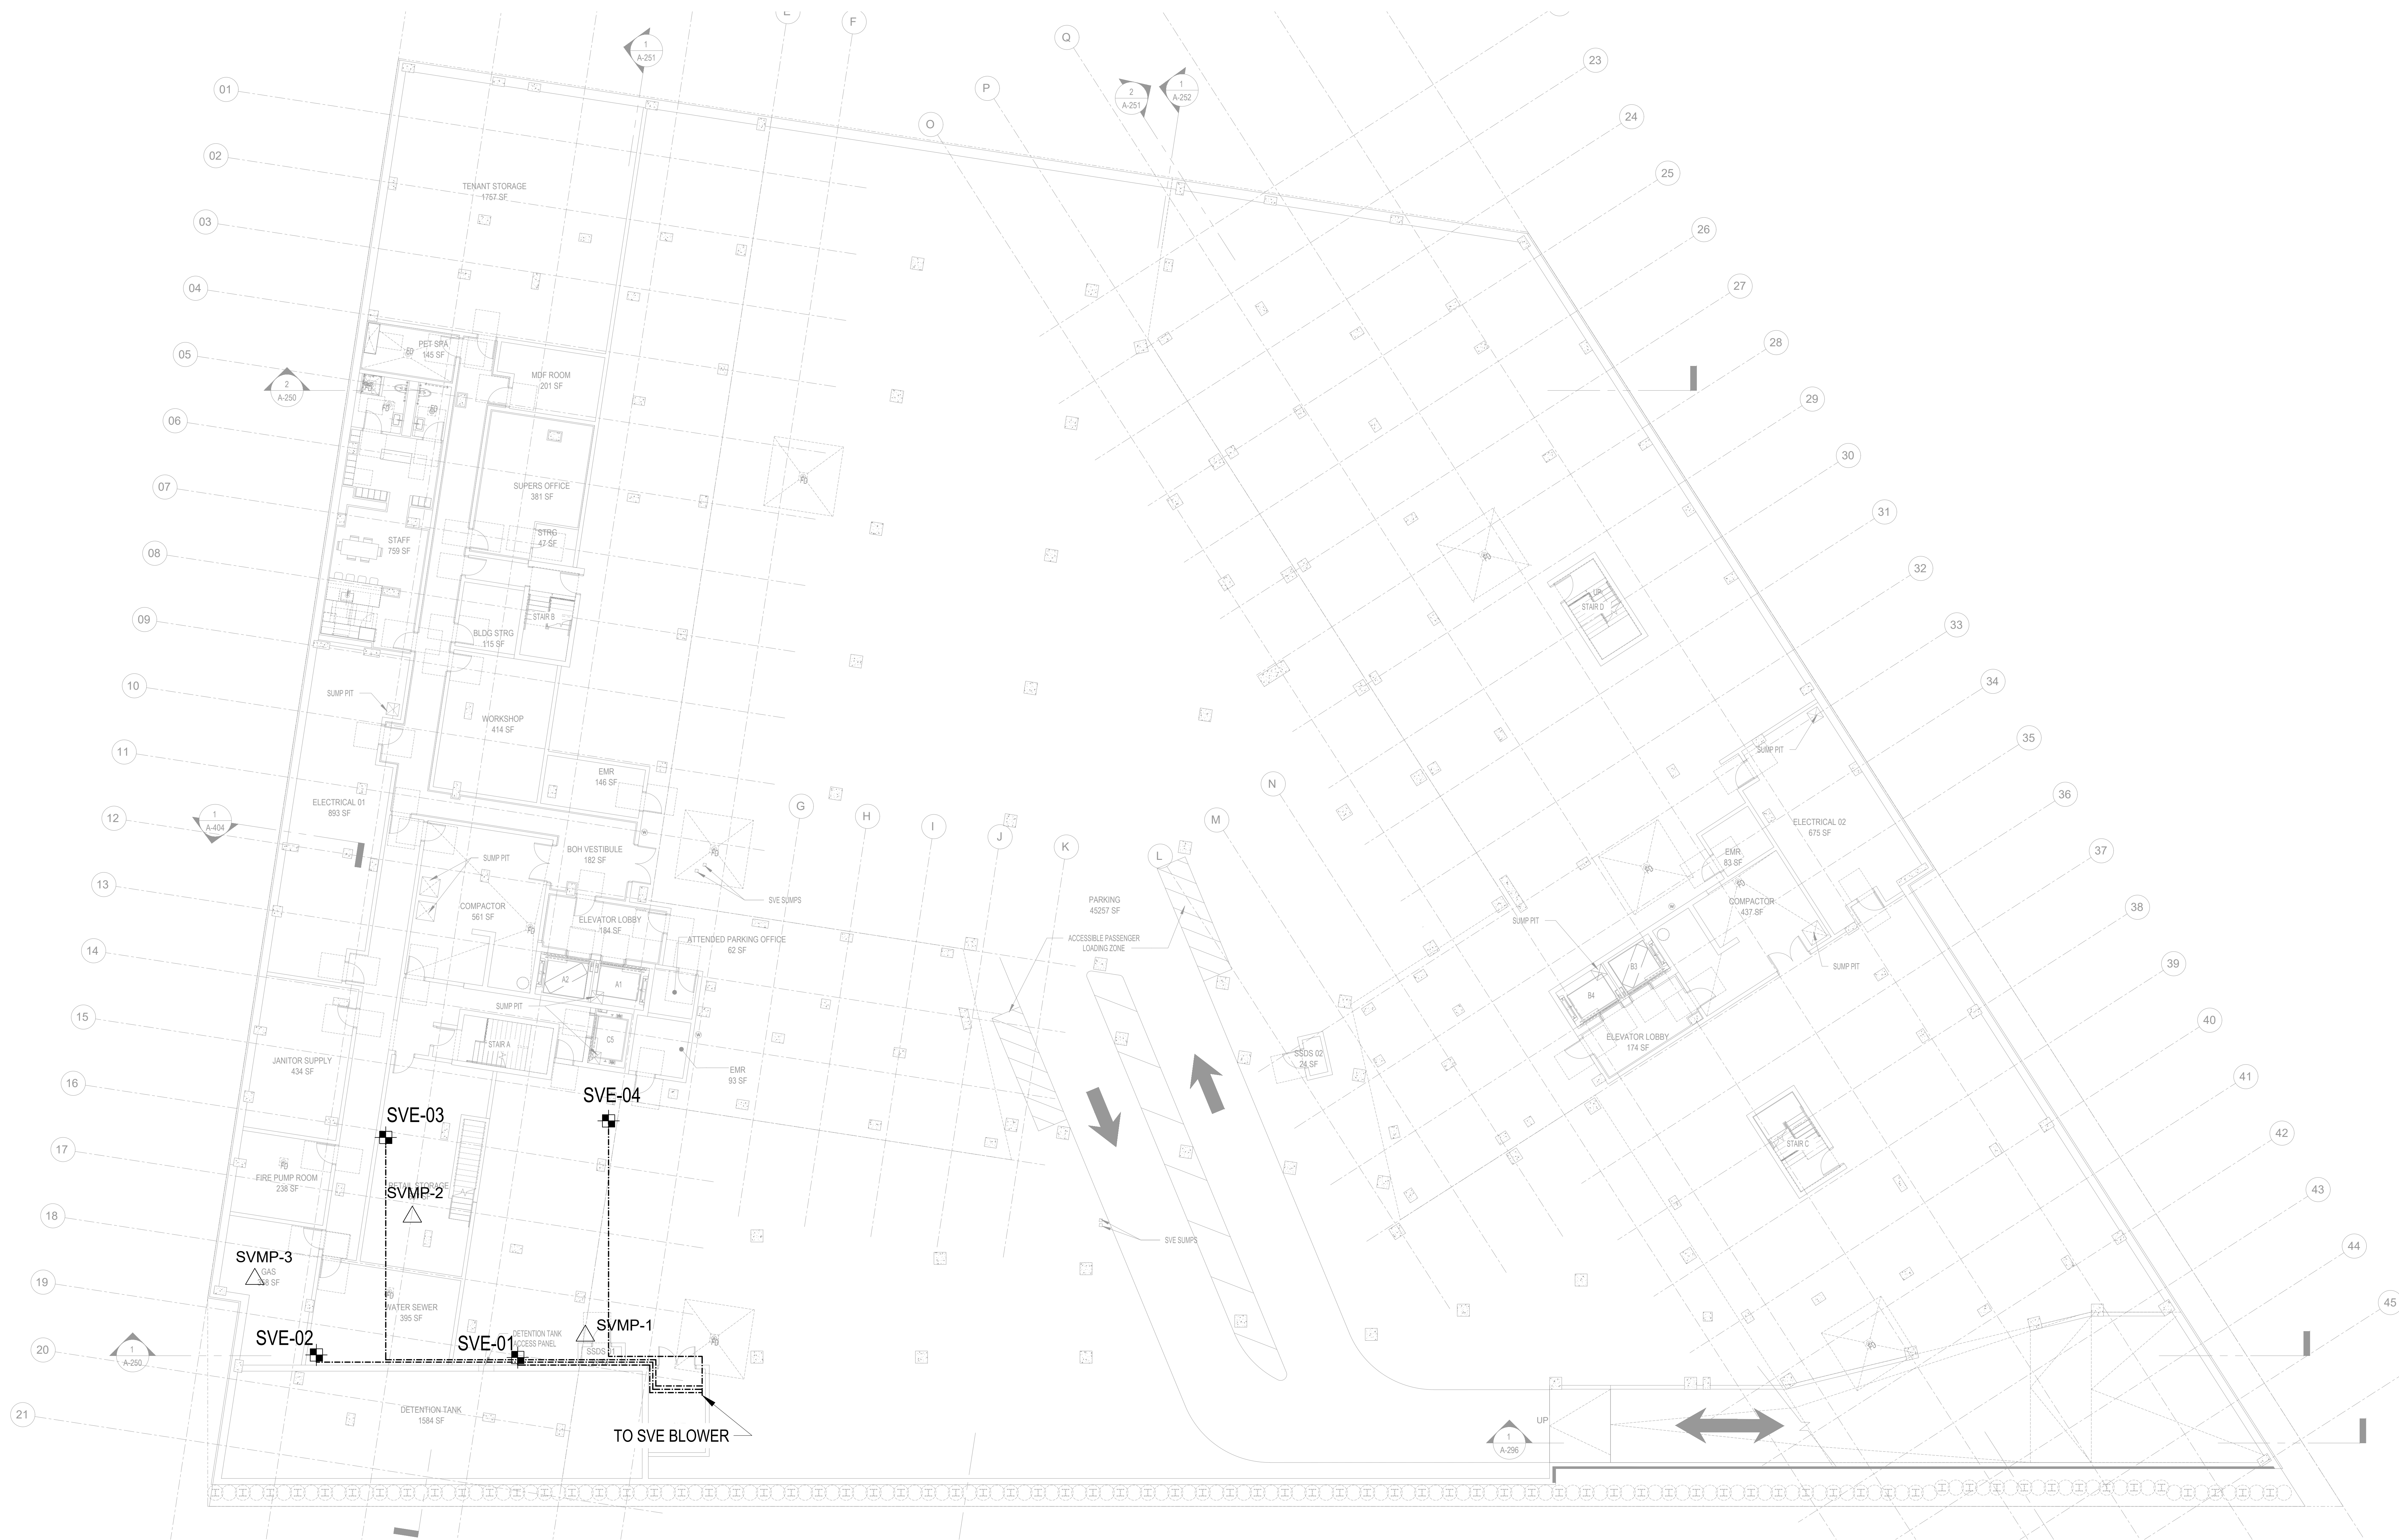
SVE LAYOUT PLAN

- Four 4-inch-diameter PVC SVE wells, which target the vadose zone treatment interval in the southwestern portion of the Site;
- Three 1-inch-diameter PVC soil vapor extraction monitoring points;
- One 15-horsepower SVE blower operating at approximately 50 inches of water (inH₂O) and 500 standard cubic feet per minute (SCFM);
- One 120-gallon moisture separator tank with a high-level alarm, transfer pump, and 55-gallon auxiliary drum with a high-level alarm;

SVE VAPOR MONITORING POINT LOCATIONS		
ID	COLUMN LOCATION	ROOM
SVMP-01	144	GARAGE (SOUTH)
SVMP-02	143	RETAIL STORAGE
SVMP-03	153	GAS ROOM
