<b>CLIENT:</b> Orange Management Inc.	<b>DATE:</b> Thursday, May 19, 2022
<b>PROJECT No.:</b> 170698601	<b>WEATHER:</b> Cloudy and Rainy, 60-70 °F, Wind: 10-20 mph WNW
<b>PROJECT:</b> Third Street Gowanus	<b>TIME:</b> 06:45 – 16:00
<b>LOCATION:</b> 125 Third Street, Brooklyn, New York	<b>BCP SITE No.:</b> C224346
<b>EQUIPMENT:</b> Soilmeco SM20 Drill Rig Grout Mixer Excavator Crane MiniRAE 3000 Photoionization Detector (3) TSI DustTrak II (2)	<b>PRESENT AT SITE:</b> <b>Langan:</b> Caleb Bogin and Kate Marino, PE <b>Allstate 12:</b> Jaydev Sonani <b>Orange Management Inc.:</b> Andrew Bradfield <b>Sterling Town Equities LLC:</b> Paul Amit <b>Quality Solutions:</b> Woody Brown

Langan was at the site to document soil/fill management and implementation of the November 2021 Soil/Fill Management Plan during initial foundation construction, as required by the New York State Department of Environmental Conservation (NYSDEC) for Brownfield Cleanup Program (BCP) Site No. C224346.

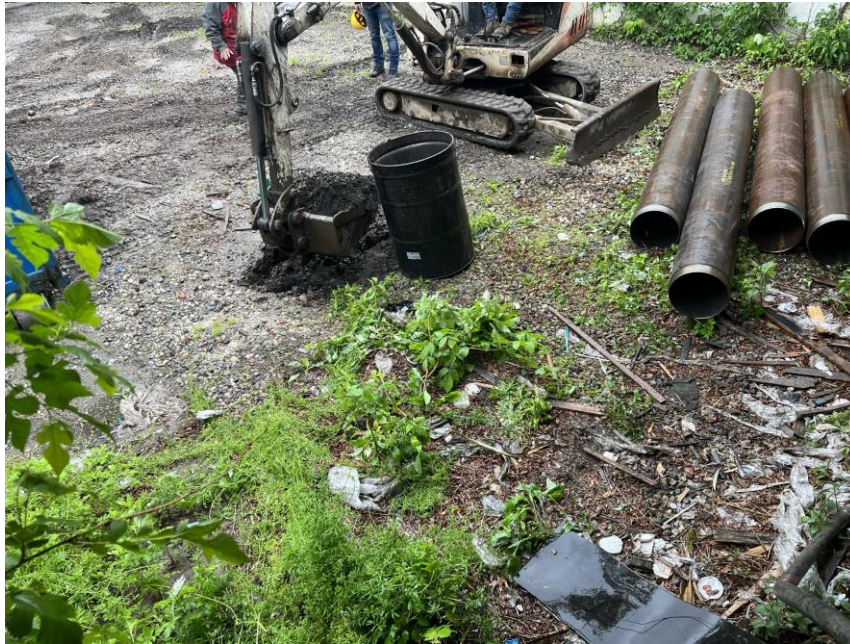
- Allstate 12 excavated an approximately 6-foot by 5-foot area to about 2 feet below grade surface (bgs) in the northern part of the site to create a temporary drilling fluid collection sump. The temporary sump and surrounding area were lined/covered with 20-millimeter-thick polyethylene sheeting. Excavated soil/fill consisted of sand with varying amounts of construction and demolition (C&D) debris and gravel. Visual, olfactory, and photoionization detector (PID) evidence of contamination was not observed. Allstate 12 containerized the soil/fill in two 55-gallon drums that were staged in the northern part of the site, pending waste characterization and off-site disposal.

**Photo 1:** Allstate 12 excavating a temporary sump and placing soil/fill into drums in the northern part of the site (facing west)

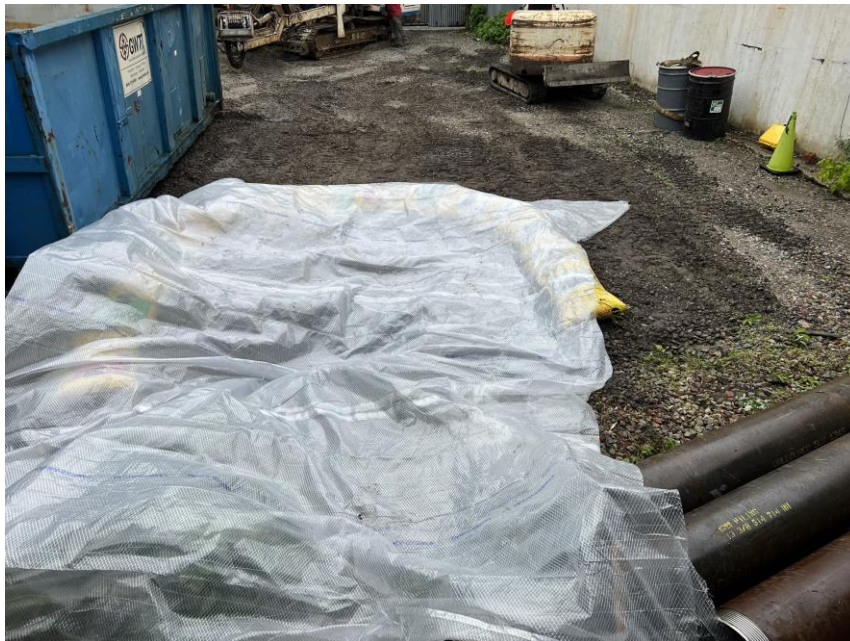
- Allstate 12 installed one foundation pile (P-2) in the northern part of the site to about 69 feet bgs using a Soilmeco SM20 drill rig. Municipally-supplied water was used during pile installation and recirculated to facilitate installation of the pile. Drilling fluids generated during pile installation were collected in the sump and pumped into a settling tank in the northern part of the site.

**Photo 2:** Polyethylene sheeting-lined sump at P-2 and settling tank in the northern part of the site (facing northwest)
