### SITE OBSERVATION REPORT

PROJECT: 250 Water Street CLIENT: WEATHER: Wind: 0.0 mph (10:28 am) to N @

**BCP SITE ID**: C231127

Langan continued implementing Phase 4 of the May 13, 2020 Remedial Investigation Work Plan (RIWP) for New York State Department of Environmental Conservation (NYSDEC) Brownfield Cleanup Program (BCP) Site No. C231127 located at 250 Water Street (Manhattan Block 98, Lot 1).

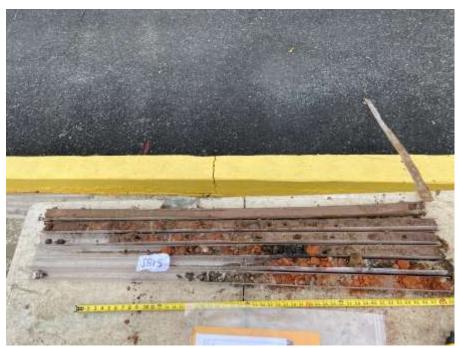
Photo 1: View of soil from boring SB15.

- o Boring SB15: Boring was advanced to 20 feet bgs. No petroleum-like odors, staining, or PID readings above background were observed. Visual evidence of elemental mercury was not identified. Total mercury concentrations evaluated with the XRF were less than the LOD.

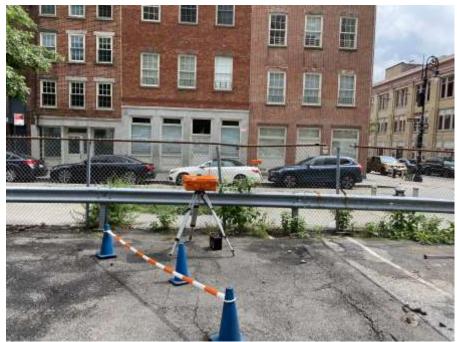
Photo 2: Perimeter CAMP station WZ-1 and off-site CAMP station PM-1 along Water Street during the drilling of boring SB28 (facing east).

• The fifteen-minute average concentration of particulate matter smaller than 10 microns in diameter (PM10) exceeded action levels from 14:38 am to 14:52 am at work zone air monitoring station. Intrusive work for the day was previously completed and the exceedance was caused by sweeping excess quick-dry cement used to set monitoring well covers. Housekeeping activities were stopped and the fifteen-minute average concentration dropped below the CAMP action level.

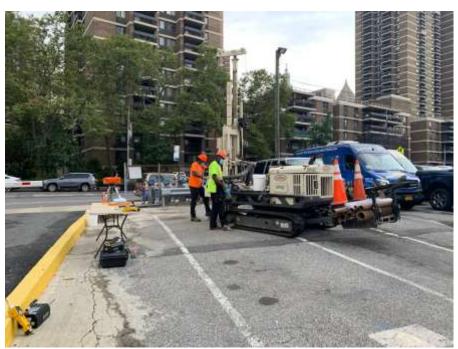
Photo 3: AARCO drilling boring SB15 (facing northwest).

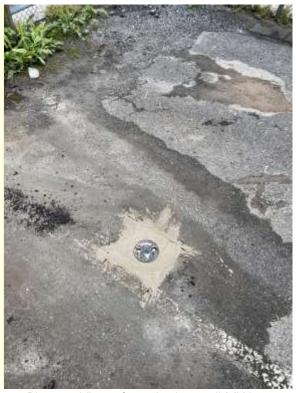
Photo 4: View of monitoring well MW11.

- AARCO used a Geoprobe 7822 DT drill rig to install monitoring wells MW11 and MW15.
  - o MW11 consists of a 2-inch-diameter polyvinyl chloride (PVC) monitoring well with 20-slot well screen from about 12 to 22 feet bgs. MW11 will be developed at a future date.
