SITE OBSERVATION REPORT

PROJECT No.: 170381202 DATE: Friday, August 21, 2020

250 Water Street **WEATHER:** Wind: SW @ 4.5 mph (3:13 pm) to CLIENT:

Langan continued implementing Phase 4 of the May 13, 2020 Remedial Investigation Work Plan (RIWP) for New York State Department of Environmental Conservation (NYSDEC) Brownfield Cleanup Program (BCP) Site No. C231127 located at 250 Water Street (Manhattan Block 98, Lot 1).

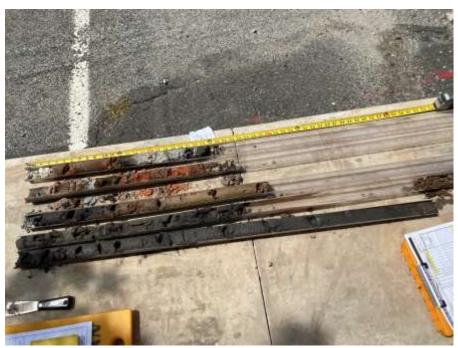
Photo 1: View of soil from boring SB33

- Boring SB33: Boring was advanced to 20 feet bgs. Petroleum-like odors, staining, and PID readings up to 6.6 ppm were observed from about 11 to 16 feet bgs. Visual evidence of elemental mercury was not identified. Total mercury concentrations evaluated with the XRF were less than the LOD.

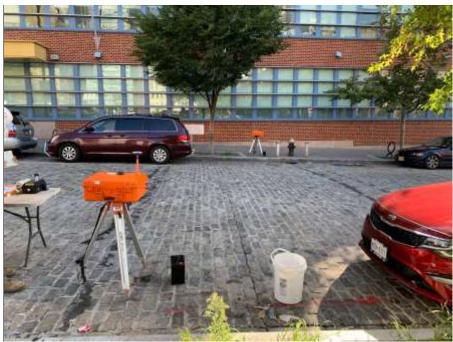
Photo 2: Perimeter CAMP station WZ-1 and off-site CAMP station PM-5 along Peck Slip during the attempted drilling of boring SB34 (facing northeast)

- AARCO installed monitoring wells MW33 and MW32.
- AARCO attempted to advance off-site soil boring SB34/MW34 using a hand augur but encountered refusal. Two additional step-off borings were attempted around the original boring location. Concrete or utility piping was encountered at the refusal depths.

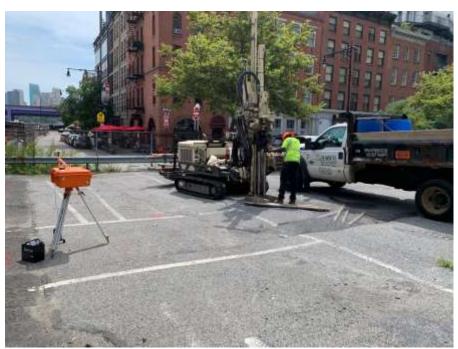
Photo 3: AARCO drilling boring SB32 (facing southeast)

- o Boring SB32: Boring was advanced to 28 feet below grade surface (bgs). Four step-off borings were attempted around the original boring location after refusal was encountered at the original boring location. Petroleum-like odors, staining, and photoionization detector (PID) readings up to 740.1 parts per million (ppm) were observed from about 10 to 22 feet bgs. Visual evidence of elemental mercury was not identified. Total mercury concentrations evaluated with the Niton XL3t XRF (XRF) were less than the limit of detection (LOD).

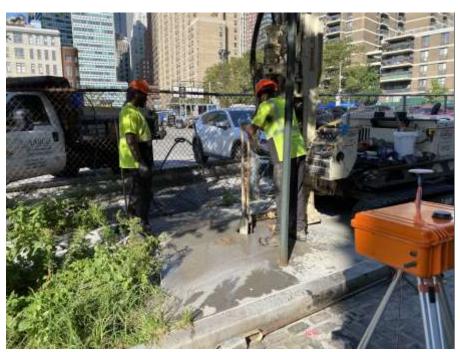
Photo 4: AARCO attempting to hand clear boring SB34 (facing west)
