SITE OBSERVATION REPORT

Thursday, July 6, 2023

250 Water Street

Langan was present to document remediation activities in accordance with the NYSDEC-approved November 2021 Remedial Action Work Plan (RAWP) at the 250 Water Street site (NYSDEC Brownfield Cleanup Program [BCP] Site No C231127).

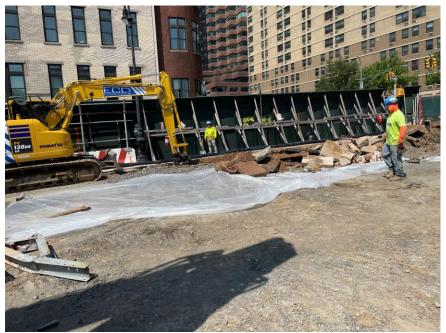
Photo 1: ECD excavating soil/fill along Beekman Street (facing northwest)

- ECD excavated an about 85-foot-long by 5-foot-wide area to a maximum depth of about 4 feet below grade surface (bgs) to identify potential subsurface utilities and/or obstructions prior to support-of-excavation (SOE) installation along Beekman Street.

- o Excavated soil/fill was screened for odors, staining, organic vapors, and mercury vapor using a handheld photoionization detector (PID) and handheld Jerome® J505 mercury vapor analyzer, respectively. Evidence of impacts was not observed and the soil/fill was temporarily stockpiled on and covered with polyethylene sheeting adjacent to the work area for future backfill into the original location.

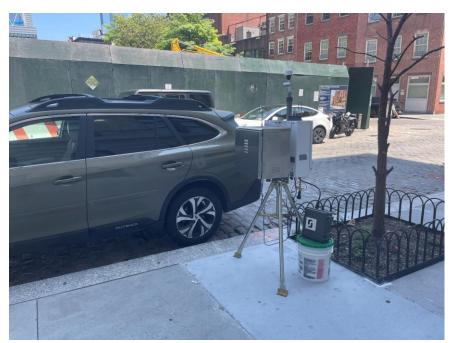
Photo 2: CAMP station WZ-1 on the western sidewalk of Beekman Street (facing southeast)

- CAMP station WZ-1 was relocated to the western sidewalk of Beekman Street from 7:19am to 3:35pm due to ground-intrusive activities along the western boundary of the site.
- CAMP station WZ-2 was relocated to the southern sidewalk of Water Street from 10:53am to 4:01pm due to ground-intrusive activities along the southern boundary of the site.
- CAMP station WZ-4 was relocated to the northern sidewalk of Pearl Street from 6:47am to 3:16pm due to ground-intrusive activities along the northern boundary of the site.
