SITE OBSERVATION REPORT

PROJECT No.: 170381202

250 Water Street

Langan was present to document remediation activities in accordance with the NYSDEC-approved November 2021 Remedial Action Work Plan (RAWP) at the 250 Water Street site (NYSDEC Brownfield Cleanup Program [BCP] Site No C231127).

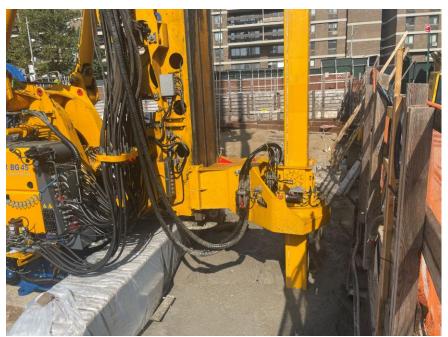
Photo 1: ECD installing a soil mix column in the eastern part of the site (facing north)

- ECD used a Bauer BG45 drill rig to install two deep soil mix columns for support-of-excavation (SOE) installation in the eastern part of the site (along Peck Slip Street). ECD's drill rig advanced a steel rod with two cutter blades at the bottom of the rod, while concurrently injecting grout through the cutting head and spinning and advancing the blades downward to a depth of about 79 feet below grade surface (bgs).

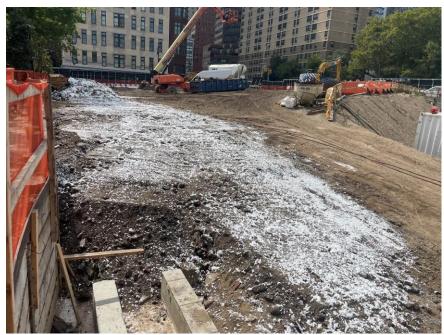
Photo 2: Atmos® AC-645 odor/vapor suppressing foam applied to soil/fill in the southern part of the site (facing northwest)

- Atmos® AC-645 odor/vapor suppressing foam was actively applied to the soil/fill during excavation as a precautionary measure.
