SITE OBSERVATION REPORT

PROJECT No.: 170381202

250 Water Street

BCP SITE ID: C231127

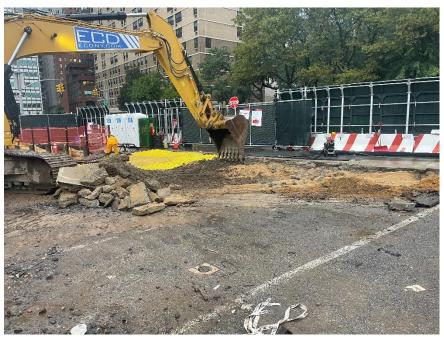
Photo 1: ECD demolishing existing asphalt and concrete in the northern part of the site (facing northwest)

- ECD demolished existing asphalt and concrete in the northern part of the site. The construction and demolition (C&D) debris was temporarily stockpiled and covered with polyethylene sheeting adjacent to the work area pending future off-site disposal.

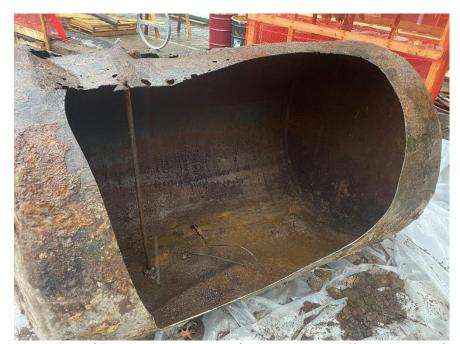
Photo 2: Decommissioned UST in the southern part of the site prior to off-site disposal (facing southeast)

- IRT decommissioned the empty 550-gallon underground storage tank (UST) staged in the southern part of the site. Decommissioning activities included cutting a hole in the UST to render it unusable and cleaning the interior of the tank using absorbent pads. The absorbent pads were containerized in a United Nations /Department of Transportation (UN/DOT)-approved 55-gallon steel drum for off-site disposal. No odors or PID readings were observed during decommissioning of the UST.

- IRT exported the about 550-gallon UST carcass for off-site disposal as scrap metal at the Gershow Recycling facility, located in Brooklyn, New York.
- IRT exported one UN/DOT-approved 55-gallon drum containing spent absorbent pads for off-site disposal at the Republic Environmental Systems facility, located in Hatfield, Pennsylvania.
- No material was imported to the site.
