### SITE OBSERVATION REPORT

**PROJECT No.:** 170381202

250 Water Street

Langan was present to document remediation activities in accordance with the NYSDEC-approved November 2021 Remedial Action Work Plan (RAWP) at the 250 Water Street site (NYSDEC Brownfield Cleanup Program [BCP] Site No C231127).

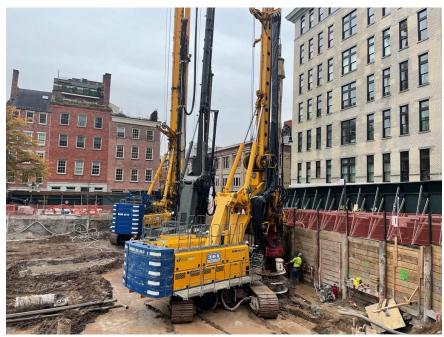
**Photo 1:** ECD installing a secant pile in western part of the site (facing southwest)

- ECD used a Bauer BG 36H drill rig to install one secant pile for the SOE system in the western part of the site (along Beekman Street). The secant piles were advanced to a depth of about 135 feet bgs.

- Drilling spoils generated during installation of the secant piles were screened for odors, staining, organic vapors, and mercury vapor using a handheld photoionization detector (PID) and handheld Jerome® J505 mercury vapor analyzer, respectively. Evidence of impacts was not observed and the drilling spoils were temporarily graded into the adjacent area for future off-site disposal.

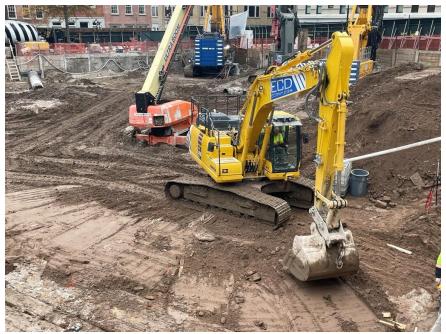
Photo 2: ECD grading soil/fill in northern part of site (facing southwest)

- ECD graded soil/fill in an about 80-foot-long by 20-foot-wide area in the north-central part of the site and an about 50-foot-long by 30-foot-wide area in the western part of the site to stabilize the surface for SOE system installation.

- o Graded soil/fill was screened for odors, staining, organic vapors, and mercury vapor using a handheld PID and handheld Jerome® J505 mercury vapor analyzer, respectively. Evidence of impacts was not observed.
