SITE OBSERVATION REPORT

250 Water Street

Langan was present to document remediation activities in accordance with the NYSDEC-approved November 2021 Remedial Action Work Plan (RAWP) at the 250 Water Street site (NYSDEC Brownfield Cleanup Program [BCP] Site No C231127).

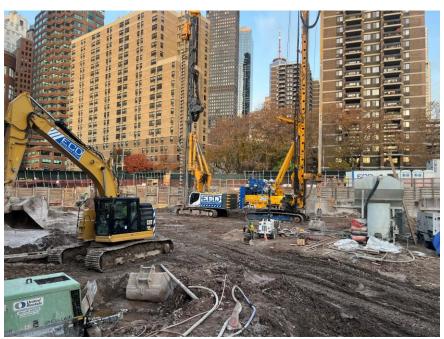
Photo 1: General view of the western part of site (facing north)

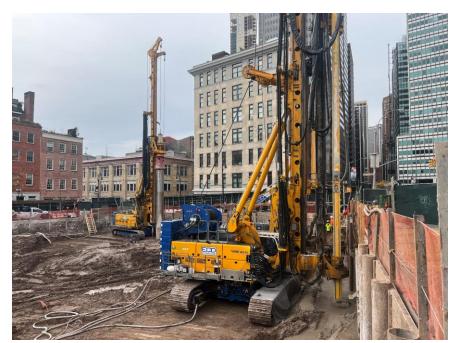
- ECD used a Bauer BG45 drill rig to install two deep soil mix columns in the northern part of the site (along Pearl Street) for the support-of-excavation (SOE) system. ECD's drill rig advanced a steel rod with two cutter blades at the bottom of the rod, while concurrently injecting grout through the cutting head and spinning and advancing the blades downward to a depth of about 120 feet bgs.

Photo 2: ECD installing a soil mix column in the northern part of site (facing west)
