SITE OBSERVATION REPORT

250 Seaport District,

PROJECT No.: 170381202

Langan was present to document remediation activities in accordance with the NYSDEC-approved November 2021 Remedial Action Work Plan (RAWP) at the 250 Water Street site (NYSDEC Brownfield Cleanup Program [BCP] Site No C231127).

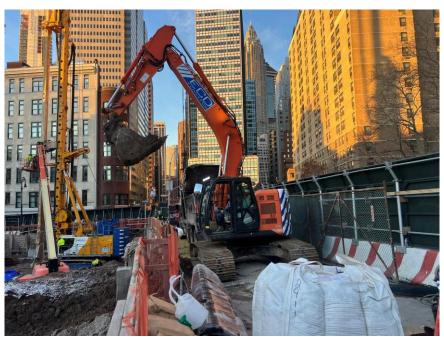
Photo 1: ECD loading a truck with soil/fill for off-site disposal (facing west)

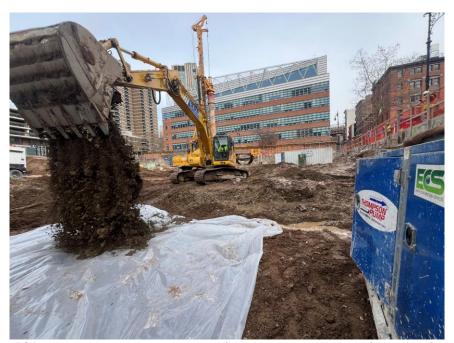
- ECD excavated an about 30-foot-long by 30-foot-wide area to a maximum depth of about 5 feet below the existing grade (approximately 15 feet bsg) in the southern part of the site (waste characterization cells WC06) for off-site disposal of non-hazardous soil/fill.

Photo 2: ECD excavating non-hazardous soil/fill in the southern part of the site (facing east)
