**Reference: #C241005 - Review Avenue Development II Site (RAD II)
Long Island City, Queens, New York
Period Review Report #3 – April 1, 2019 through March 31, 2020**

**Enclosure 2
NEW YORK STATE DEPARTMENT OF ENVIRONMENTAL CONSERVATION
Site Management Periodic Review Report Notice
Institutional and Engineering Controls Certification Form**

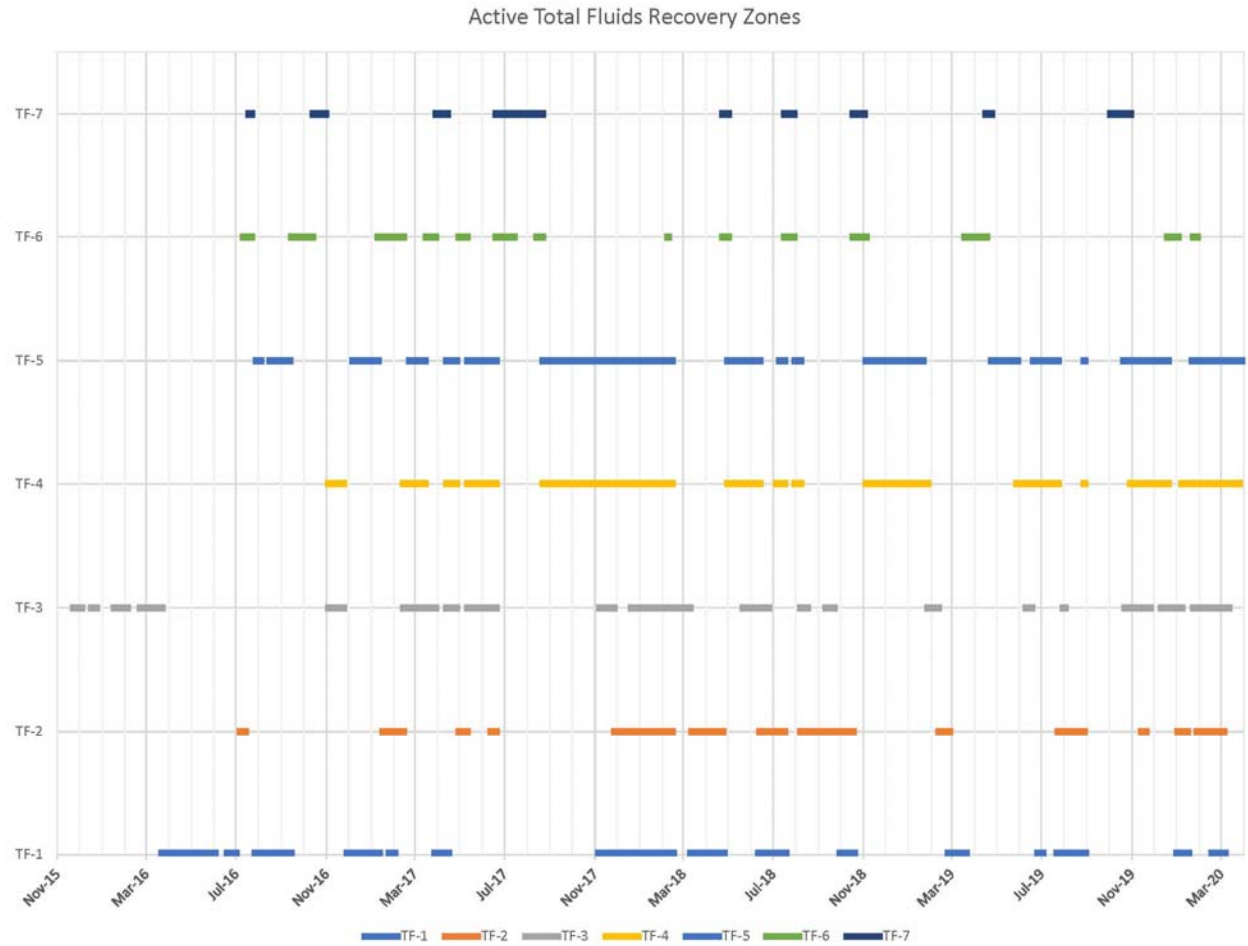
Ten (10) VER/TF wells are installed on RAD I and twenty (20) VER/TF wells are installed on the RAD II Site. VER applies a vacuum at the extraction well head, creating a pneumatic gradient causing air flow and enhanced product flow through the formation towards the extraction well. TF pumping creates a hydraulic cone of depression to further enhance the recovery of LNAPL, along with the VER, in areas where higher viscosity LNAPL present. Thirty (30) VER wells were installed and associated control systems on RAD I and RAD II. Of the total recovered and disposed of LNAPL volume, 324,365 gallons were recovered by the VER/TF recovery system to date and 29,287 gallons for the reporting period. The VER/TF system had a monthly average production of 87 gallons per calendar day with a peak monthly average of 235 gallons per calendar day and a minimum monthly average of 8 gallons per calendar day for the reporting period. When taking into account system uptime and normalizing the production per equivalent system run-day, the VER/TF recovery system averaged 110 gallons per run-day which represents a 80% decrease from the 549 gallon per run-day average production rate realized during the first 16-1/2 month reporting period. The VER/TF recovery system had a total of 29,144 run hours to date and 7,242 hours for the reporting period. Actual system uptime averaged 88.96% for the year ranged from a low of 77.3% to a high of 100%. System uptime increased significantly from the 68.02% average realized during the first 16-1/2 months of operation. This uptime improvement is largely a result of upgrading the Oil/Water separation system with the addition of a Tube Skimmer and changing the type of Biocide injected which does not impact the performance of the Sequestering Agent. The

following table provides a graphic summary of extraction zone operations during the reporting period.

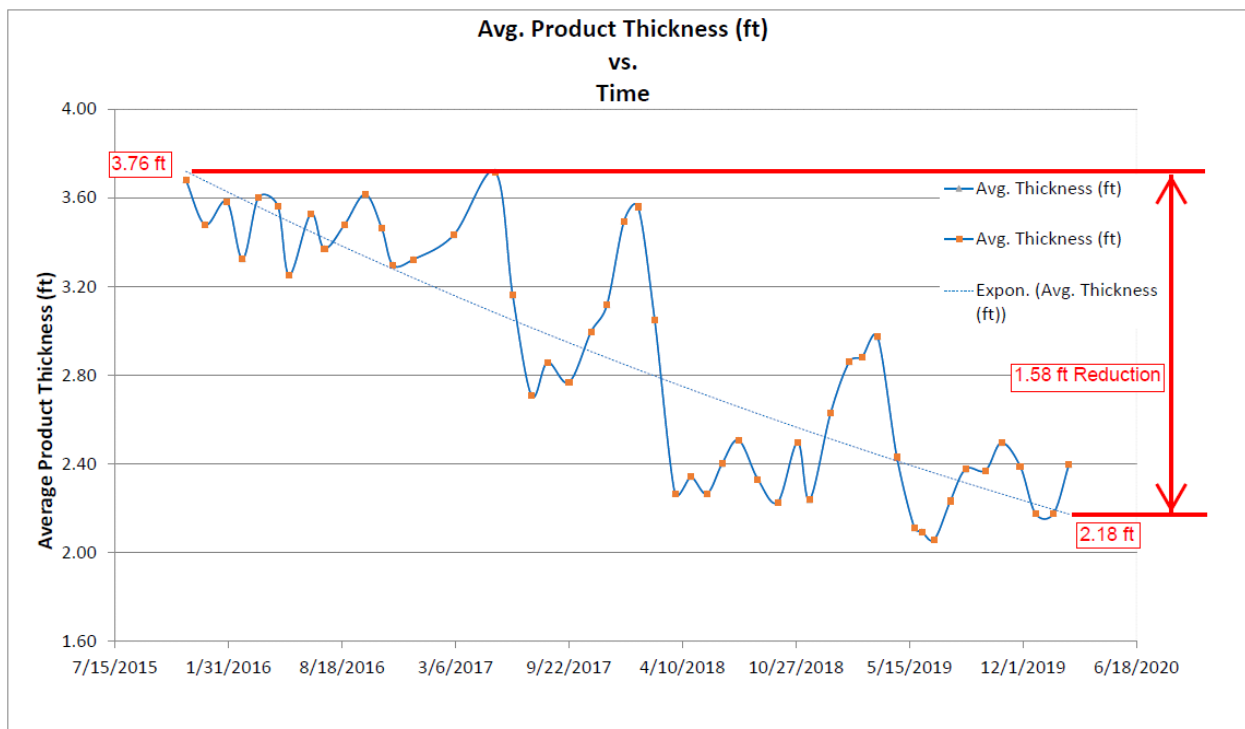
2.4.1 LNAPL Gauging

Site wide LNAPL gauging events at thirty-three (33) LNAPL monitoring wells on RAD I and RAD II provide evidence that average LNAPL thickness is trending downwards across the site and has decreased by approximately 1.58 feet (on average) at the end of February 2020 as illustrated in the figure below (the March 2020 gauging event was canceled due to COVID 19 safety concerns). This average thickness decrease is significantly greater than the 0.17 feet average decrease presented approximately three (3) years earlier at the end of March 2017, 0.68 feet average decrease presented two (2) years earlier at the end of March 2018 and 1.44 feet average decrease presented one (1) year earlier at the end of March 2019.
